Savannah (SC 170, US 17) and Pinckney Island (US 278) National Wildlife Refuges

Road Safety Audit

Beaufort and Jasper Counties, South Carolina

March 5-6, 2008

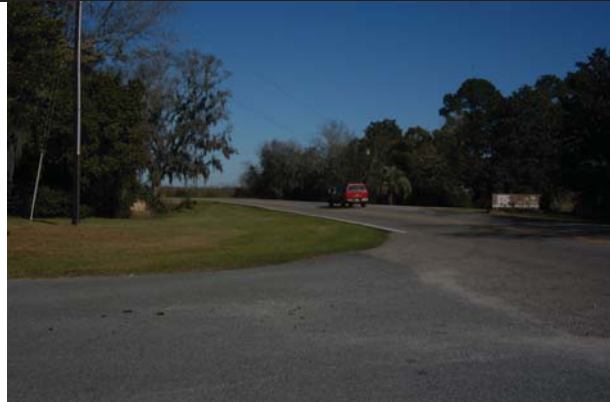
Lack of turn-lanes along SC-170 and US-17 at Savannah NWR access points and proposed visitor center. There are no turn-lanes from SC-170 at the entrances to the maintenance facility and the wildlife drive. There are currently no turn lanes along US-17 at the entrance to the proposed visitor center; however, there are plans to install a right-turn lane during construction of the visitor center. These are high-speed roadways and turn lanes help to separate turning-vehicles from through traffic. This is a particular concern because there is heavy truck traffic along these routes. To compound the issue, there is a horizontal curve near the access point to the maintenance facility, which limits sight distance.

View of access points to maintenance facility and Savannah NWR wildlife drive. This photo illustrates the lack of turn lanes at the access points and the horizontal curve that limits sight distance.

Suggestion: Install right- and left-turn lanes at access points to Savannah NWR facilities. Particularly at the maintenance facility, entrance to the wildlife drive, and entrance to the proposed visitor center. Left-turn lanes on rural roads can be expected to experience a 48% reduction in crashes when compared to a stop-controlled intersection without left-turn lanes (FHWA-SA-07-015).

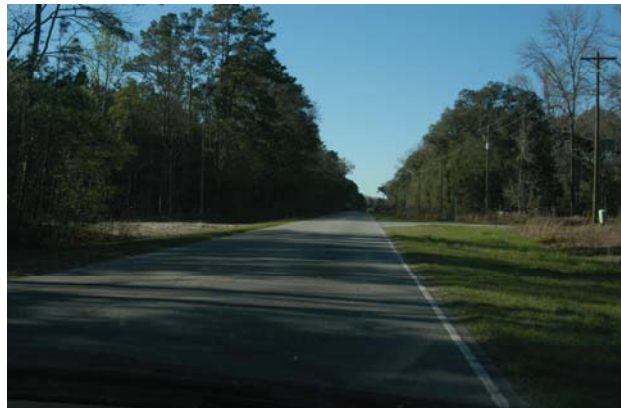
View of US-17 near the new visitor center. The photo shows the entrance to the new visitor center on the left and Sawgrass St. on the right. The photo illustrates that there appears to be space (not necessarily right-of-way) to provide turn lanes for the entrance and the residential street.

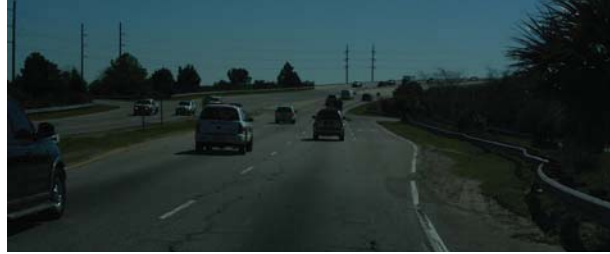
lanes on US-278: While turn lanes and acceleration lanes are installed on US-278 at Pinckney Island, the length of the turn and acceleration lanes appear to be relatively short. This is a particular concern for vehicles towing boats because these vehicles require greater stopping and acceleration distances. Current limitations (i.e., bridges on either side of the entrance to Pinckney Island) restrict the possible lengthening of the turn lanes.

View of US-278 eastbound just prior to the entrance of Pinckney Island. There is a right- and left-turn lane from US-278, but the lengths are relatively short. The photo also shows one of the nearby bridges that restricts the length of turn lanes in the westbound direction.

Suggestion: Consider lengthening turn and acceleration lanes when US-278 is upgraded from a 4-lane to 6-lane cross-section. The widening of US-278 will likely not be completed for many years due in large part to projected project costs, which are estimated at over \$155 million dollars. In the interim, one option may be to provide an underpass between the boat access and the Pinckney Island NWR. This could be done at a fraction of the cost. An underpass would eliminate left-turns and crossing movements at this location and all movements would be right-in and right-out only. The underpass could potentially be constructed under the bridge to the east of the entrances. See Appendix B for illustration of proposed underpass.

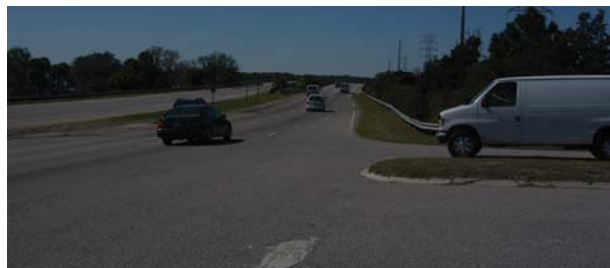
View of US-278 westbound from the entrance to the Pinckney Island NWR. Photo shows the limited acceleration lane for vehicles entering US-278.

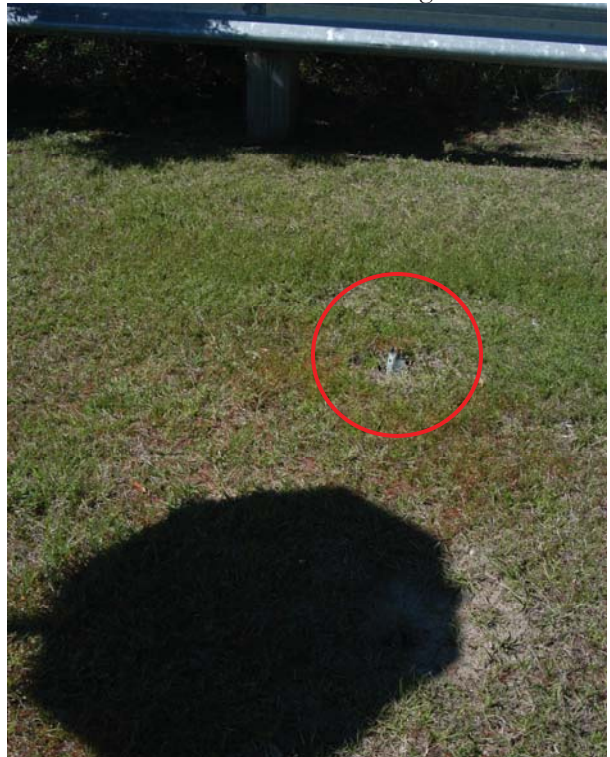
Evidence of overshooting the right turn lane may be found in the number of severed sign posts on the NW corner and guardrail strikes on the SE corner.

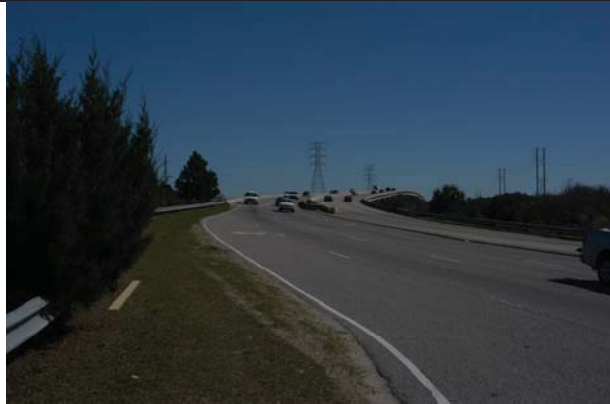
Access on horizontal curves: *The access to Pinckney Island NWR and the Savannah NWR maintenance facility are located on horizontal curves. The horizontal curve at Pinckney Island is compounded by vertical curvature. Horizontal and vertical curvature limits sight distance for motorists traveling along US-278 and SC-170, and also for motorists exiting the NWR facilities.*

View of US-278 to the east of the entrance to Pinckney Island NWR. Photo shows the horizontal and vertical curvature that limit sight distance near the entrance.

Suggestion: Consider trimming the vegetation at the entrance to the Savannah NWR maintenance facility to improve sight distance along the horizontal curve. Advance intersection warning signs along US-278 and SC-170 may be appropriate to warn drivers on the mainline of crossing or entering vehicles (see Issue 2: Signage and Pavement Markings). Controlling vehicles speeds on the curve on SC-170 may be another option, provided a formal speed study is conducted that demonstrates speeding is an issue. Refuge staff believed this to be an issue. “Optical speed bars”, are used to reduced vehicles speeds approaching and entering the curve. The bars are spaced such that it appears to the motorist that they are going faster than they actually are and therefore they will reduce their speed to compensate

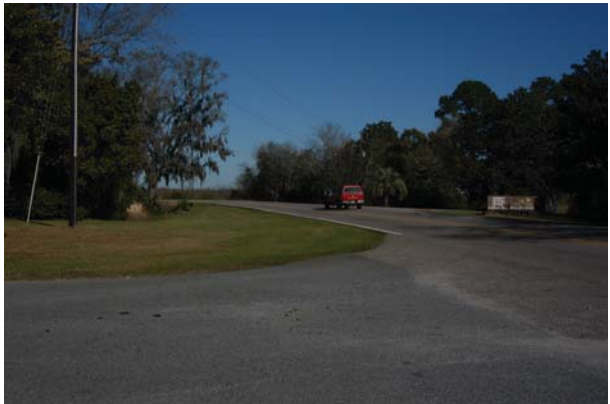
View of the entrance to the Savannah NWR maintenance facility. Photo shows that the entrance is located near a horizontal curve, which limits the view of the entrance from SC-170.

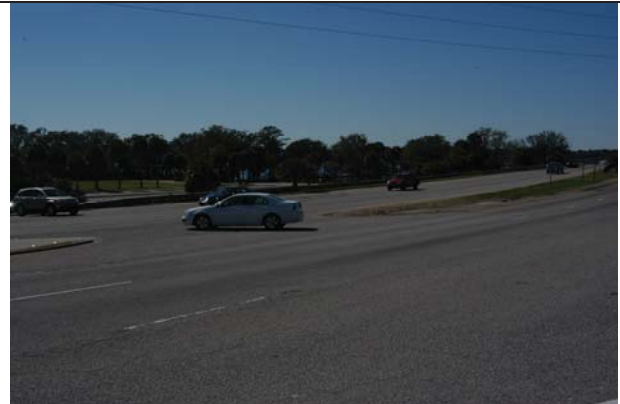
There was a lack of guidance within the median opening at the access to the boat launch and Pinckney Island NWR along US-278. Lack of guidance is particularly critical at night where motorists waiting in the median opening may have difficulty positioning their vehicle where it is not conflicting with through traffic.

View of median opening at the entrance to Pinckney Island NWR. The photo illustrates the lack of pavement markings and delineation within the median opening. As a result, motorists are unsure where to position themselves in the median, which leads to conflicts in the median and potential sight distance obstructions.

Suggestion: Delineate nose of median openings at access points with pavement markings and post-mounted delineators. Also consider installing STOP bars and double yellow centerline in median openings to provide better guidance.

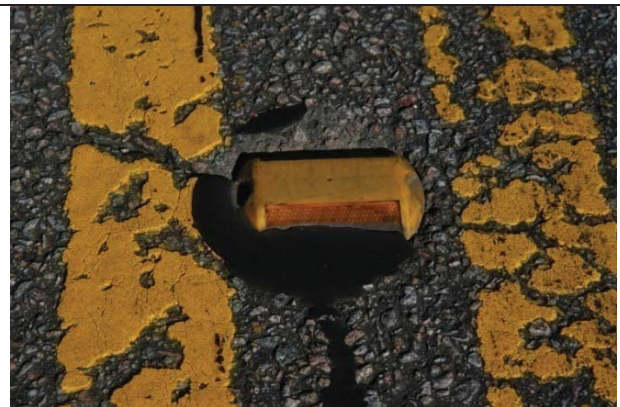
Roadway Delineation: *Guidance measures for motorists during nighttime and poor visibility conditions are worn or missing. Specifically, the pavement markings are faded and raised pavement markers (RPMs) are missing in several sections. There is also no supplemental guidance (e.g., post-mounted delineators) in curved sections.*

Photo shows an example of how the pavement markings are deteriorating. The photo also shows an example of a raised pavement marker.

- Upgrade to retroreflective signs and pavement markings.
- Replace missing RPMs.
- Install post-mounted delineators along corridor, especially at horizontal curves. Post-mounted delineators on rural two-lane curves reduced run-off-road crashes by 15 percent (Foody and Taylor, 1966). The FHWA Low Cost Safety Improvements Workshop indicates that post-mounted delineators reduce run-off-road crashes between 25 to 58 percent.

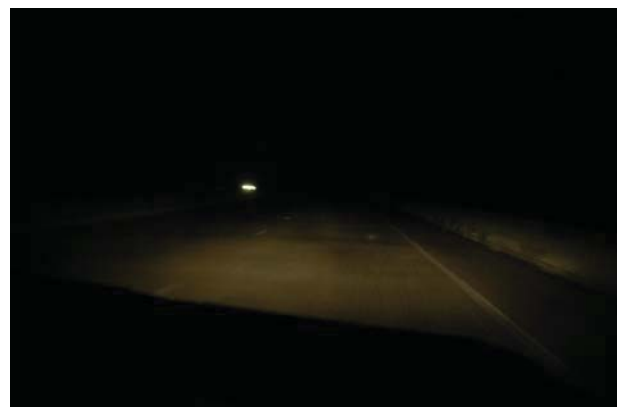
Photo shows the lack of guidance at night due to the faded pavement markings and lack of delineators.

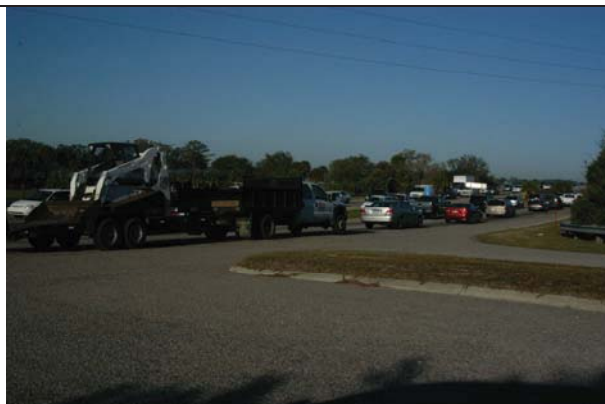
Stop and go traffic on US-278: In the morning, commuters and visitors are traveling to Hilton Head Island and the traffic is stop-and-go in the eastbound direction. In the evening, the problem occurs in the westbound direction. Crash data reflects this condition with the high percentage of rear-end collisions along this section (50 percent). To compound the issue, this can be a heavy fog area and there is horizontal and vertical curvature along US-278. Special events in Savannah, GA may also create congestion.

View of US-278. Photo shows the heavy traffic congestion in both directions during the morning peak period.

Suggestion: The long-range plans to widen this section of US-278 to a six-lane facility will help to alleviate the congestion and reduce rear-end crashes. A short-range consideration may be to place BE PREPARED TO STOP (W3-4) signs in the area where traffic can be expected to stop due to congestion. A medium-range consideration may be to install a similar warning sign with flashers that activate during periods of congestion or to deploy a traffic warning system such as a variable message sign to warn motorists of slow or stopped traffic during periods of heavy congestion.

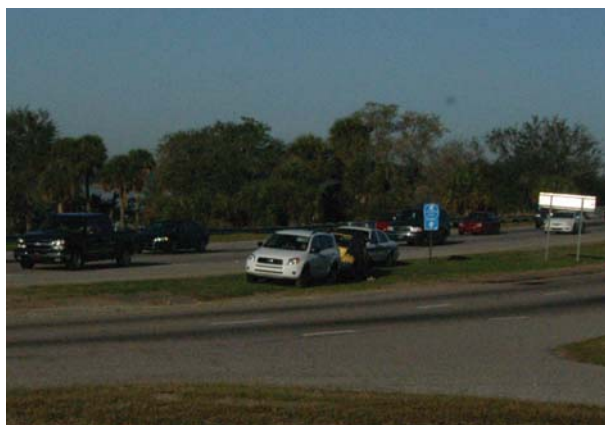
View of US-278 from the entrance to Pinckney Island. Photo shows a rear-end crash that occurred during the morning peak period when traffic congestion was creating stop-and-go conditions.

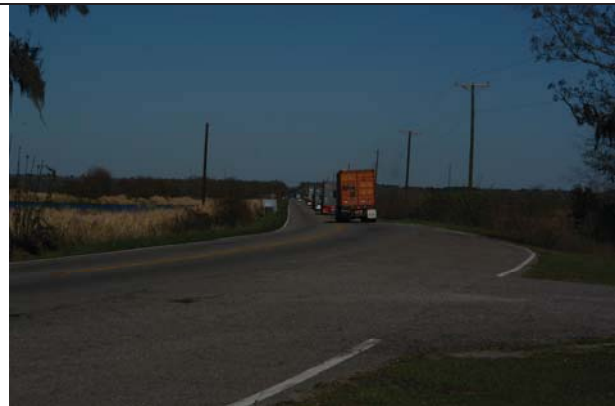
Narrow or no paved shoulders: There is a lack of paved shoulders along US-278, US-17, and SC-170 limiting access for bicyclists and also reduces the recovery area for errant vehicles.

View of SC-170 eastbound. Photo shows the lack of paved and unpaved shoulders, particularly along the horizontal curve. The photo also illustrates the significant truck traffic along this route.

Suggestion: Consider increasing shoulder width, especially on horizontal curves and near access points. Increasing shoulder width near access points provides an area for right-turning vehicles to decelerate and get out of the traffic stream. Normal resurfacing projects include a 2 ft paved shoulder, which would improve existing conditions. Adding a 2 ft shoulder can be expected to reduce run-off-road and sideswipe crashes by about 13 percent (Harwood et al., 2000) to 16 percent (FHWA-SA-07-015).

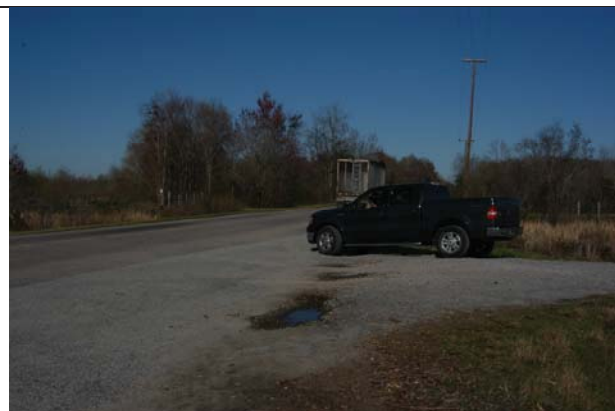
Rough transition from wildlife drive exit to SC-170: The exit from the wildlife drive onto SC-170 is not a smooth transition. There are several pot holes at the exit and a grade change between the shoulder and the drive. This rough transition causes motorists to traverse the area at relatively low speeds while entering a high-speed roadway.

View of exit from Laurel Hill Wildlife Drive to SC-170. Photo shows the rough transition from the wildlife drive onto SC-170.

Suggestions: Consider improving the transition from the wildlife drive exit onto SC-170. This will allow motorists to enter SC-170 at greater speeds.

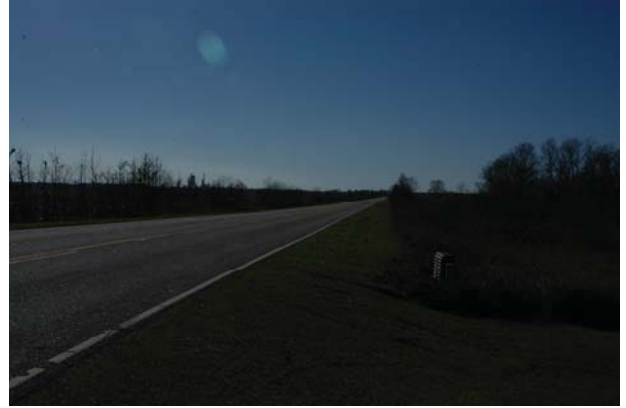
Drop-offs on levees: SC-170 is built along levees within the study area. As noted previously, there are no guardrails along the roadway to prevent vehicles from running off the road. Furthermore, there are no paved shoulders and limited unpaved shoulders. Run-off road crashes were noted as a particular concern by the staff at the Savannah NWR. These crashes were not recorded with a police report because once the vehicle leaves the road, the motorist is responsible for removing the vehicle.

View of SC-170 near the entrance to the Savannah NWR maintenance facility. Photo shows the lack of shoulders and guardrail as well as the drop-off from the roadway into the wetlands.

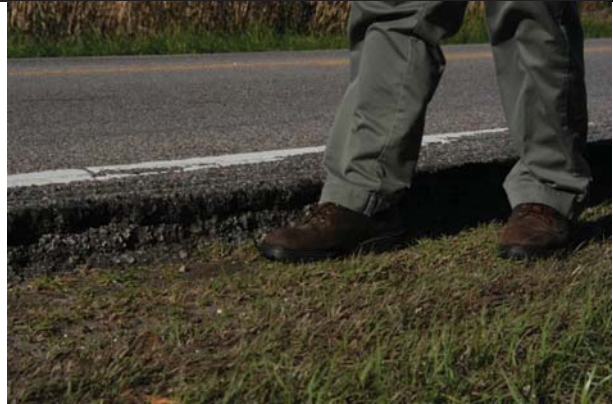
Pavement edge drop-offs: Pavement edge drop-offs were identified as a safety concern along sections of SC-170 and US-17. This is a particular safety concern because drivers may over-correct when they leave the roadway, which can lead to cross-over, head-on crashes or run-off-road crashes.

Example of large pavement edge drop-off along SC-170 near the entrance to the Laurel Hill Wildlife Drive.

Suggestions: Consider using a beveled “safety edge” during resurfacing projects. Also, consider maintenance practices including shoulder stabilization to prevent pavement edge drop-offs. Shoulder stabilization is particularly important due to the large truck volumes on these roads. Correcting shoulder edge drop-offs can reduce run-off-road and head-on crashes because the beveled edge allows for a more controlled recovery at a less sharp angle.

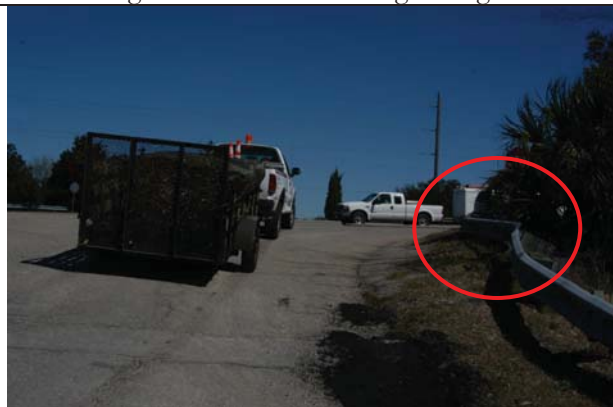
Damaged guardrail: The guardrail is currently damaged to the point where it will not function properly on the southeast corner of the entrance to the boat access along US-278. It is likely that this section was damaged from a vehicle that misjudged the length of the right-turn lane (see Issue 1).

View of entrance to boat launch along US-278 across from the Pinckney Island NWR. Photo shows the damaged guardrail in the southeast quadrant of the intersection.

Suggestions: Replace the section of damaged guardrail so that it functions properly in the event that another errant vehicle runs off the road in the same location.

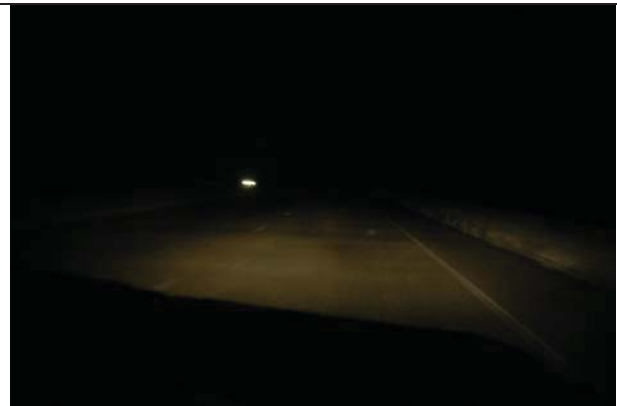
Nighttime guidance: *There is a general lack of guidance along the US-278, US-17, and SC-170 corridors. Specifically, there is a lack of guidance (i.e., pavement markings and delineators) at median openings on US-278. Along US-17 and SC-170, the pavement markings are faded and raised pavement markers (RPMs) are missing.*

View along study section of US-278 at night. Photo shows the lack of nighttime guidance due to the faded pavement markings and lack of raised pavement markers along the centerline.

- Install or replace raised pavement markers along the centerline.
- Install high-visibility pavement markings.
- Install high-intensity signs.
- Delineate nose of median opening using pavement markings and post-mounted delineators.
- Install double yellow centerline and STOP bar in median opening.

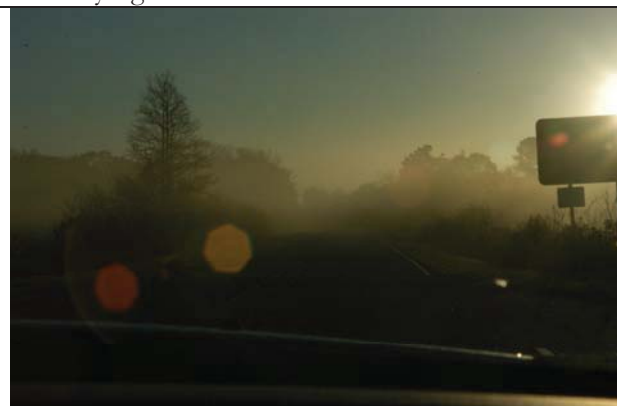
Fog: *Fog is a common occurrence along these sections of US-278 and SC-170. To compound this issue, there is heavy traffic congestion along US-278 and heavy truck traffic along SC-170. At certain times, particularly dawn and dusk, the sun can interact with the fog to produce even greater visibility issues.*

Photo shows the effect of fog and glare along SC-170 in the early morning hours. Roadway alignment is difficult to see as are roadway signs.

Suggestion: Consider fog-warning system to detect presence of fog and provide advisory speeds for motorists.

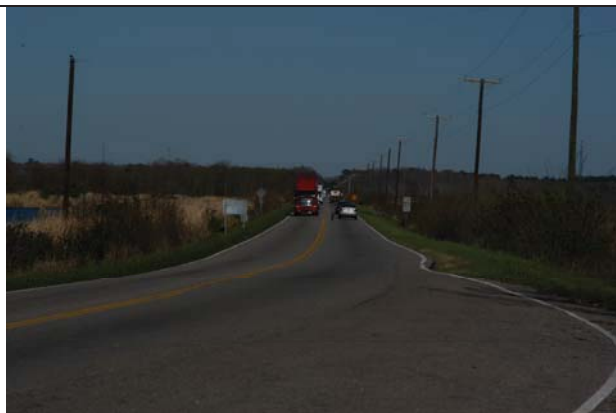
View of SC-170 between the access points to the Laurel Hill Wildlife Drive. Photo shows the lack of shoulders and bicycle access between the access points to the wildlife drive. The photo also shows truck traffic on this roadway, which creates an even greater hazard for bicyclists due to their width and the wind blasts caused by high speed passing.

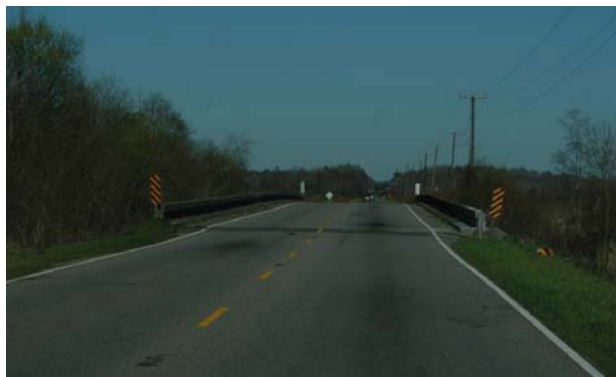
View of typical bridge along SC-170. Photo shows the limited shoulder area along the bridge that does not provide adequate separation for bicyclists and pedestrians. One suggestion is that when bridges are replaced, widen shoulders per SCDOT standards to provide adequate separation between vehicles and bicyclists.
