The Road Inventory of Cabeza Prieta National Wildlife Refuge Ajo, Arizona

Prepared By:
Federal Highway Administration
Central Federal Lands Highway Division
March & April 2008

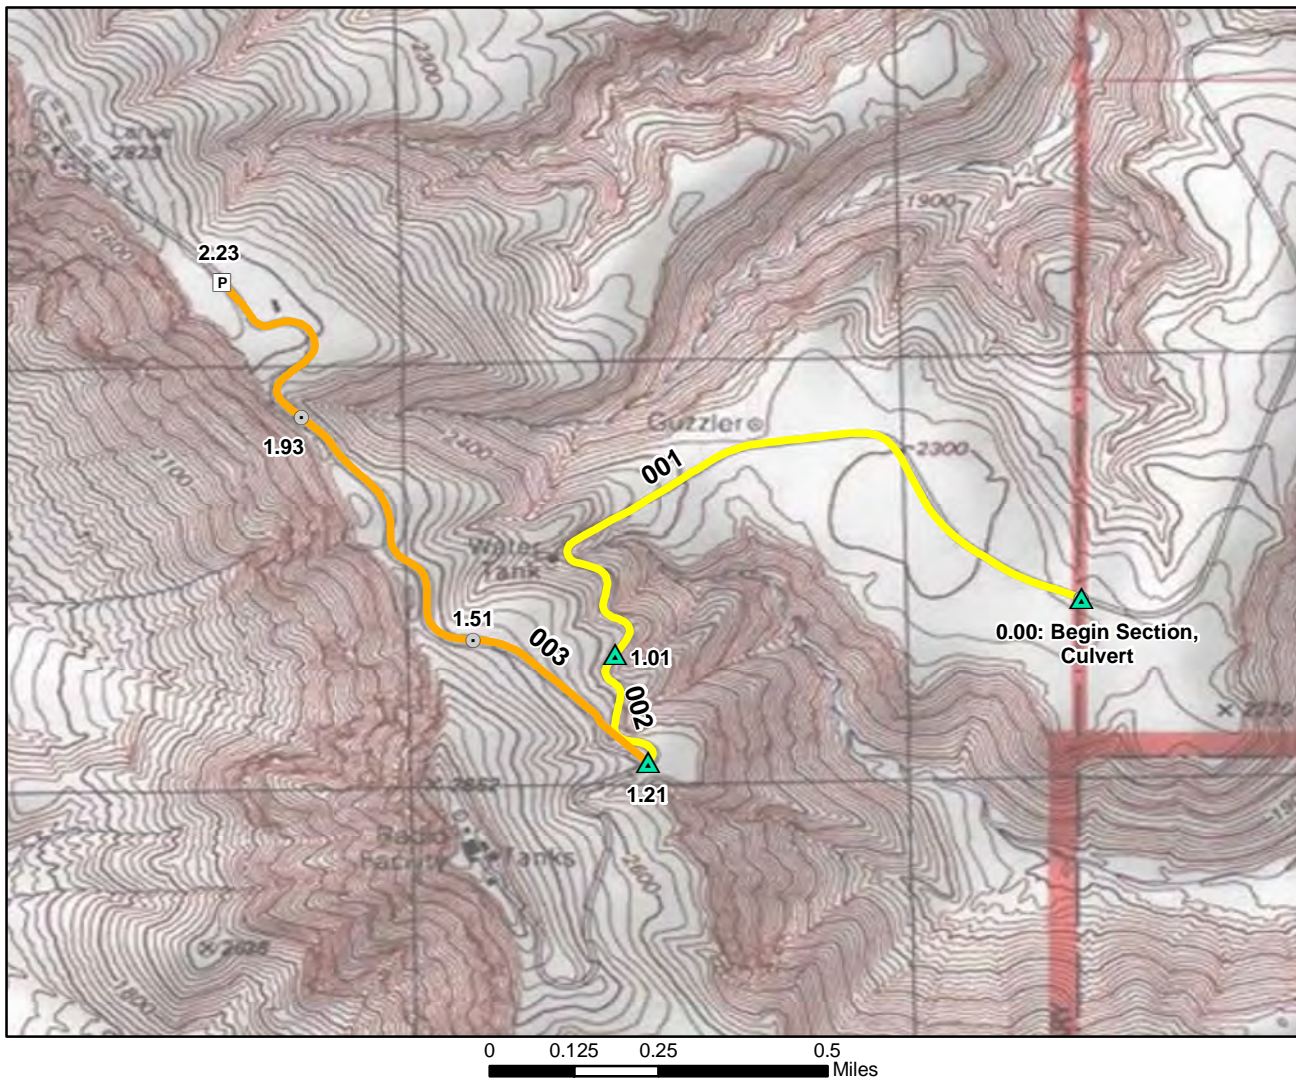
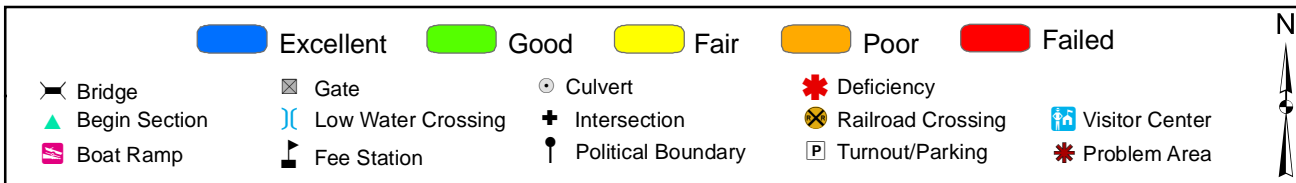
ROUTE: 101 Childs Mountain Road TOTAL LENGTH: 2.24 Miles

Section Number	001	002	003		
Section Length (miles)	1.01	0.20	1.03		
Inspection Date	3/31/2008	3/31/2008	3/31/2008		
Section Information					
Surface Type	Asphalt	Asphalt	Asphalt		
Number of Lanes	2	2	2		
Roadway Width (feet)	20	20	18		
Roadway Condition Information					
Condition	Fair	Fair	Poor		
Remaining Service Life (years)	10	10	4		
Cost Estimate	\$110100	\$21800	\$612300		
CRV	\$1218800	\$241300	\$1242900

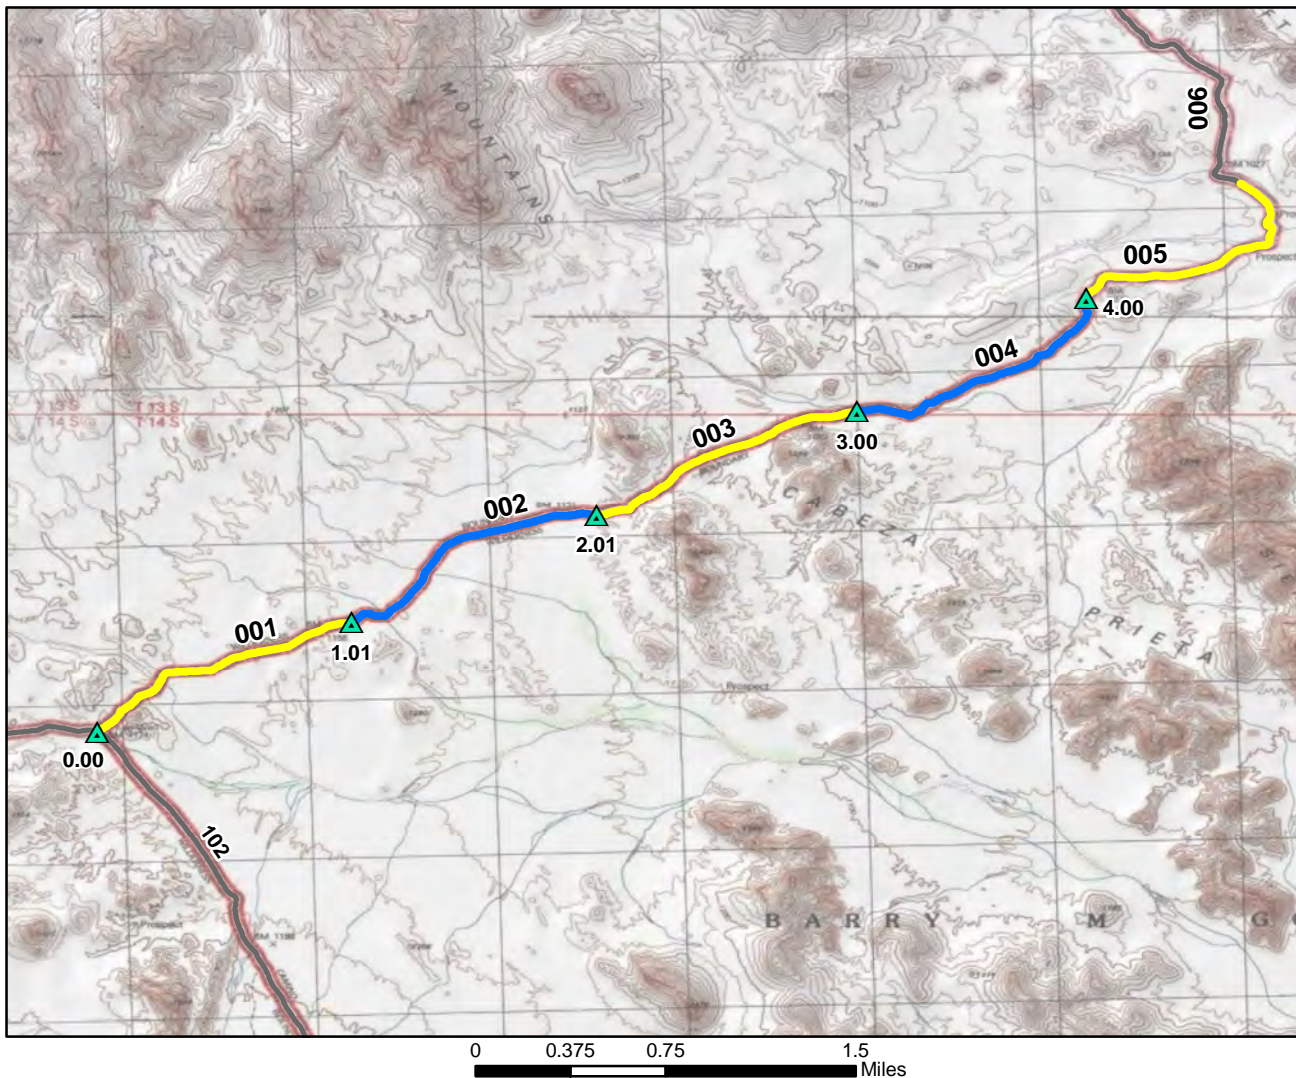
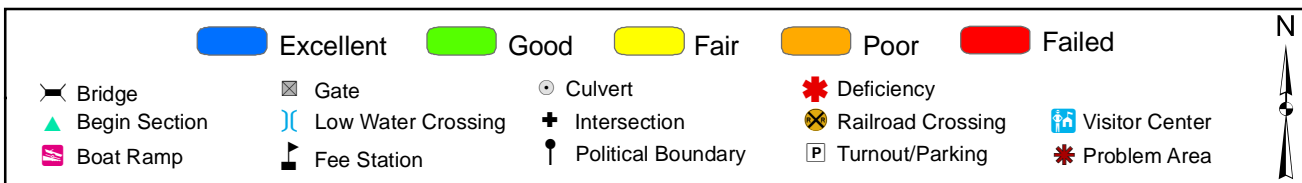
ROUTE: 400 Christmas Pass Road TOTAL LENGTH: 17.57 Miles

Section Number	001	002	003	004	005
Section Length (miles)	1.01	1.00	1.00	1.00	0.99
Inspection Date	4/1/2008	4/1/2008	4/1/2008	4/1/2008	4/1/2008
Section Information					
Surface Type	Native	Native	Native	Native	Native
Number of Lanes	1	1	1	1	1
Roadway Width (feet)	10	10	10	10	10
Roadway Condition Information					
Condition	Fair	Excellent	Fair	Excellent	Fair
Remaining Service Life (years)	3	8	3	8	3
Cost Estimate	\$2200	\$0	\$2200	\$0	\$2200
CRV	\$363400	\$359800	\$359800	\$359800	\$356200

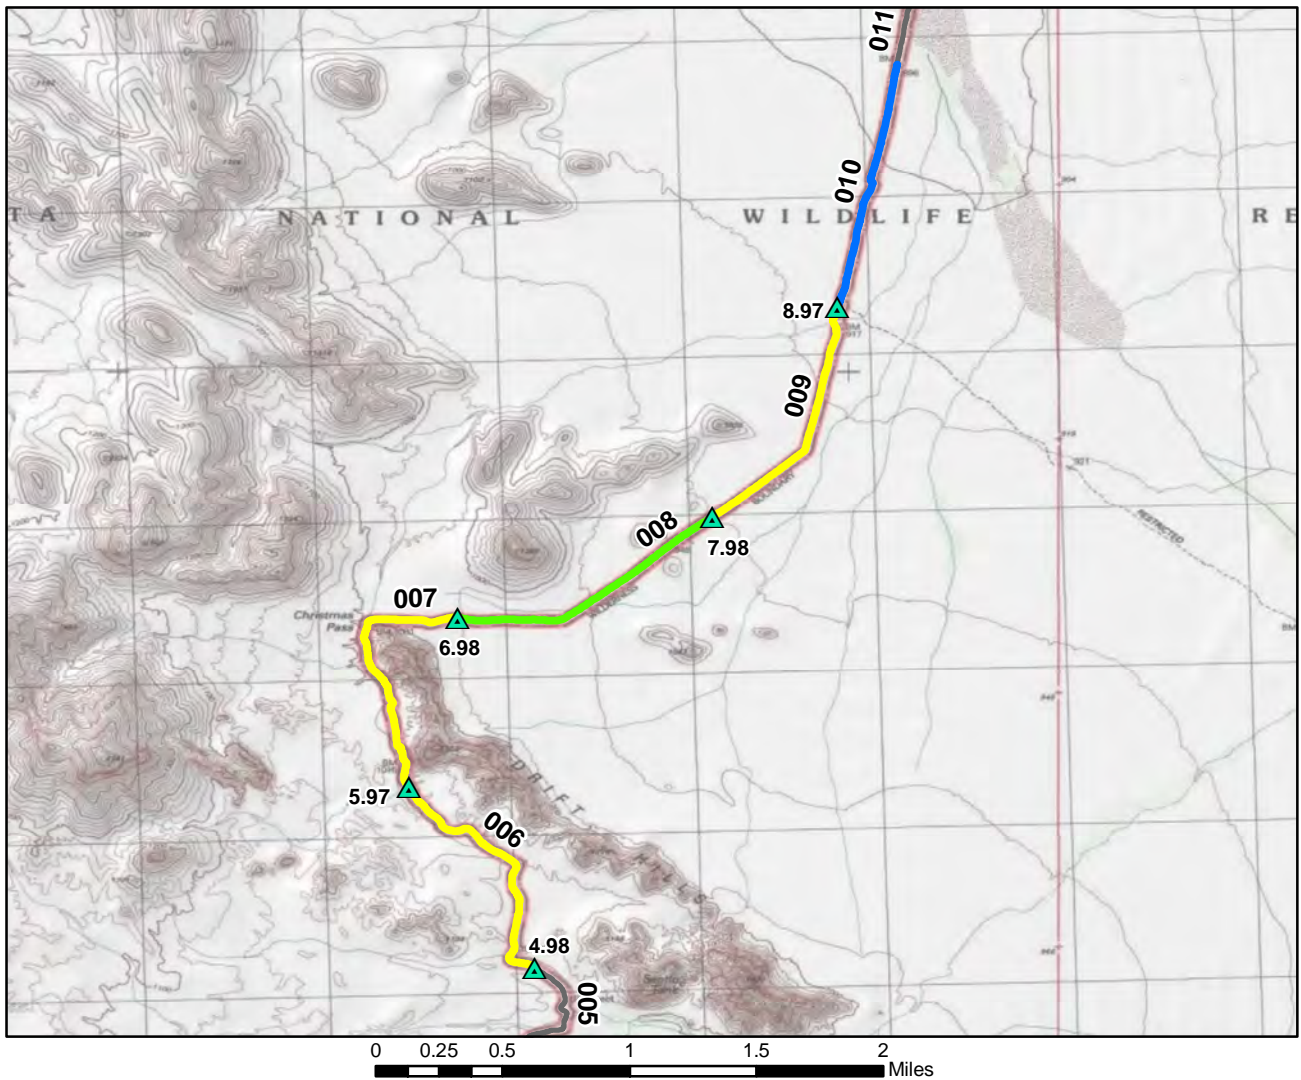
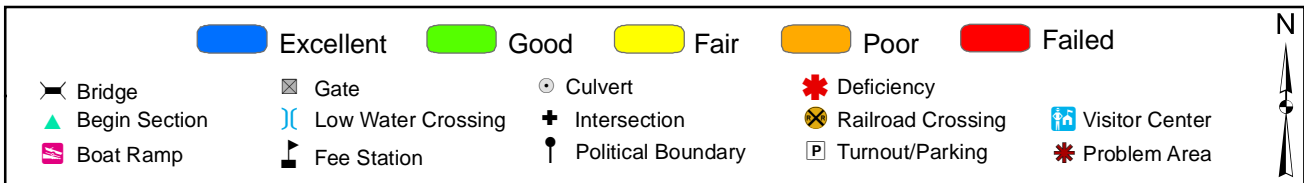
ROUTE: 400 Christmas Pass Road

Section Number	006	007	008	009	010
Section Length (miles)	0.99	1.01	1.00	0.99	0.99
Inspection Date	4/1/2008	4/1/2008	4/1/2008	4/1/2008	4/1/2008
Section Information					
Surface Type	Native	Native	Native	Native	Native
Number of Lanes	1	1	1	1	1
Roadway Width (feet)	10	10	10	10	10
Roadway Condition Information					
Condition	Fair	Fair	Good	Fair	Excellent
Remaining Service Life (years)	3	3	7	3	8
Cost Estimate	\$2200	\$2200	\$1700	\$2200	\$0
CRV	\$356200	\$363400	\$359800	\$356200	\$356200

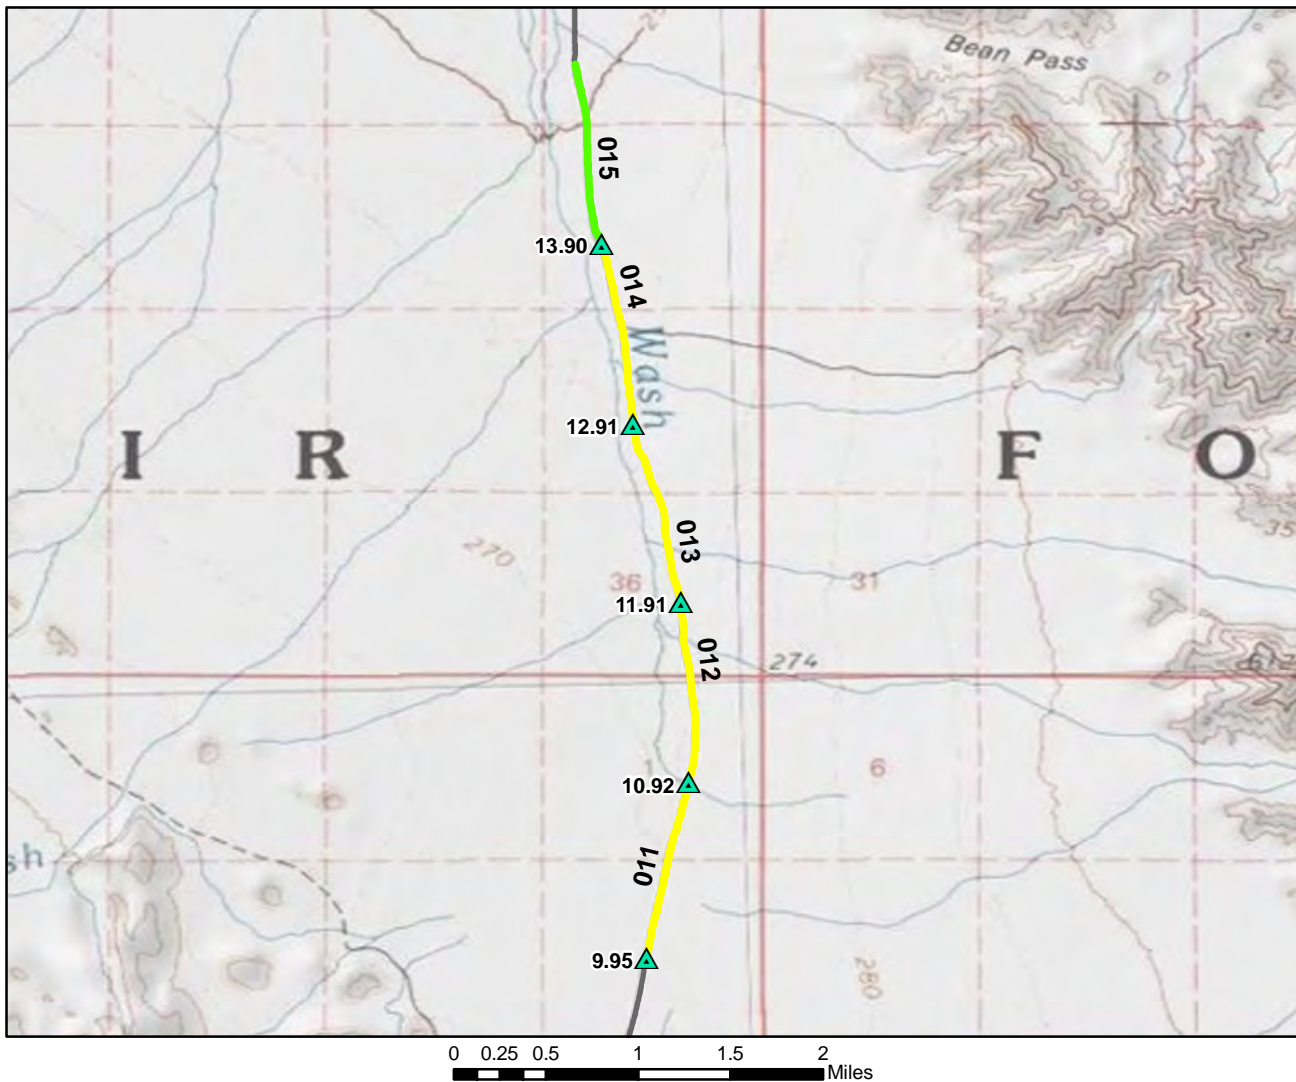
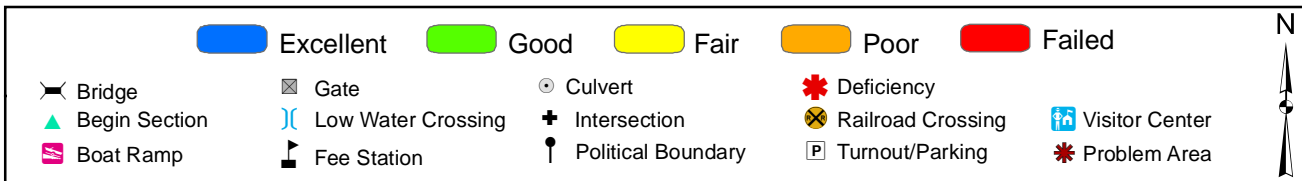
ROUTE: 400 Christmas Pass Road

Section Number	011	012	013	014	015
Section Length (miles)	0.97	0.99	0.99	0.99	0.98
Inspection Date	4/1/2008	4/1/2008	4/1/2008	4/1/2008	4/1/2008
Section Information					
Surface Type	Native	Native	Native	Native	Native
Number of Lanes	1	1	1	1	1
Roadway Width (feet)	10	10	10	10	10
Roadway Condition Information					
Condition	Fair	Fair	Fair	Fair	Good
Remaining Service Life (years)	3	3	3	3	5
Cost Estimate	\$2100	\$2200	\$2200	\$2200	\$1700
CRV	\$349000	\$356200	\$356200	\$356200	\$352600

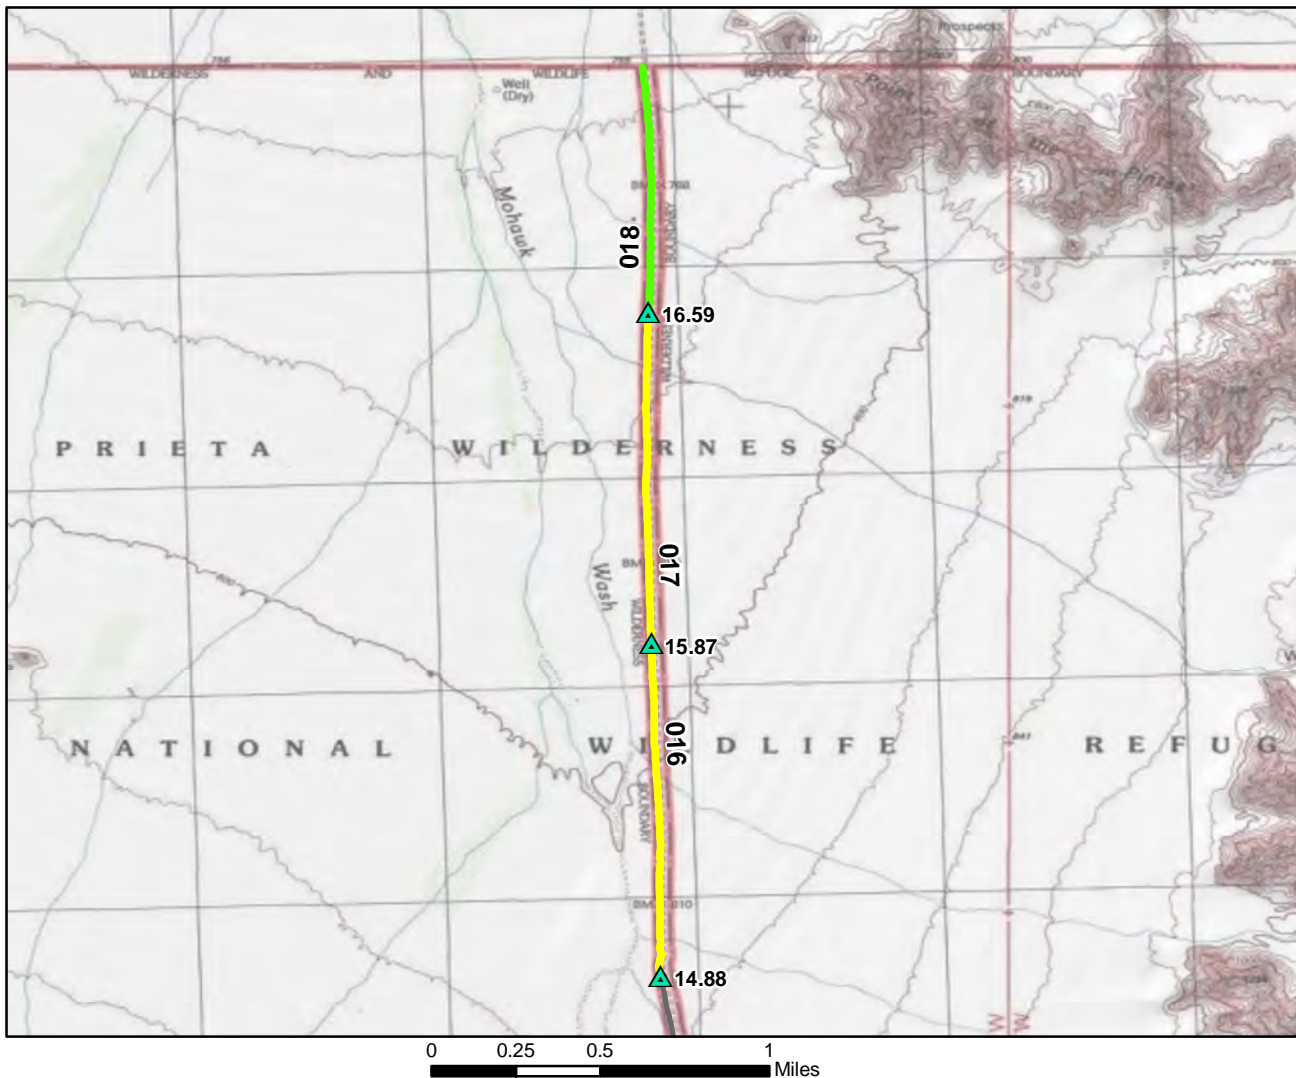
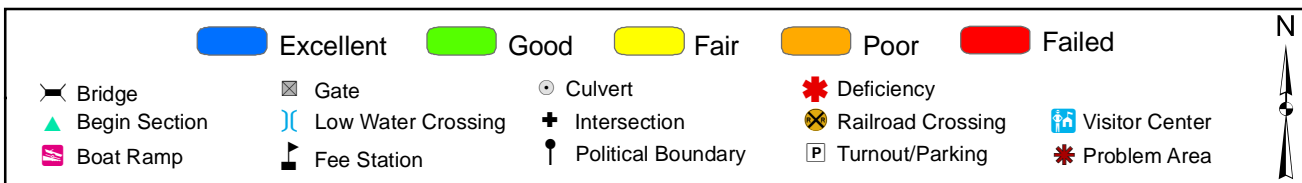
ROUTE: 400 Christmas Pass Road TOTAL LENGTH: 17.57 Miles

Section Number	016	017	018		
Section Length (miles)	0.98	0.98	0.72		
Inspection Date	4/1/2008	4/1/2008	4/1/2008		
Section Information					
Surface Type	Native	Native	Native		
Number of Lanes	1	1	1		
Roadway Width (feet)	10	10	10		
Roadway Condition Information					
Condition	Fair	Fair	Good		
Remaining Service Life (years)	3	3	5		
Cost Estimate	\$2100	\$2100	\$1200		
CRV	\$352600	\$352600	\$259100

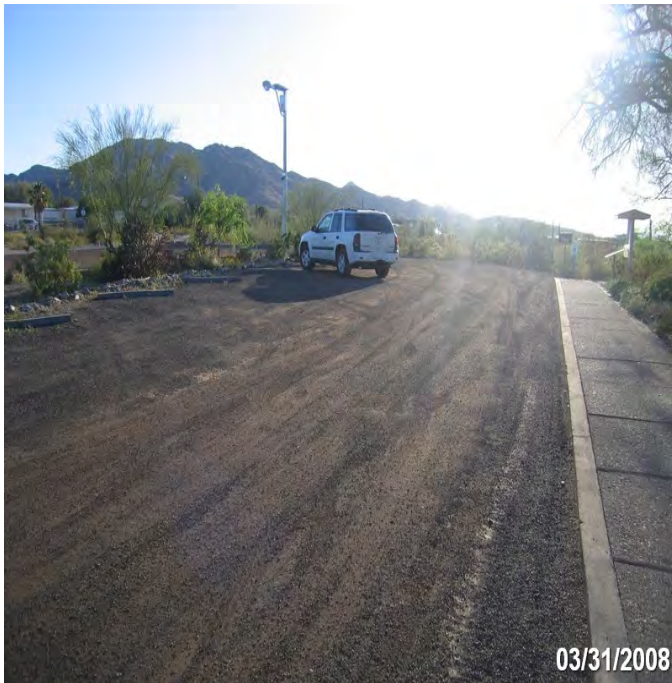
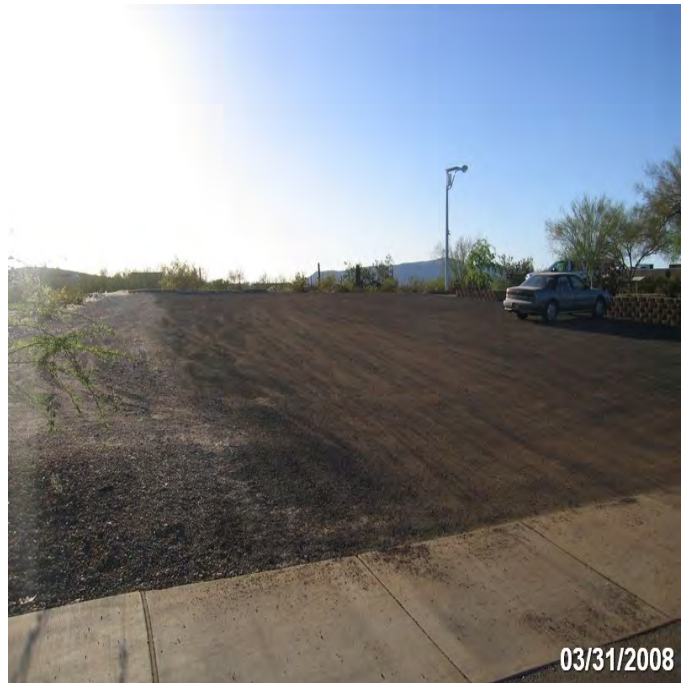
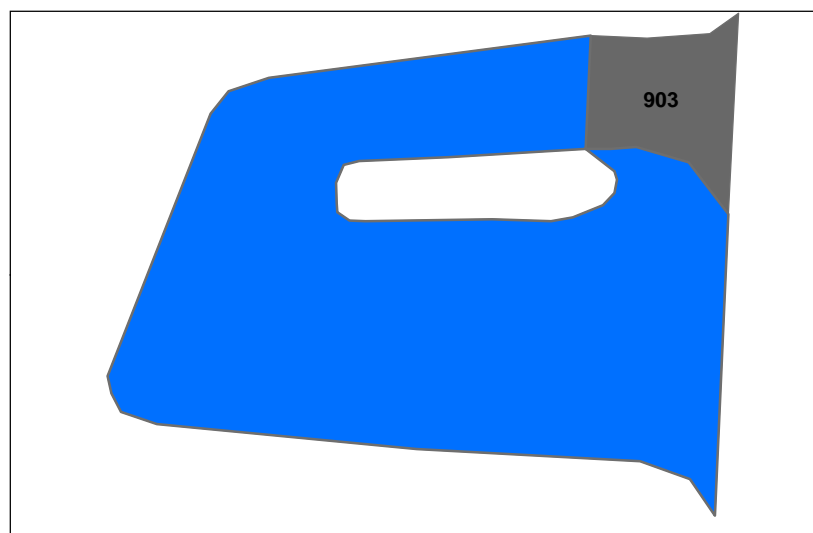
Route 900: Headquarters Gravel Parking Area

Asset Number	Date Visited	Surface Type	Area (sq ft)	Condition	Cost to Improve
10010056	3/31/2008	Gravel	15579	Excellent	\$0

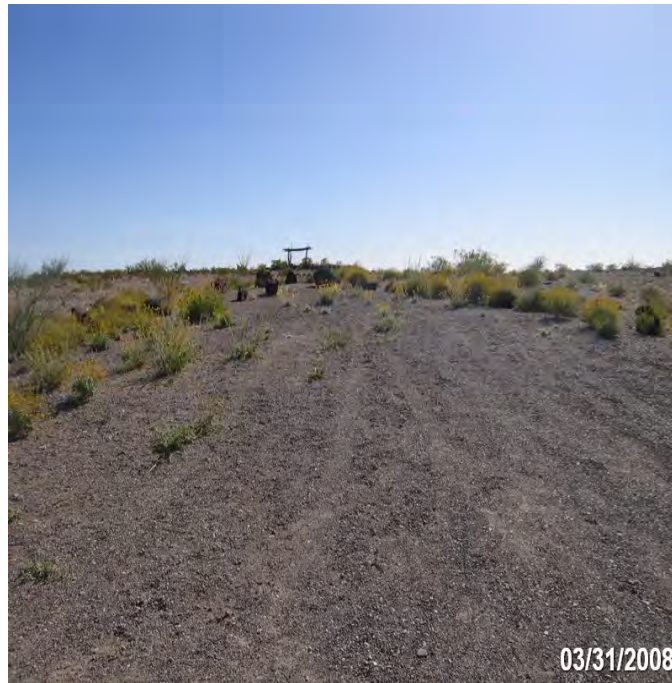
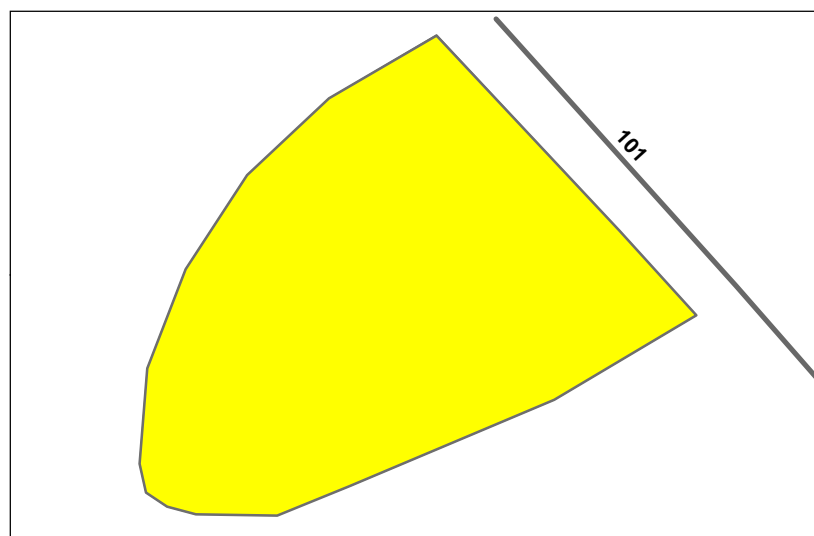
Route 901: Overlook Parking Area

Asset Number	Date Visited	Surface Type	Area (sq ft)	Condition	Cost to Improve
10059024	3/31/2008	Gravel	2450	Fair	\$700

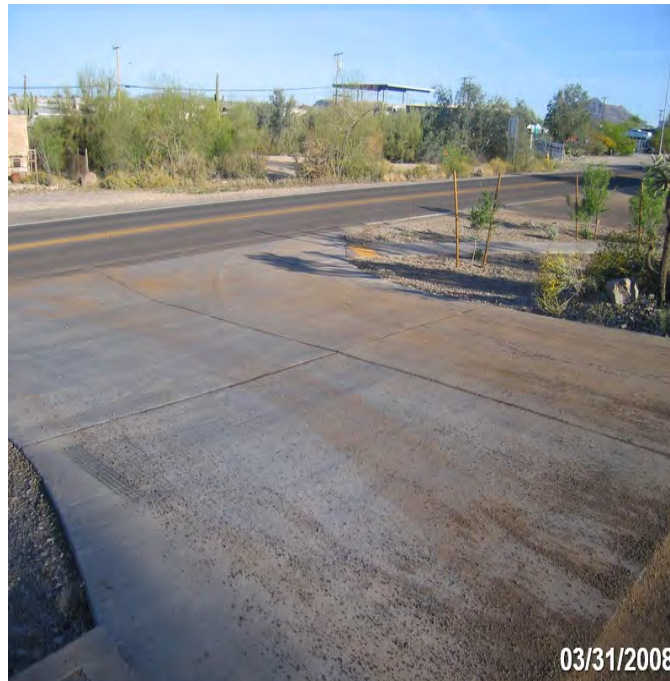
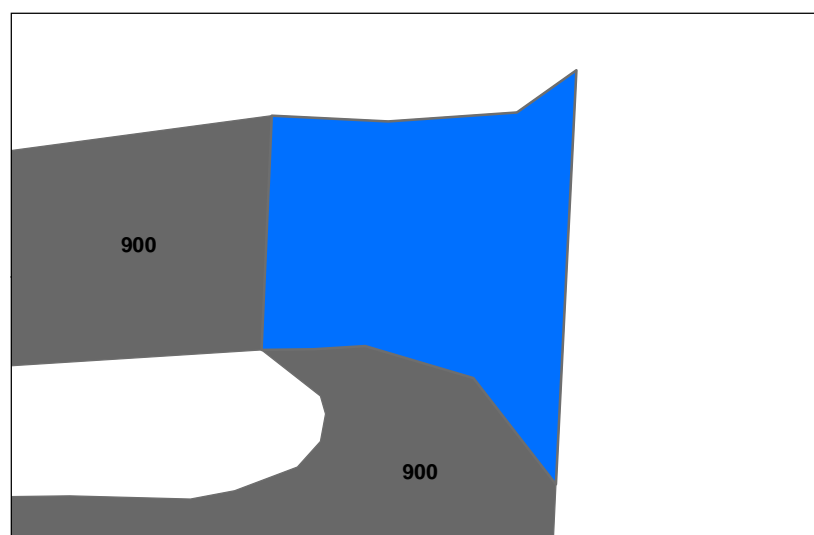
Route 903: Headquarters Concrete Parking Area

Asset Number	Date Visited	Surface Type	Area (sq ft)	Condition	Cost to Improve
10010056	3/31/2008	Concrete	1559	Excellent	\$0
