The Road Inventory of Long Lake National Wildlife Refuge Moffit, North Dakota

Prepared By:
Federal Highway Administration
Central Federal Lands Highway Division
June 2008

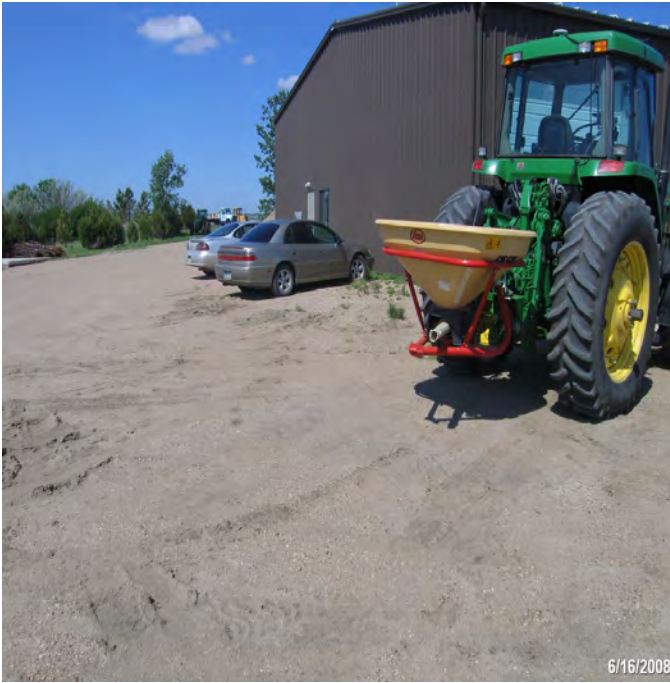
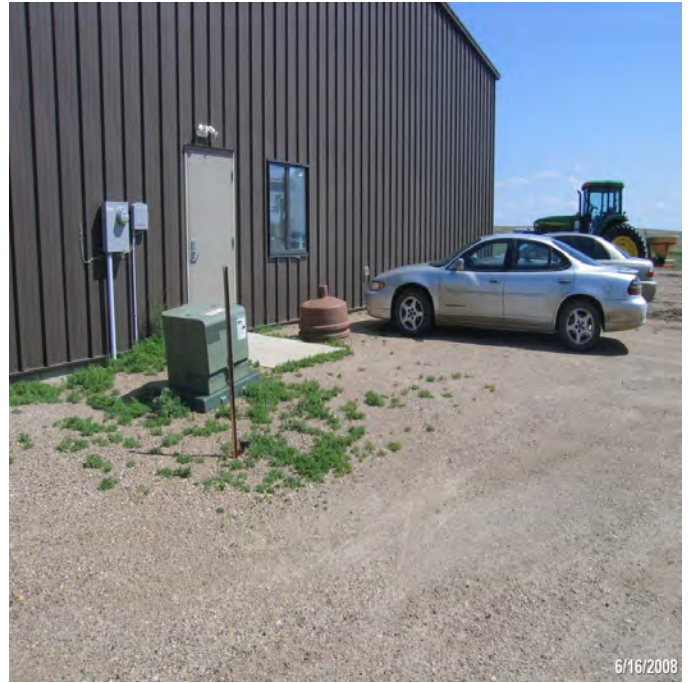
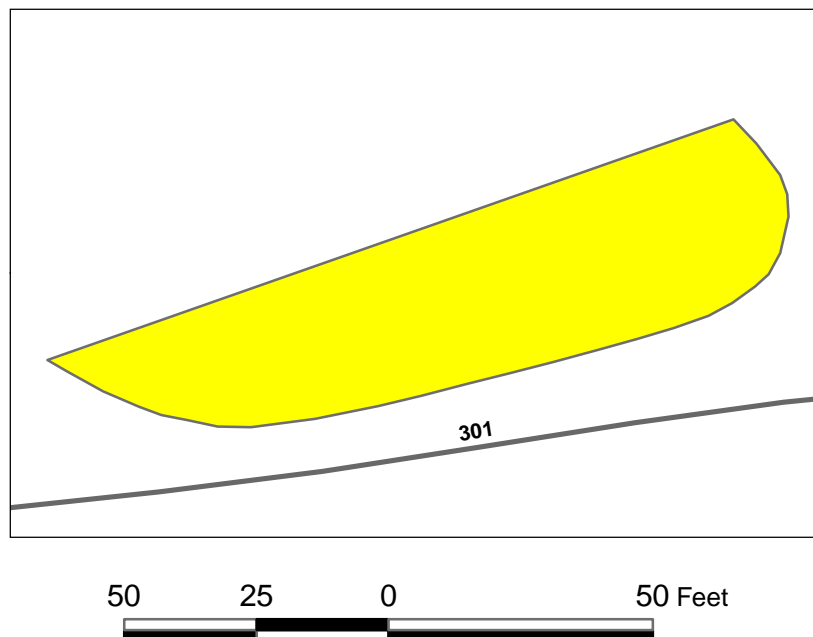
Route 802: Shop Parking A

Asset Number	Date Visited	Surface Type	Area (sq ft)	Condition	Cost to Improve
10045733	6/16/2008	Gravel	2596	Fair	\$700

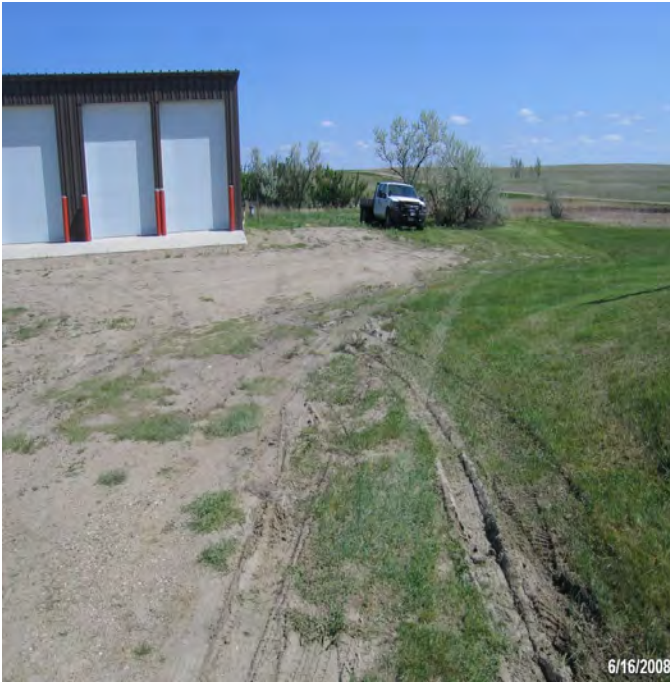
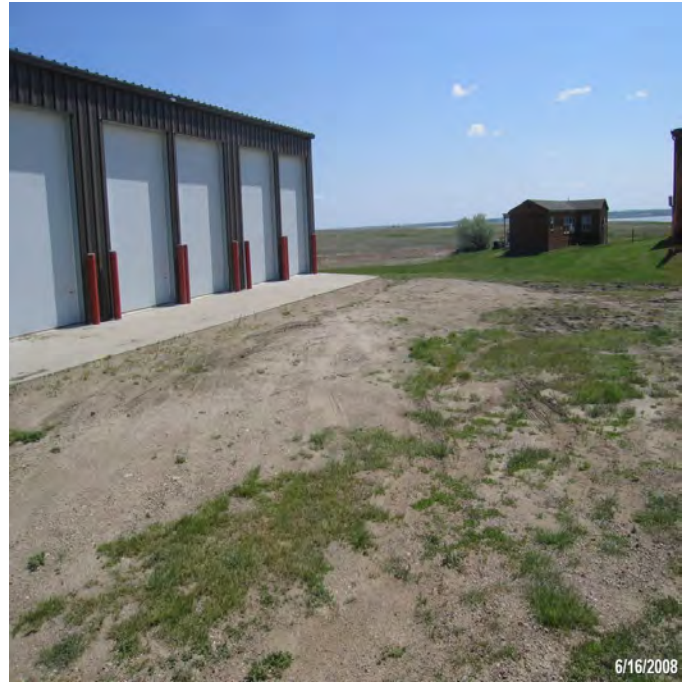
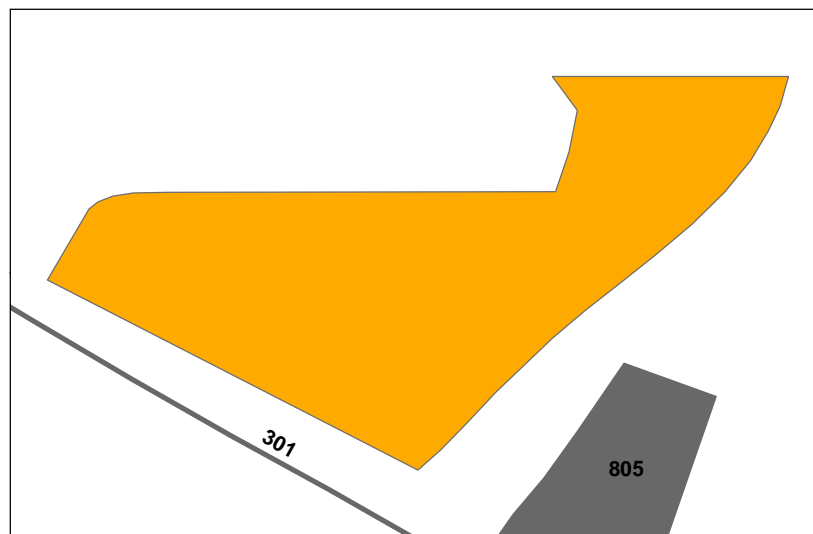
Route 803: Shop Parking B

Asset Number	Date Visited	Surface Type	Area (sq ft)	Condition	Cost to Improve
10045733	6/16/2008	Native	4762	Poor	\$3700

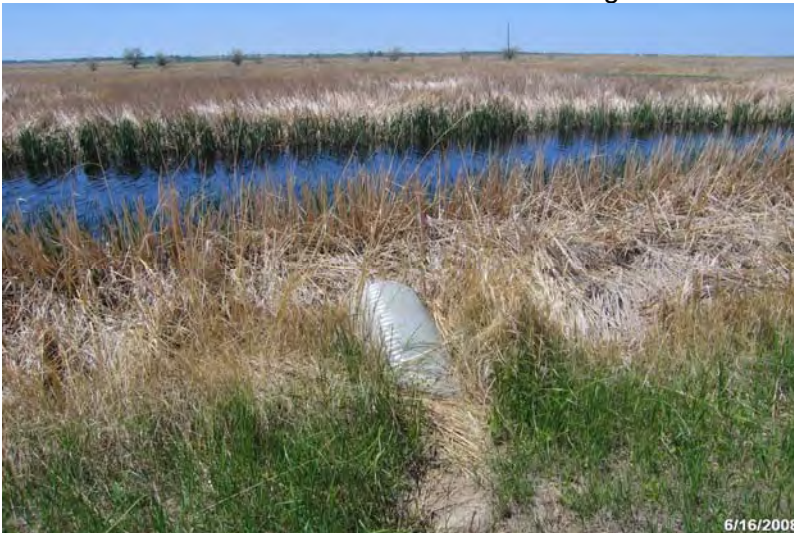
Photo # 6020 - MP 1.96 – Culvert - DEFICIENCY

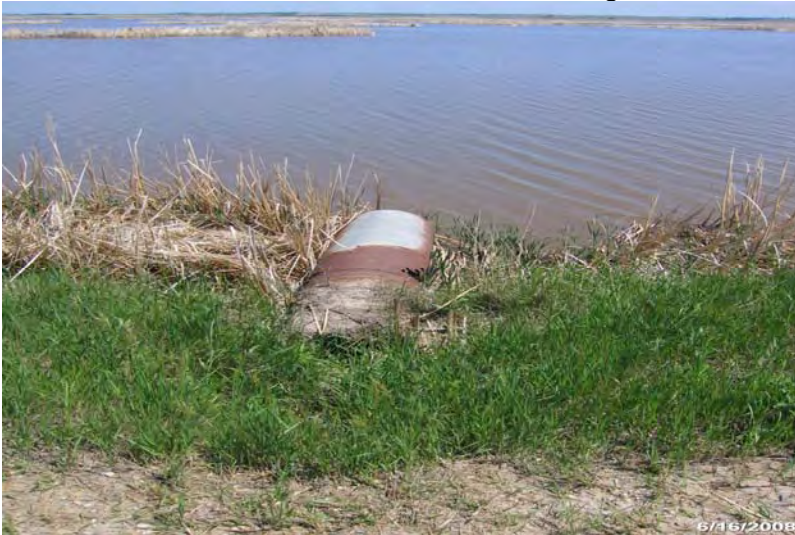
Photo # 6021 - MP 1.96 – Culvert Deficiency

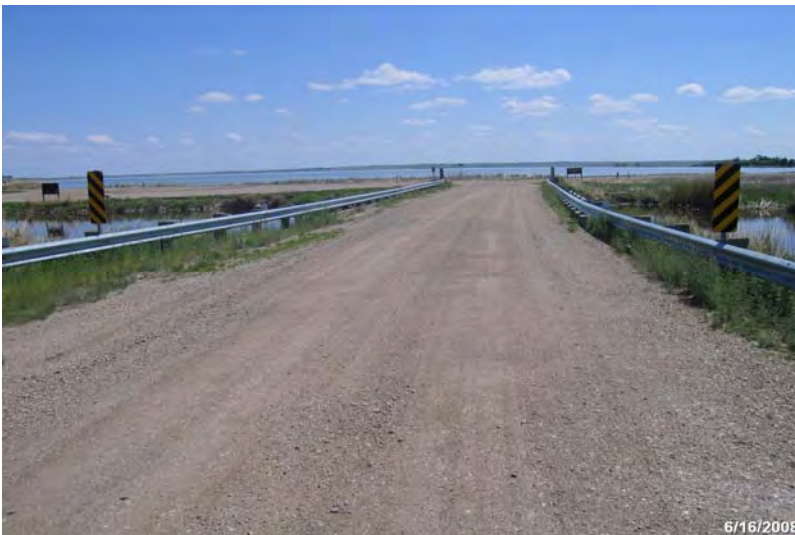
Photo # 6001 - MP 0.03 - Bridge
