The Road Inventory of Cahaba River National Wildlife Refuge Fort McClellan, AL

Prepared By: Federal Highway Administration Central Federal Lands Highway Division August, 2011

Cahaba River National Wildlife Refuge - 43665

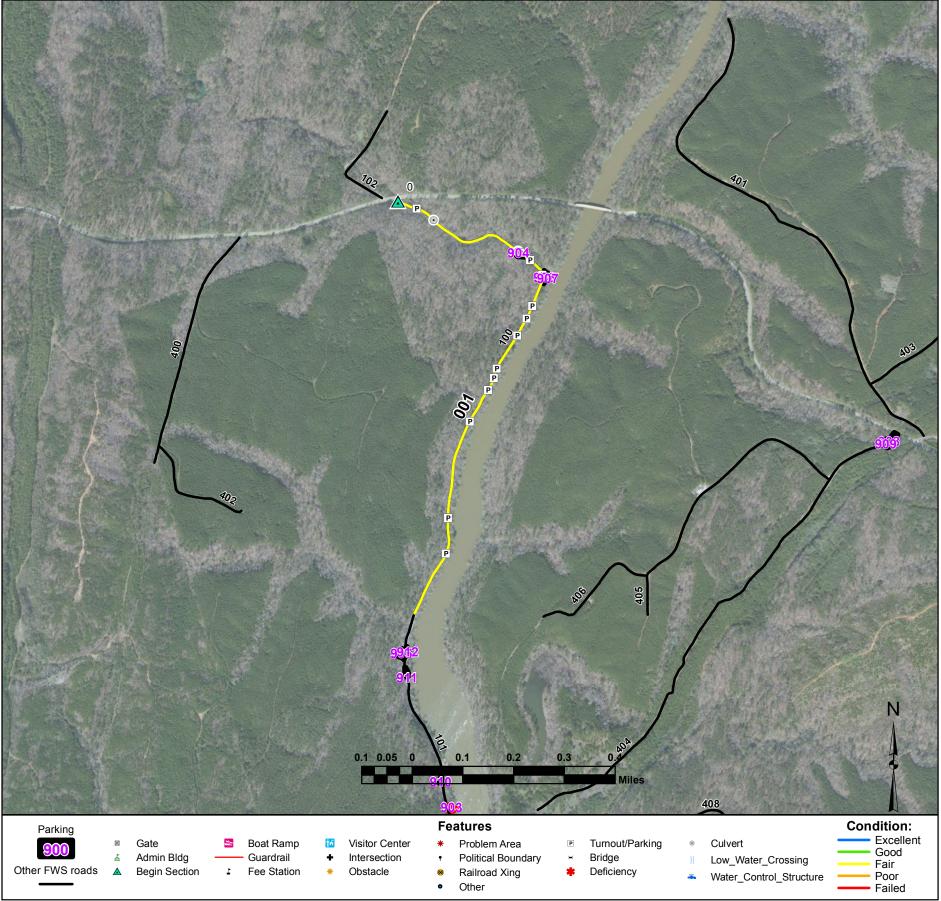
River Road A

Asset Number	10051649		
Section Number	001		
Section Length (miles)	0.97		
Inspection Date	06-21-2011		
Surface Type	Gravel		
Number of Lanes	2		
Roadway Width (feet)	16		
Condition	Fair		
Remaining Service Life (years)	4		
Estimated Cost to Repair	\$3,200		
Current Replacement Value	\$615,300

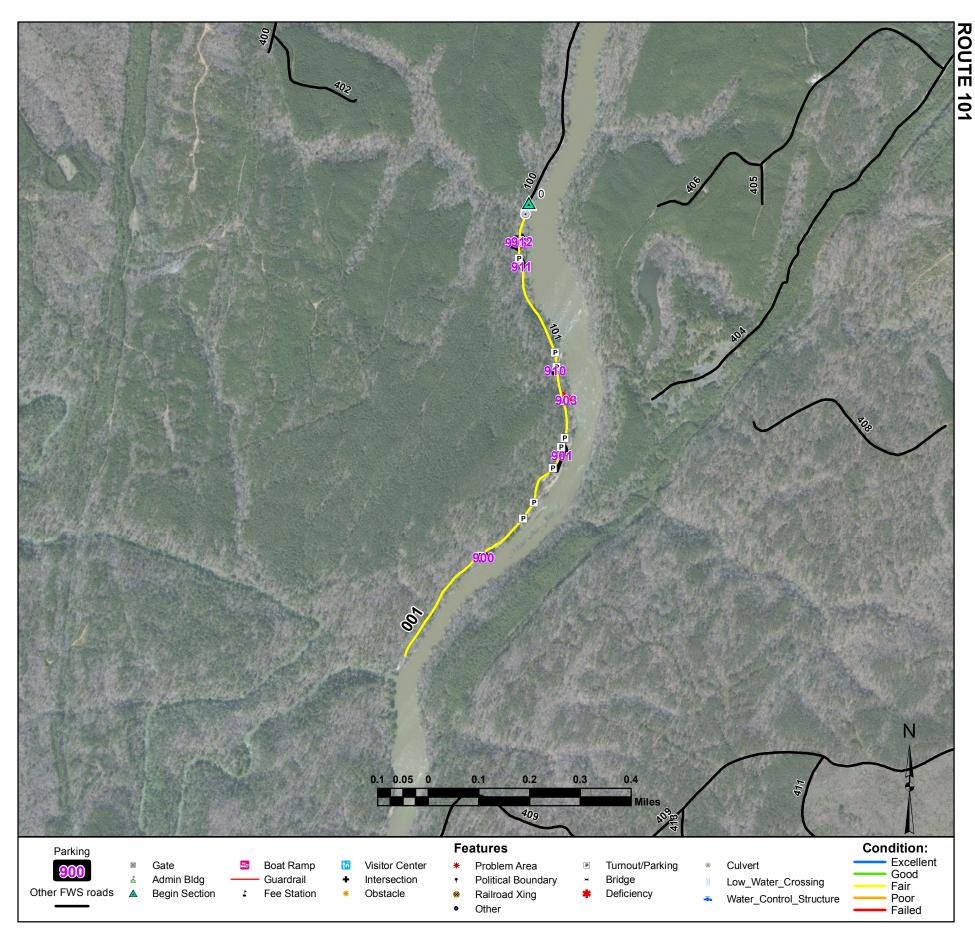
River Road B

Condition	Fair		
Remaining Service Life (years)	4		
Estimated Cost to Repair	\$3,100		
Current Replacement Value	\$595,100

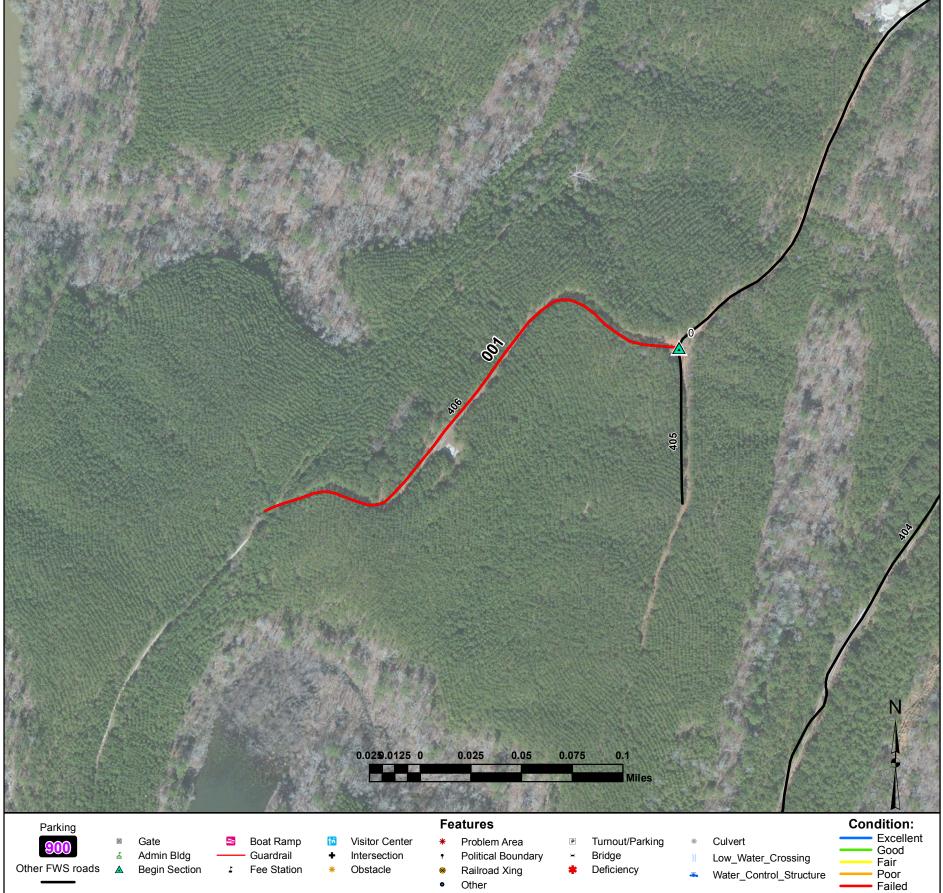
Lobiolly Road B

Condition	Failed		
Remaining Service Life (years)	0		
Estimated Cost to Repair	\$113,700		
Current Replacement Value	\$149,400

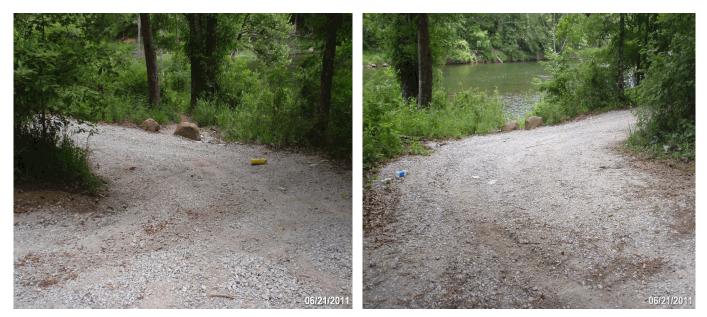
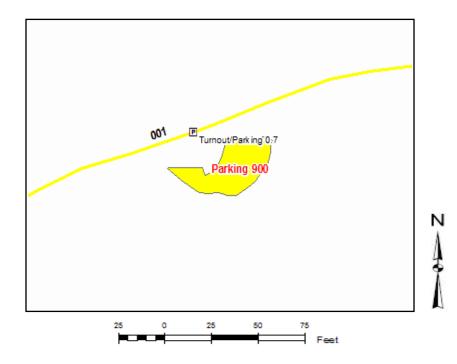
900: River Road B Parking #5

Asset Number	Date Visited	Surface Type	Area (Sq Ft)	Condition	Cost to Improve
	06/21/2011	Gravel	1,105	Fair	300

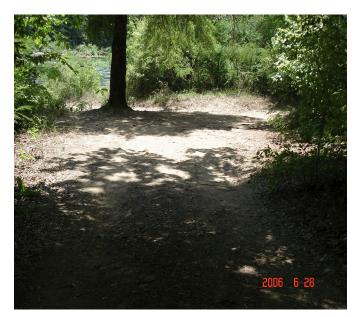
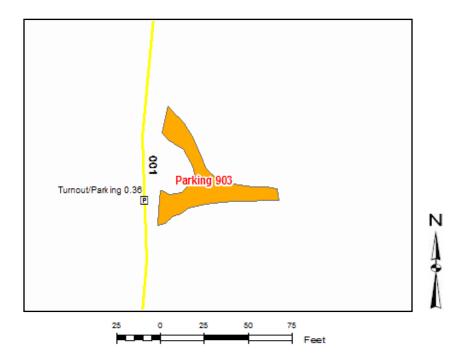
Asset lumber	Date Visited	Surface Type	Area (Sq Ft)	Condition	Cost to Improve
	06/28/2006	Native	1,429	Poor	1,100

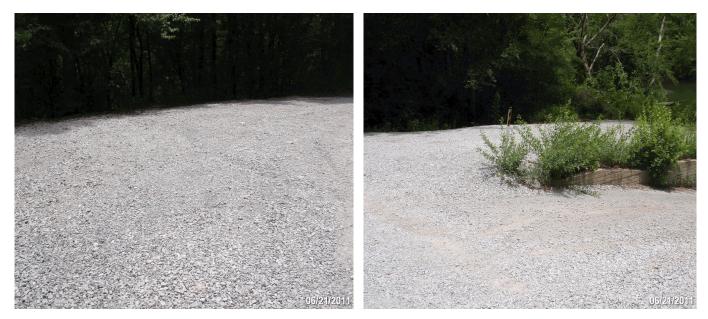
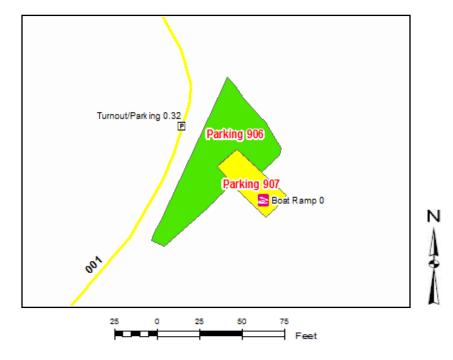
906: River Road A Boat Ramp Parking Area

Asset Number	Date Visited	Surface Type	Area (Sq Ft)	Condition	Cost to Improve
	06/21/2011	Gravel	3,094	Good	400

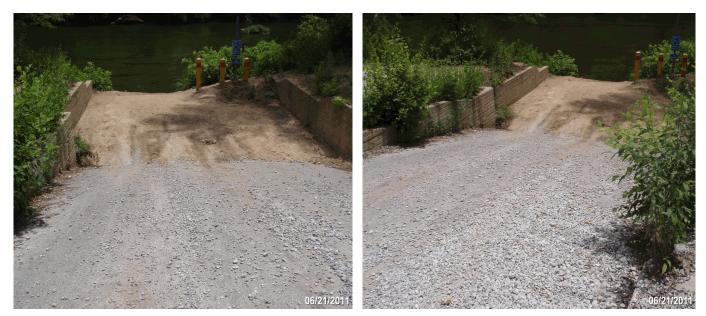
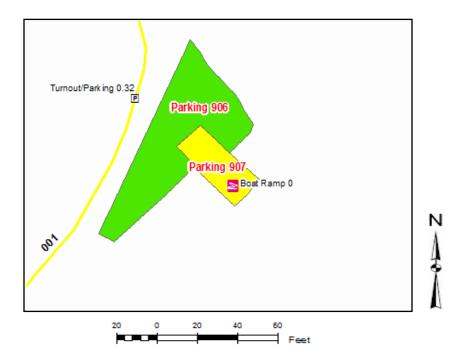
907: River Road A Boat Ramp Handicapped Parking

Asset Number	Date Visited	Surface Type	Area (Sq Ft)	Condition	Cost to Improve
	06/21/2011	Asphalt	838	Fair	700

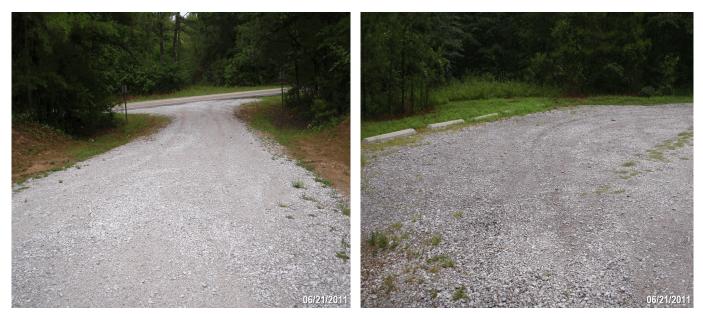
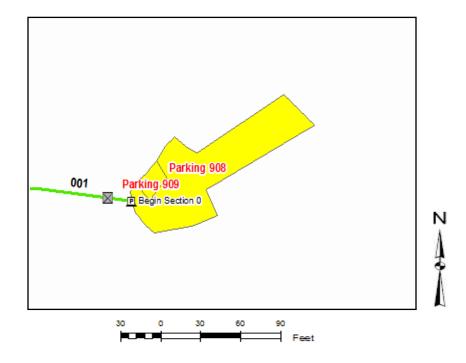
908: Overlook Trail Parking

Ass Num	 Date Visited	Surface Type	Area (Sq Ft)	Condition	Cost to Improve
	06/21/2011	Gravel	6,072	Fair	1,500

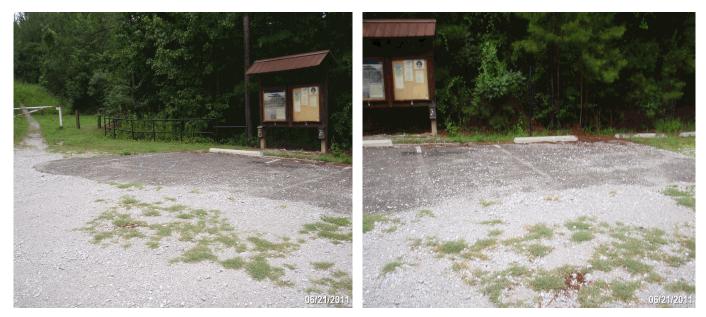
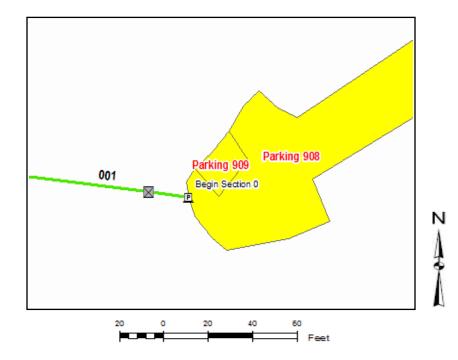
909: Overlook Trail Handicapped Parking

Asset	Date	Surface	Area	Condition	Cost to
Number	Visited	Type	(Sq Ft)		Improve
	06/21/2011	Asphalt	402	Fair	300

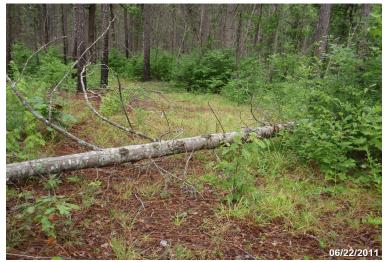
Photo # CARI_C4_0058 - MP 0.05 - Problem Area 001 ROUTE NUMBER: 408 ROUTE NAME: Cliff Road
