The Road Inventory of Hopper Mountain National Wildlife Refuge Fillmore, CA

Prepared By: Federal Highway Administration Central Federal Lands Highway Division April 2012

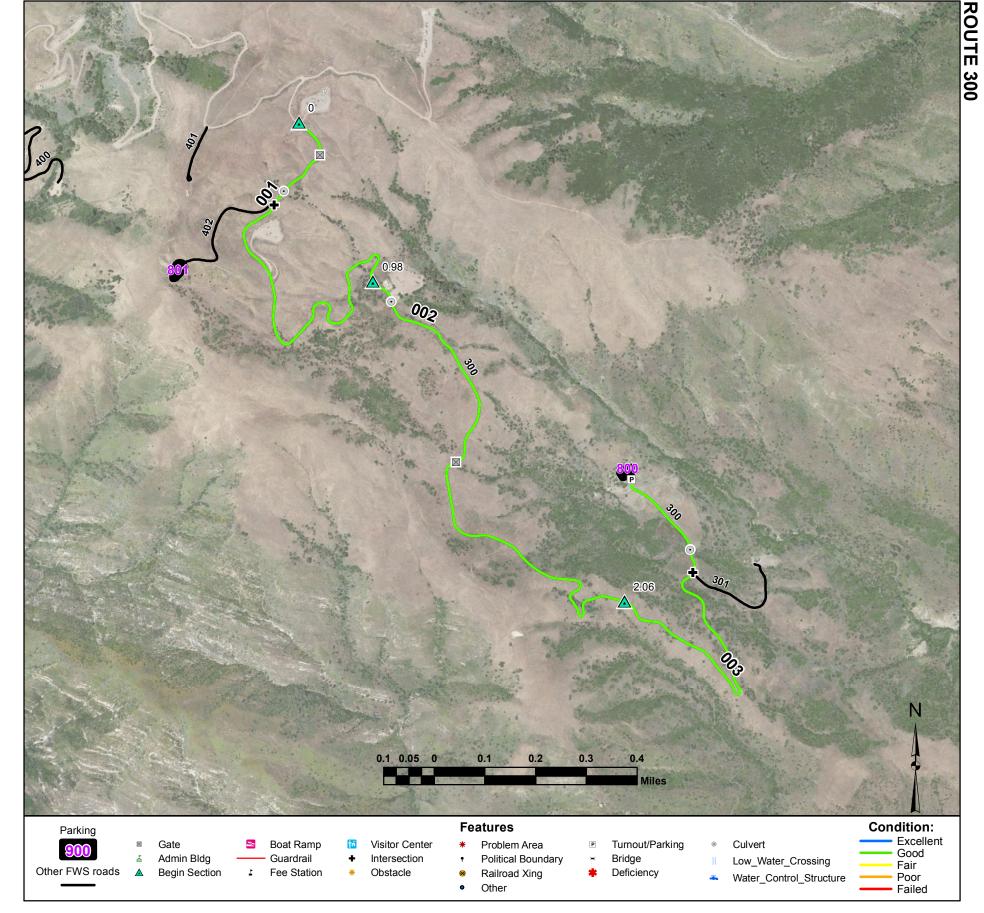
Hopper Ranch Road

Asset Number	10001464	10001464	10001464
Section Number	001	002	003
Section Length (miles)	0.98	1.08	0.83
Inspection Date	12-09-2011	12-09-2011	12-09-2011
Surface Type	Native	Native	Native
Number of Lanes	1	1	1
Roadway Width (feet)	12	12	12
Condition	Good	Good	Good
Remaining Service Life (years)	5	5	5
Estimated Cost to Repair	\$2,100	\$2,300	\$1,700
Current Replacement Value	\$426,500	\$473,300	\$362,600

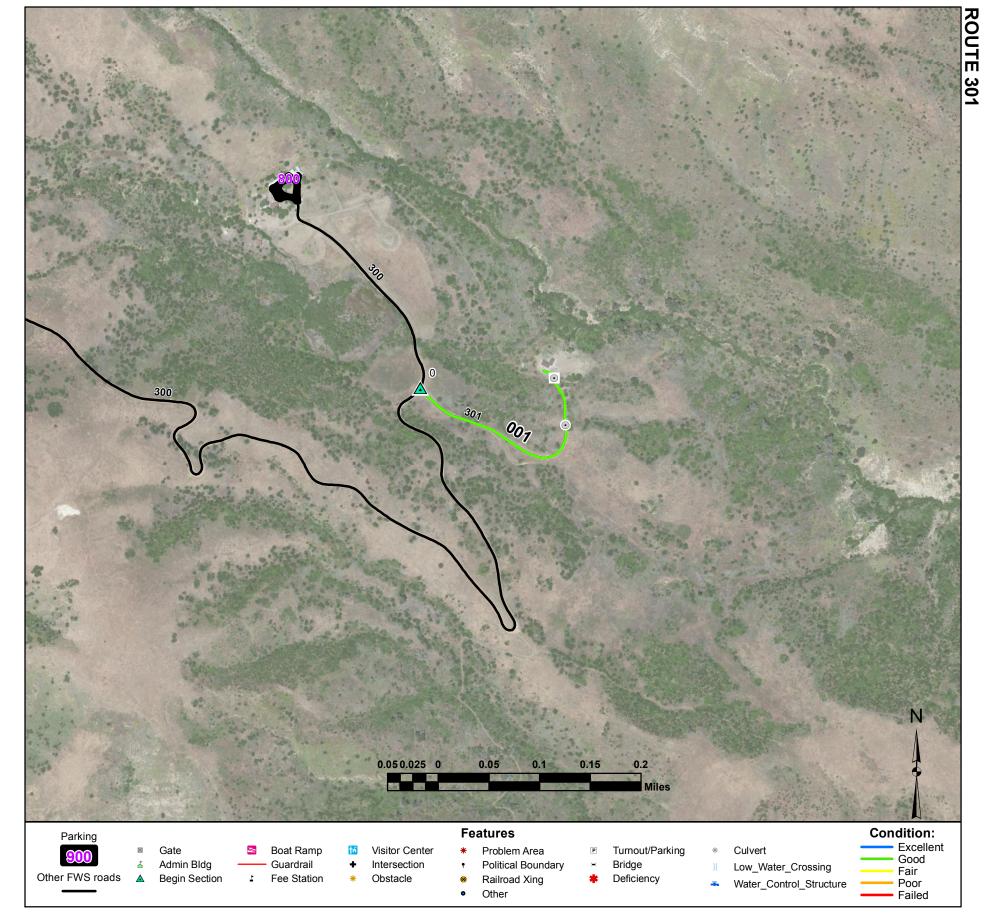
Flight Pen Road

•
Asset Number	-		
Section Number	001		
Section Length (miles)	0.25		
Inspection Date	12-09-2011		
Confess Tons	Netive		
Surface Type	Native		
Number of Lanes	1 1		
Roadway Width (feet)	12		
Condition	Good		
Remaining Service Life (years)	7		
Estimated Cost to Repair	\$500		
Current Replacement Value	\$109,400

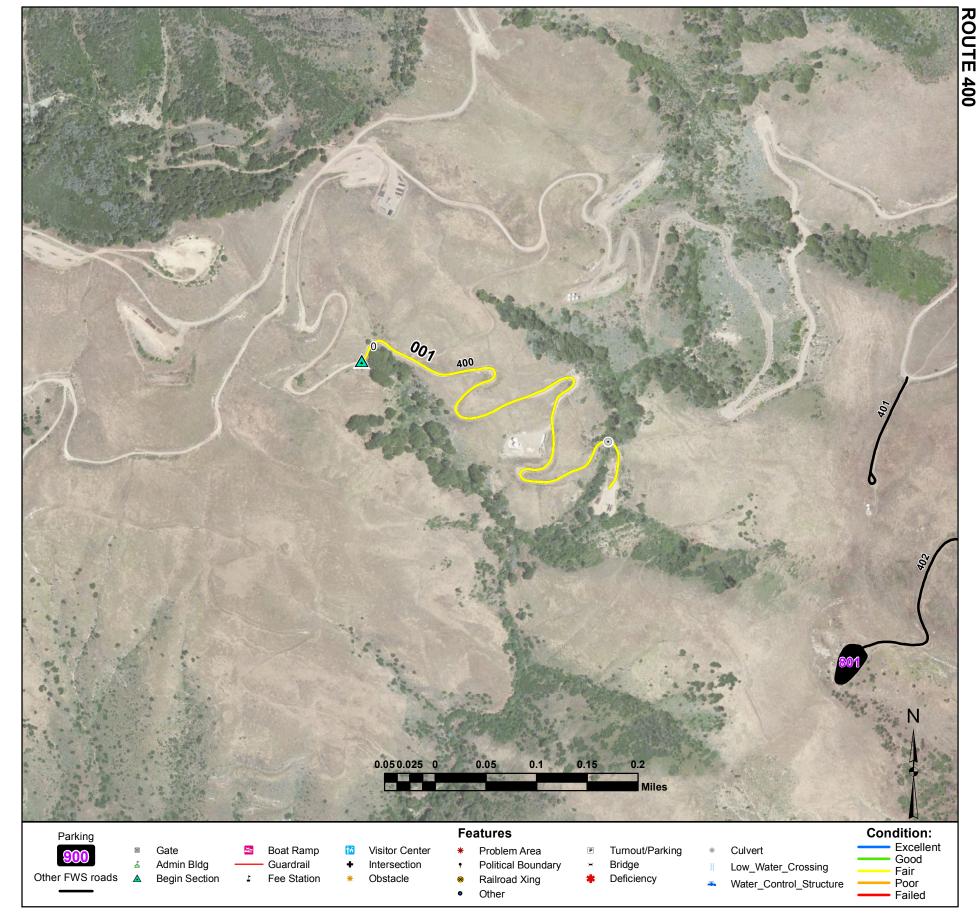
Pole Canyon Access Road

Asset Number	-		
Section Number	001		
Section Length (miles)	0.62		
nspection Date	12-09-2011		
urface Type	Native		
lumber of Lanes	1		
loadway Width (feet)	10		
ondition	Fair		
emaining Service Life (years)	4		
stimated Cost to Repair	\$1,700		
urrent Replacement Value	\$272,300

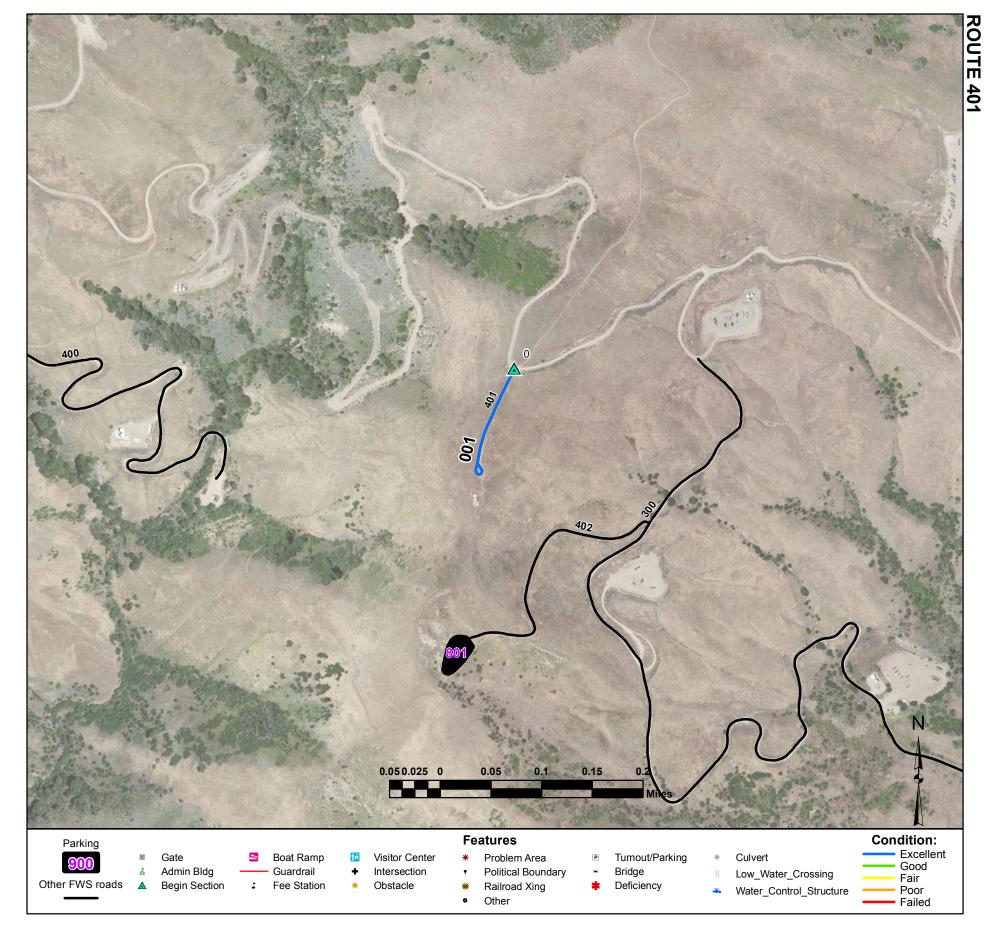
Silvertanks Access Road

Asset Number	-		
Section Number	001		
Section Length (miles)	0.12		
Inspection Date	12-09-2011		
Cunface Tune	NI-45		
Surface Type	Native		
Number of Lanes	1		
Roadway Width (feet)	12		
Condition	Excellent		
Remaining Service Life (years)	8		
Estimated Cost to Repair	\$0		
Current Replacement Value	\$54,500

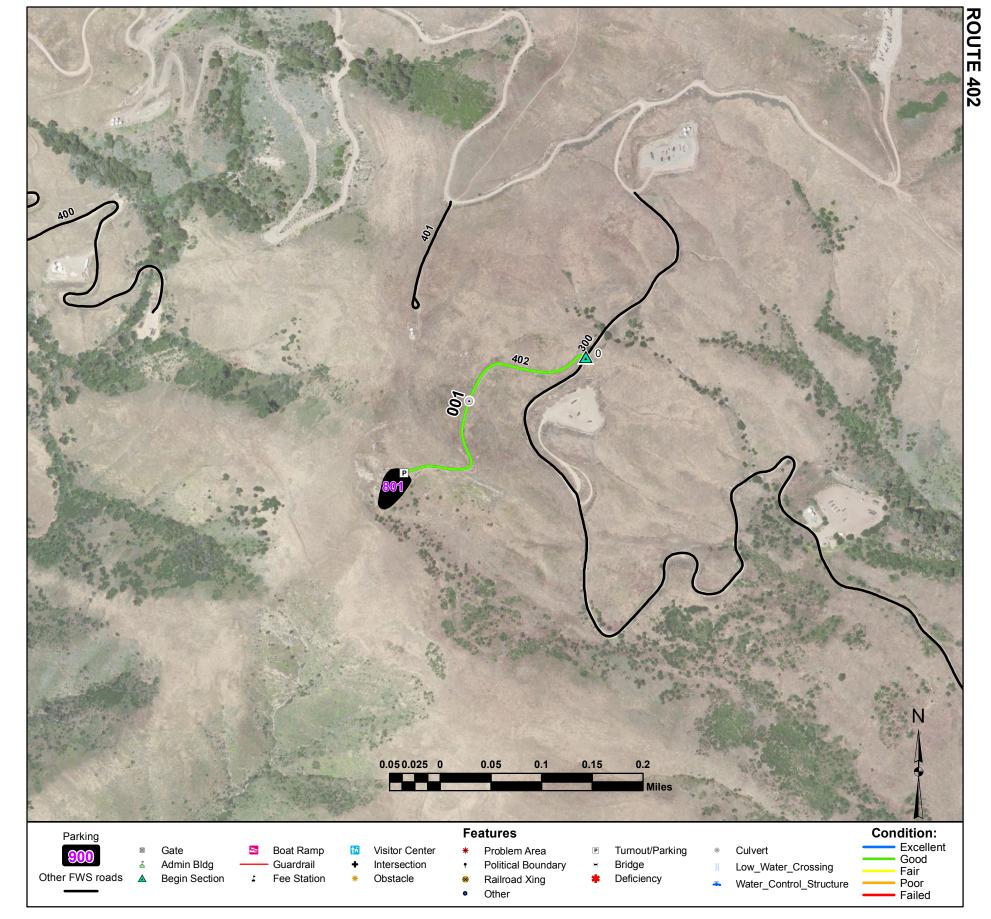
ATV Training Site Access Road

Asset Number	-		
Section Number	001		
Section Length (miles)	0.28		
nspection Date	12-09-2011		
Surface Type	Native		
lumber of Lanes	1		
toadway Width (feet)	12		
ndition	Good		
emaining Service Life (years)	7		
stimated Cost to Repair	\$600		
urrent Replacement Value	\$120,600

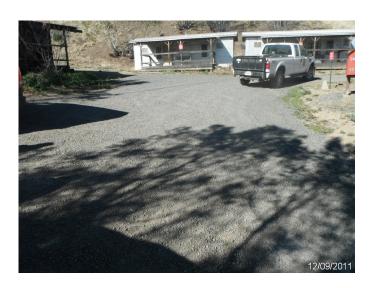
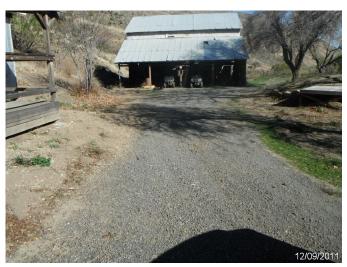
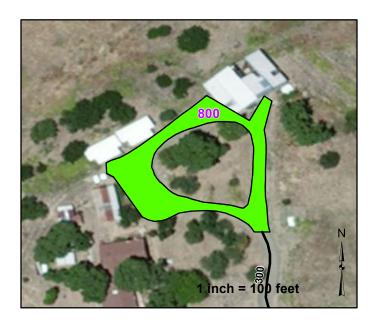
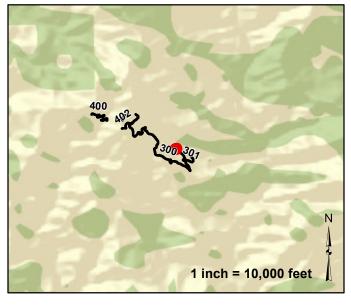
Route Number:800 Hopper Ranch Parking Lot

Asset Number	Area	Condition	Surface Type	Cost to Improve	Inspection Date	Current Replacement Value
-	6655	Good	Gravel	\$1,200	12-09-2011	\$40,300

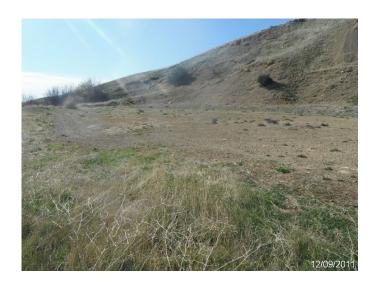
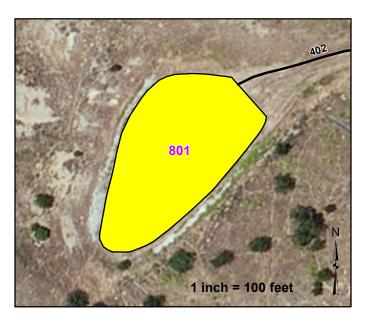
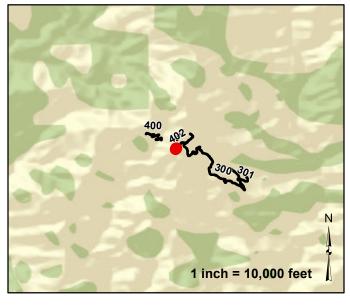
Route Number:801

Asset Number	Area	Condition	Surface Type	Cost to Improve	Inspection Date	Current Replacement Value
-	16169	Fair	Gravel	\$5,200	12-09-2011	\$98,000

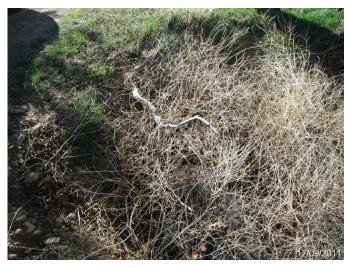
Photo: HOMO_C4_0142 Route: 300-001-0.19 Metal Culvert 25ft long 18in dia. 2ft deep Asset# 10001464

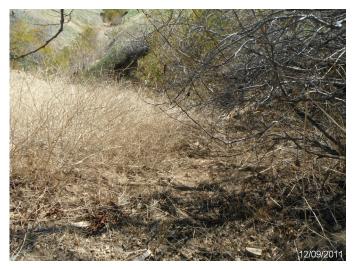
Photo: HOMO_C4_0143 Route: 300-001-0.19 Metal Culvert 25ft long 18in dia. 2ft deep Asset# 10001464

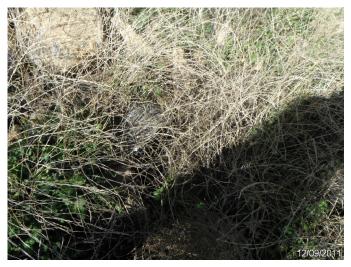
Photo: HOMO_C4_0145 Route: 300-002-1.03 Metal Culvert 35ft long 24in dia. 3ft deep Asset# 10001464

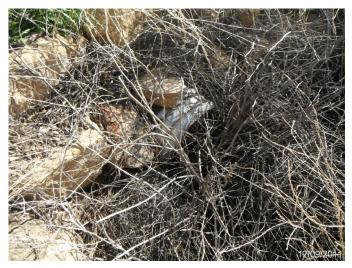
Photo: HOMO_C4_0146 Route: 300-002-1.03 Metal Culvert 35ft long 24in dia. 3ft deep Asset# 10001464

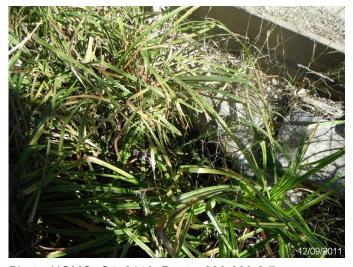
Photo: HOMO_C4_0149 Route: 300-003-2.7 Metal Culvert 25ft long 18in dia. 1ft deep Asset# 10001464

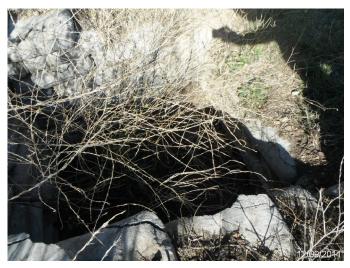
Photo: HOMO_C4_0154 Route: 301-001-0.19 Metal Culvert 25ft long 18in dia. 2ft deep Asset# NA

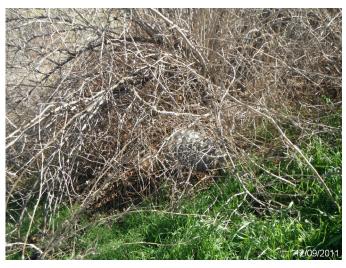
Photo: HOMO_C4_0155 Route: 301-001-0.19 Metal Culvert 25ft long 18in dia. 2ft deep Asset# NA

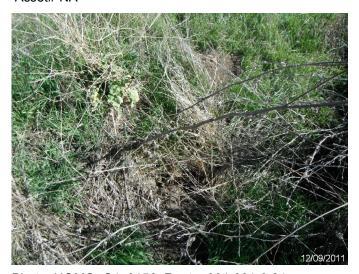
Photo: HOMO_C4_0156 Route: 301-001-0.24 Metal Culvert 30ft long 18in dia. 1ft deep Asset# NA

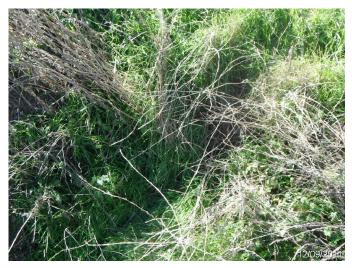
Photo: HOMO_C4_0157 Route: 301-001-0.24 Metal Culvert 30ft long 18in dia. 1ft deep Asset# NA

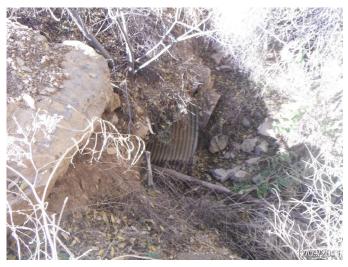
Photo: HOMO_C4_0135 Route: 400-001-0.57 Metal Culvert 30ft long 48in dia. 3ft deep Asset# NA

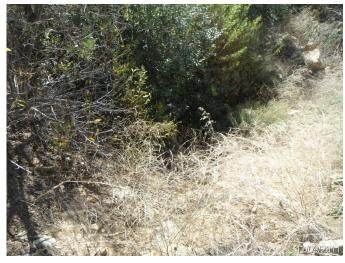
Photo: HOMO_C4_0136 Route: 400-001-0.57 Metal Culvert 30ft long 48in dia. 3ft deep Asset# NA

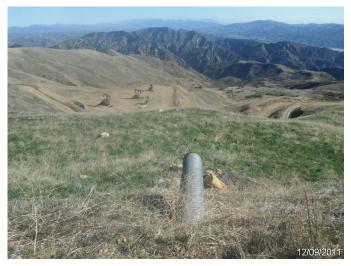
Photo: HOMO_C4_0160 Route: 402-001-0.14 Metal Culvert 20ft long 18in dia. 1ft deep Asset# NA

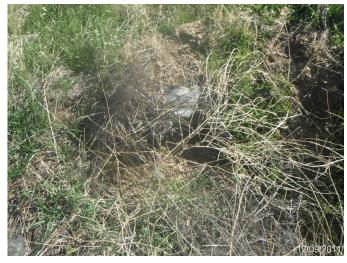
Photo: HOMO_C4_0161 Route: 402-001-0.14 Metal Culvert 20ft long 18in dia. 1ft deep Asset# NA
