The Road Inventory of Humboldt Bay National Wildlife Refuge Loleta, CA

Prepared By:
Federal Highway Administration
Central Federal Lands Highway Division
April 2012

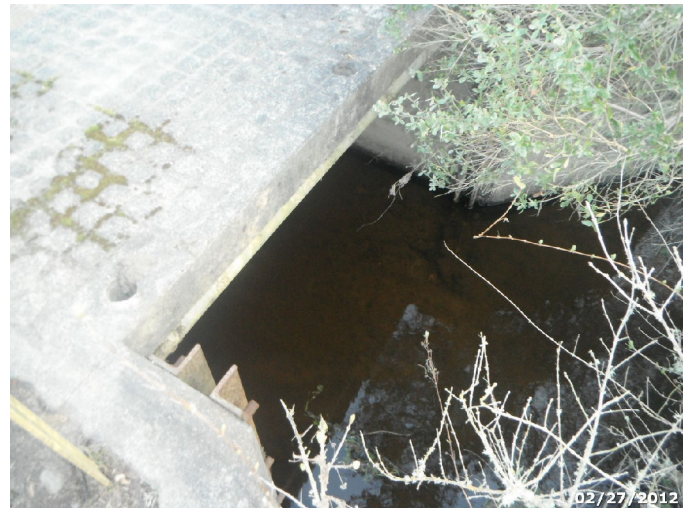
Photo: HUBA_C4_1592 Route: 010-002-0.63
Concrete Culvert Box 24ft long 6ft x 10ft 1ft deep
Asset# NA

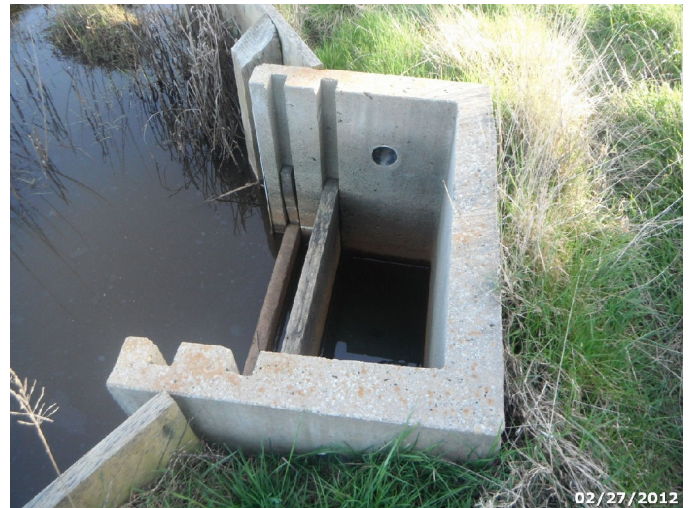
Photo: HUBA_C4_1599 Route: 102-001-0.21
Metal WCS Flashboard Riser 40ft long 24in dia. 3ft deep
Asset# NA

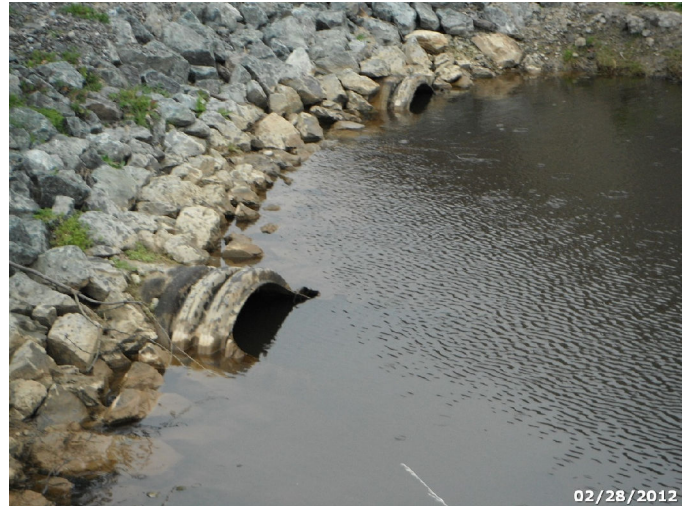
Photo: HUBA_C4_1673 Route: 400-001-0.05
Plastic Culvert 40ft long 48in dia. 2ft deep
Asset# 10000105

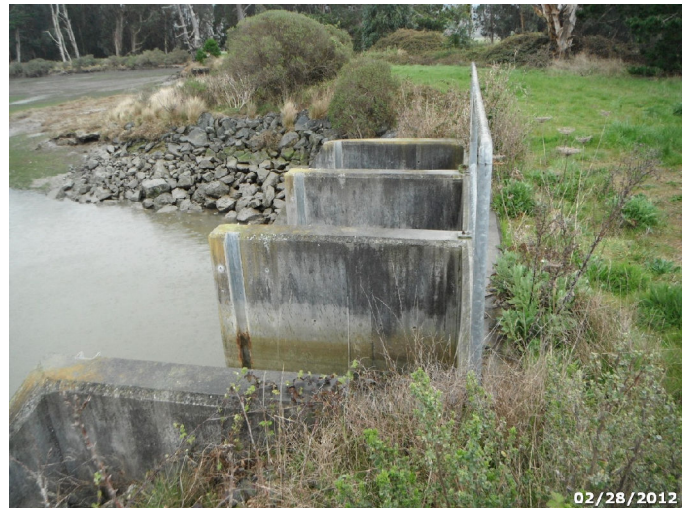
Photo: HUBA_C4_1682 Route: 400-003-2.6
Metal WCS Flashboard Riser 30ft long 1ft deep
6x10 Box Culvert Asset# NA

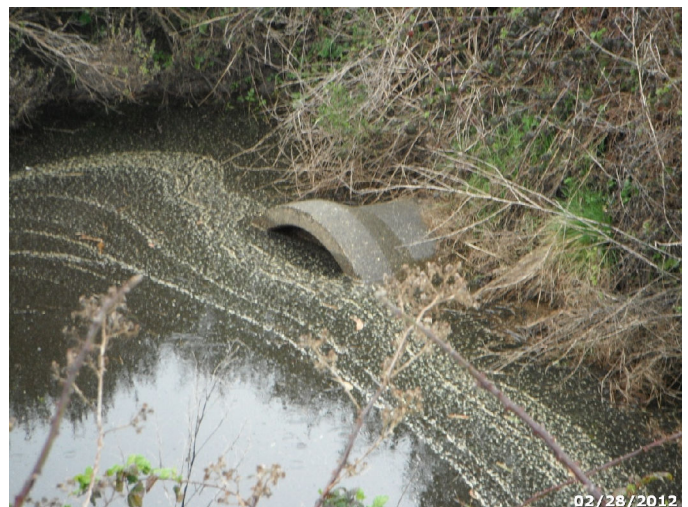
Photo: HUBA_C4_1683 Route: 400-003-2.6
Metal WCS Flashboard Riser 30ft long 1ft deep
6x10 Box Culvert Asset# NA

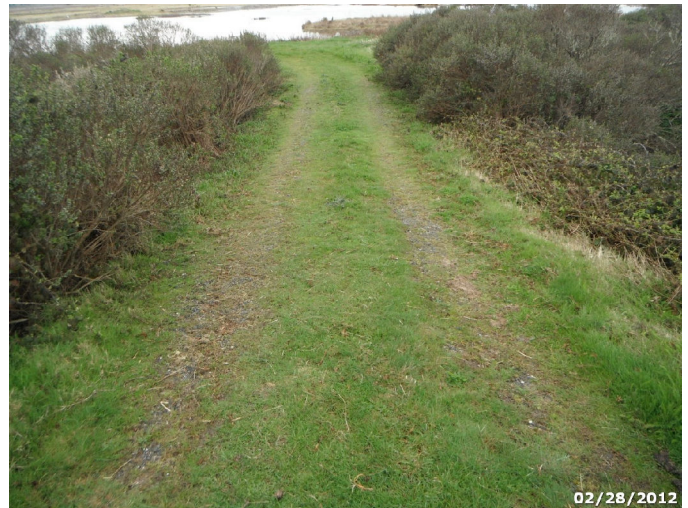
Photo: HUBA_C4_1686 Route: 400-004-2.58
Concrete Culvert 30ft long 48in dia. 4ft deep
Asset# 10000105

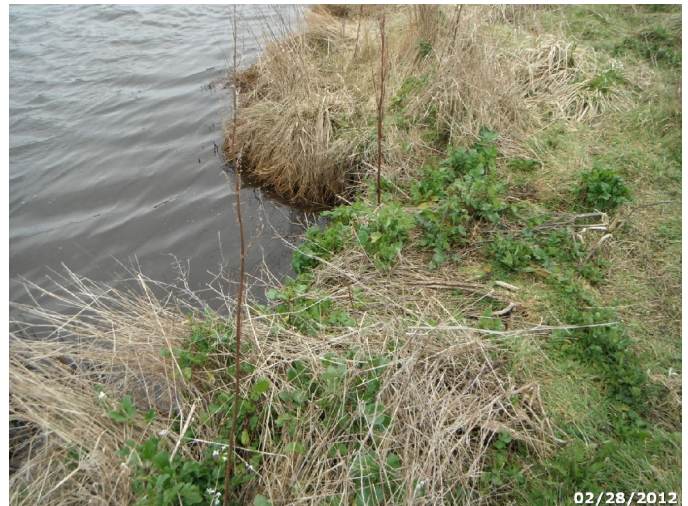
Photo: HUBA_C4_1687 Route: 400-004-3.02
Metal WCS Flashboard Riser 30ft long 24in dia. 1ft deep
Asset# NA

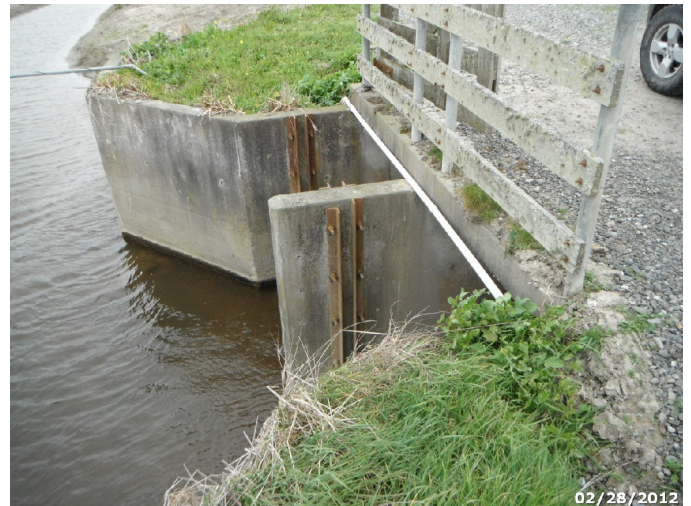
Photo: HUBA_C4_1703 Route: 401-001-0.3
Wood Open Rail Gate
Asset# 10000122

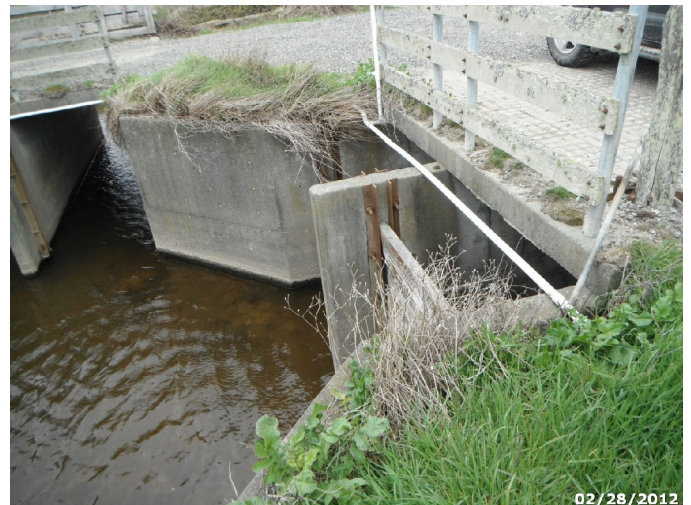
Photo: HUBA_C4_1702 Route: 401-001-0.3
Concrete WCS Flashboard Riser 20ft long 1ft deep
5x10 Box Culvert Asset# 10036313

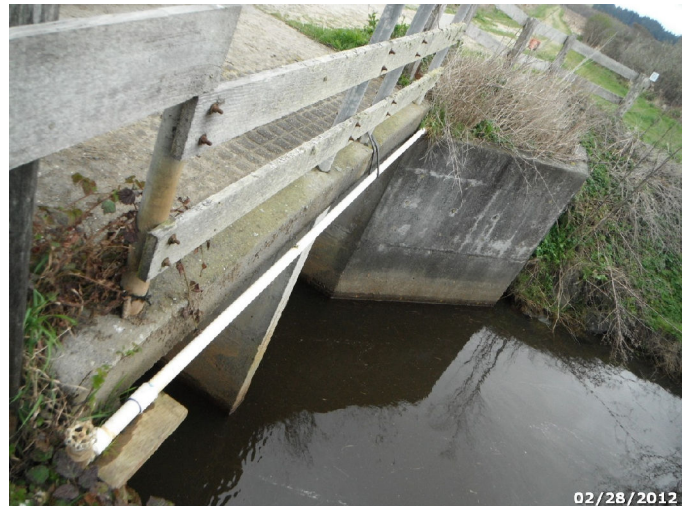
Photo: HUBA_C4_1695 Route: 401-002-0.7
Concrete WCS Flashboard Riser 20ft long 1ft deep
5x10 Box Culvert Asset# 10036309

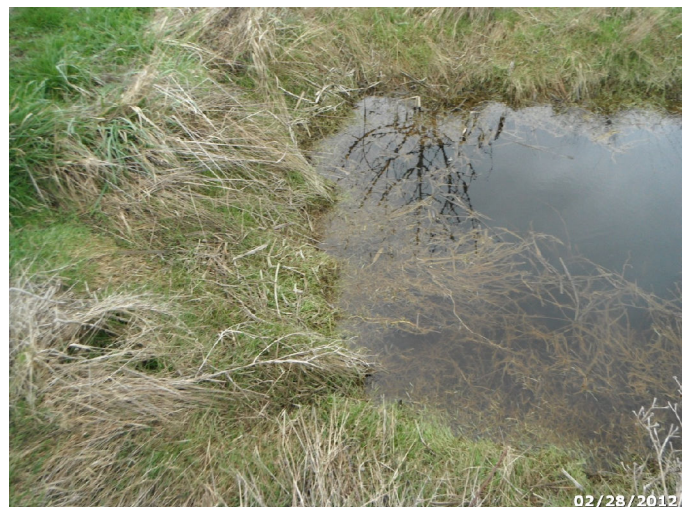
Photo: HUBA_C4_1693 Route: 401-002-0.76
Plastic WCS Flashboard Riser 25ft long 24in dia. 3ft deep
Asset# 10065099

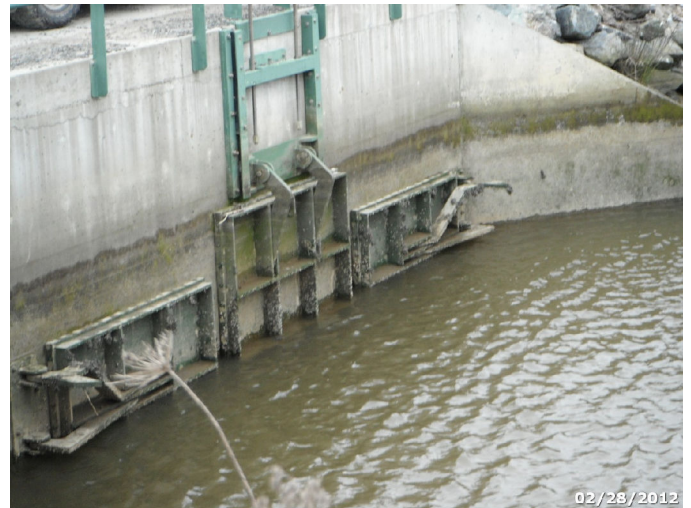
Photo: HUBA_C4_1712 Route: 403-002-1.13
Concrete WCS Other 25ft long 1ft deep
5x12 Box Culvert Asset# 10061429
