# The Road Inventory of San Diego National Wildlife Refuge Chula Vista, CA

Prepared By: Federal Highway Administration Central Federal Lands Highway Division April 2012

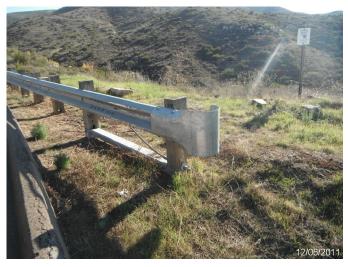
Photo: SADI\_C4\_0171 Route: 100-001-0.42 Guard\_Guide\_Rail Guardrail Galvanized\_Steel 899.0 ft long Asset# 10001862

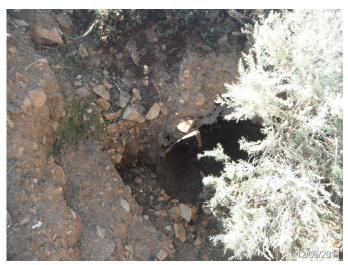
Photo: SADI\_C4\_0146 Route: 400-001-0.12 Metal Culvert 30ft long 36in dia. 3ft deep Asset# 10001887

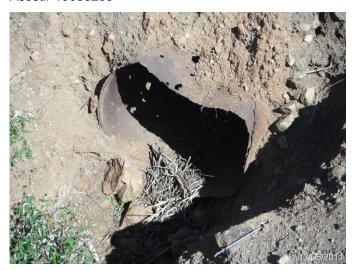
Photo: SADI\_C4\_0147 Route: 400-001-0.12 Metal Culvert 30ft long 36in dia. 3ft deep Asset# 10001887

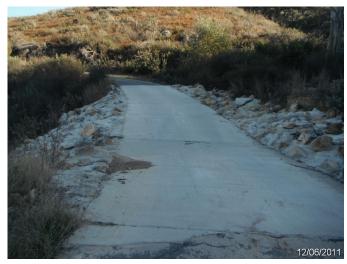
Photo: SADI\_C4\_0176 Route: 403-003-1.3 Concrete Low Water Xing 61.0ft long 15.0ft wide Asset# NA

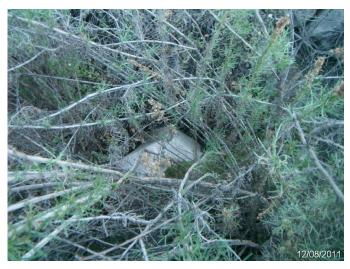
Photo: SADI\_C4\_0120 Route: 405-002-0.3 Metal Culvert 15ft long 18in dia. 1ft deep Asset# 10001929

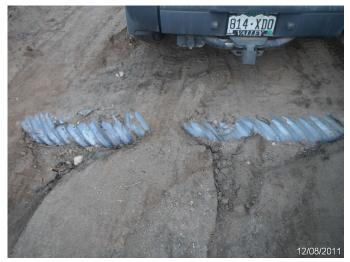
Photo: SADI\_C4\_0121 Route: 405-002-0.3 Deficiency Culvert Replace Asset# 10001929

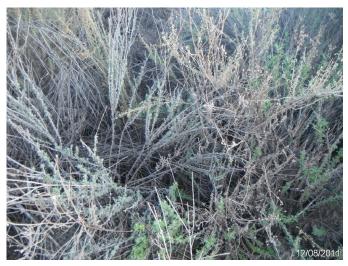
Photo: SADI\_C4\_0122 Route: 405-002-0.41 Metal Culvert 15ft long 18in dia. 1ft deep Asset# 10001929

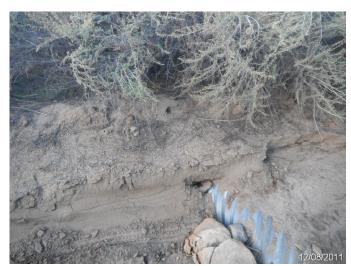
Photo: SADI\_C4\_0123 Route: 405-002-0.41 Metal Culvert 15ft long 18in dia. 1ft deep Asset# 10001929
