# The Road Inventory of Sonny Bono Salton Sea National Wildlife Refuge Calipatria, CA

Prepared By:  
Federal Highway Administration  
Central Federal Lands Highway Division  
April 2012

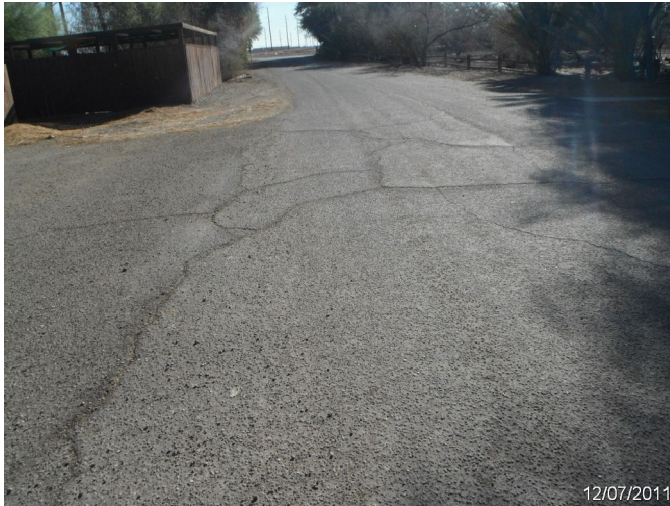
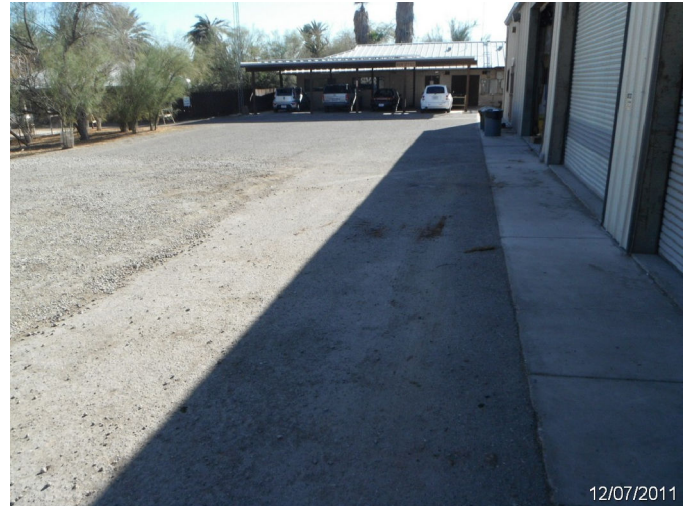
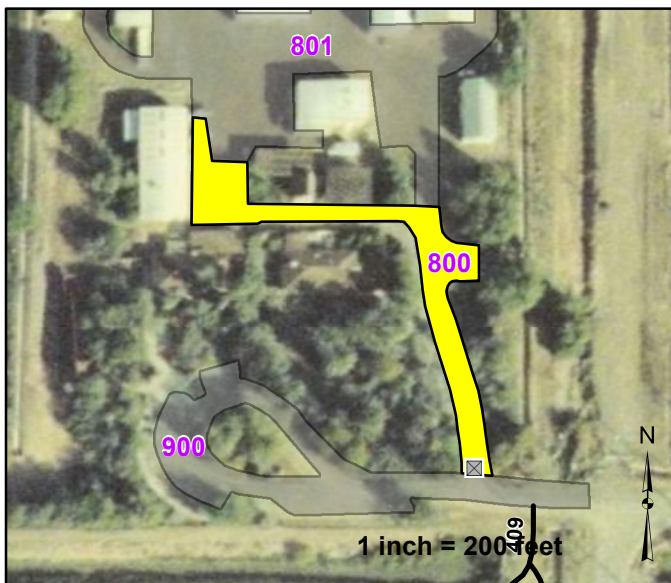
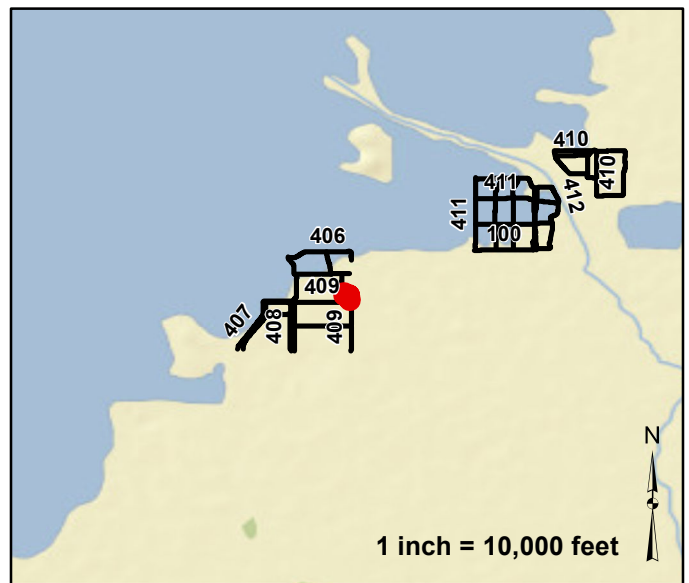
## Route Number:800

Asset Number	Area	Condition	Surface Type	Cost to Improve	Inspection Date	Current Replacement Value
10000666	14118	Fair	Asphalt	\$14,200	12-07-2011	\$150,900

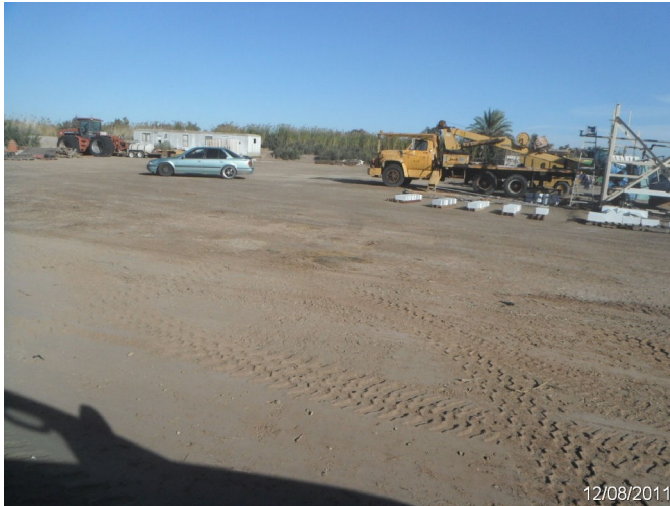
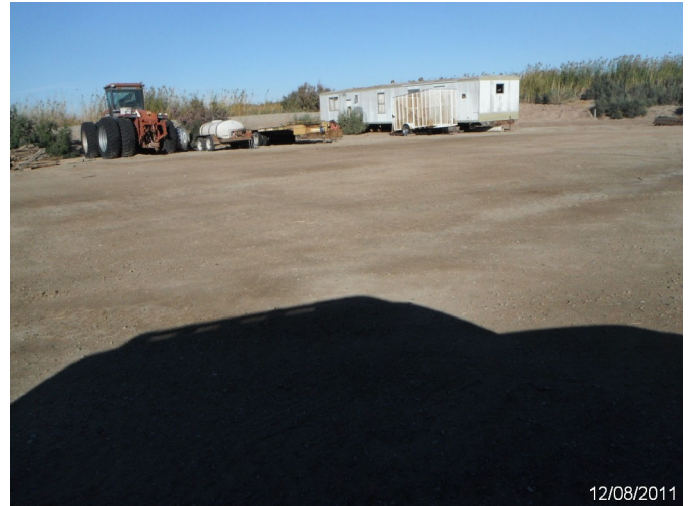
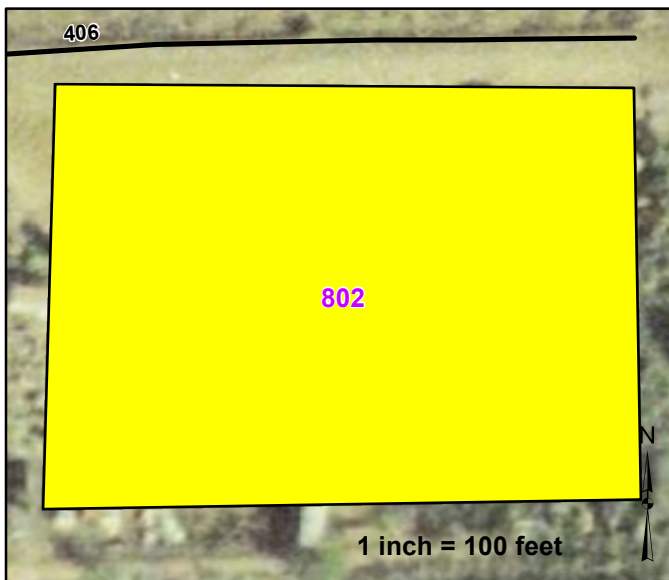
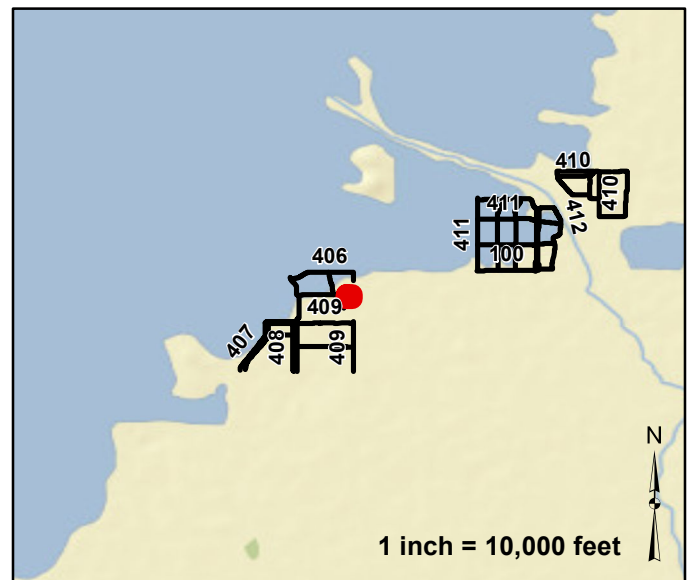
## Route Number:802

Asset Number	Area	Condition	Surface Type	Cost to Improve	Inspection Date	Current Replacement Value
-	55711	Fair	Gravel	\$17,400	12-08-2011	\$325,000

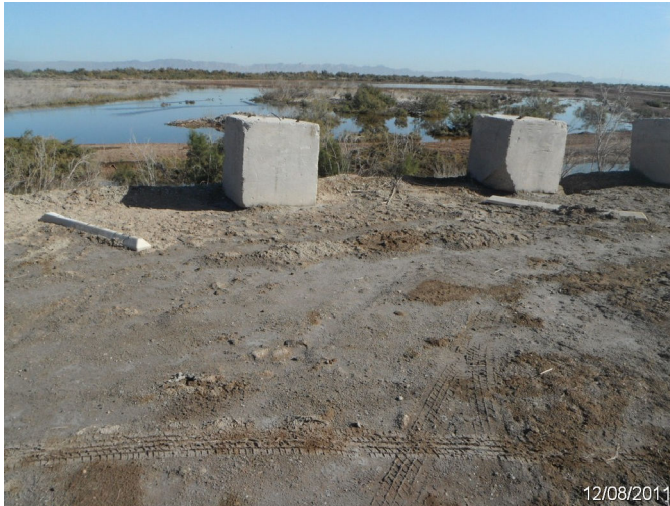
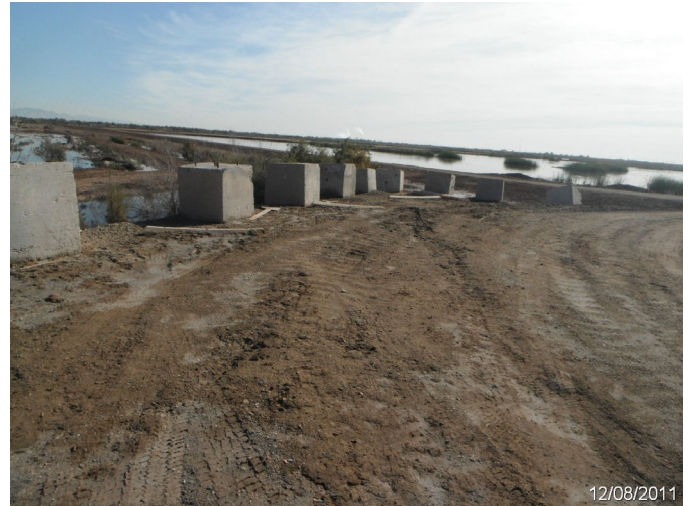
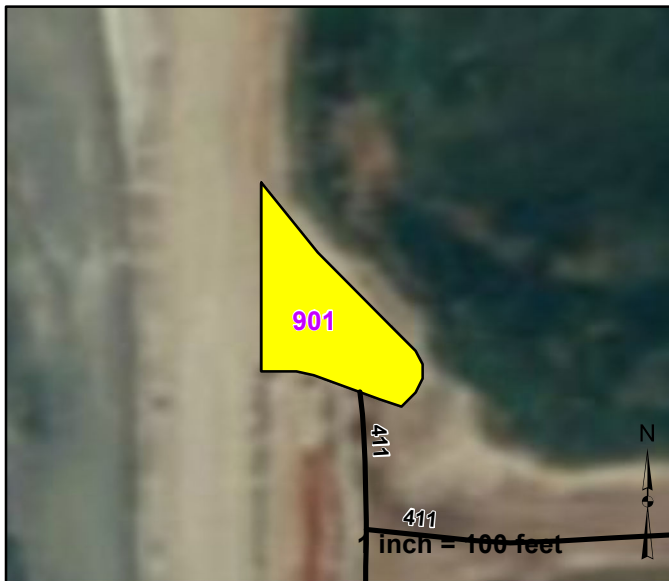
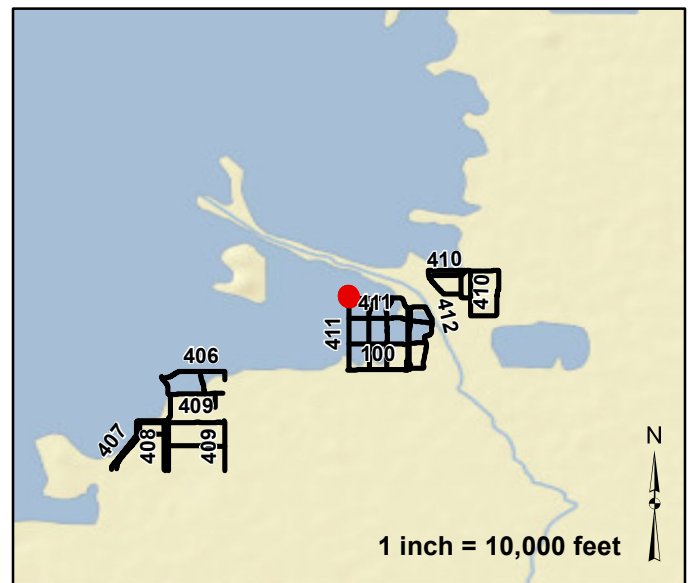
## Route Number:901

Asset Number	Area	Condition	Surface Type	Cost to Improve	Inspection Date	Current Replacement Value
-	4048	Fair	Native	\$1,300	12-08-2011	\$10,200

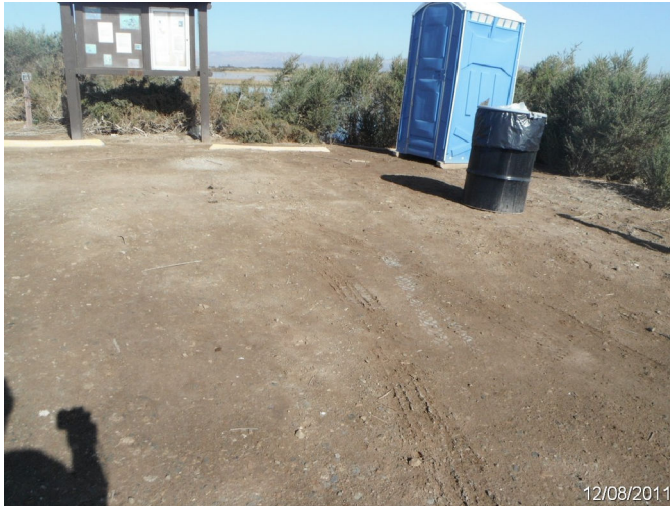
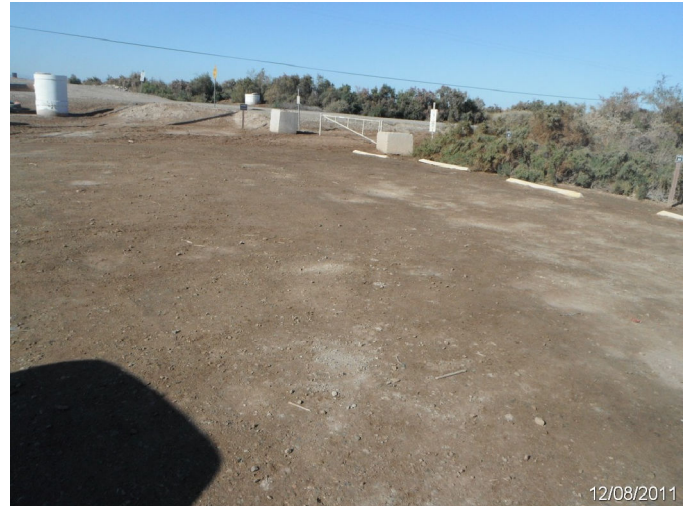
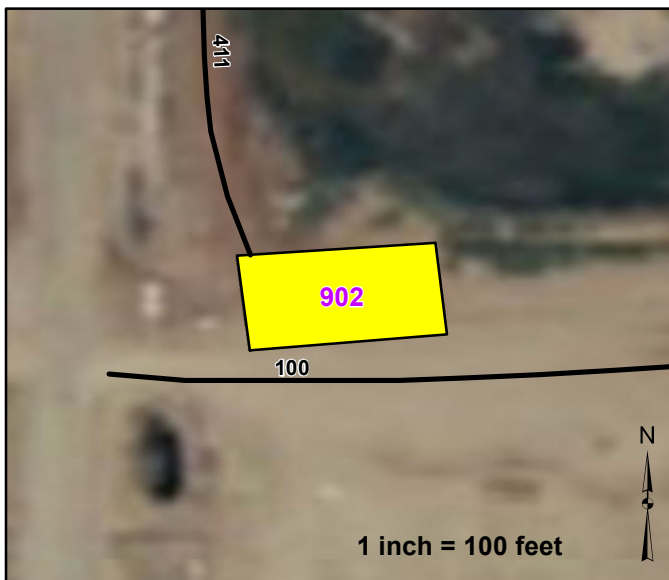
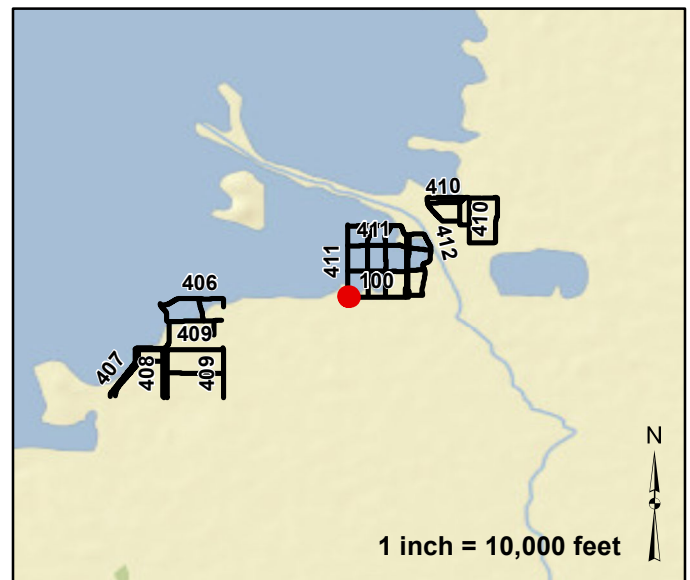
## Route Number:902

Asset Number	Area	Condition	Surface Type	Cost to Improve	Inspection Date	Current Replacement Value
-	4218	Fair	Native	\$1,300	12-08-2011	\$10,600

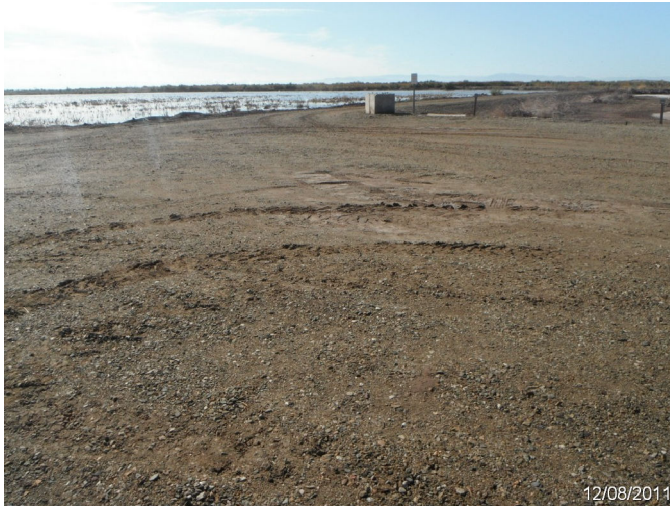
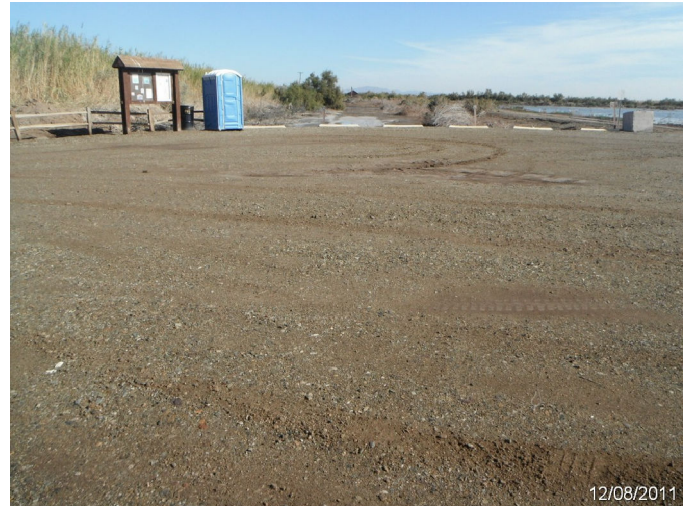
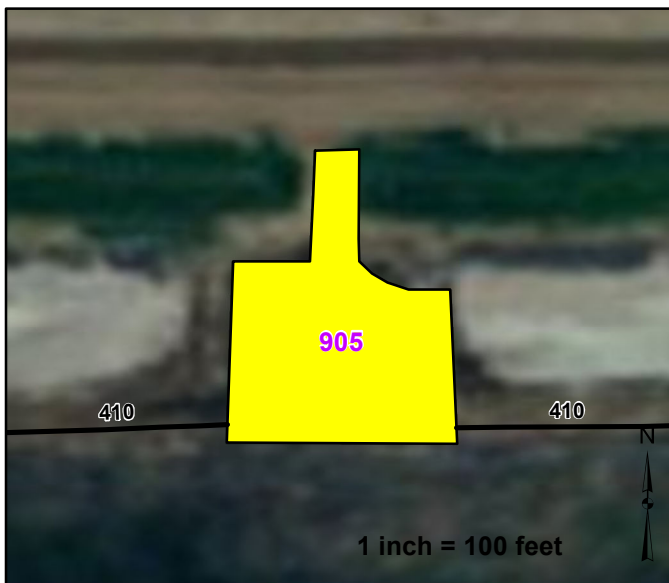
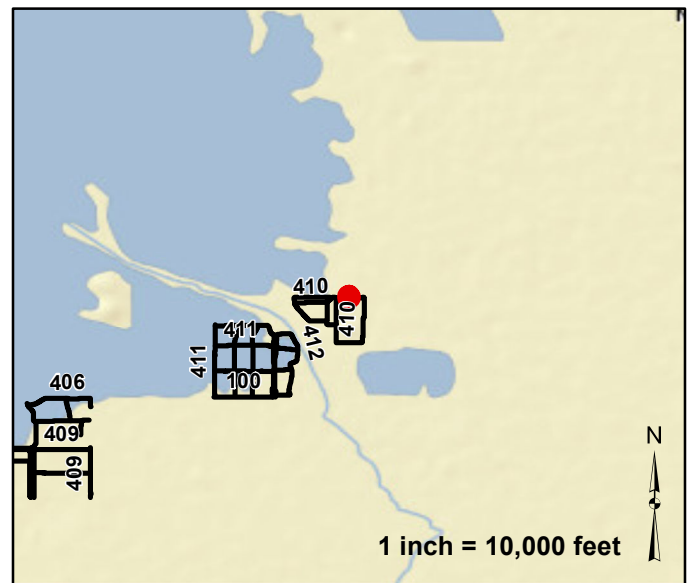
## Route Number:905

Asset Number	Area	Condition	Surface Type	Cost to Improve	Inspection Date	Current Replacement Value
-	9904	Fair	Gravel	\$3,100	12-08-2011	\$57,800

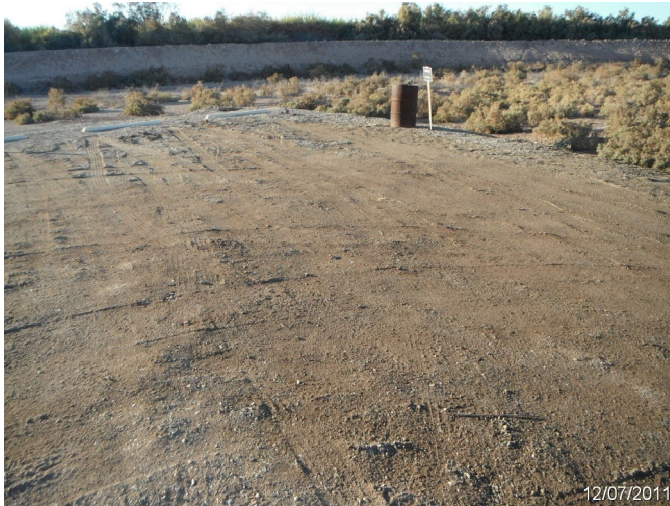
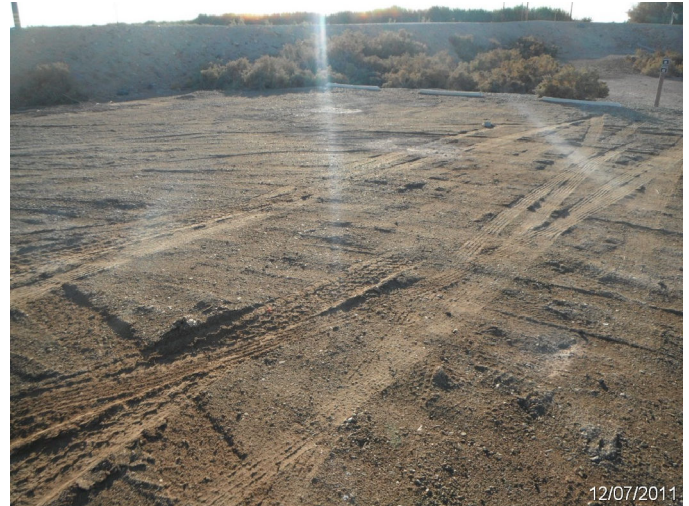
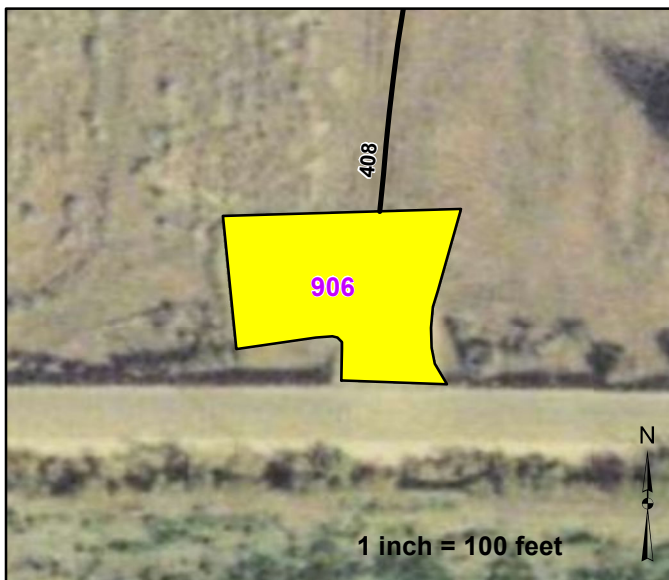
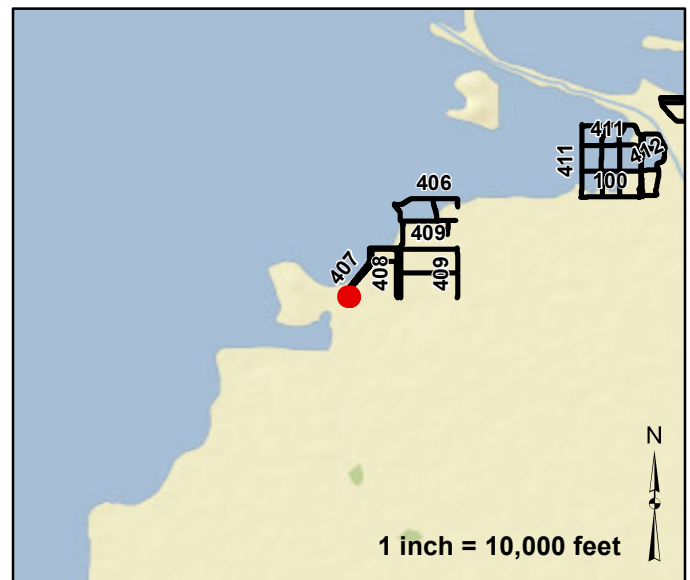
## Route Number:906

Asset Number	Area	Condition	Surface Type	Cost to Improve	Inspection Date	Current Replacement Value
-	7132	Fair	Gravel	\$2,200	12-07-2011	\$41,600
