## **Cultural Resource Re-evaluation Form**

Reso	urce Number: 5JA782
Temp	porary Resource Number:
	Cultural Resource Reevaluation Form
	(page 2 of 2)
9.	Changes in Condition: When the structure was recorded in 1991, it was used by a grazing permitee for storage. The barn
	has been abandoned for several years and is in poor condition. The roofing material on the main barn (shingles) and the
	two lean-tos (roll) are basically gone. The roof of the west lean-to is collapsing in the center. There is a window frame
	with two windows in the west wall; the top three logs on the north side of the frame have collapsed. The concrete
	foundation is broken. The rock foundation under the south wall of the main barn has been undermined by rodent
	burrows in three places. The foundation under the east lean-to is breaking up. The roof is collapsing on the north end;
	the walls below are collapsing behind the loading chute.

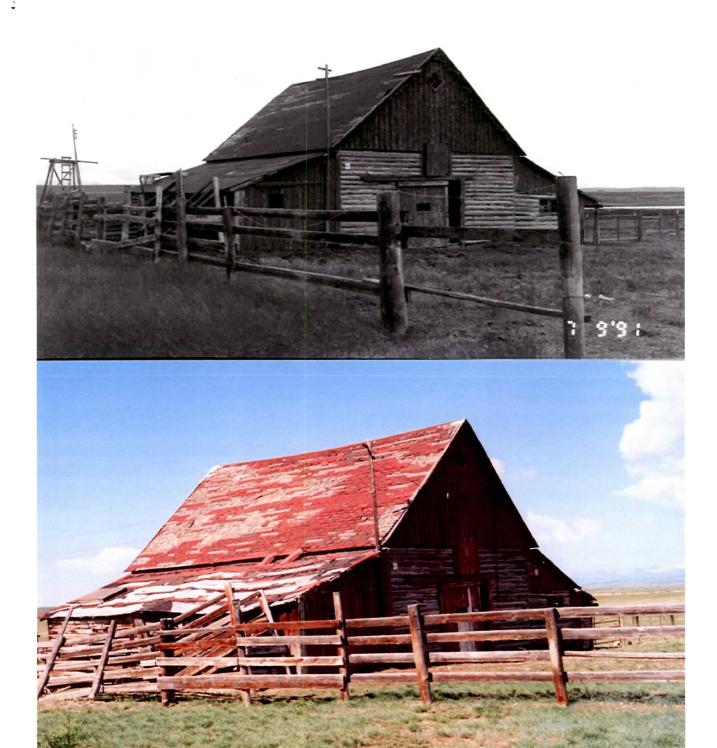
Figure 1: 1991 and 2003 photos of the north and east walls of the Hampton Barn. Note the deterioration of the shed roof and the wall collapse.

10.	Changes to Location or Size Information: None
11.	Changes in Ownership: None
12.	Other Changes, Additions, or Observations
13.	National Register Eligibility Assessment:
	Eligible Not eligible X Need data
	Explain: The barn does not possess characteristics that make it eligible for nomination to the National Register. It is not
	associated with any significant events or individuals and lacks those qualities that would make it architecturally
	significant. It is typical of barns throughout the west in that it was used to house livestock during its life as part of an
	operating ranch. Its use as a dairy barn is interesting, but not historically significant.
<u>1</u> 4.	Management Recommendations: The deteriorated condition of the barn makes it a safety hazard. Demolition is
	recommended.

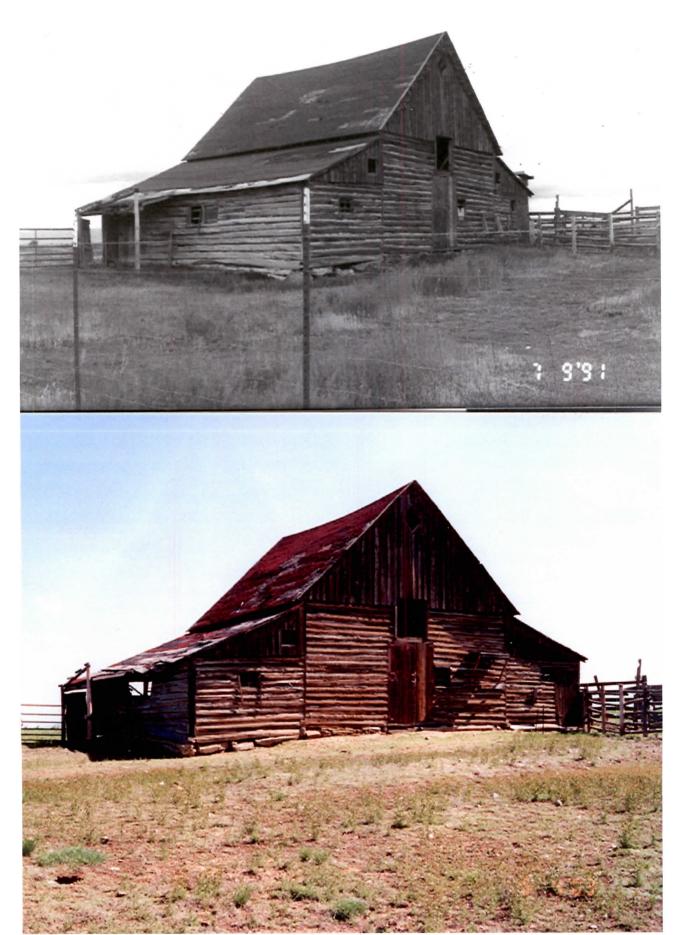
Figure 2: West and south walls of the Hampton Barn. Note the deteriorated shed room and
