UNITED STATES DEPARTMENT OF AGRICULTURE  
BIOLOGICAL SURVEY

PRELIMINARY REPORT

LAKE BOWDOIN

MALTA, MONTANA

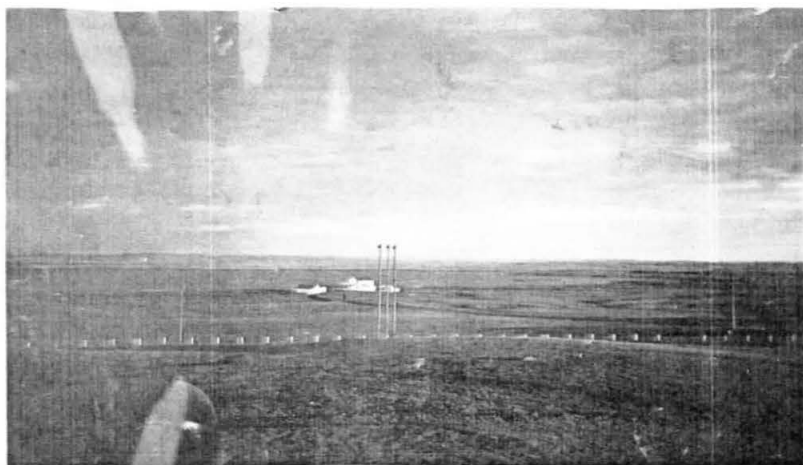
- # 1 Taken from a point on canal bank at bend in canal east of Club house, shows Gun Club buildings and general view of Lake toward the northeast.
- # 2 A close-up of the Lake shore, showing tule islands, taken from a point south and west of the Club house and looking east.
- # 3 Looking southwest from hilltop near center of Sec. 33. In foreground, dike and in background, town of Bowdoin.

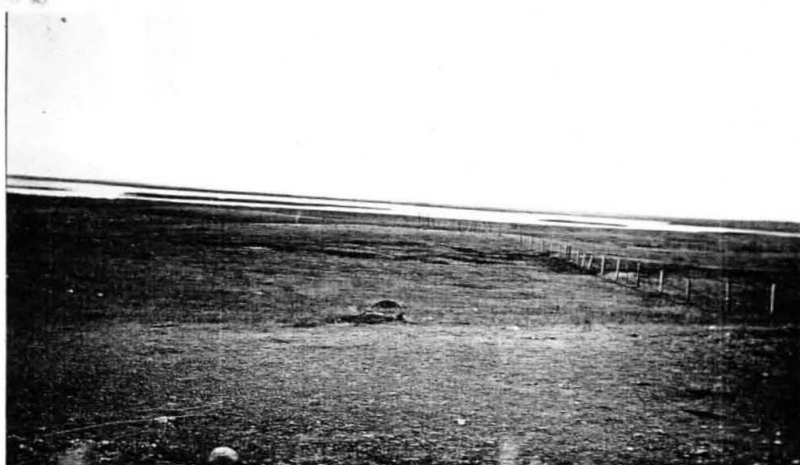
2

In the south one-half of the Lakes are numerous tule islands and around the shore is Marsh area, the ditch leading from the Lake to the northeast and the area into which said ditch empties are full of marsh and tule growth even though dry this year. That is, the roots are still there, the tops are eaten to the ground by cattle and horses that are grazed on this area by virtue of grazing leases from the Reclamation Service.

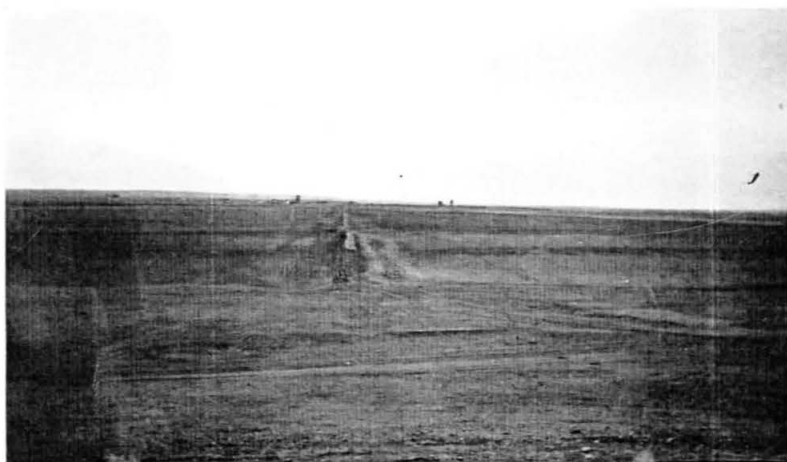
3

This project was built, but flooded so much land and Railway grades that a lawsuit resulted and the project was abandoned. After its abandonment, the dike was cut and the "dry lake bed" drained by the farmers who had been flooded out. Now the local sportsmen have had an F.E.R.A. project plug the hole in the dike in order to reflood the area marked "dry lake bed" for a water fowl area, which is protected by a State Game Refuge(dotted line on map).
