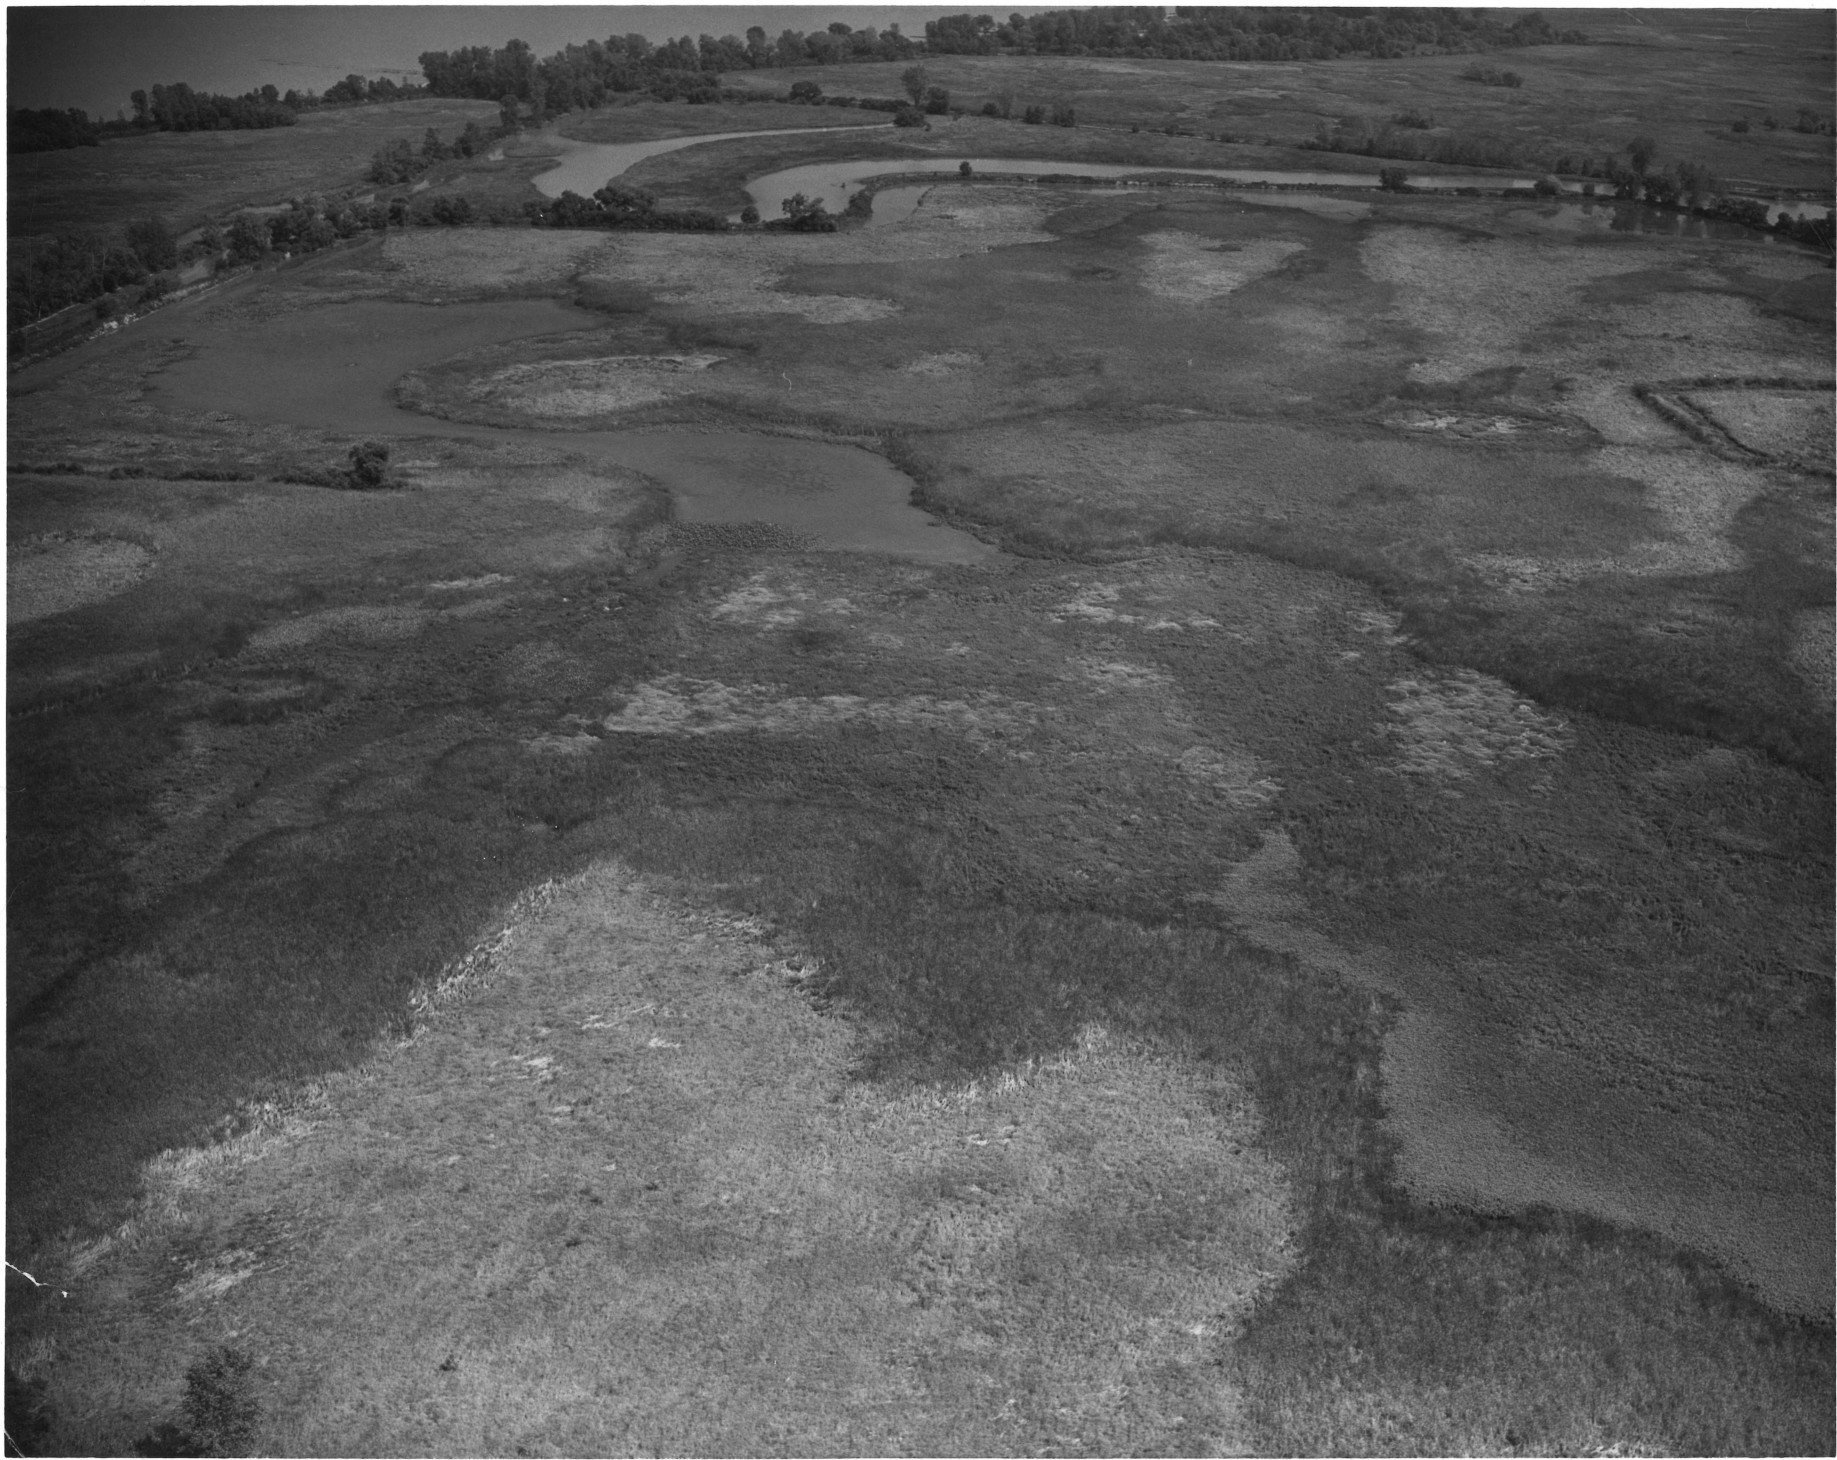
⑦ 9-7-63

7. Major portion of Searle Marsh tract 20, camera facing east. Upper part of photo shows "horseshoe bend" in Crane Creek and major portion of Dewey tract no. 18. Almost entire dike system of Searle Marsh needs complete overhaul. A part of the dike cut out shortly after this picture was taken, and all of the water was lost. Light colored area (water) in upper left corner is Lake Erie at mouth of Crane Creek. North end of B & T, Inc., tract no. 19, shows in upper right corner of photo.
