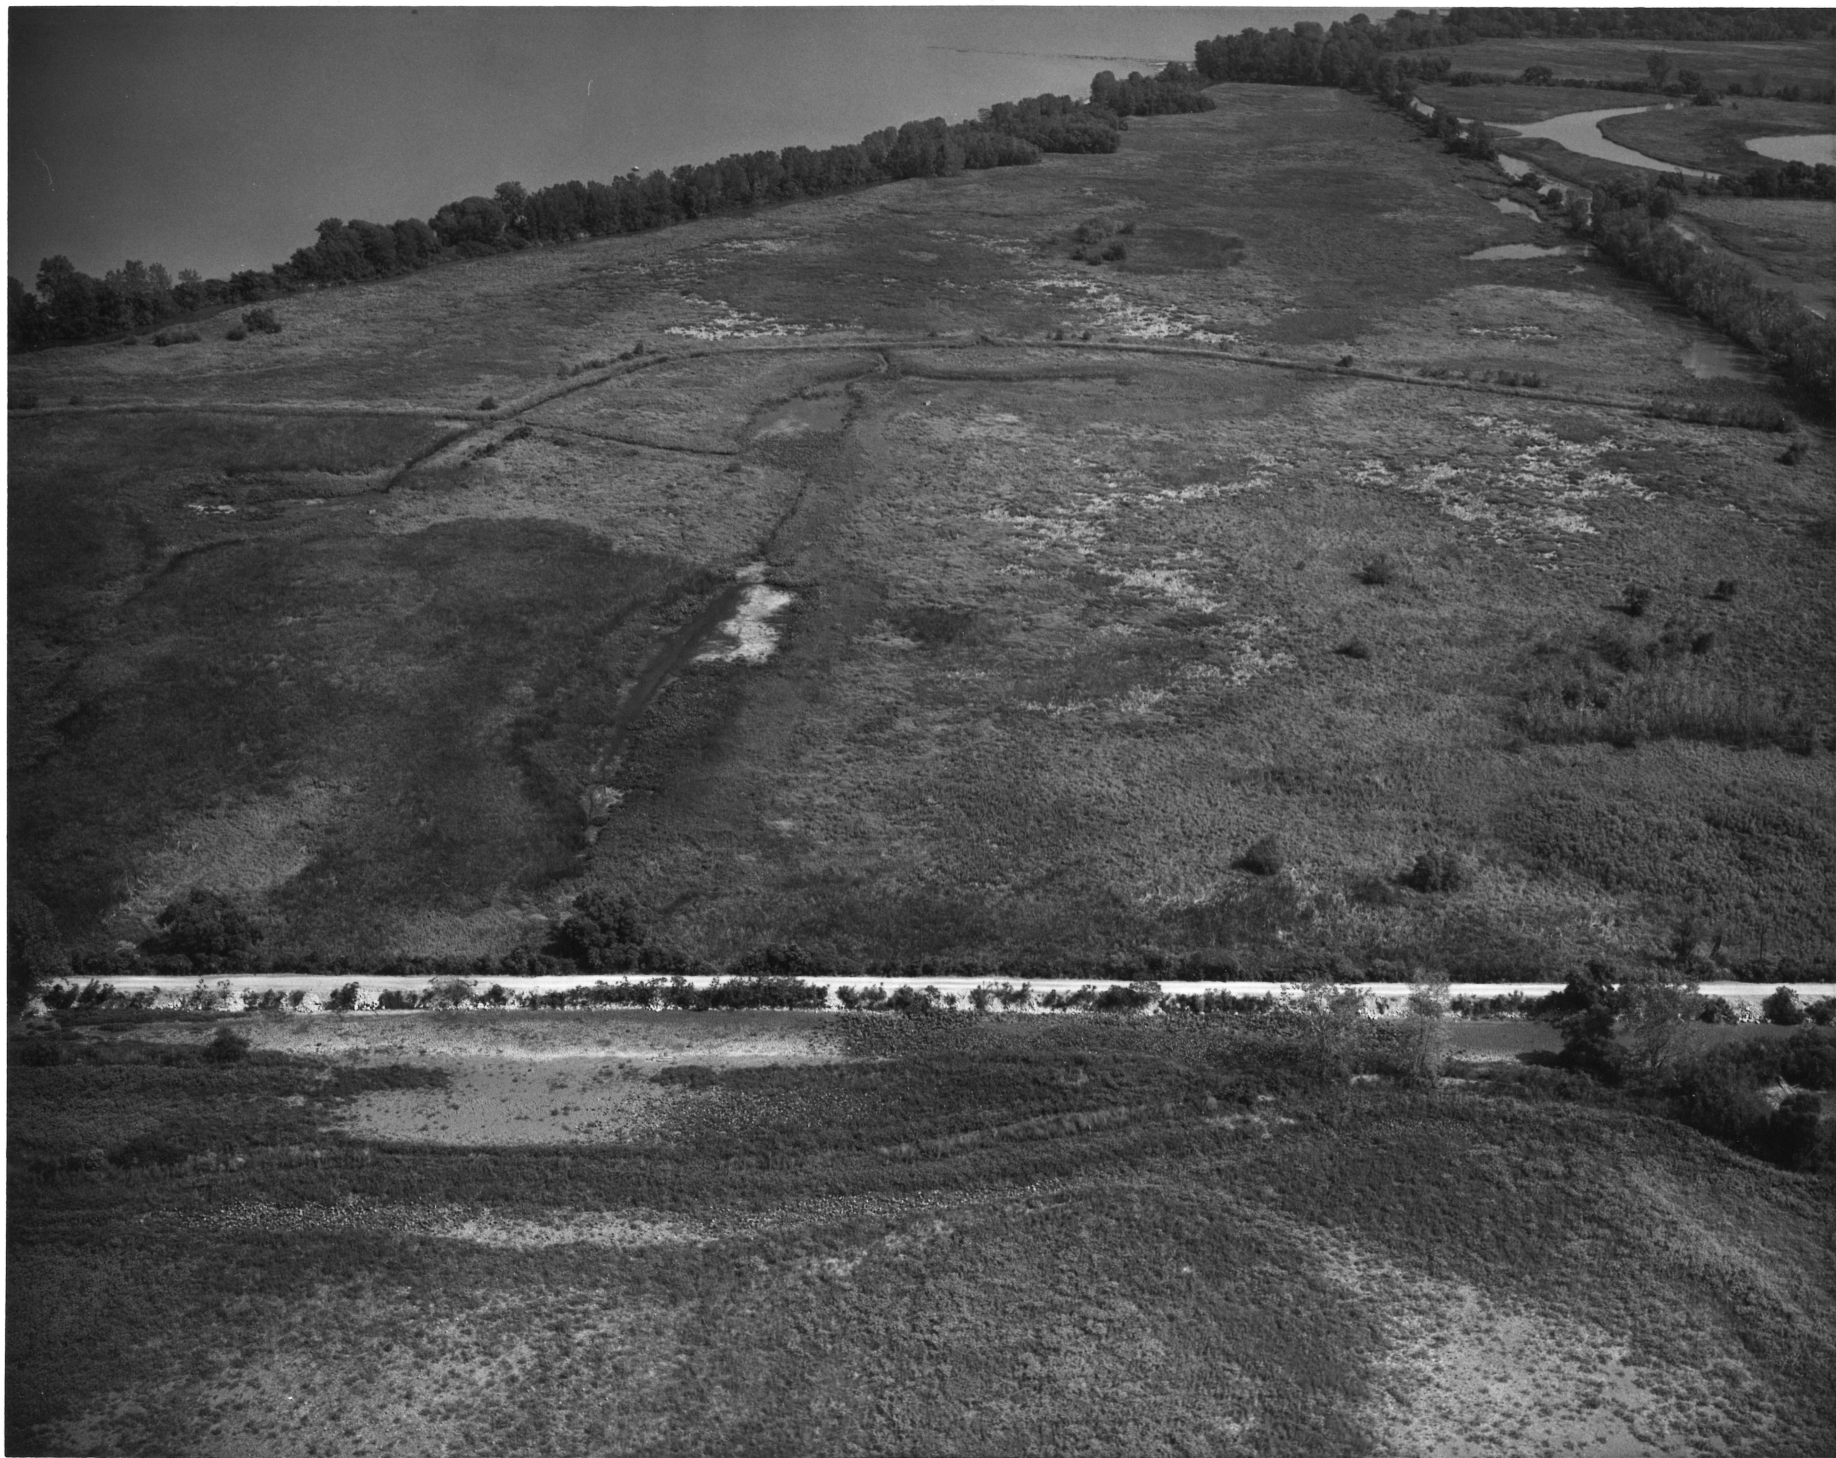
10. Major portion of Willow Point Club tract no. 10, camera facing east. Eastern boundary (dike trail) of Pintail Marsh tract no. 11 crosses lower part of photo. Some riprap had to be placed along the dike in 1963, more will be needed to permanently secure the dike. Dike work will also be needed to permanently secure the Willow Point Marsh. The remains of old pier-pilings can be seen extending out into Lake Erie at top center. They are at the mouth of Crane Creek where some type of structure is needed to keep mouth of Creek open.
