Avian Protection Plan Lostwood National Wildlife Refuge

Avian Protection Plan

Lostwood National Wildlife Refuge

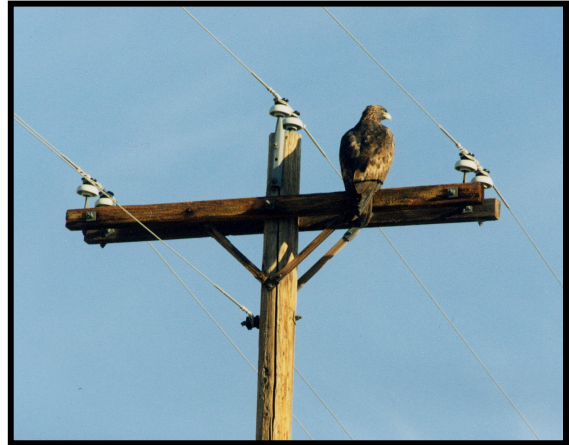
Photo 2 Golden Eagle and a Typical Three-Phase Tangent Structure

This separation is appropriate in areas where large raptors are less likely to occur. In areas where eagles use these poles as preferred perches (Photo 2), additional protection to minimize the electrocution risk would be recommended. Retrofitting is also appropriate on older REA three-phase tangent structures where the crossarm is mounted on the lower pole-top pin through bolt. These older type units have decreased outer to center phase separation because the crossarm is mounted closer to the pole top.

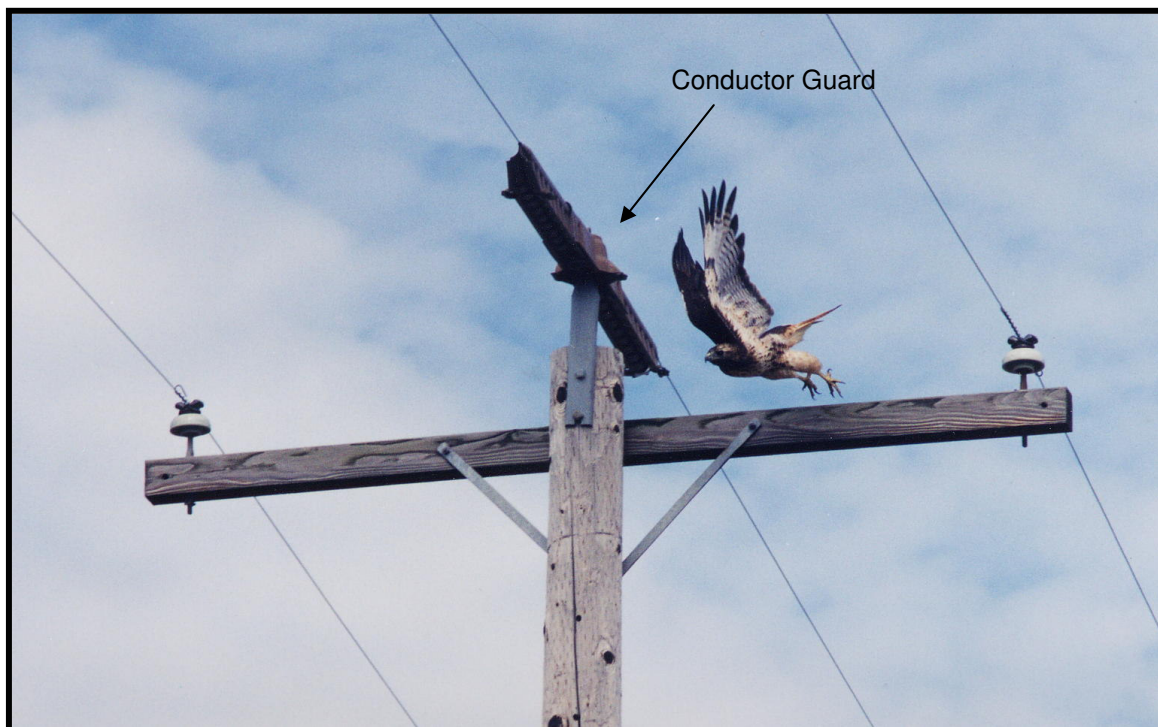
Photo 3 Kaddas Bird Guard Mounted on a Preferred Perch Structure

Conductor guards can be installed with hotline sticks and will accommodate small line angles. The most widely used cover is the Kaddas *Bird Guard*. The ends of the Kaddas covers must be trimmed for a proper fit to the conductor. Failure to properly trim the ends may result in the covers coming off in strong winds. Some utilities also fit armor rods over the conductor prior to fitting conductor covers, due to wind abrasion and vibration concerns. In areas where airborne contamination is a concern, a conductor cover with a silicone coating may be preferable.

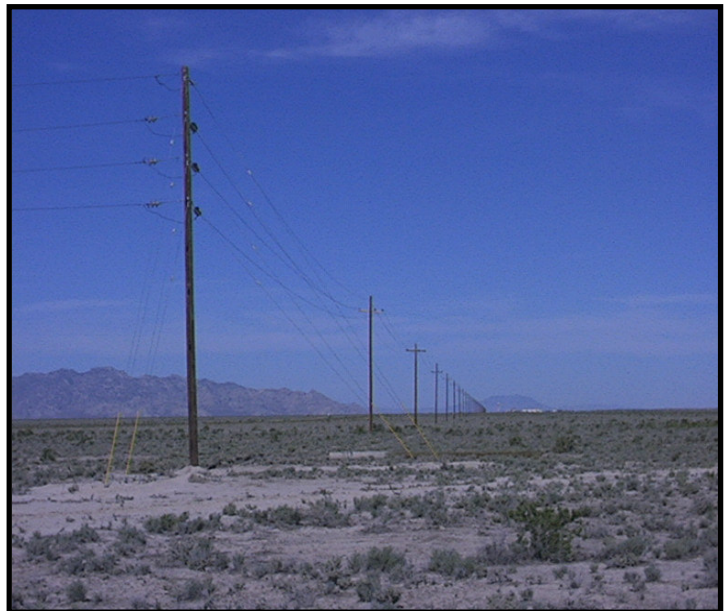
Photo 7 Three-Phase Vertical Bird-Friendly Angle Structure

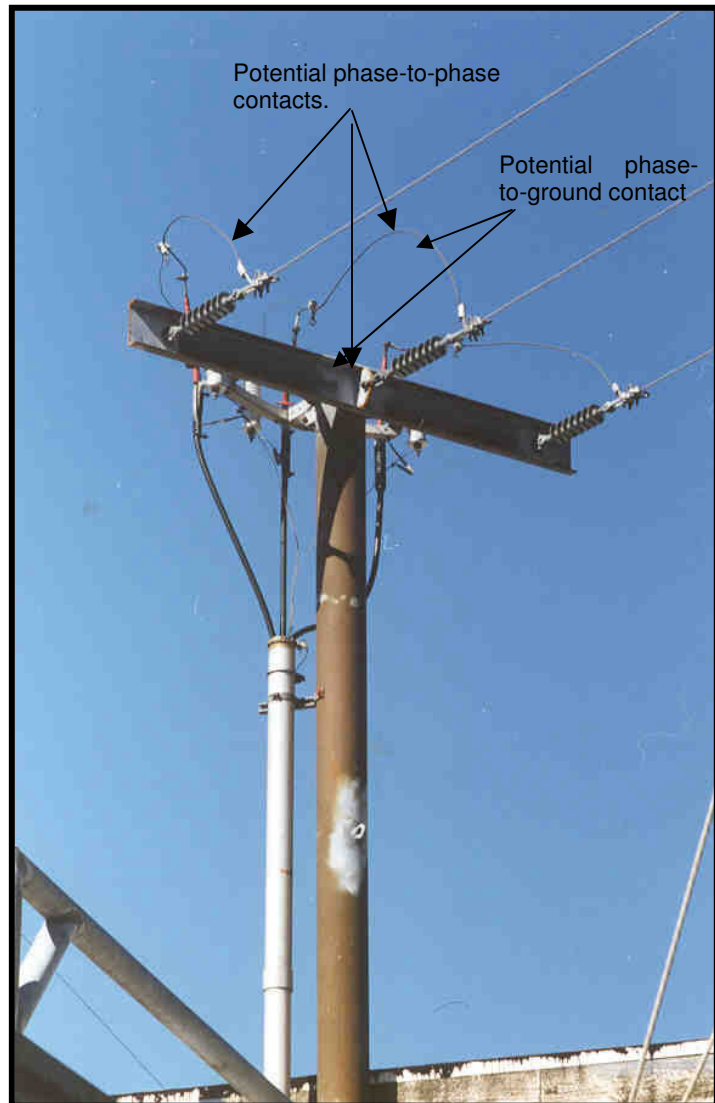
Photo 11 Metal Crossarm Posing a Significant Phase-to-Ground Electrocution Risk

North American distribution utilities have historically selected wood as the material of choice for poles and crossarms. Accordingly, most animal-proofing techniques are designed for use on wood pole structures. Recently other materials, such as concrete and steel, are being used in distribution line construction. Sometimes non-wood crossarms are used because they are not susceptible to woodpecker damage. In some regions of the U.S., woodpecker damage to wood poles is the most significant cause of pole deterioration. When steel crossarms are substituted for wood, the critical clearance for animals often becomes the phase-to-crossarm separation (i.e., phase-to-ground) (Photo 11).

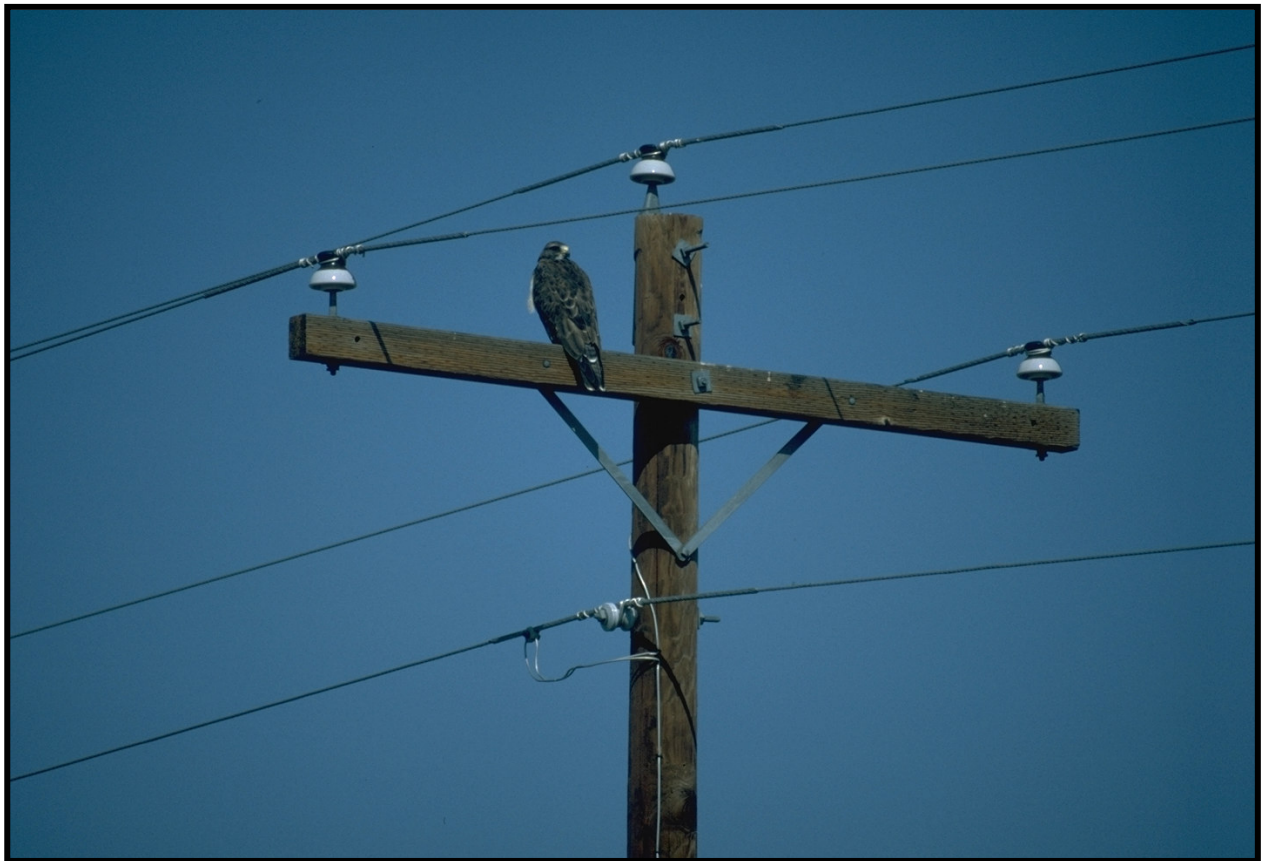
Photo 12 Swainson's Hawk Perching on a Crossarm Supported by an Ungrounded Metal Crossarm Brace

Prior to 1972, it was common to employ grounded metal crossarm braces. These braces were attached with lag bolts to the pole and crossarm front (Photo 12). Birds perching on crossarms were able to simultaneously touch one energized conductor and a grounded brace. The Rural Electric Association abandoned metal braces in 1972 because grounded braces were contributing to raptor electrocutions. The metal braces were replaced with nonconductive wood braces. All new construction should employ nonconductive braces to minimize animal contacts. In addition, existing metal braces should not be grounded.

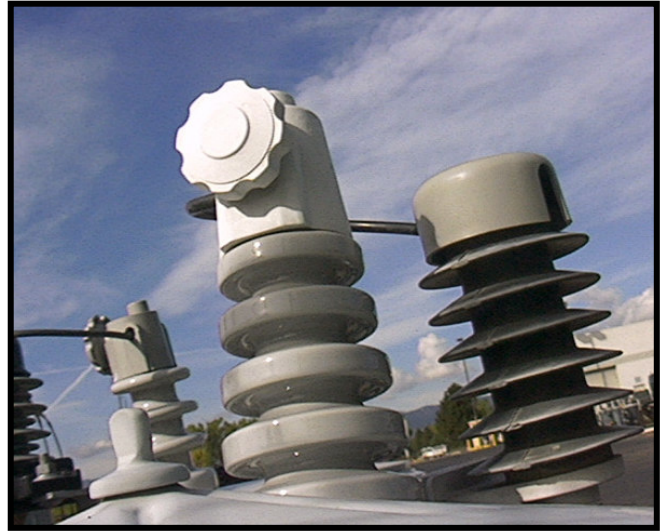
**Photo 14 “Wheel-Type” Bushing Cover
Delivered with the Transformer**

Bushing covers and 600V-insulated wire are a protective system that can provide the necessary insulation level to minimize animal-caused outages. New transformers can be ordered with a “wheel-type” wildlife protector (Photo 14) installed by the transformer manufacturer (Table 4). Porcelain protector models also are available from Porcelain Products Company that will have limited deterioration from exposure to ultraviolet rays, moisture, and temperature extremes. The porcelain protectors are available in either a top entry or side-cable entry.

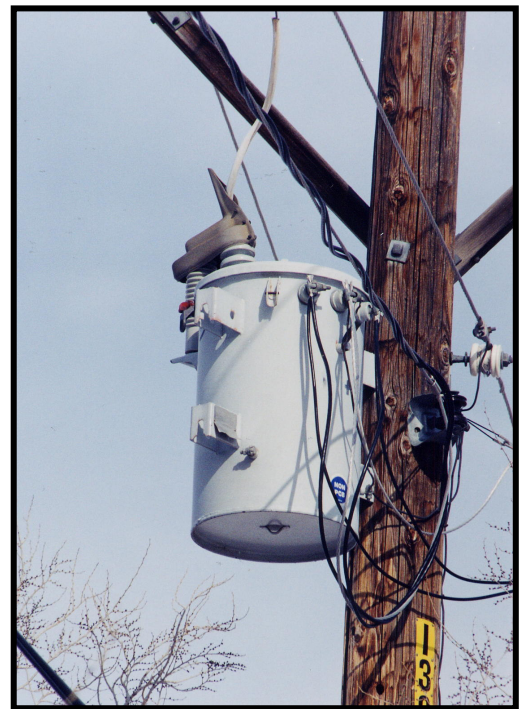
Photo 17 Combination Arrester/ Bushing Cover

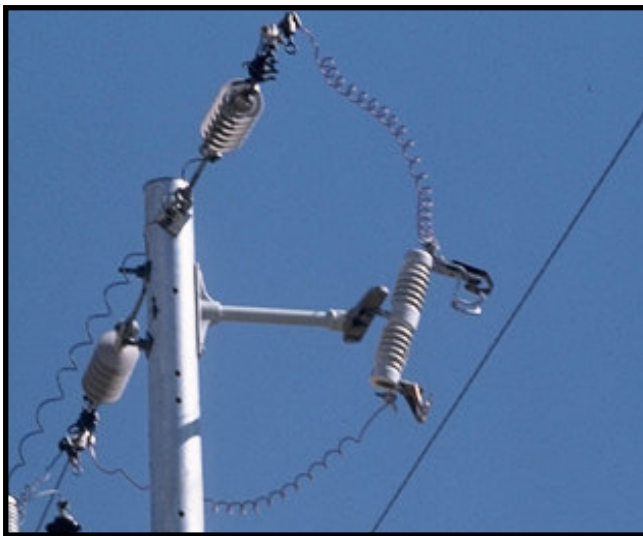
Photo 19 Cutout Mounted on an Insulated Fiberglass Bracket to Isolate Animal Contacts

A cutout is a device used to make a fused connection between primary conductors; this device is often called a "fused cutout." If the fuse fails, this mechanism provides a visible open, which can be seen from the ground. The top plate of the cutout is energized and can be problematic to animals if they are mounted near a grounded surface. There are two ways to prevent cutout problems, isolation and insulation. Isolation entails mounting cutouts in a manner that makes an animal contact more difficult, such as on insulated fiberglass brackets (Photo 19)

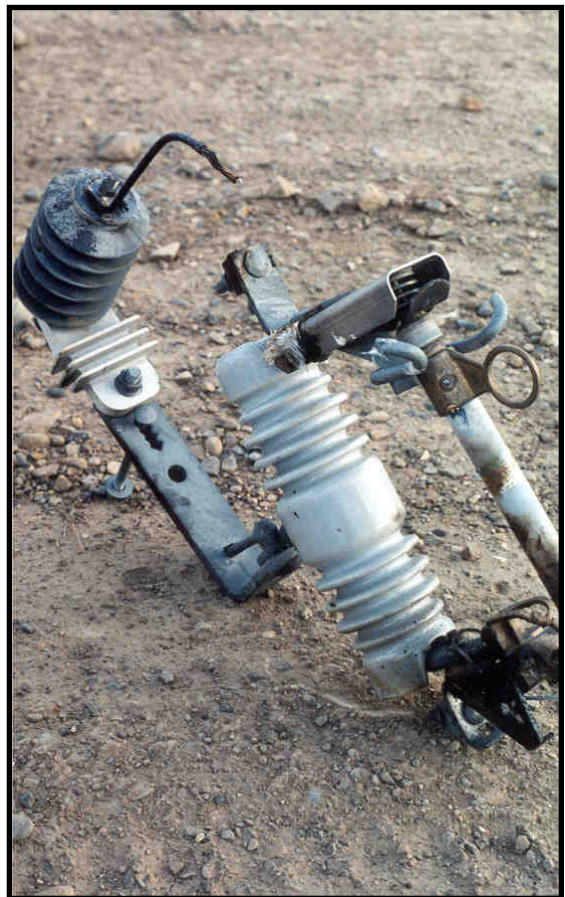
Photo 20 Damaged Cutout Resulting from an Animal Contact

Cutouts are often installed with metal L-brackets (see Section 5.14, Brackets). If the metal bracket is grounded it can easily allow for an animal to bridge the distance between a cutout and ground (Photo 20).

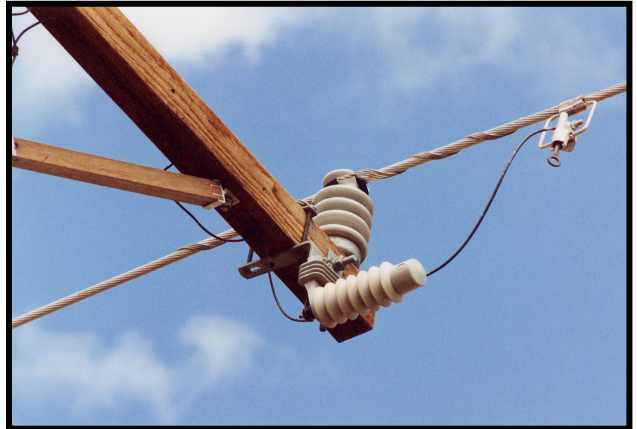
Photo 26 Horizontally Mounted Surge Arrester to Reduce Animal Exposure

The position of an arrester can be modified to reduce potential contacts. Installing arresters in a horizontal fashion with insulated leads reduces exposure to animals (Photo 26). This installation also should include an insulated cap. Attention should be placed on the groundwire exiting the bottom of the arrester. If the groundwire is in proximity to any energized hardware, it too should be insulated (Photo 27). Any conductors that cannot be covered should be wrapped with insulating tape.

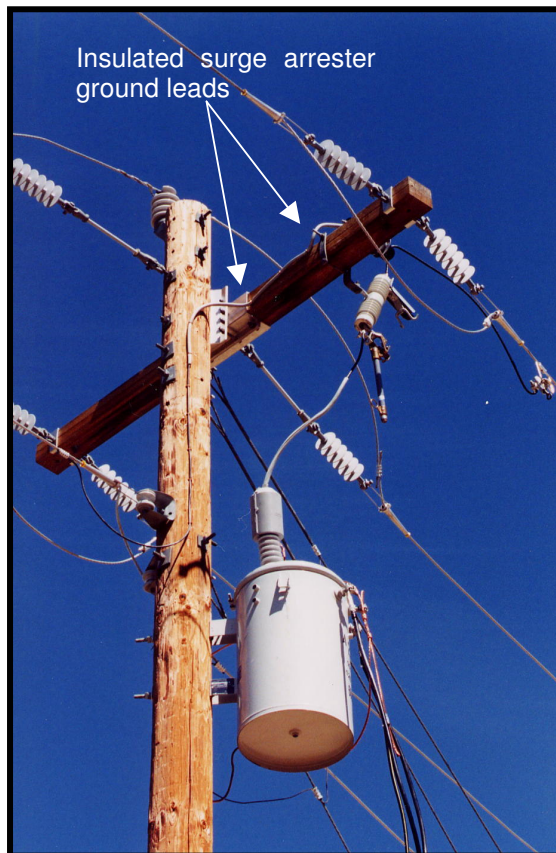
Photo 27 Insulated Surge Arrester Ground to Eliminate Phase-to-Ground Animal Contacts

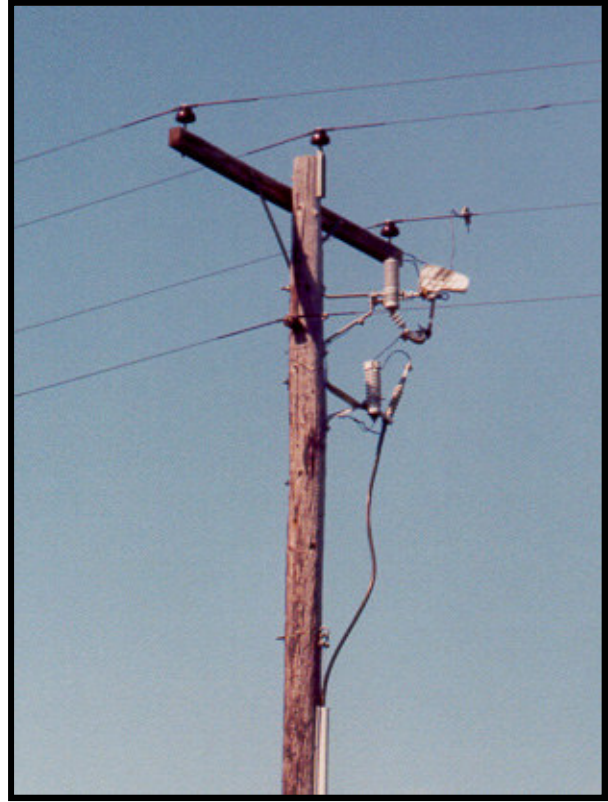
**Photo 34 Single-Phase Metal
Cutout/Arrester and Pothead Bracket**

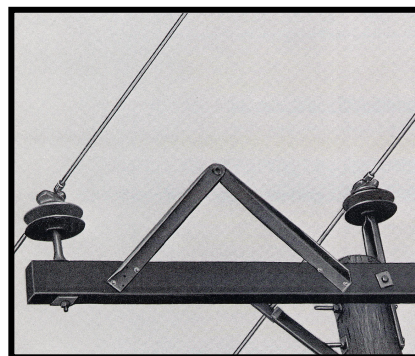
Photo 39 Hendrix Perch Guard that is Adjustable and Mounts on the Vertical Crossarm Surface

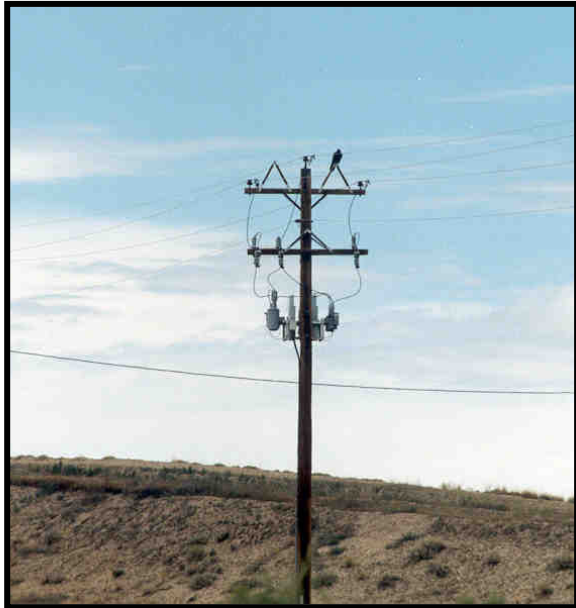
Photo 40 Bird Perching on a Triangle Perch Guard

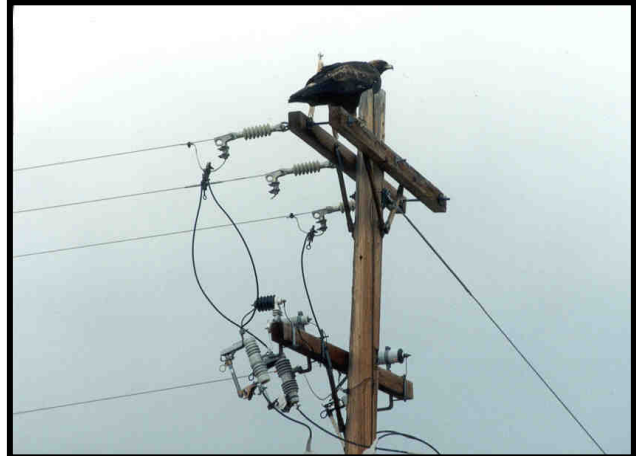
Photo 41 Perch Guard Shifting an Eagle Toward the Safe Side of a Deadend Unit

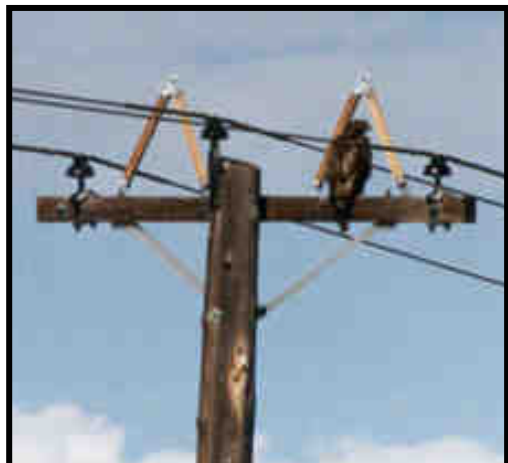
Photo 43 Raptor Perching under a Perch Guard

Perch guards should be sized properly to discourage birds from perching under or adjacent to the guards (Photo 43), and purchased with a protective coating to prevent UV deterioration. Home-made guards without UV protection will often prematurely deteriorate, becoming ineffective (Photo 44).

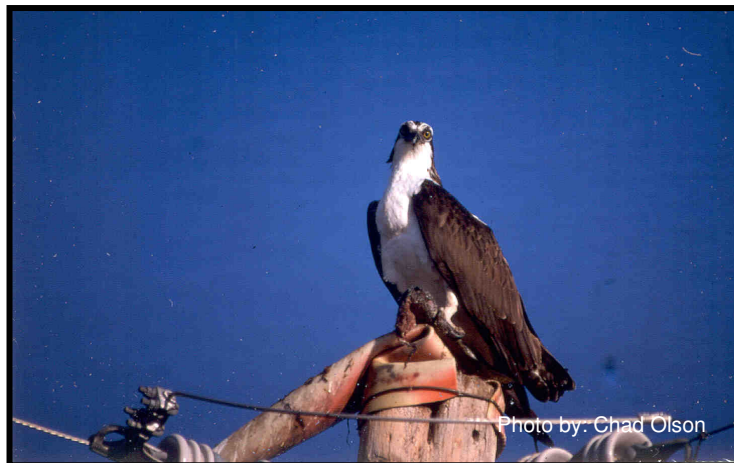
Photo 44 Deteriorated Traffic Cone used as a Perch Guard

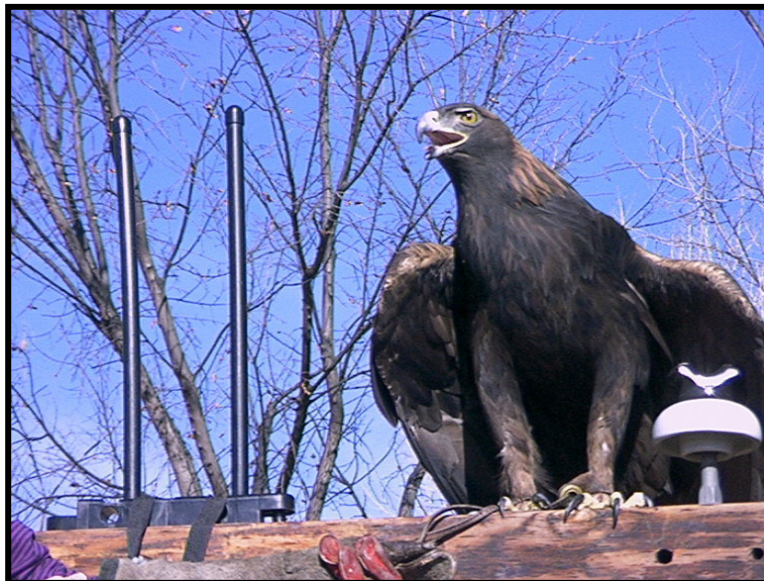
Photo 47 Golden Eagle Perched next to a Mission Engineering Bird Guard

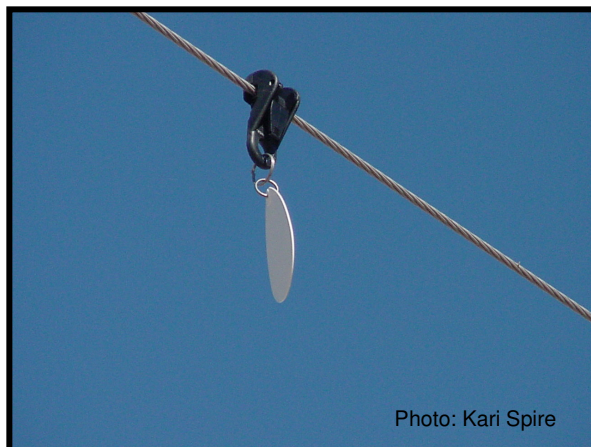
Photo 48 White Flapper

The Flapper (Photo 48) was designed in South Africa in partnership with Preformed Line Products, ESKOM, and the Endangered Wildlife Trust (EWT). The Flapper is distributed by Kaddas and is designed to securely grip wires up to a diameter of 0.75 inch with a locking plastic jaw. The Flapper can be installed and removed from the ground (Photo 49); has been UV stabilized; and is available in red, white, and black. Black and white flappers provide maximum contrast.

The Flapper is used in Africa and is effective at reducing collisions. However, ESKOM has experienced problems with the device shifting in some of the earlier versions (van Rooyen 2000).

A new Flapper version was released this year. According to the distributor, this unit when properly applied will not shift and move on the line. The manufacturer also recommends using silicone adhesive on the clamp (Klein part number 51138). There are two versions of the Flapper, one is attached with a ratcheted clamp, and the other is installed with a breakaway composite screw using a hotline stick. The Flapper is available with a luminescent paint that will glow in low light situations. The color of devices plays an important role in reducing collisions (Kreithen 1996).

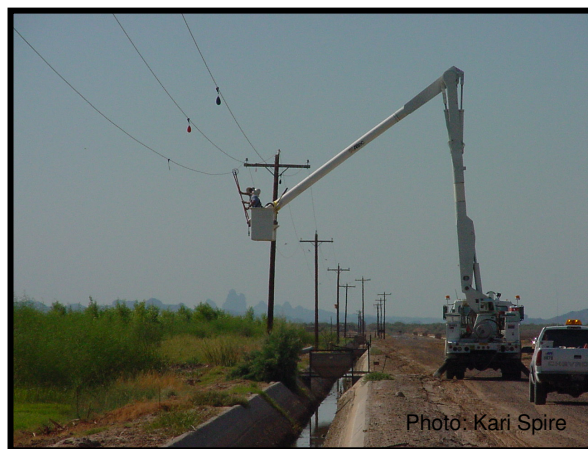
Photo 49 Flapper Installation

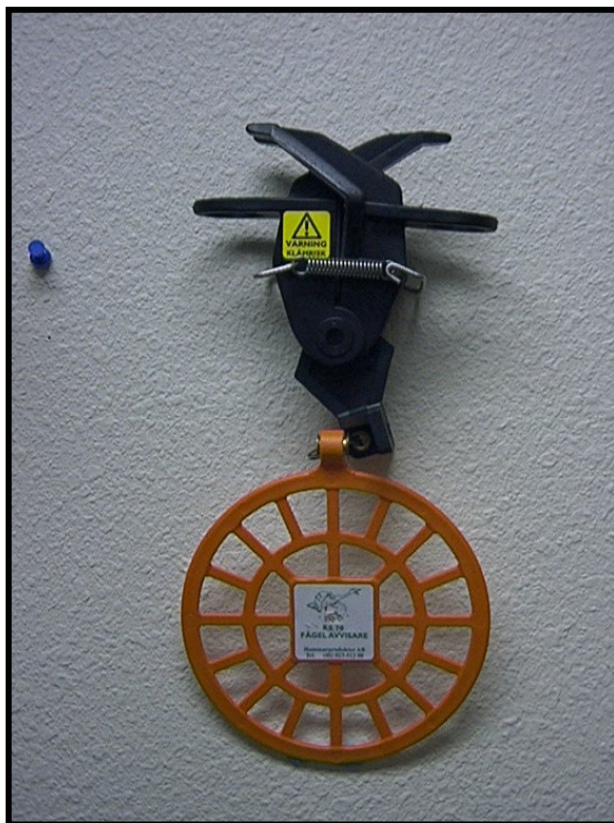
Photo 50 BirdMARK Bird Flight Diverter

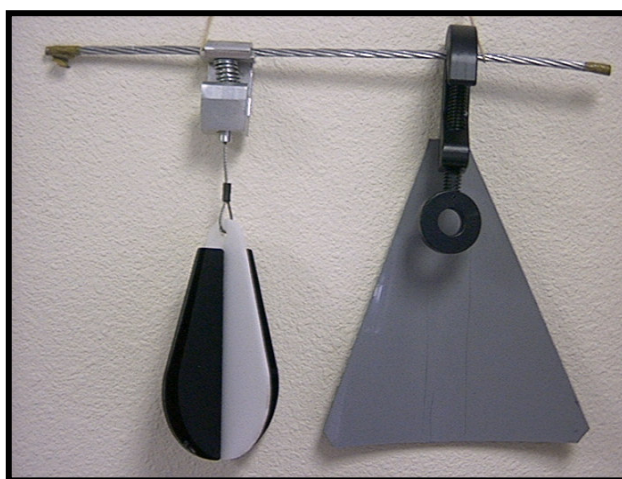
Photo 51 Mission Engineering (left) and MIDSUN (right) Bird Diverters

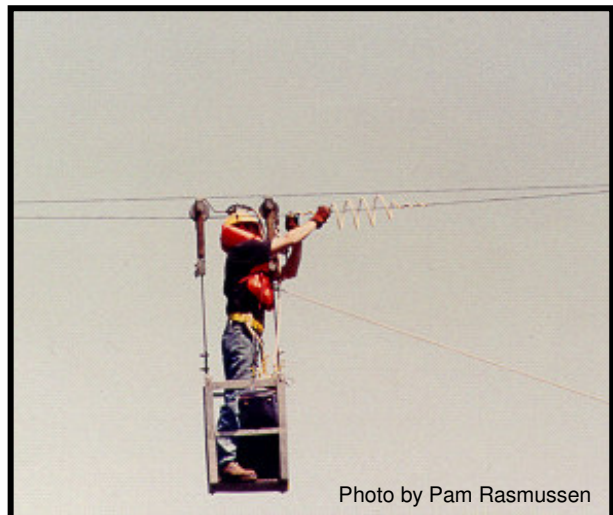
Photo 54 Lineman installing SFDs from a Suspended Pull Cart

In this example, a lineman was placed in a line cart on the shield wire and pulled himself across the shield wire by hand to install the diverters (Photo 54). It took a three-man crew 2 hours of setup time for each wire crossing and 30 minutes for the lineman in the cart to install the SFDs. To date no additional collisions or deaths have been documented (Rasmussen 2001).

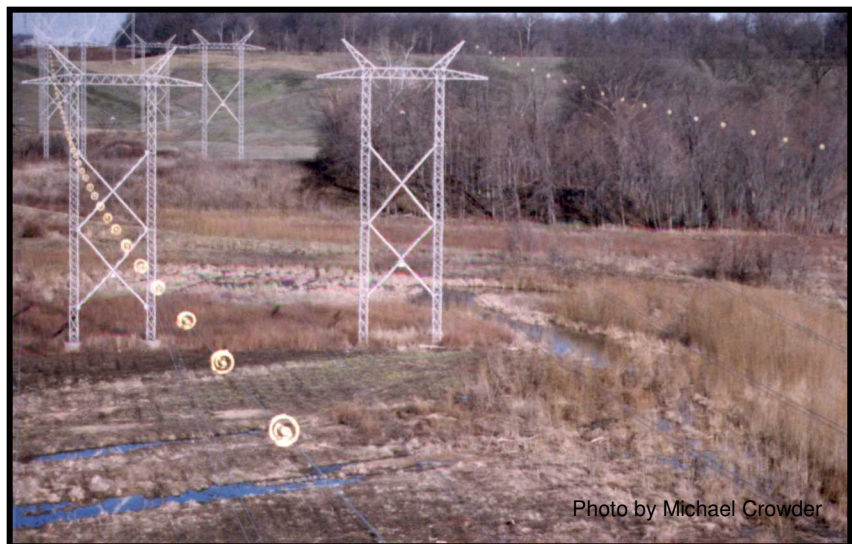
Photo 55 Swan Flight Diverters Installed at a 20-foot Interval in Indiana

In Indiana, the SFD has also recently shown to be effective in reducing waterfowl collisions with overhead static wires (Crowder 2000). The spacing of the SFDs in Crowder's 1998-2000 study was 20 feet apart (Photo 55). The close spacing was required to compare the effectiveness of the SFD to the BFD.
