**EFFECTIVENESS OF MARKING POWERLINES
TO REDUCE SANDHILL CRANE COLLISIONS**

Anne E. Morkill and Stanley H. Anderson

Wyoming Cooperative Fish & Wildlife Research Unit
Box 3166, University Station
Laramie, Wyoming 82071

November, 1990

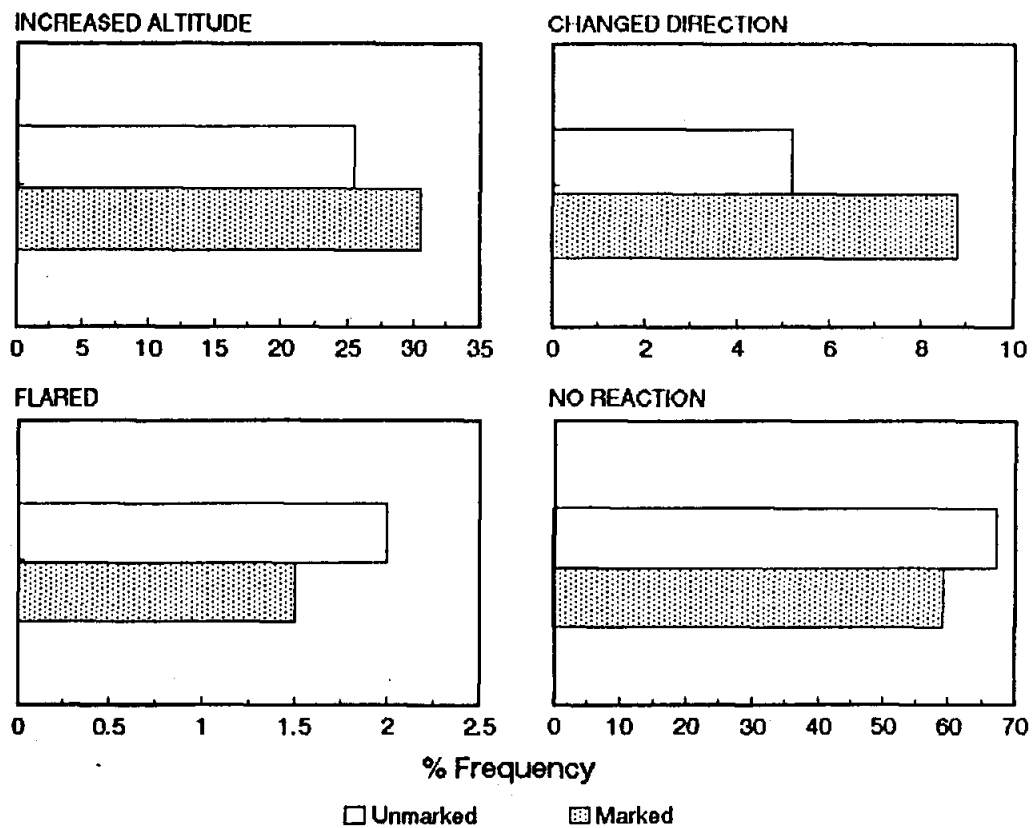
Figure 3. Crane reactions to marked and unmarked spans at nine upland study segments, 1988-90.

unmarked spans. Among cranes flying over unmarked spans, flare reactions were comparatively more common. This behavior suggested that cranes approaching marked spans saw the balls and were more likely to adjust their altitude or direction to avoid the balls. On the other hand, cranes approaching unmarked spans may have been less aware of the wires and were more likely to flare from the wires. Data on reaction distances and height flown over wires support the significant effect of markers on crane flight behavior.

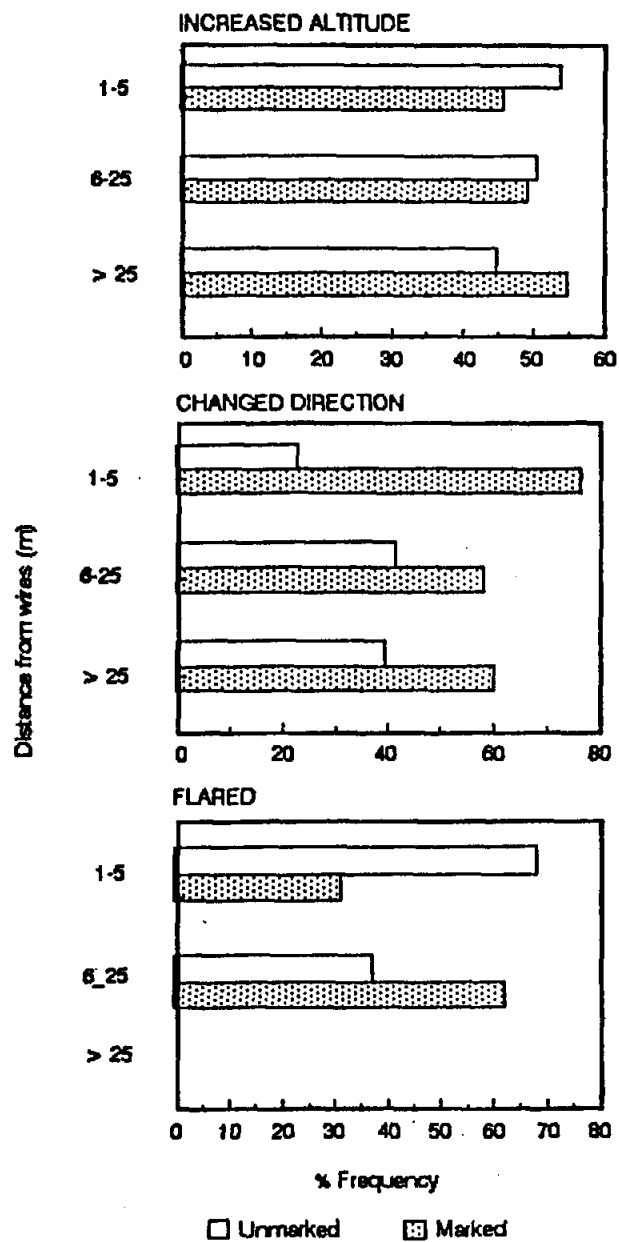
Figure 4. Crane reaction distances at marked and unmarked spans at nine upland study segments, 1989-90.

Reaction type and reaction distance differed between marked and unmarked spans ($p < 0.001$) (Figure 4). More cranes increased altitude at distances farther than 25 m from marked wires than at unmarked spans, suggesting that cranes saw the balls at a distance and adjusted altitude accordingly. In contrast, cranes flared more often within 1-5 m of unmarked wires, perhaps because they were unaware of the wires and approached closely before flaring away. Cranes changed direction at all distances more often at marked spans than unmarked spans.

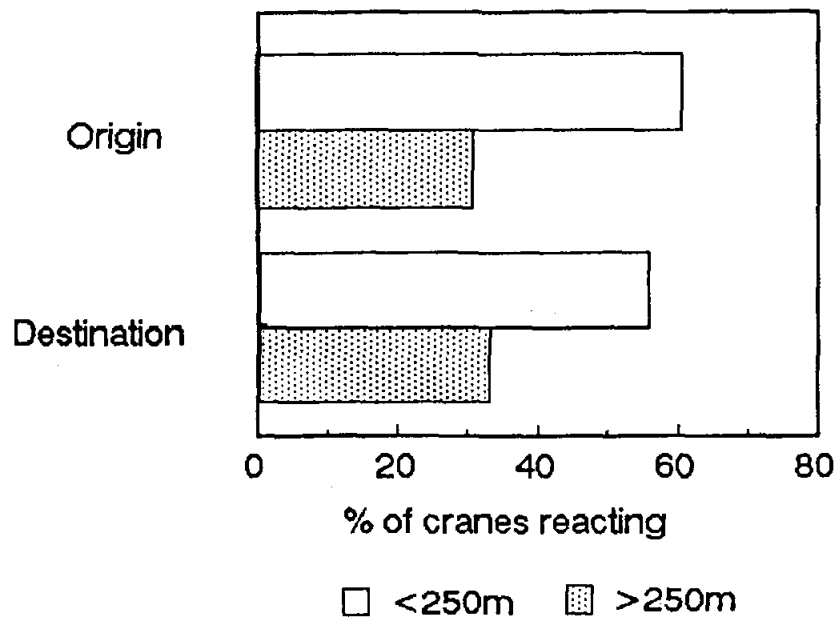
Figure 6. Crane reactions to nine upland study segments in relation to flight distance from origin and destination, 1989-90.
