# Carolina Sandhills National Wildlife Refuge

## Road Safety Audit

## **Carolina Sandhills National Wildlife Refuge**

US Route 1 and Wildlife Refuge Entrance

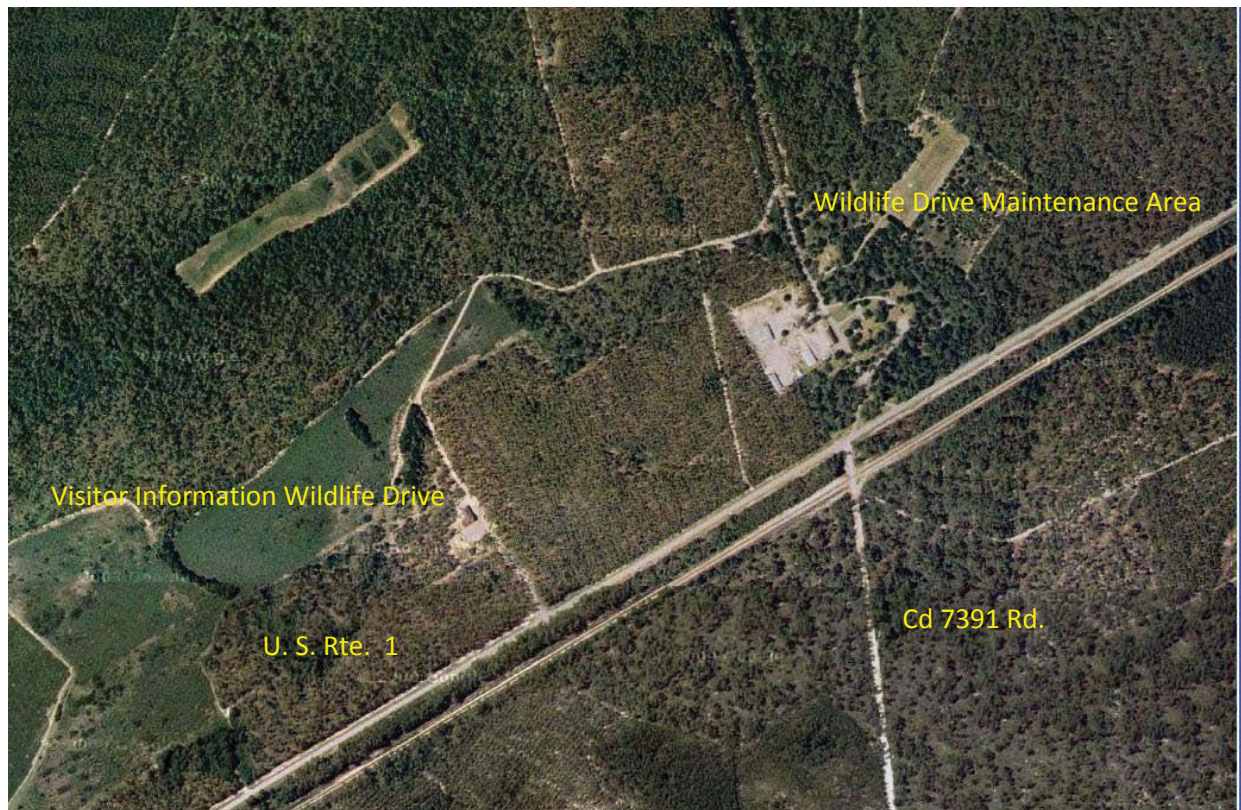
### Existing Condition

US Rte 1 is functionally classified as a two-lane principal arterial that traverses the city of McBee in Chesterfield County in rolling terrain, and the entrance to Carolina Sandhills National Wildlife Refuge is 3-1/2 miles north of McBee. US Rte 1 is the main access for Refuge visitors. The Average Daily Traffic (ADT) is approximately 1650 vehicles per day (vpd), and the Refuge entrance average approximately 100 vehicles per day (vpd). The percentage of trucks travelling on US Rte 1 is 15% according to SCDOT, and buses are permissible. The posted speed limit is 55 miles per hour. The existing typical section is two-12' asphalt paved lanes with 1-foot paved shoulders and variable width turf shoulders. The existing typical section on the Refuge maintenance entrance and the Visitor Center / Headquarters entrance is 18-foot and 26-foot, respectively.

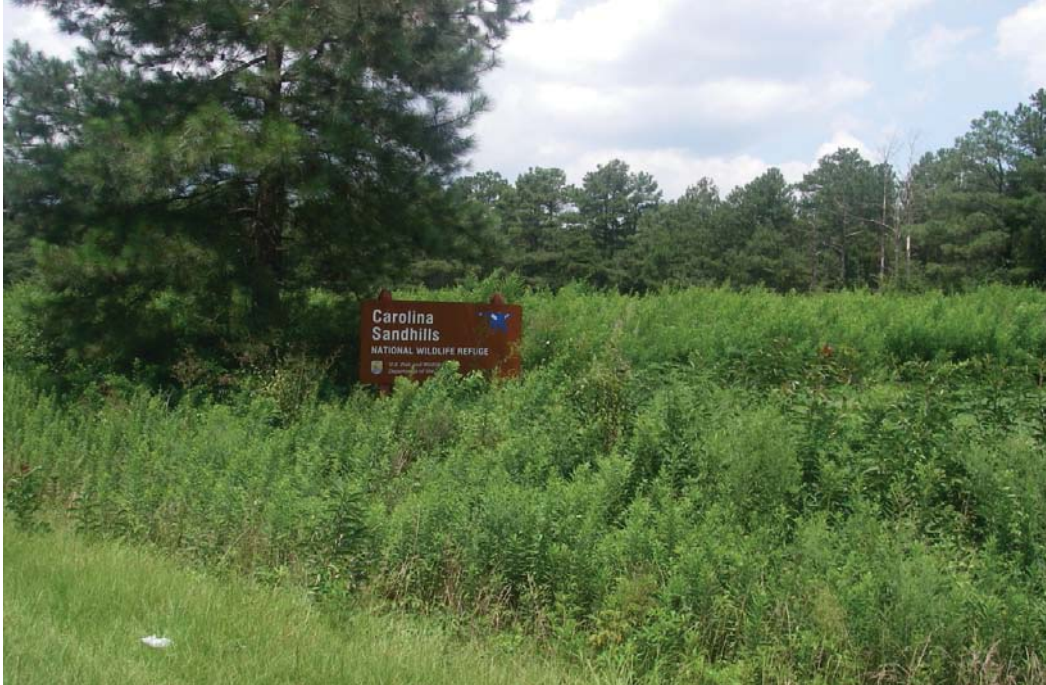
Photo 1: The Carolina Sandhills National Wildlife Refuge entrance sign is covered with vegetation and appears to be of substandard height.

- The “Carolina Sandhills National Wildlife Refuge” boundary sign is covered with vegetation. The sign is offset far from the roadway and appears to be of substandard height. Relocate and install the boundary sign to conform to MUTCD guidelines (see photo 1)

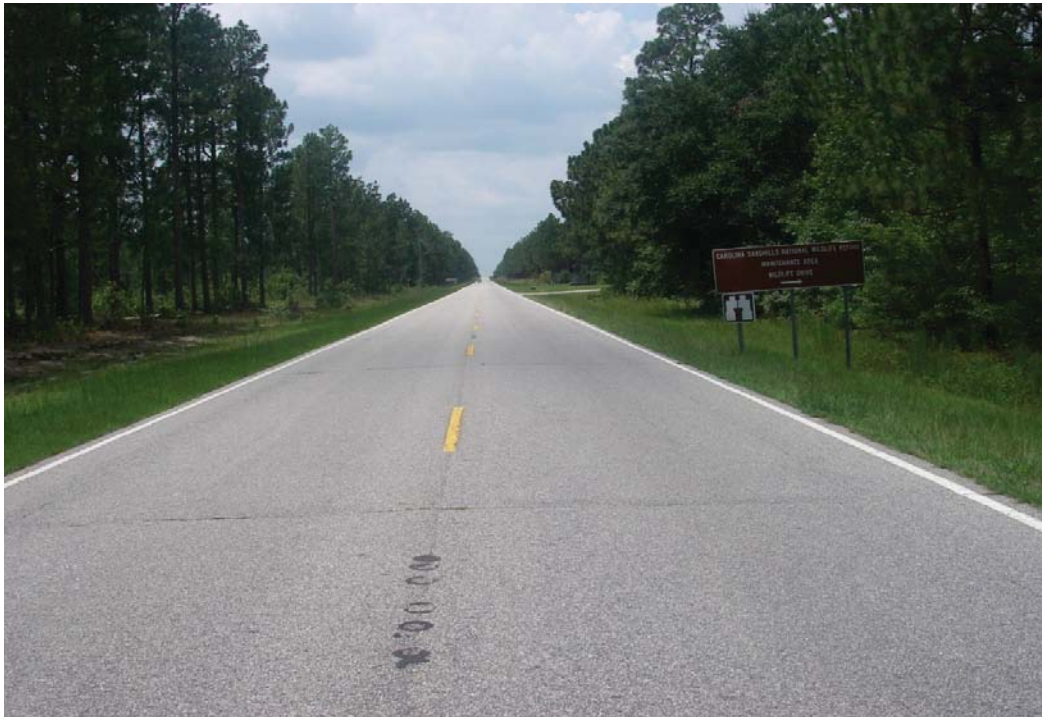
Photo 2: The Carolina Sandhills National Wildlife Refuge Maintenance Area Wildlife Drive sign does not conform to the MUTCD, and also sign restricts sight distance looking northbound.

- There is no advance guide sign southbound before the “Carolina Sandhills National Wildlife Refuge Maintenance Area Wildlife Drive with Arrow” sign. This sign also obstructs sight distance looking northbound from the North Wildlife Drive Maintenance Area entrance. This sign should be set about 2’ further to the right of the travel lanes to improve sight distance (see photo 2)

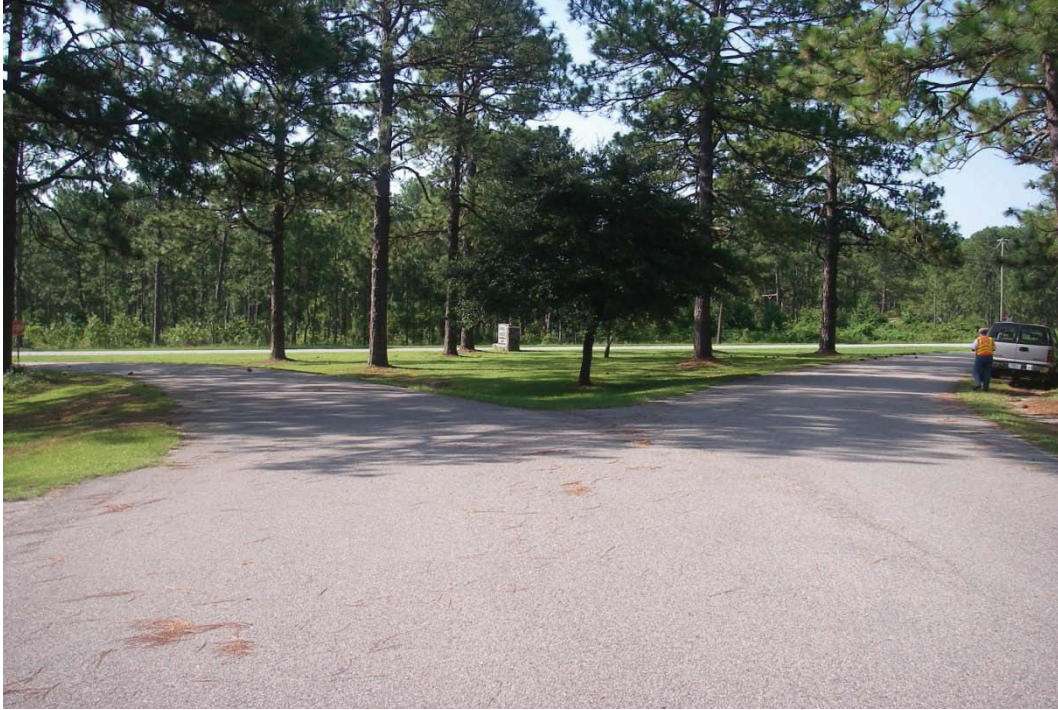
Photo 3: Wildlife Drive north entrance Y-intersection Stop sign to US Rte 1 approaches does not conform to MUTCD

- The Wildlife Drive north entrance Y-intersection Stop (R1-1) signs do not conform to MUTCD. The MUTCD require 5-feet height above edge of pavement (see photos 3&4).

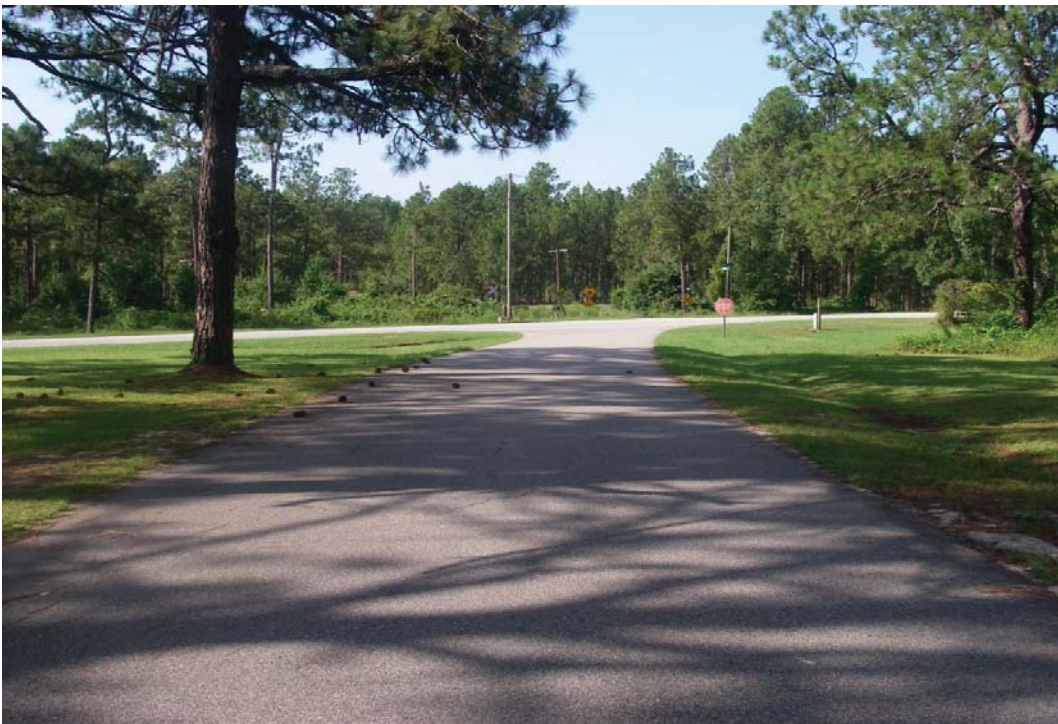
Photo 4: Wildlife Drive north entrance Y-intersection Stop sign to US Rte 1 approaches does not conform to MUTCD

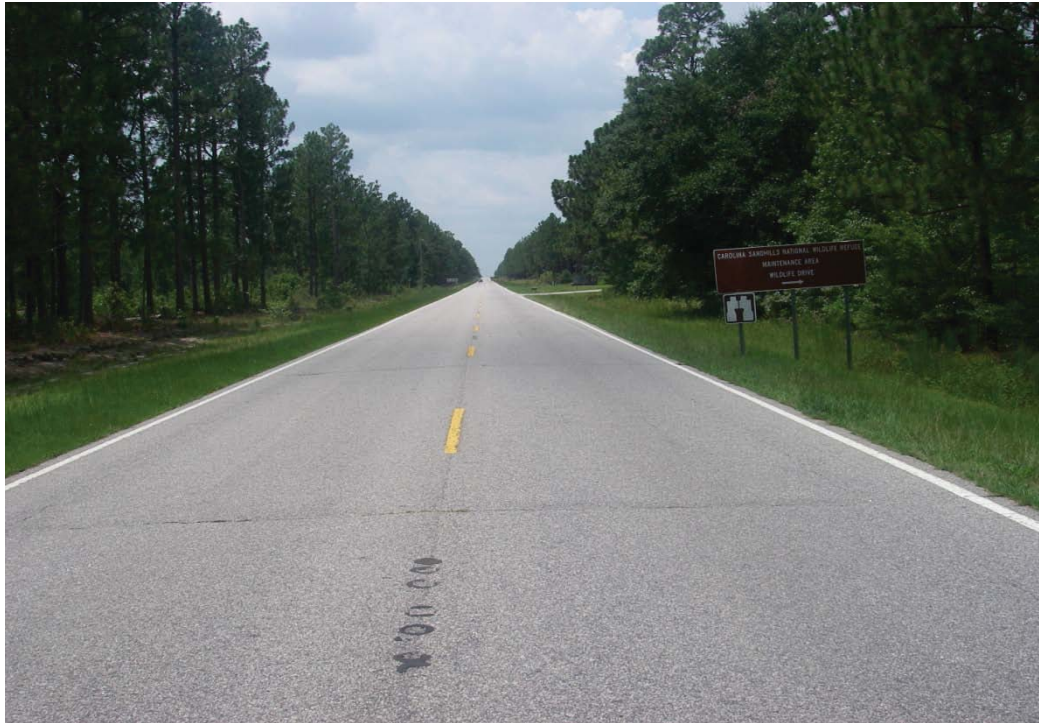
Photo 5: Refuge Maintenance Entrance Area sign obstructs sight distance, looking northbound from the Wildlife Drive North Entrance. Also, passing is permitted along US Rte 1.

- Passing is permitted along US Rte 1 at both the north and south Wildlife Drive intersections, creating unsafe conditions for motorists entering US Rte 1 (see photos 5&6).

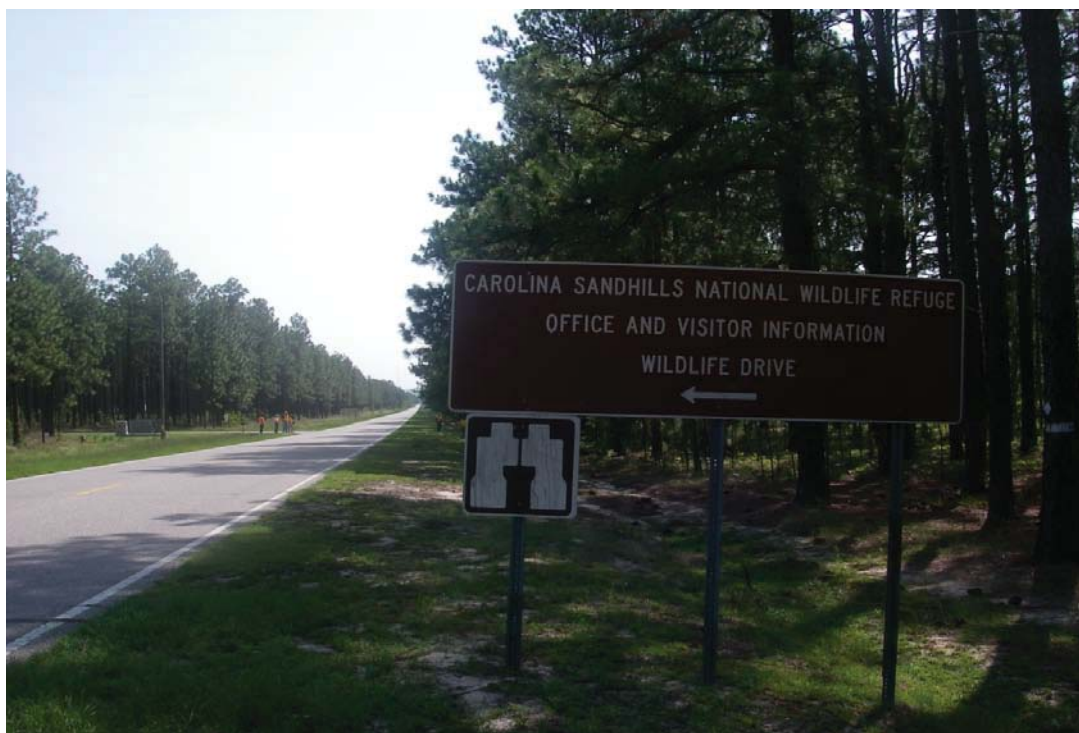
Photo 6: Northbound US Rte 1 showing passing at the Wildlife Drive South Entrance intersection

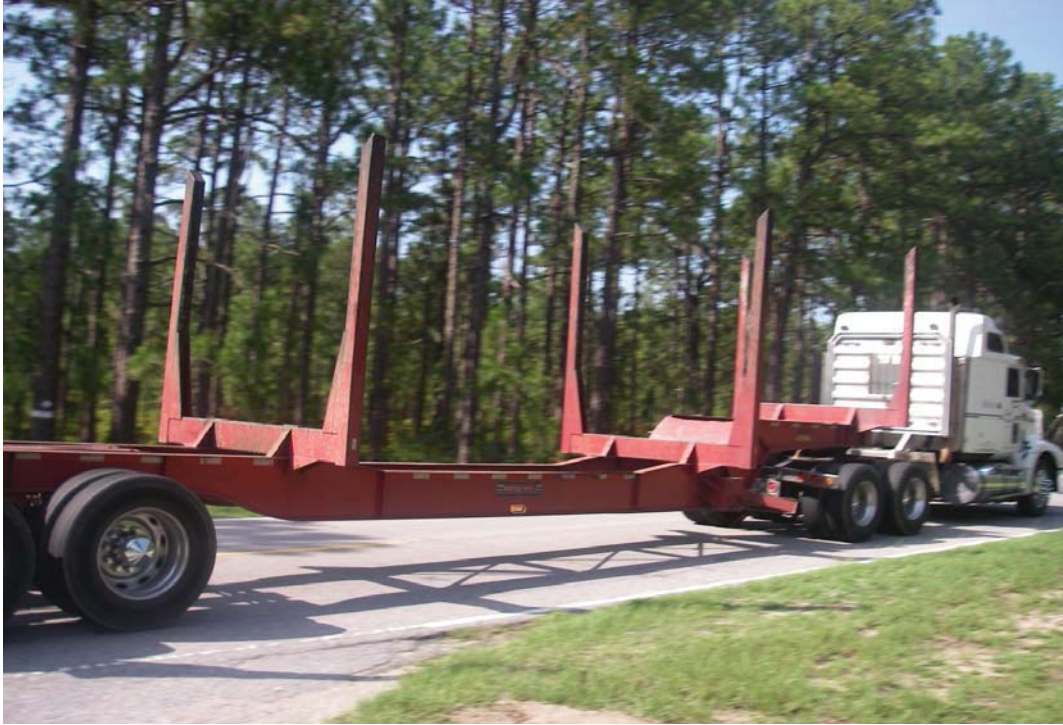
Photo 7: Presence of large semitrailer heading southbound along US Rte 1

- Significant presence of large semitrailers along US Rte 1 (see photos 7&8)
- There is no advance guide sign northbound before the “Carolina Sandhills National Wildlife Refuge Office and Visitor Information Wildlife Drive with Arrow” sign (see photo 9).

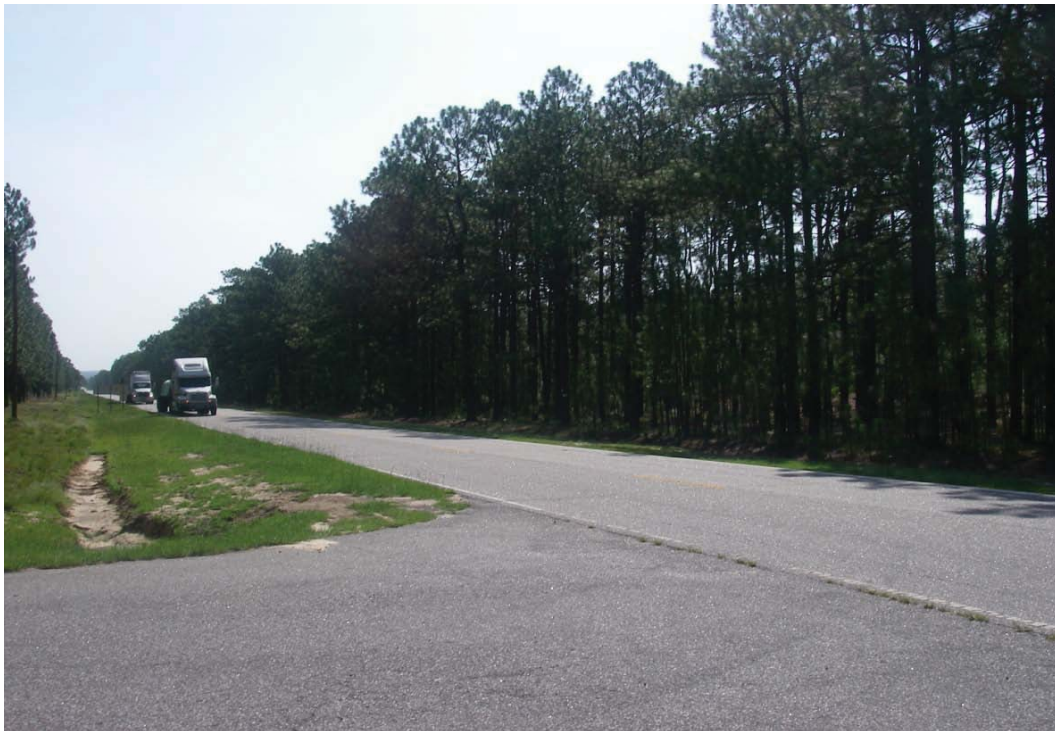
Photo 8: Presence of large semitrailers heading northbound US Rte 1

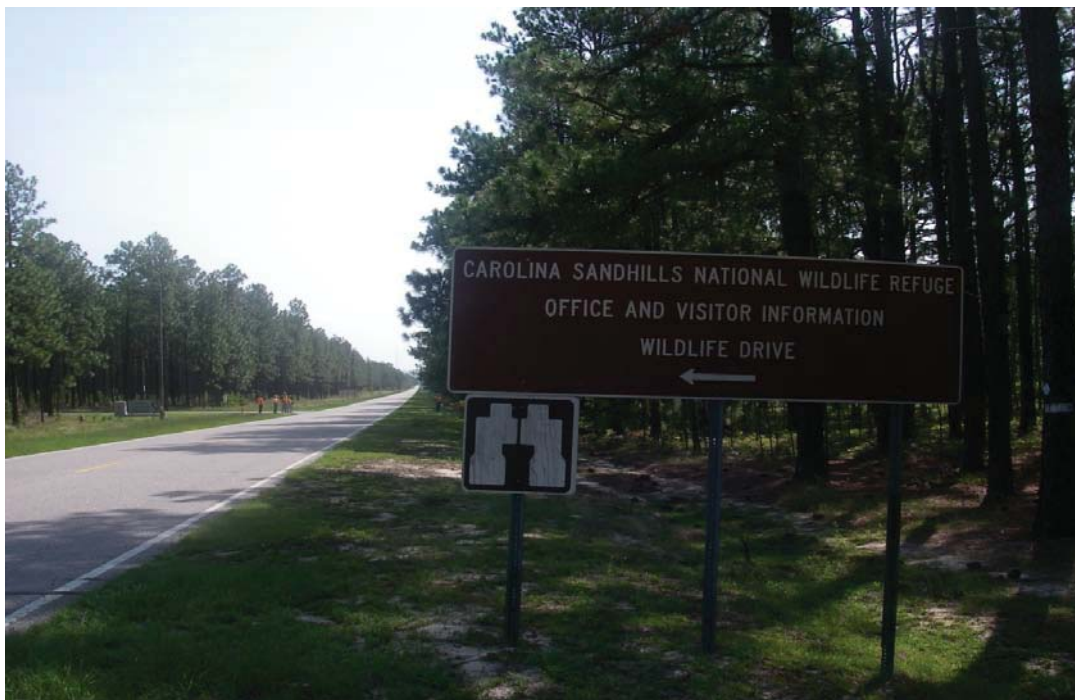
Photo 9: Northbound US Rte 1 showing Carolina Sandhills National Wildlife Refuge Office/Visitor Information Wildlife Drive - no advance guide sign prior to Refuge sign

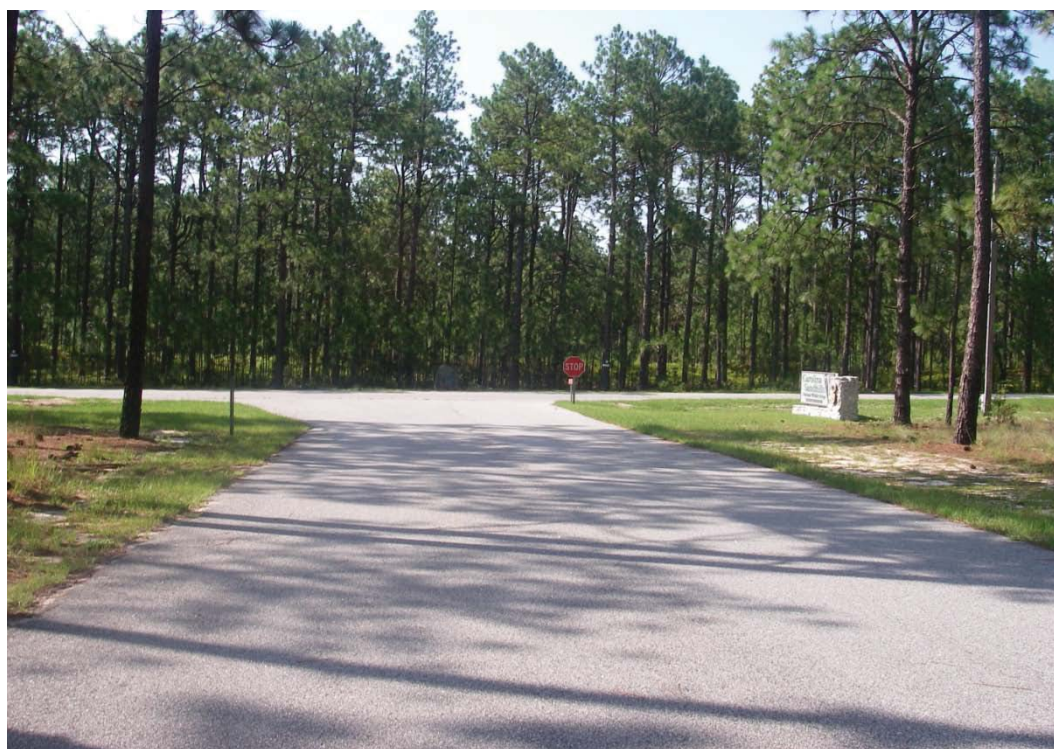
Photo 10: Southbound showing Wildlife Drive South Entrance to US Rte 1. Stop sign does not conform to MUTCD

- The Stop (R1-1) sign at the Wildlife Drive South Visitor Center Entrance to US Rte 1 does not conform to MUTCD. The MUTCD require 5-feet height above edge of pavement (see photo 10)

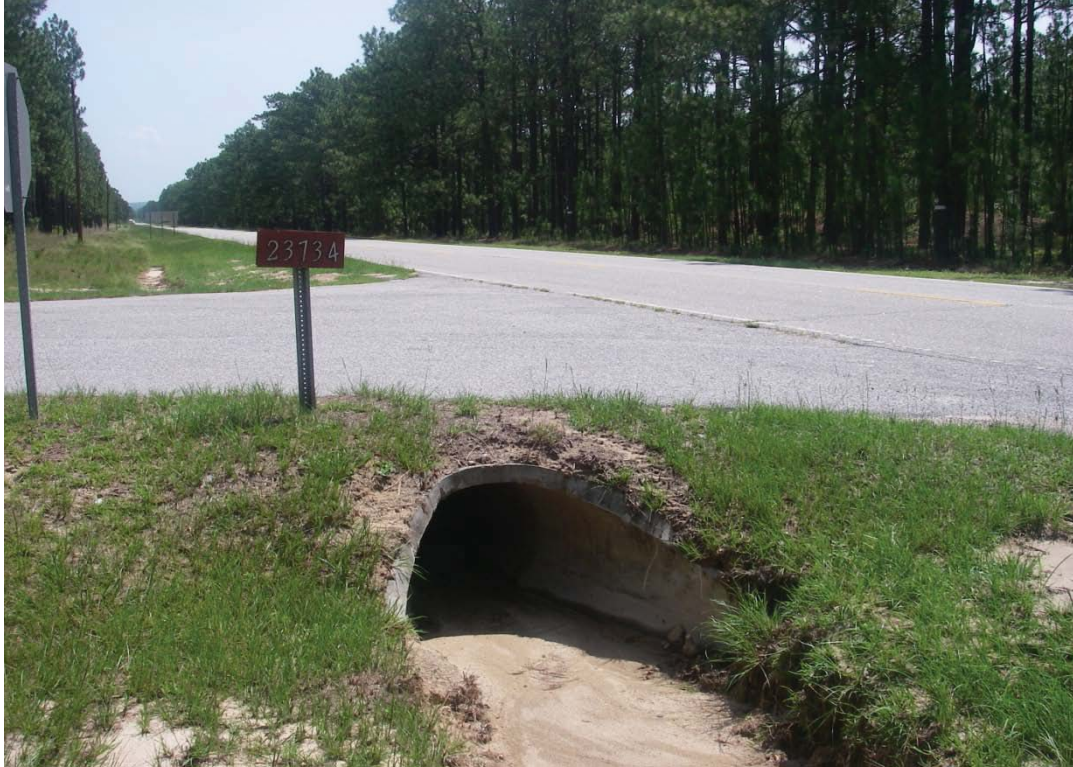
Photo 11: Culvert at Wildlife Drive South Entrance protrudes the clear zone

- The culvert at the Wildlife Drive South Visitor Center Entrance protrudes within the clear zone and is not traversable. Possible treatments include flattening the slopes, moving the culvert further offset from the main travel way, adding bars / pipes to allow the vehicle wheels to safely pass over (see photo 11).
