The Trail Inventory of Attwater Prairie Chicken NWR

Eagle Lake, TX

Prepared By:
Federal Highway Administration
Central Federal Lands Highway Division
February, 2012

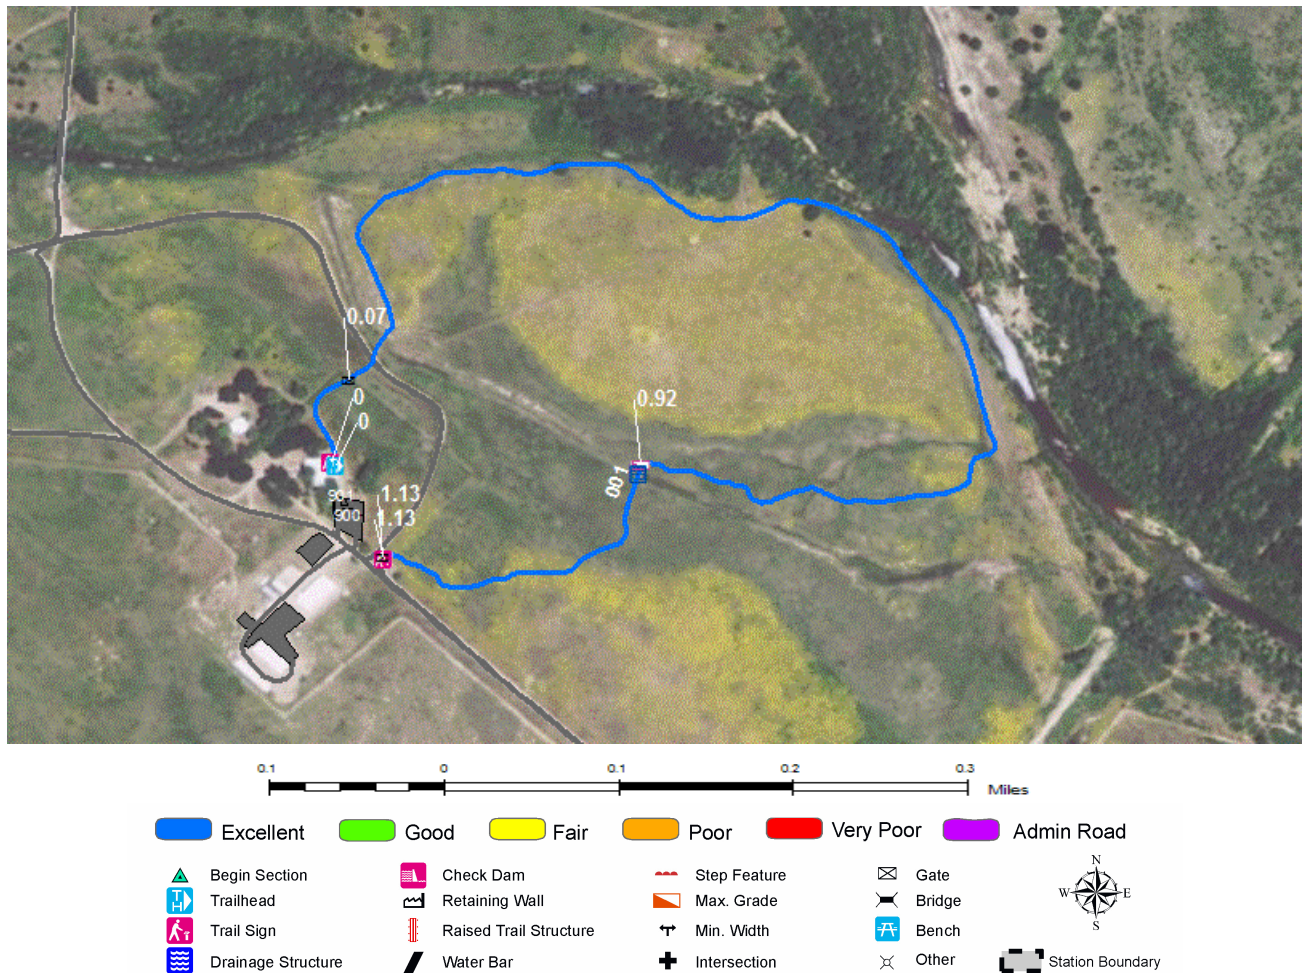
TRAIL CONDITION

Trail Name: Sycamore Trail
Trail Number: T300

Section Number	001
Section Length (miles)	1.13
SAMMS Number	N/A
Rating Date	03/28/2011
Trail Section Information	
Trail Class	TC3
Surface Type	Mowed
Surface Firmness	Hard
Width (inches)	75
Average Grade (%)	4.5
Average X-slope (%)	4.50
Trail Condition Information	
Deferred Maintenance	
CRV	\$36,179
FCI	0.00
Condition	Excellent

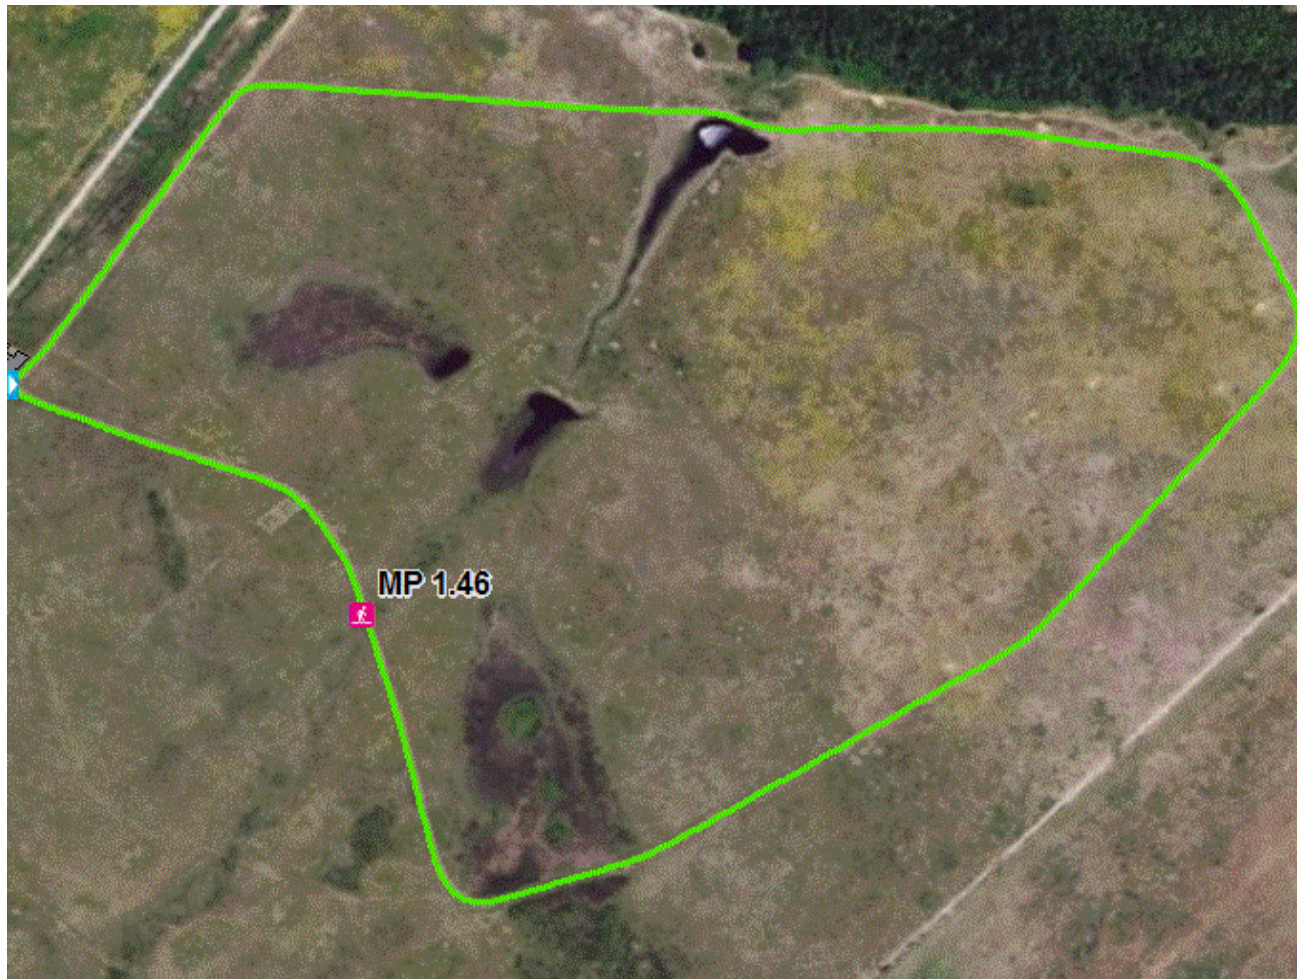
TRAIL DEFICIENCY

Trail Name: Pipit Trail

Mile Post	1.46
Section Number	001
Photo Number	ATPR_C2_1540
Deficiency	Drainage
Action	Replace
Item	Culvert -lf
Quantity	10
Deferred Maintenance	\$1,130
