# **The Trail Inventory of Malheur National Wildlife Refuge Princeton, Oregon**

**Prepared By:  
Federal Highway Administration  
Central Federal Lands Highway Division  
June 2007**

# Malheur NWR

## Trail and Trail Feature Summaries

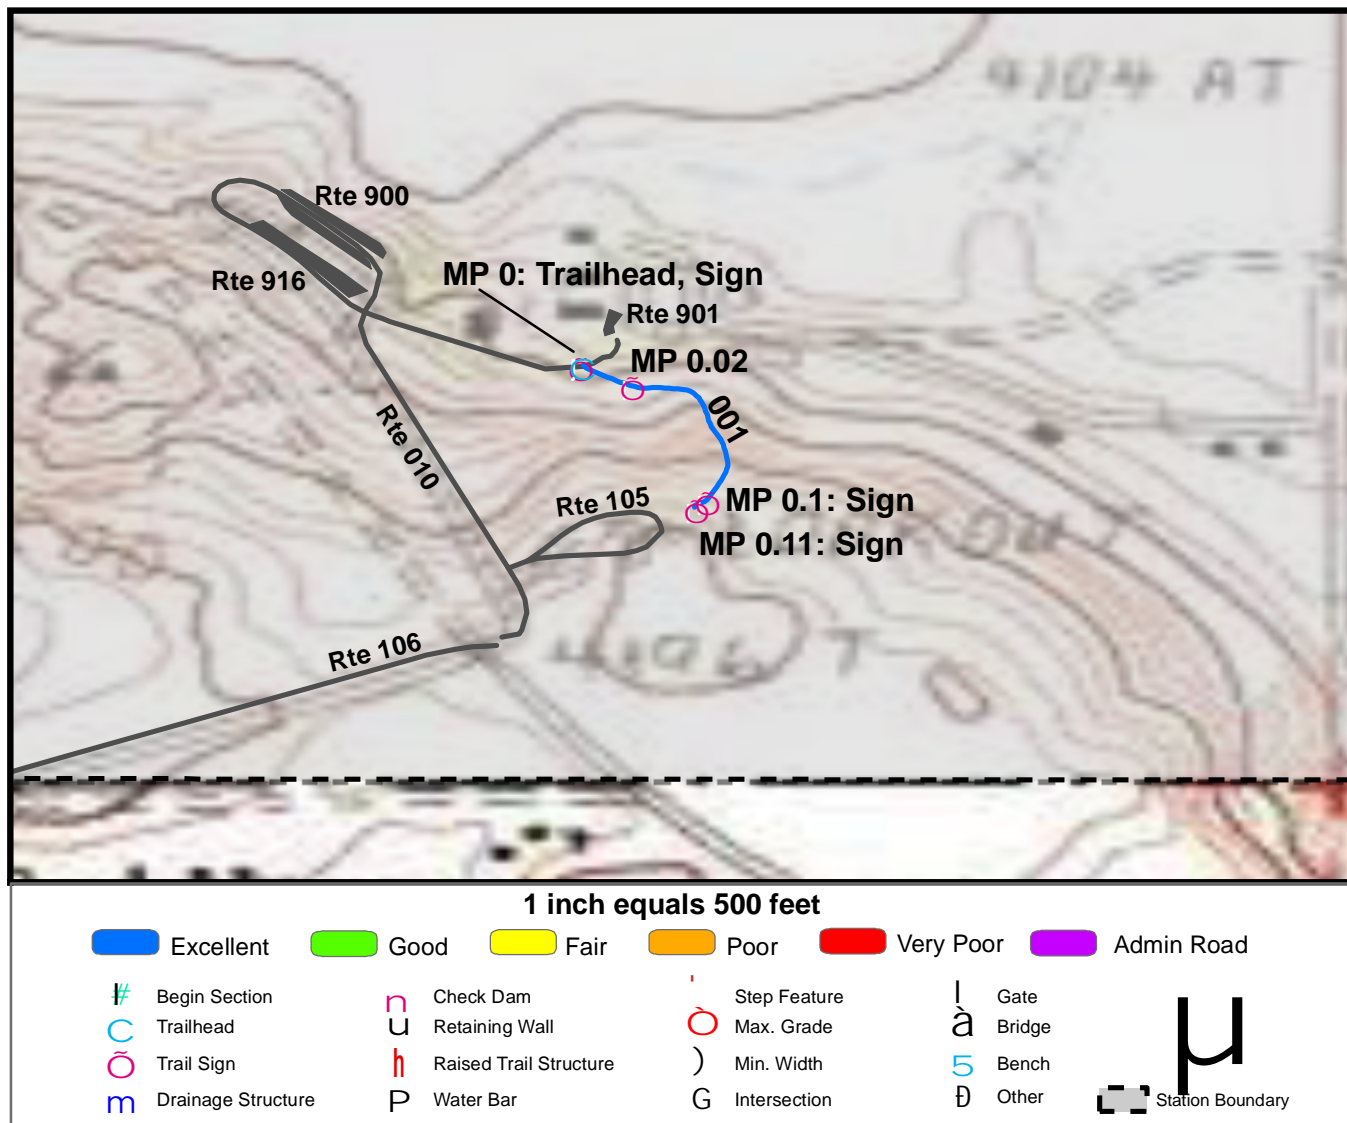
# TRAIL CONDITION

Section Number	001				
Section Length (miles)	0.11				
SAMMS Number	10037672				
Rating Date	6/25/2007				
<b>Trail Section Information</b>					
Trail Class	TC3				
Surface Type	Gravel				
Surface Firmness	Hard				
Width (inches)	36				
Average Grade (%)	7.9				
Average X-slope (%)	2.3				
<b>Trail Condition Information</b>					
Deferred Maintenance	\$0				
CRV	\$9704				
FCI	0				
Condition	Excellent

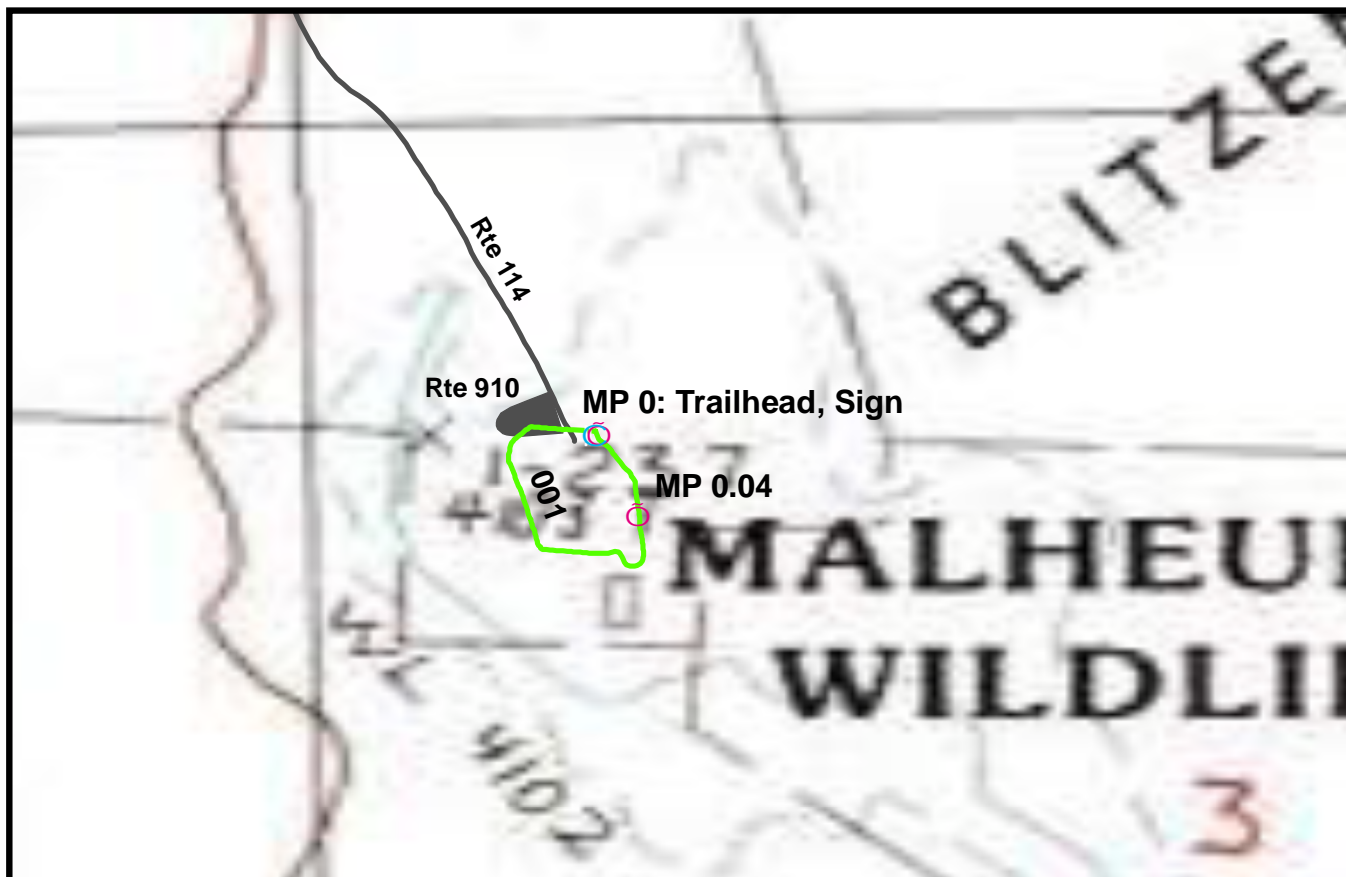
# TRAIL CONDITION

Section Number	001				
Section Length (miles)	0.2				
SAMMS Number	N/A				
Rating Date	6/26/2007				
<b>Trail Section Information</b>					
Trail Class	TC3				
Surface Type	Gravel				
Surface Firmness	Firm				
Width (inches)	72				
Average Grade (%)	0.7				
Average X-slope (%)	2.5				
<b>Trail Condition Information</b>					
Deferred Maintenance	\$1031				
CRV	\$36169				
FCI	0.029				
Condition	Good

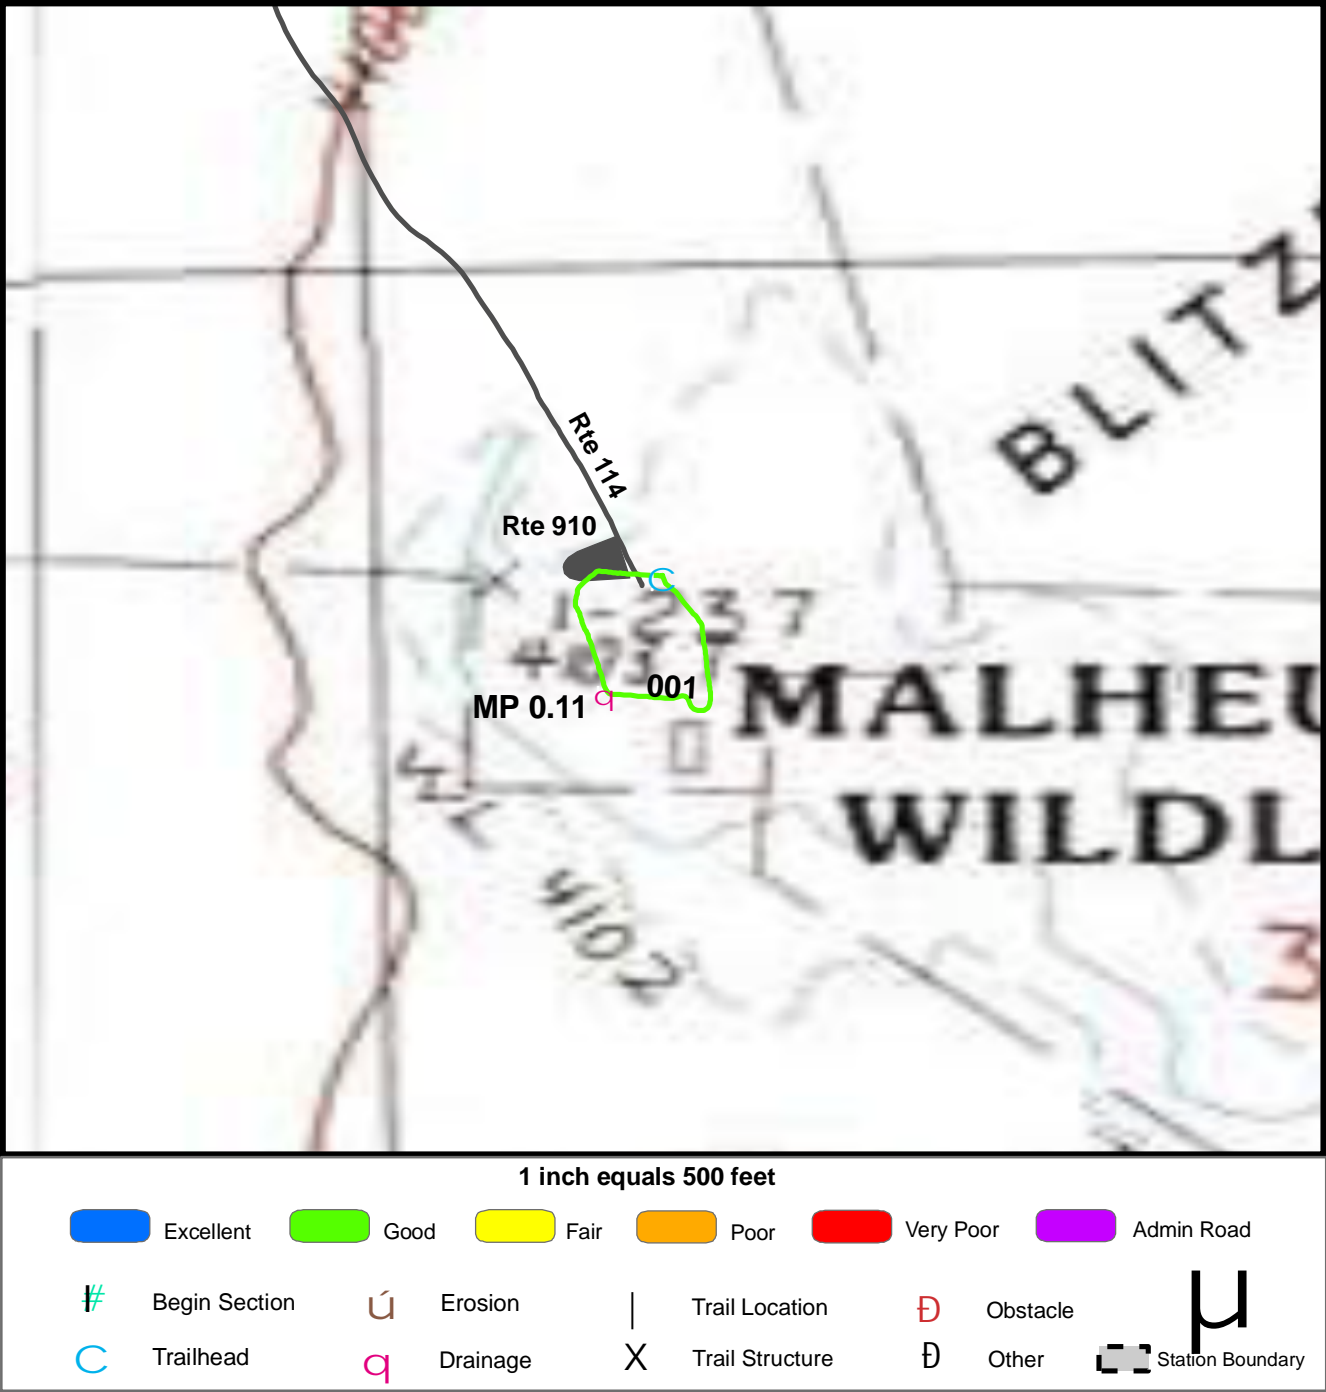
TRAIL DEFICIENCY

Mile Post	0.11			
Section Number	001			
Photo Number	118			
Deficiency	Drainage			
Action	Build/Add			
Item	Culvert -lf			
Quantity	8			
Deferred Maintenance	\$1031

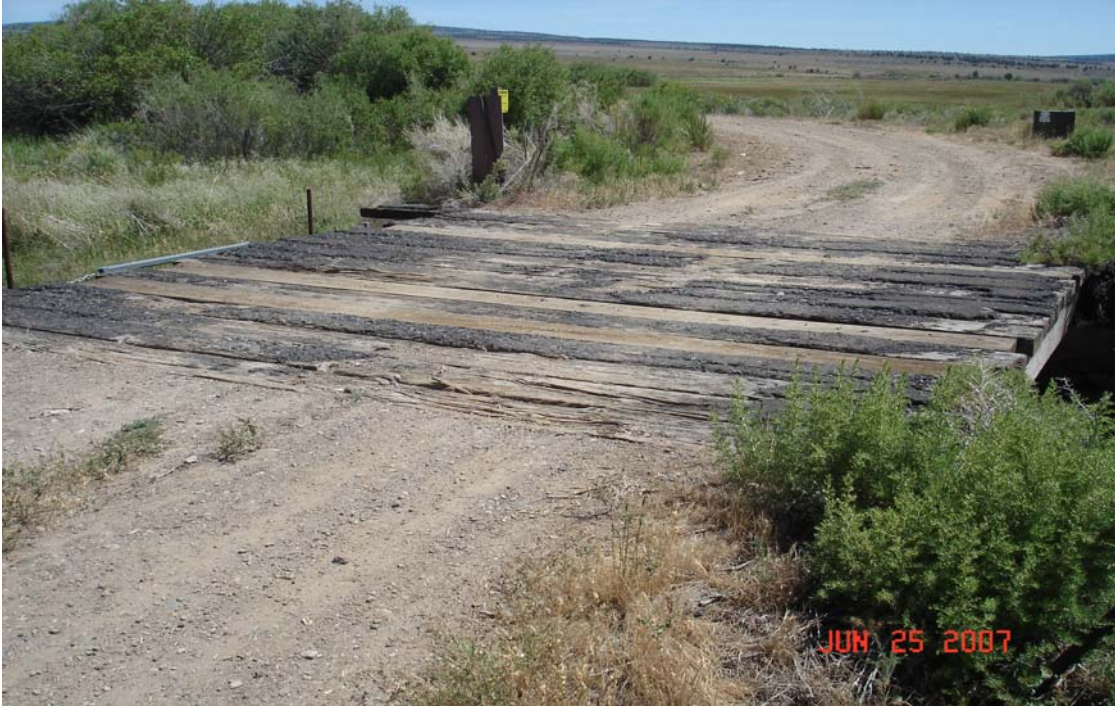
Photo # 27 - MP 3.18 - Bridge

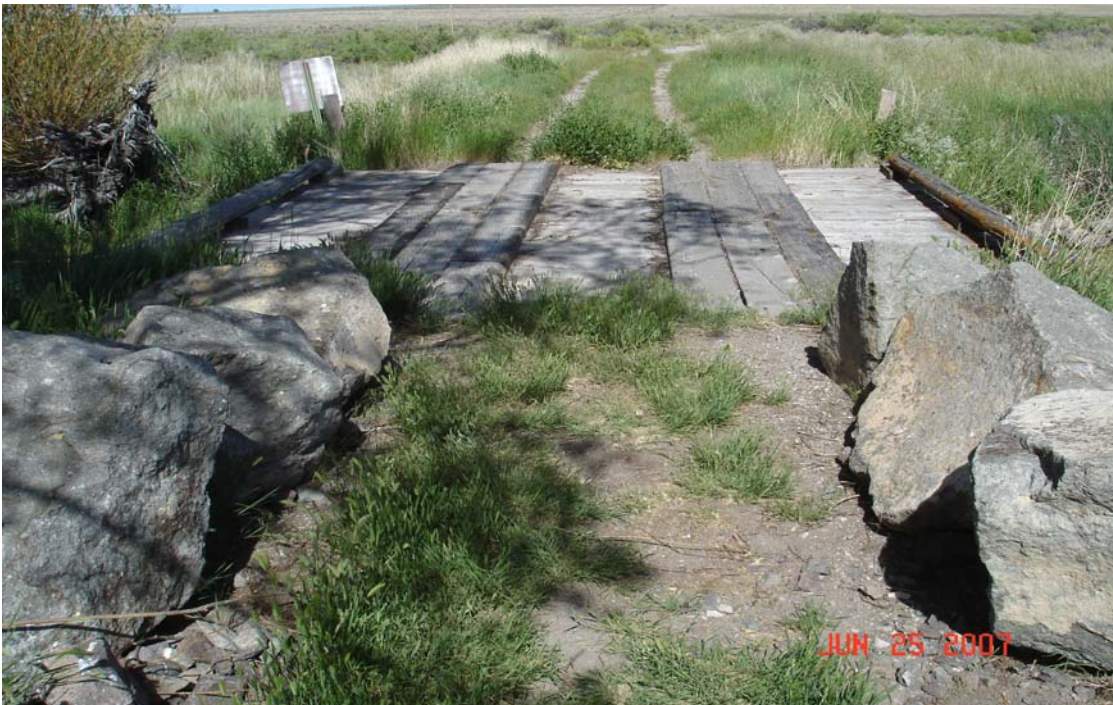
Photo # 54 - MP 0.11 - Begin Section 002, Bridge

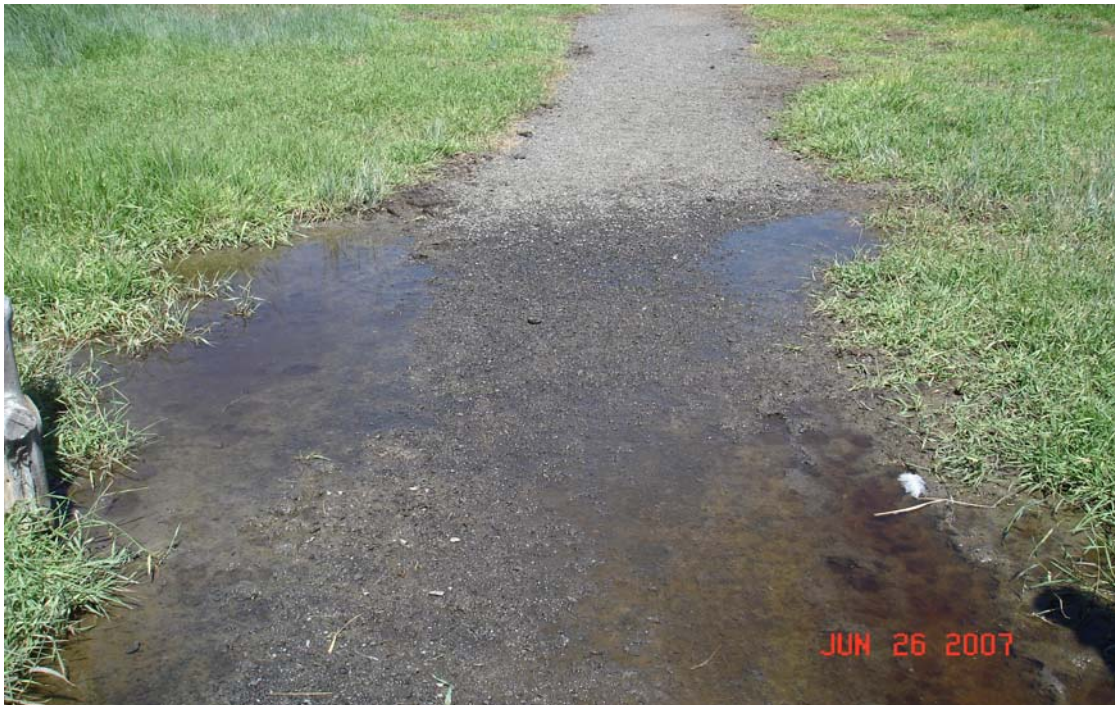
Photo # 118 - MP 0.11 - Drainage Deficiency
