The Trail Inventory of Merced NWR Los Banos, CA

Prepared By:
Federal Highway Administration
Central Federal Lands Highway Division
January, 2012

Merced NWR

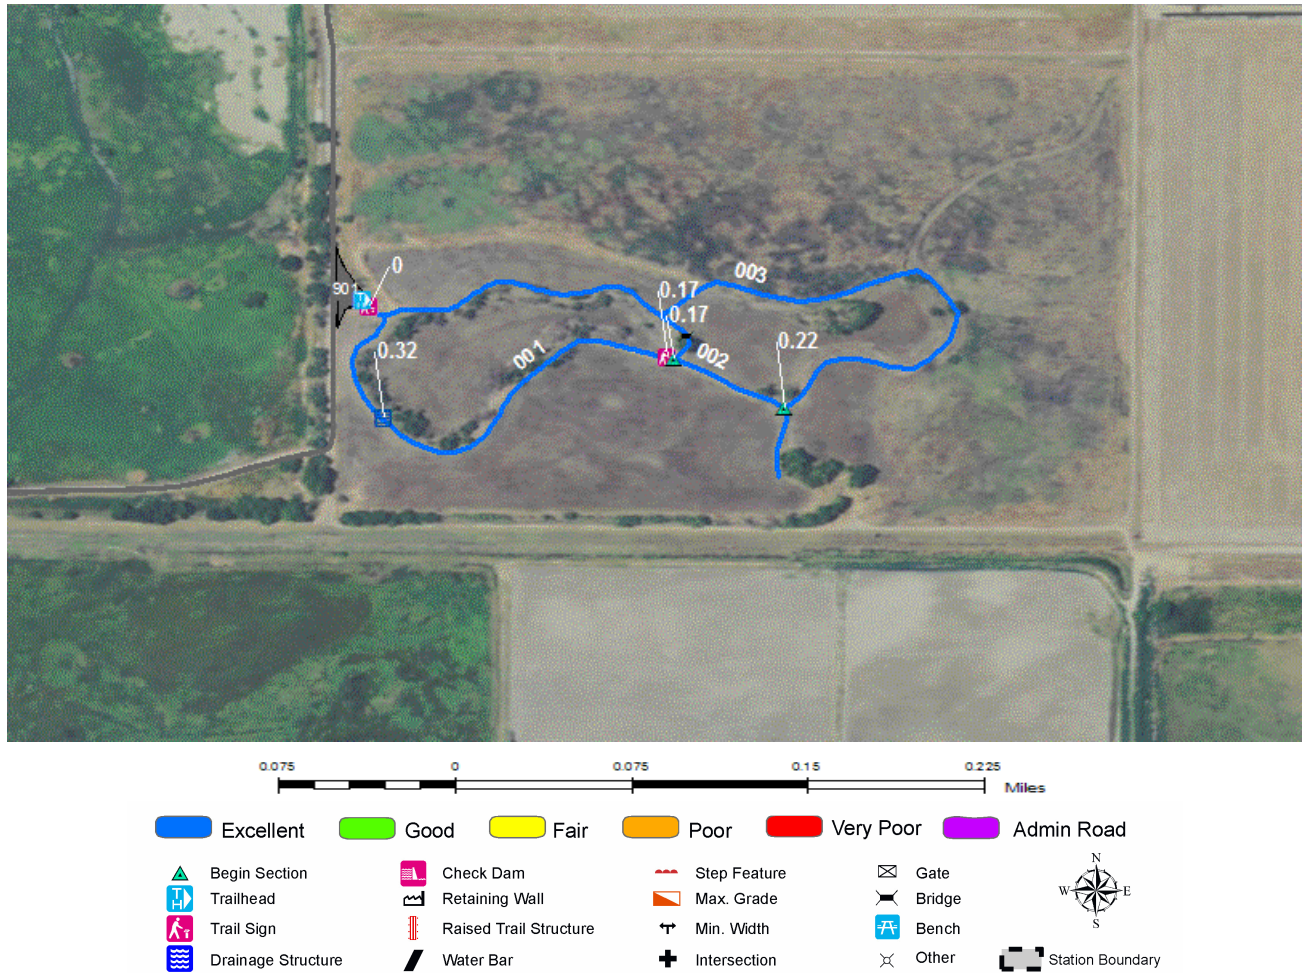
TRAIL CONDITION

Trail Name: Bittern Marsh Trail
Trail Number: T302

Section Number	001	002	003
Section Length (miles)	0.37	0.08	0.23
SAMMS Number	10046623	10046623	10046623
Rating Date	07/12/2007	09/27/2011	09/27/2011
Trail Section Information			
Trail Class	TC3	TC3	TC3
Surface Type	Mowed	Gravel	Gravel
Surface Firmness	Firm	Firm	Firm
Width (inches)	96	96	96
Average Grade (%)	1.0	1.0	1.0
Average X-slope (%)	1.80	1.80	1.80
Trail Condition Information			
Deferred Maintenance	\$160		
CRV	\$20,733	\$19,560	\$56,238
FCI	0.00	0.00	0.00
Condition	Excellent	Excellent	Excellent

Deferred Maintenance	CRV	FCI	Condition
\$160	\$96,532	0.00	Excellent

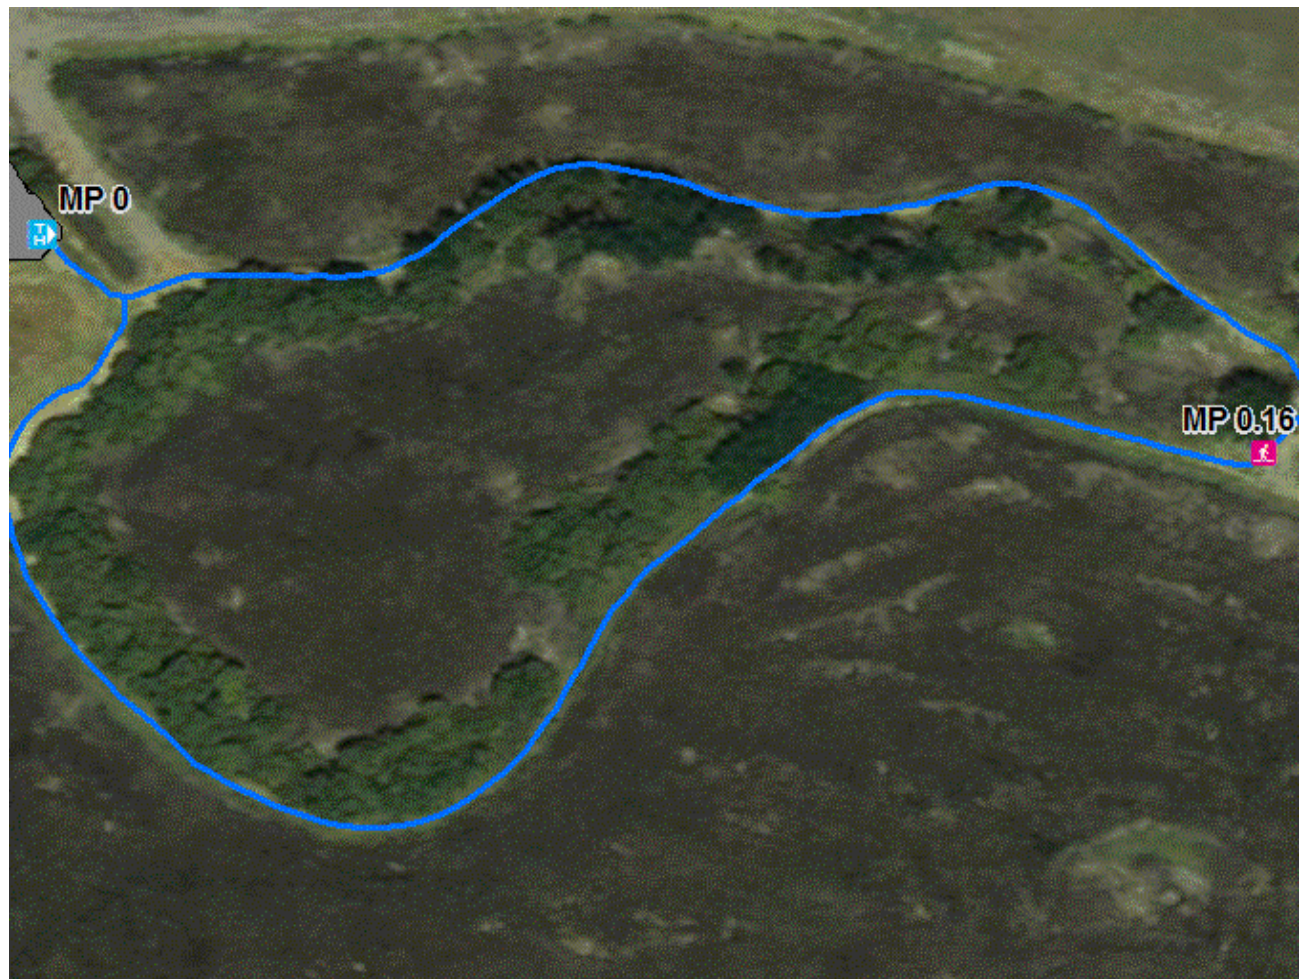
TRAIL DEFICIENCY

Trail Name: Bittern Marsh Trail

Mile Post	0.16
Section Number	001
Photo Number	MERC_C2_0006
Deficiency	Drainage
Action	Build/Add
Item	Tread -sf
Quantity	80
Deferred Maintenance	\$160
