Minnesota FWS Stations Trail Summaries

The Trail Inventory of Agassiz National Wildlife Refuge Middle River, Minnesota

Prepared By: Federal Highway Administration Central Federal Lands Highway Division July, 2006

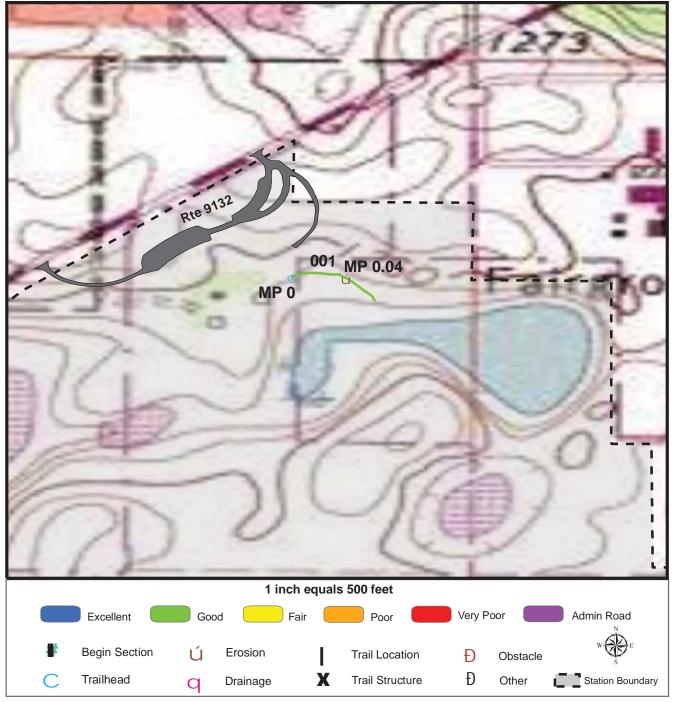
Trail Number: T400		Region: 3	TOTAL LENGTH: 0.58 Miles
Mile Post	0.04		
Section Number	001		
Photo Number	1165		
Deficiency	Erosion		
Action	Build/Add		
Item	Water Bar:Wood -each		
Quantity	2		
Deferred Maintenance	\$300

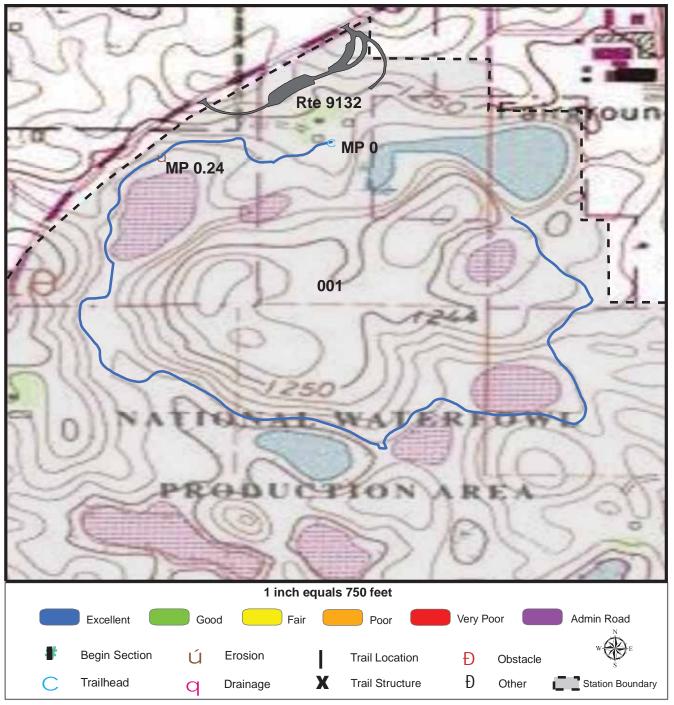
Trail Number: T401		Region: 3	TOTAL LENGTH: 1.54 Miles
Mile Post	0.24		
Section Number	001		
Photo Number	1180		
Deficiency	Erosion		
Action	Build/Add		
Item	Water Bar:Wood -each		
Quantity	1		
Deferred Maintenance	\$200

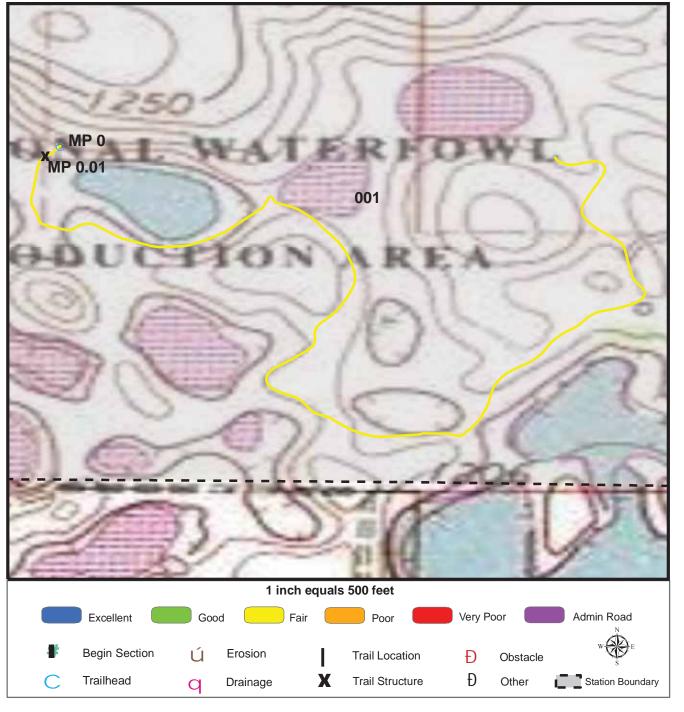
Trail Number: T403		Region: 3	TOTAL LENGTH: 1.03 Miles
Mile Post	0.01		
Section Number	001		
Photo Number	1189		
Deficiency	Trail Structure		
Action	Build/Add		
Item	Boardwalk -If		
Quantity	408		
Deferred Maintenance	\$16600		
		1

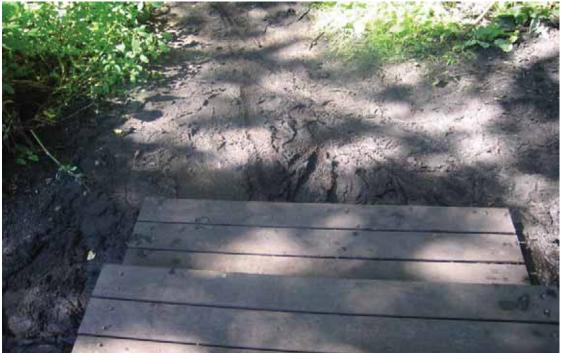
Photo # 0631 - MP 0.15 - Drainage Deficiency

Trail Number: T200		Region: 3	TOTAL	LENGTH: 3.8 Miles
Mile Post	0.15	0.42	0.5	0.53
Section Number	003	004	006	007
Photo Number	0631	0640	0643	0646
Deficiency	Drainage	Trail Structure	Trail Structure	Drainage
Action	Build/Add	Repair	Repair	Build/Add
ltem	Boardwalk -If	Boardwalk -If	Boardwalk -If	Boardwalk -If
Quantity	10	5	5	30
Deferred Maintenance	\$455	\$151	\$151	\$1264

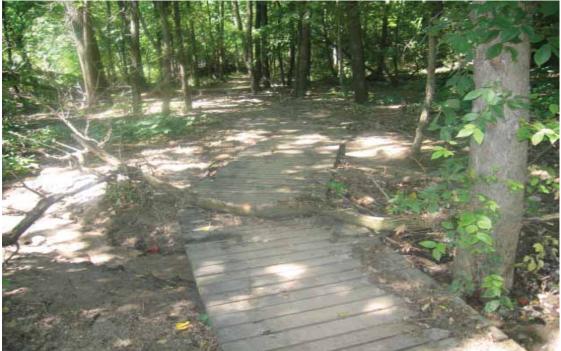
Photo # 0647 - MP 0.58 - Boardwalk, Trail Structure Deficiency

•	Trail Number: T200		Region: 3	TOTAL	LENGTH: 3.8 Miles	
	Mile Post	0.83	0.9	0.58	0.62	
	Section Number	007	007	007	007	
	Photo Number	0651	0653	0647	0649	
	Deficiency	Erosion	Erosion	Trail Structure	Trail Structure	
	Action	Build/Add	Build/Add	Build/Add	Repair	
	ltem	Water Bar:Wood -each	Water Bar:Wood -each	Boardwalk -If	Boardwalk -If	
	Quantity	2	10	40	5	
	Deferred Maintenance	\$255	\$1073	\$1668	\$151	
					1 1

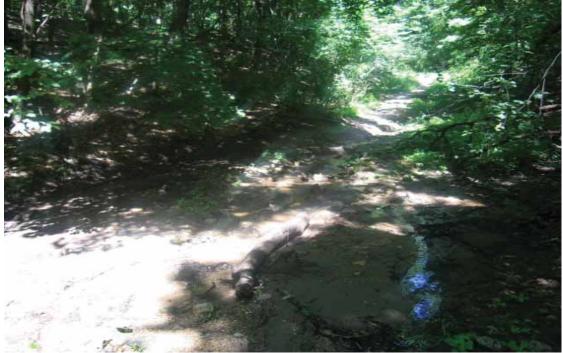
Photo # 0650 - MP 0.75 - Trail Structure Deficiency

Trail Number: T200		Region: 3	TOTAL	LENGTH: 3.8 Miles
Mile Post	0.75	1.91	2.64	2.68
Section Number	007	008	008	008
Photo Number	0650	0660	0663	0664
Deficiency	Trail Structure	Erosion	Erosion	Erosion
Action	Build/Add	Build/Add	Build/Add	Repair
Item	Boardwalk -If	Water Bar:Wood -each	Water Bar:Wood -each	Tread -sf
Quantity	120	2	2	30
Deferred Maintenance	\$4906	\$255	\$255	\$124

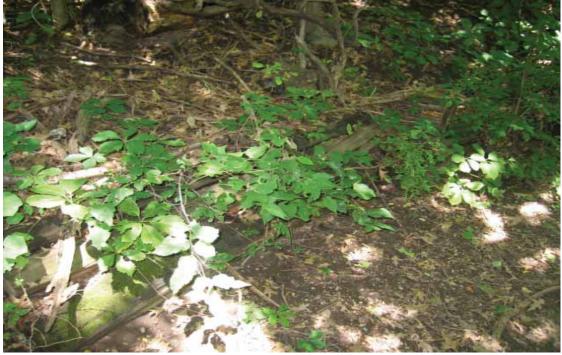
Photo # 0655 - MP 1.08 - Trail Structure Deficiency, Crib: Log

Trail Number: T200		Region: 3	TOTAL	LENGTH: 3.8 Miles
Mile Post	1.08	1.26	1.66	
Section Number	008	008	008	
Photo Number	0655	0655	0659	
Deficiency	Trail Structure	Trail Structure	Trail Structure	
Action	Replace	Repair	Repair	
ltem	Crib: Log -cf	Puncheon -If	Boardwalk -If	
Quantity	75	10	10	
Deferred Maintenance	\$58644	\$107	\$252	
	1

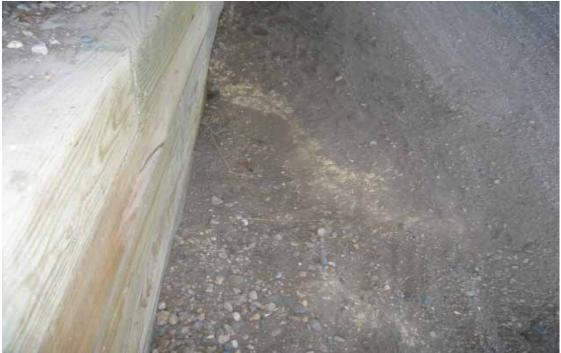
Photo # 0529 - MP 0.44 - Erosion Deficiency

Trail Number: T300		Region: 3	TOTAL	LENGTH: 2.1 Miles
Mile Post	0.4	0.41	0.44	0.45
Section Number	001	001	001	001
Photo Number	0528	0528	0529	0530
Deficiency	Erosion	Erosion	Erosion	Erosion
Action	Build/Add	Repair	Repair	Repair
ltem	Drainage Dips -each	Tread -sf	Tread -sf	Tread -sf
Quantity	2	30	15	15
Deferred Maintenance	\$172	\$131	\$90	\$90
