Photographs of powerline right of way, Patuxent Wildlife Research Center, Summer and Fall of 1968. Taken by David Smith. These photographs were taken mainly from camera points established earlier by Higman. They show the state of the vegetation before and during the selective control work done in 1968 and constitute an integral part of Smith's report.

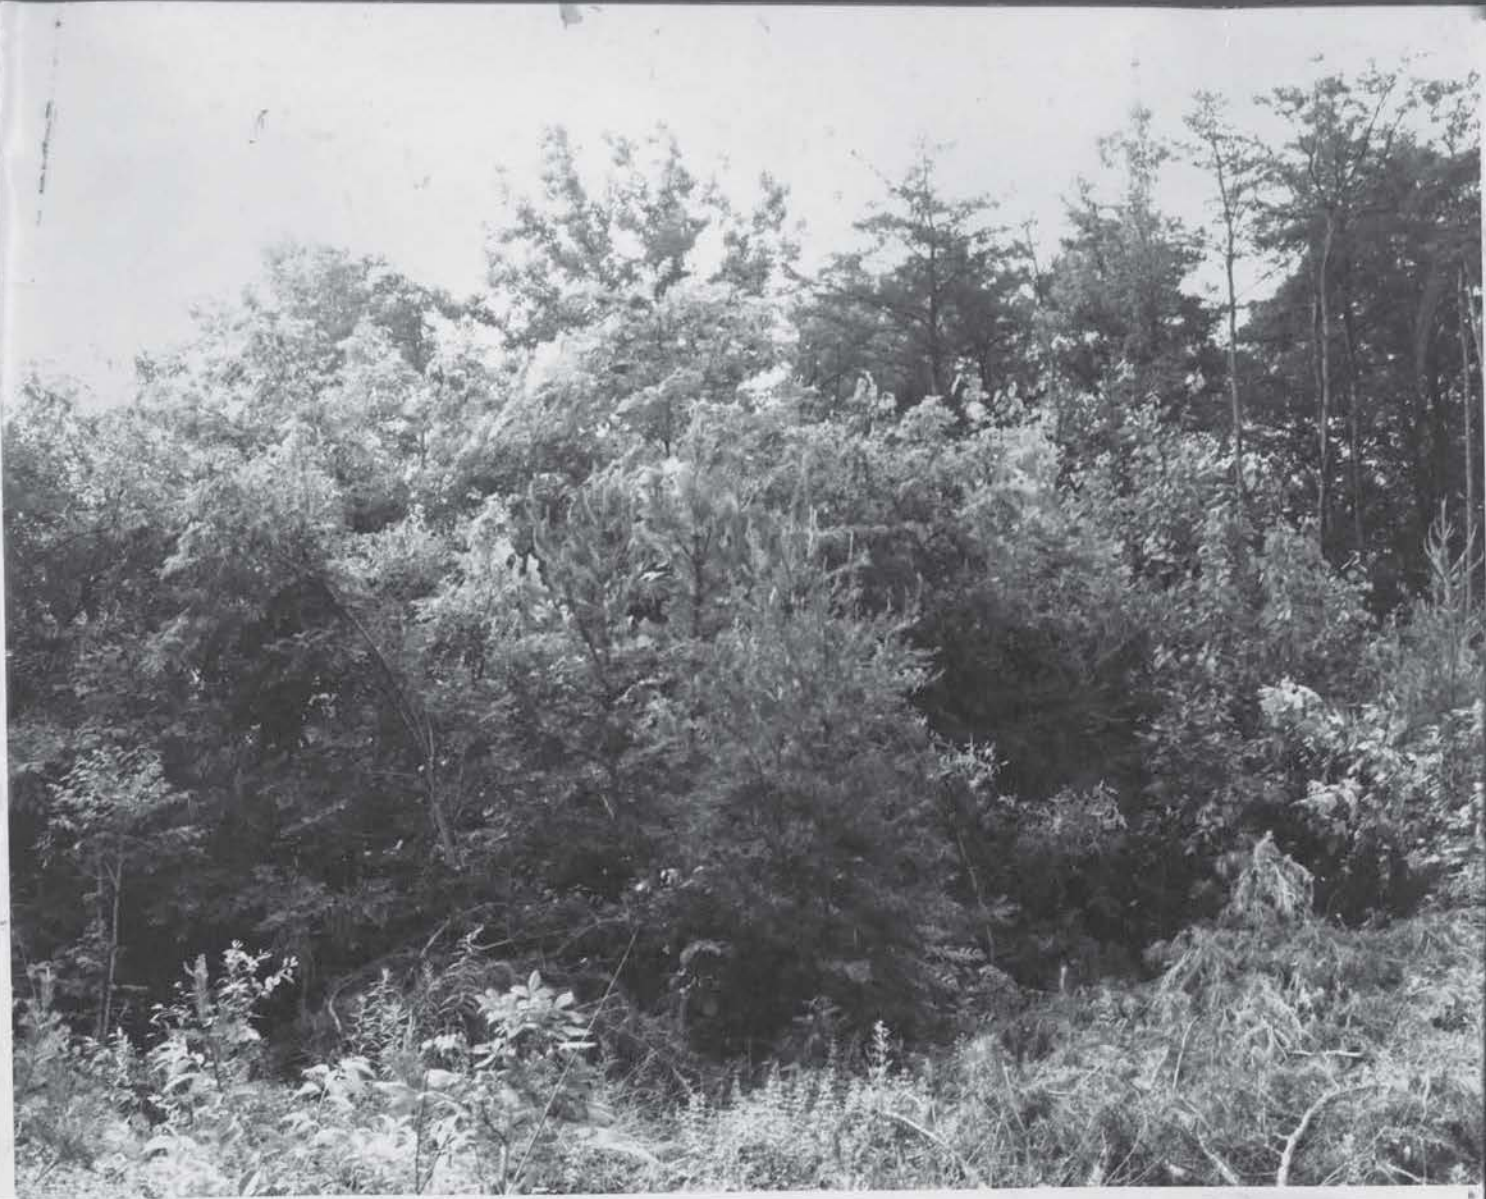
Figure 1 Upland site with *Robinia pseudoacacia*, *Populus grandidentata*, and *Pinus virginiana* predominant. The trees at the right are *Populus grandidentata*; the trees in the foreground are *Pinus virginiana* (some cut); and the trees in the left foreground are *Robinia pseudoacacia*. The small tree, in the lower left corner, is an *Aralia spinosa*. To the right of this tree, a *Prunus serotina* and a *Carya tomentosa* are present. These seedlings are positioned in front of the *Vaccinium* sp. and the *Solidago graminifolia*. To the right of the *Solidago graminifolia*, a patch of *Lysimachia quadrifolia* is present. Between the *Pinus virginiana* and the *Populus grandidentata*, there is a *Quercus phellos*. The view is southeast from Higman's Camera Point #1, Map I, about 63 feet east of the fence and 14 feet south of the access trail.

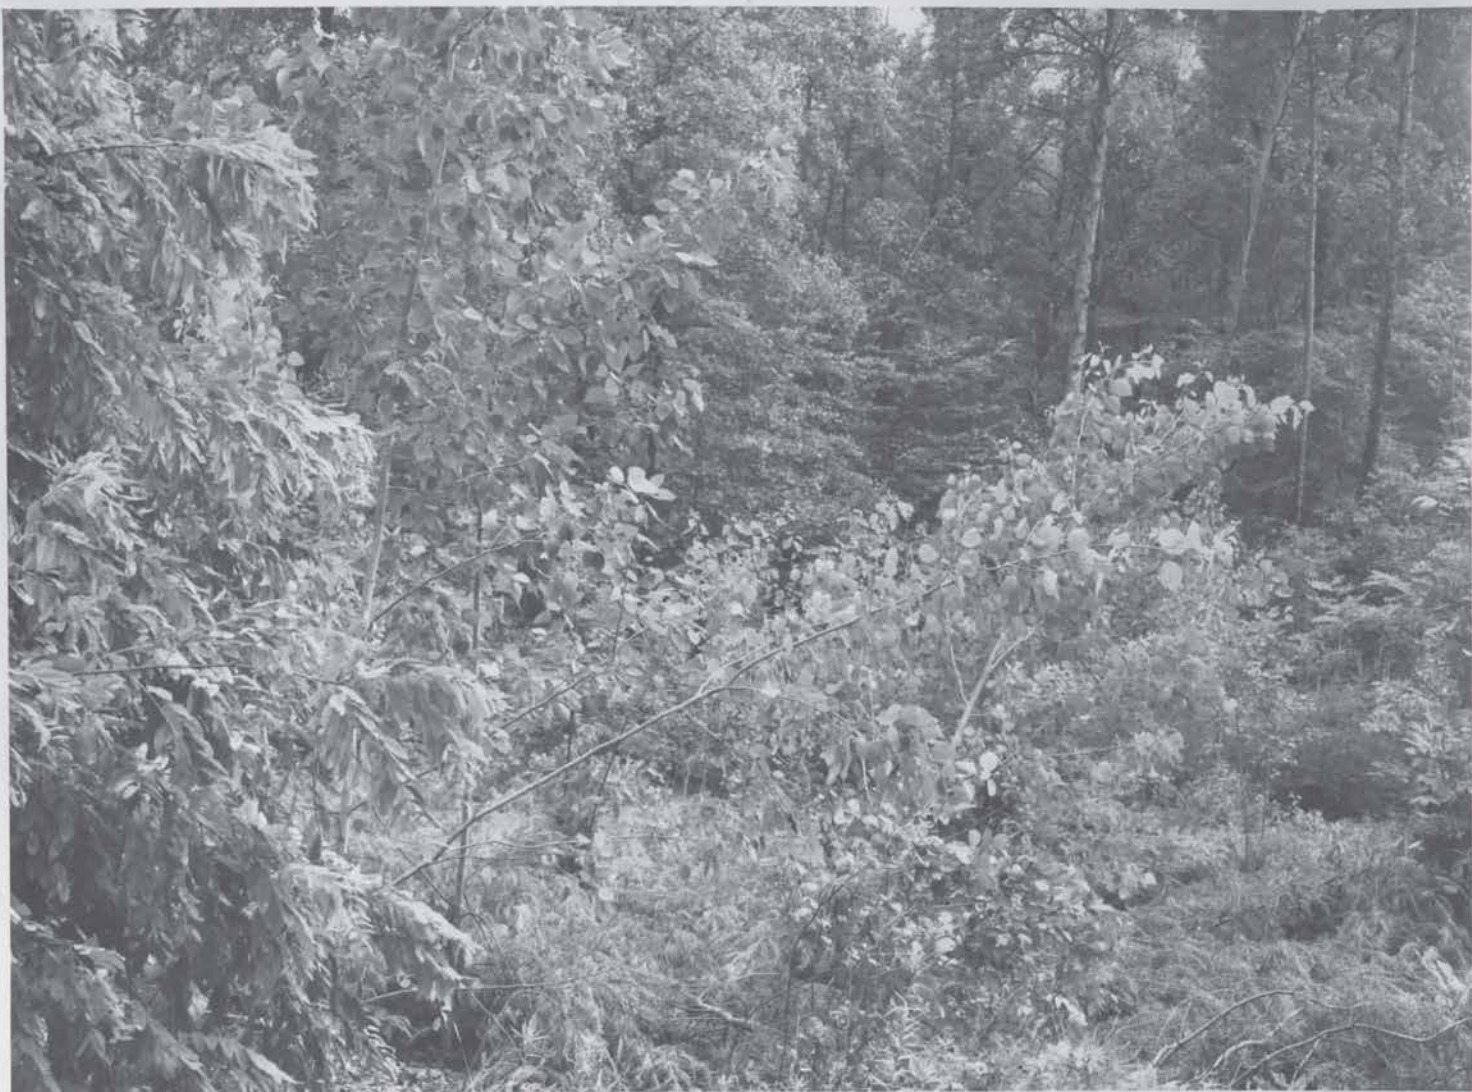
Figure 2 Upland site (photographed after pines were cut) dominated by *Pinus virginiana*, *Populus grandidentata*, and *Robinia pseudoacacia*. Upright trees in center are *Populus grandidentata*, and the tree in the left foreground is a *Robinia pseudoacacia*. A *Carya tomentosa* is situated at the far lower right corner. The *Solidago graminifolia* (only two plants) is situated in the center front foreground. The view is northeast toward PML589 stake from Higman's Camera Point #2, Map I, which is 112 feet east of the fence.

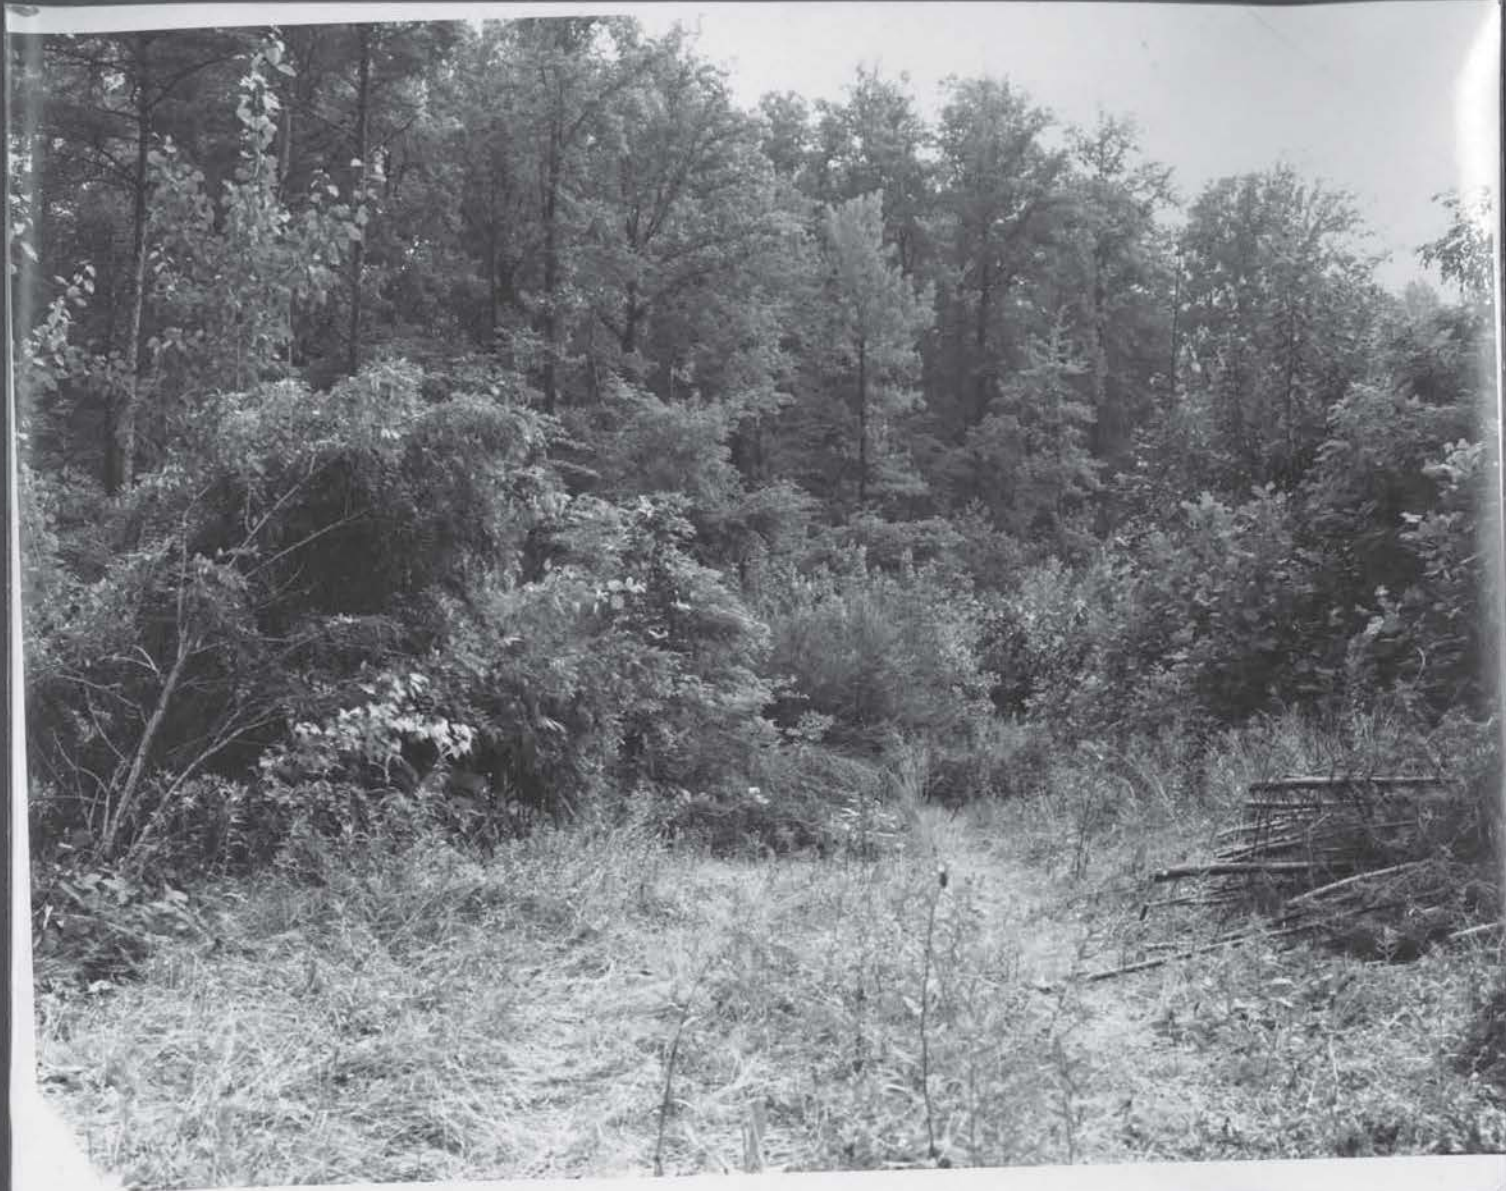
Figure 3 Photo of access trail. Site dominated by *Pinus* spp., *Liriodendron tulipifera*, *Populus grandidentata*, and *Robinia pseudoacacia*. In right foreground are *Liriodendron tulipifera*, *Populus grandidentata*, and *Robinia pseudoacacia*. In front of these is a pile of *Pinus virginiana*. In the left background are *Robinia pseudoacacia*, *Populus grandidentata*, *Pinus* spp., and *Acer rubrum*. The *Acer rubrum* is positioned beneath the leaning *Robinia pseudoacacia*. In the foreground and along the access trail, there are *Andropogon virginicus*, *Danthonia spicata*, and *Solidago graminifolia*. The view is east from Higman's Camera Point #3, Map I, which is 70 feet east of the boundary fence, along the access trail.

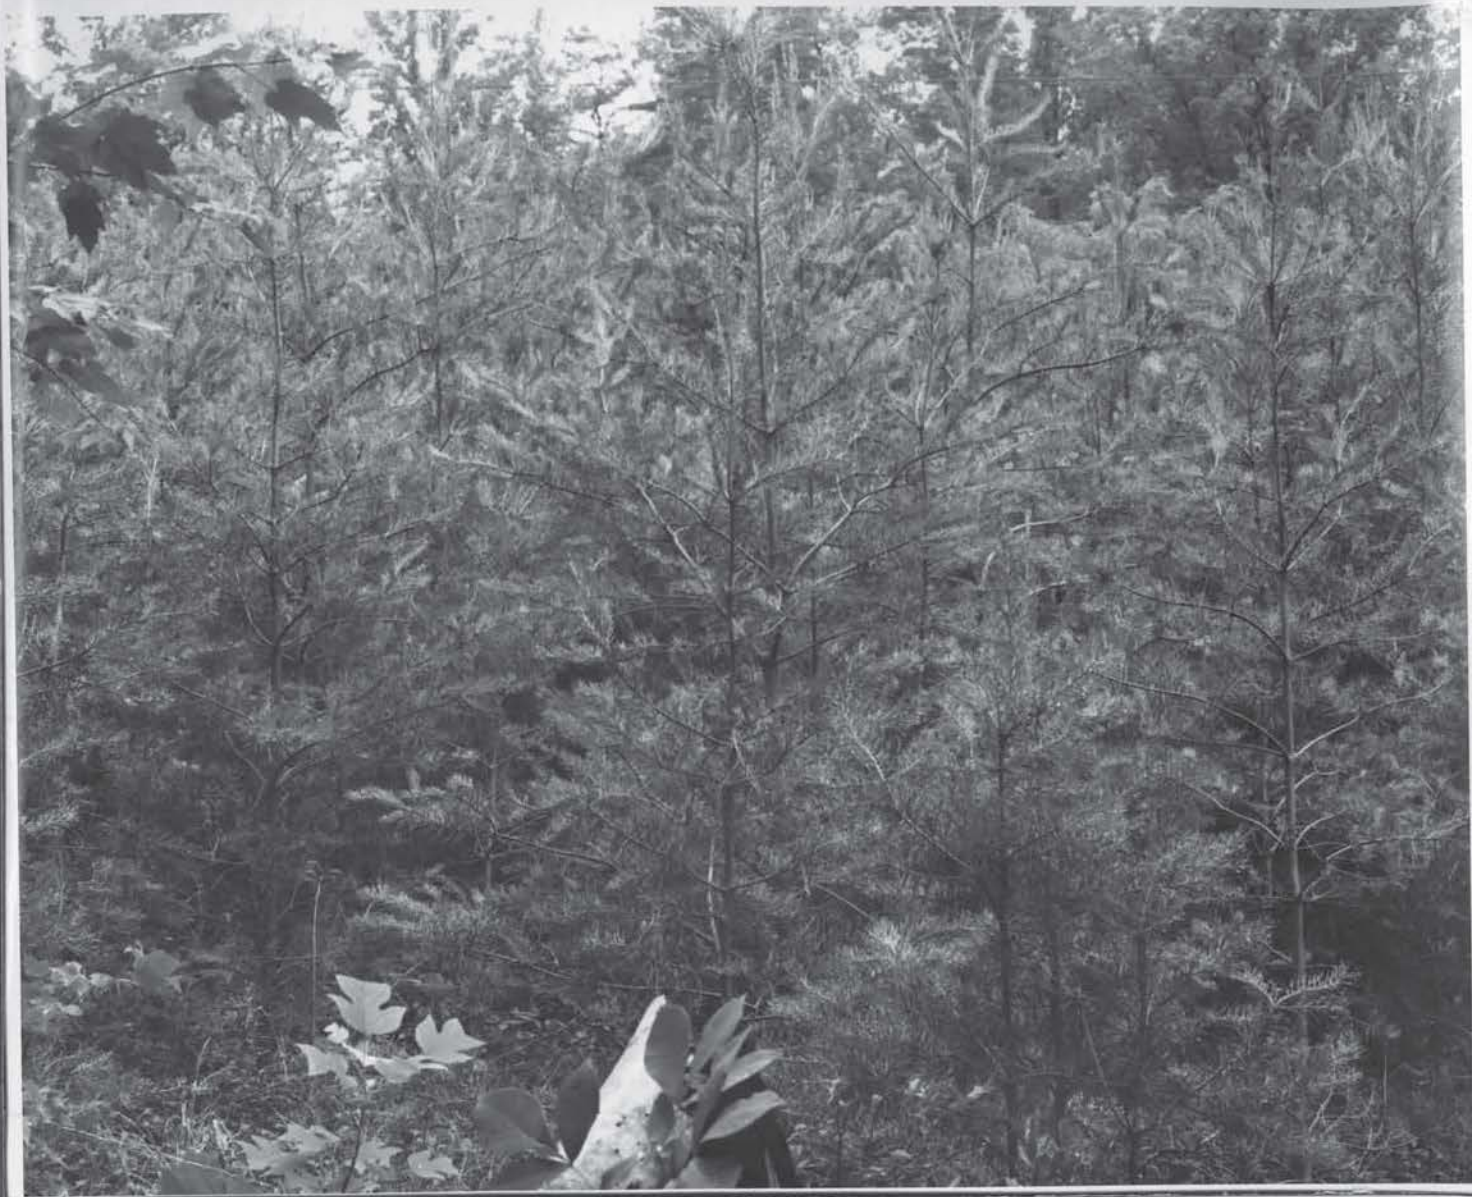
Figure 4 Site dominated by *Pinus virginiana*. An *Acer rubrum* limb is leaning to the right in the extreme upper left corner. A *Liriodendron tulipifera* and a *Carya tomentosa* are situated next to a log in the lower left half of this photo. This photo was taken from Higman's Camera Point #4, Map I, at the 1579 stake.

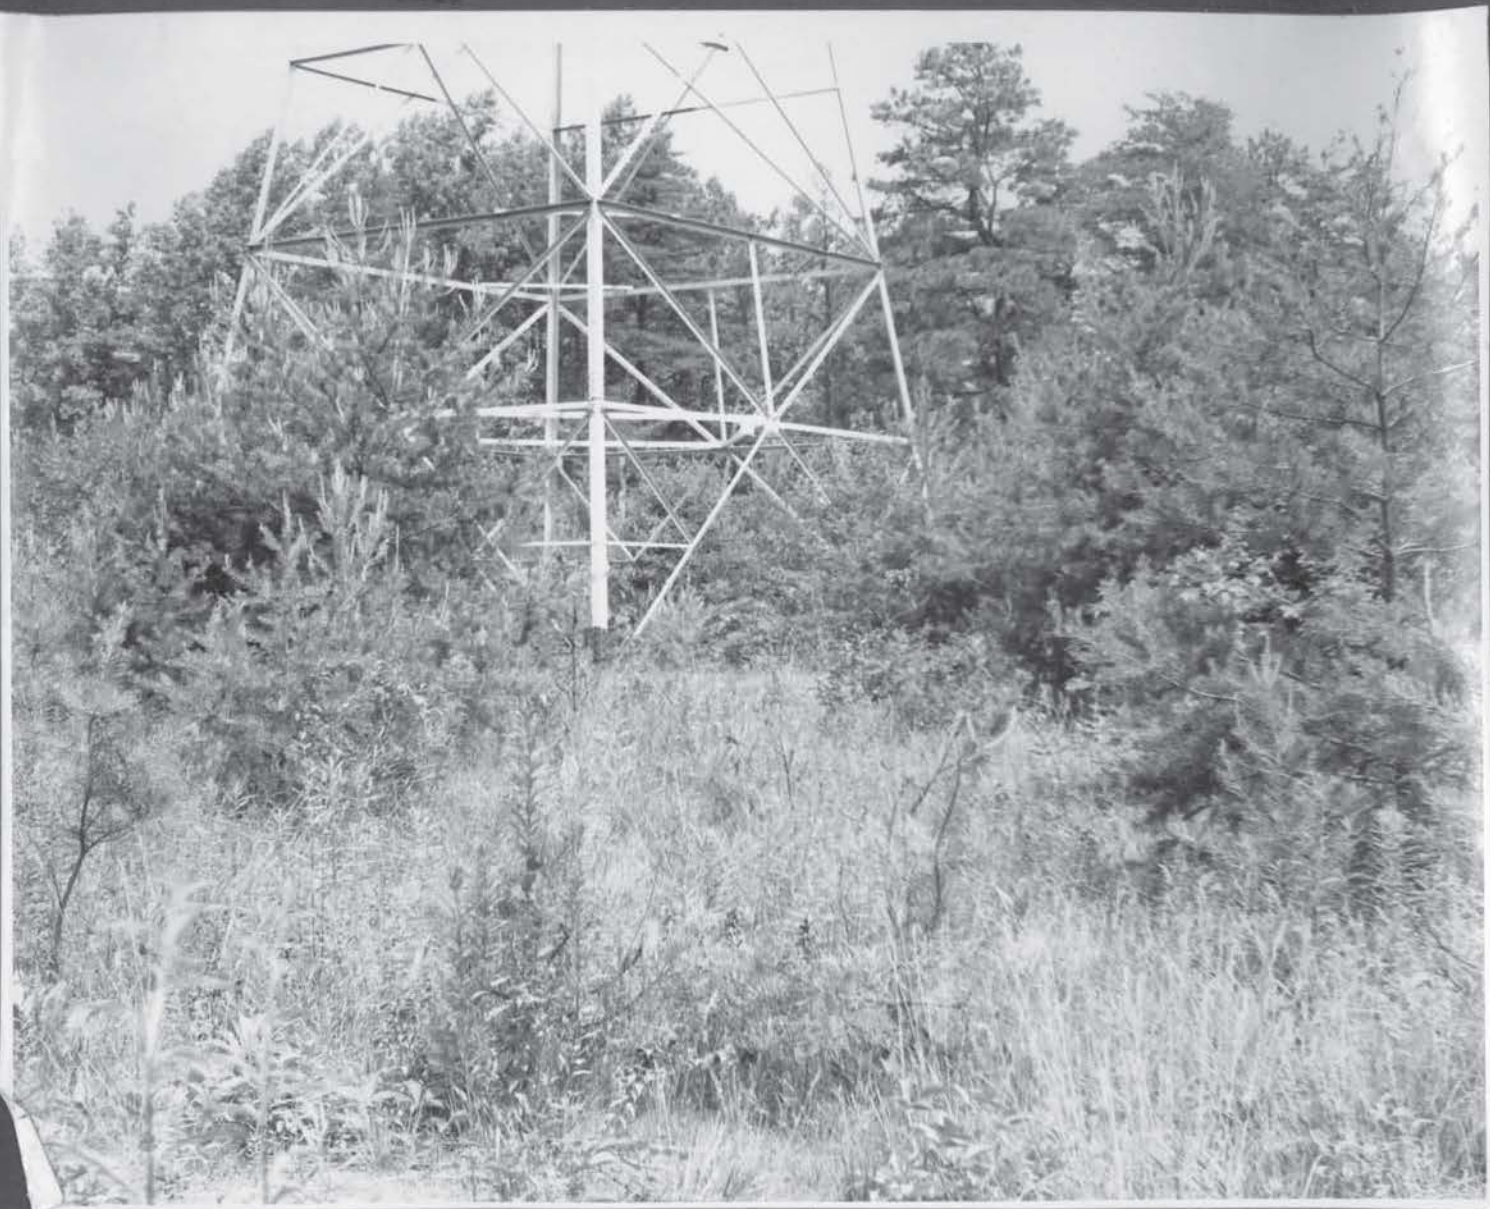
Figure 5 The tree species are predominately *Pinus* spp. and *Nyssa sylvatica*. The *Pinus* spp. are on the right and left sides of the tower. The *Nyssa sylvatica* are in the background behind the tower. One of these *Nyssa sylvatica* is situated behind the first tall *Pinus* sp. in the right foreground. The foreground herbs are predominately *Andropogon virginicus* and *Solidago graminifolia*. View is northwest from Smith's Camera Point #I, Map II, near the access trail.

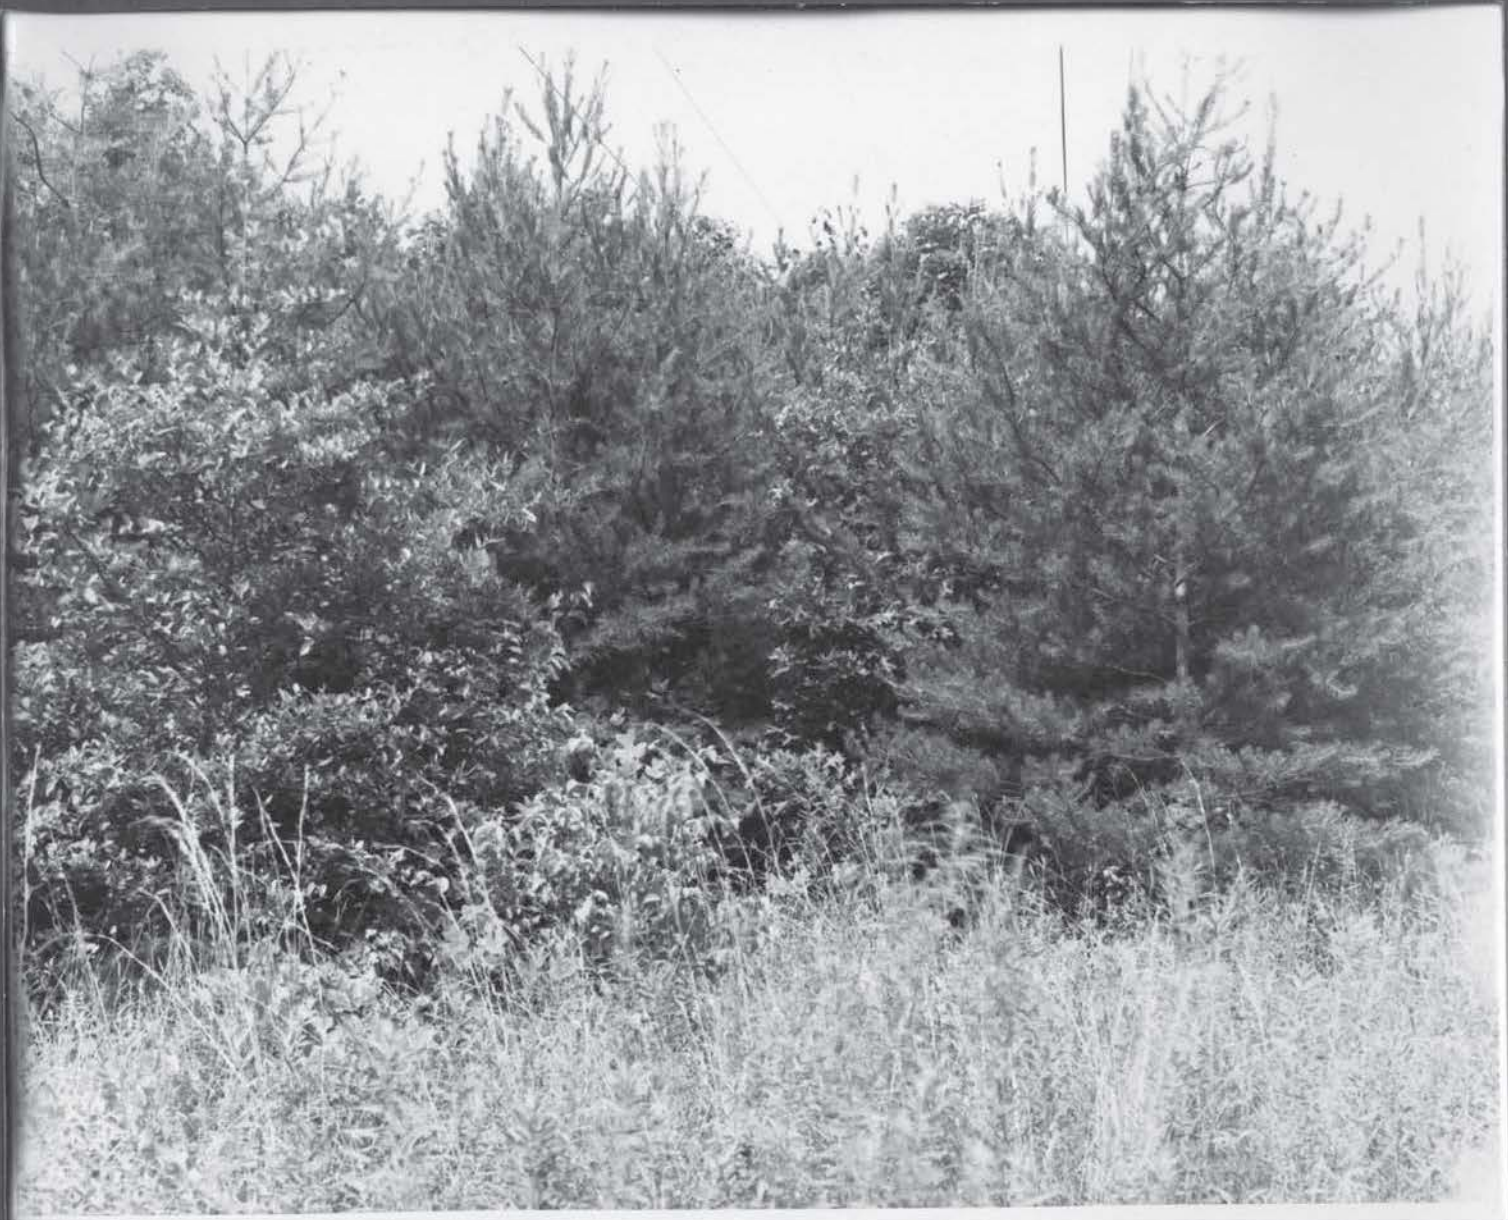
Figure 6 Dominant trees, in the foreground, are *Pinus virginiana* and *Nyssa sylvatica*. The *Nyssa sylvatica* are situated in the left foreground (to the right of the *Liriodendron tulipifera* seedling) and between the center *Pinus virginiana* behind the *Quercus palustris*. The trees in the background beneath the wires are (from left to right) *Populus grandidentata* and *Robinia pseudoacacia*. The foreground herb is primarily *Andropogon virginicus*. View is west 60 feet north, following access trail, from Smith's Camera Point #I. The camera point is Smith's Camera Point #II, Map II.

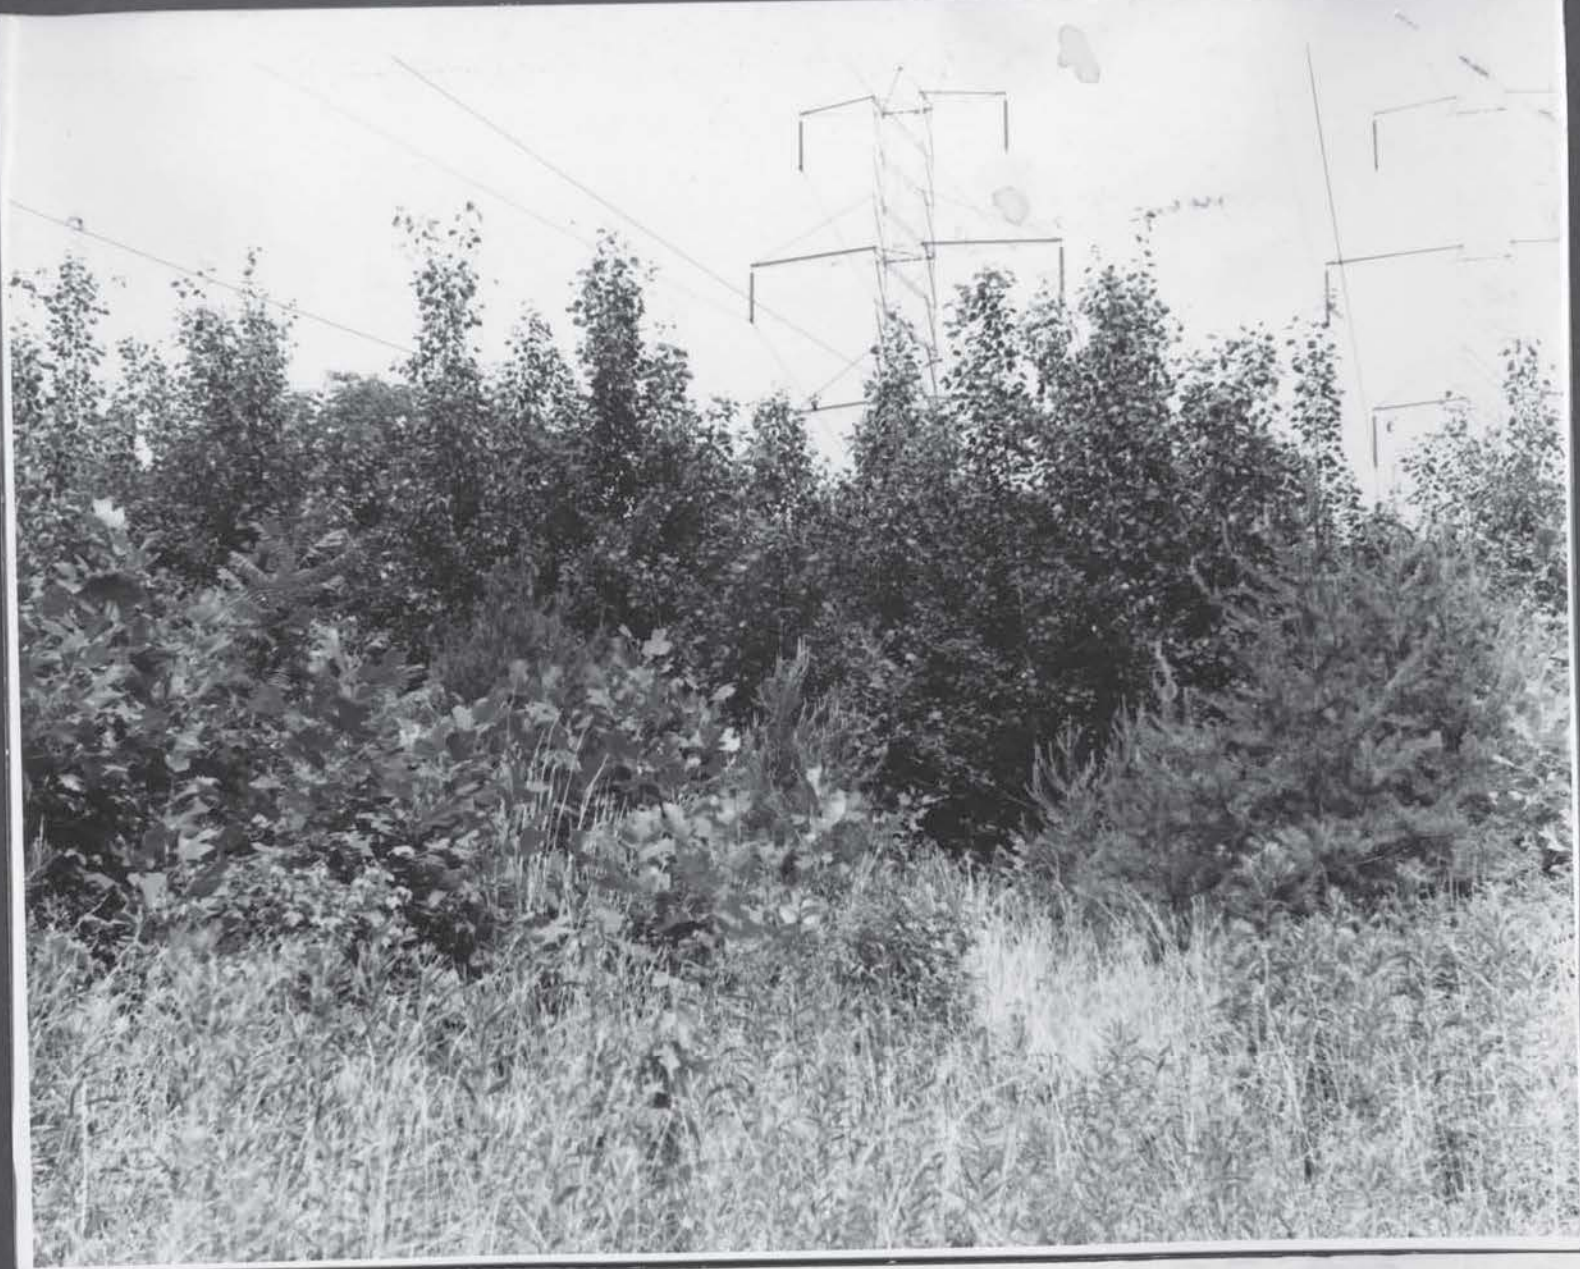
Figure 7 Site dominated by *Populus grandidentata*. In front of these (from left to right) are *Liriodendron tulipifera* and *Pinus virginiana* (in lower left corner), and *Pinus virginiana* next to the *Liriodendron tulipifera* seedling, to the extreme right. There is a *Rhus* sp. among the *Liriodendron tulipifera* in the lower left corner. The foreground herbs are primarily *Andropogon virginicus* and *Solidago* spp. View is east from Smith's Camera Point #III, Map II, about 30 feet north of access trail.

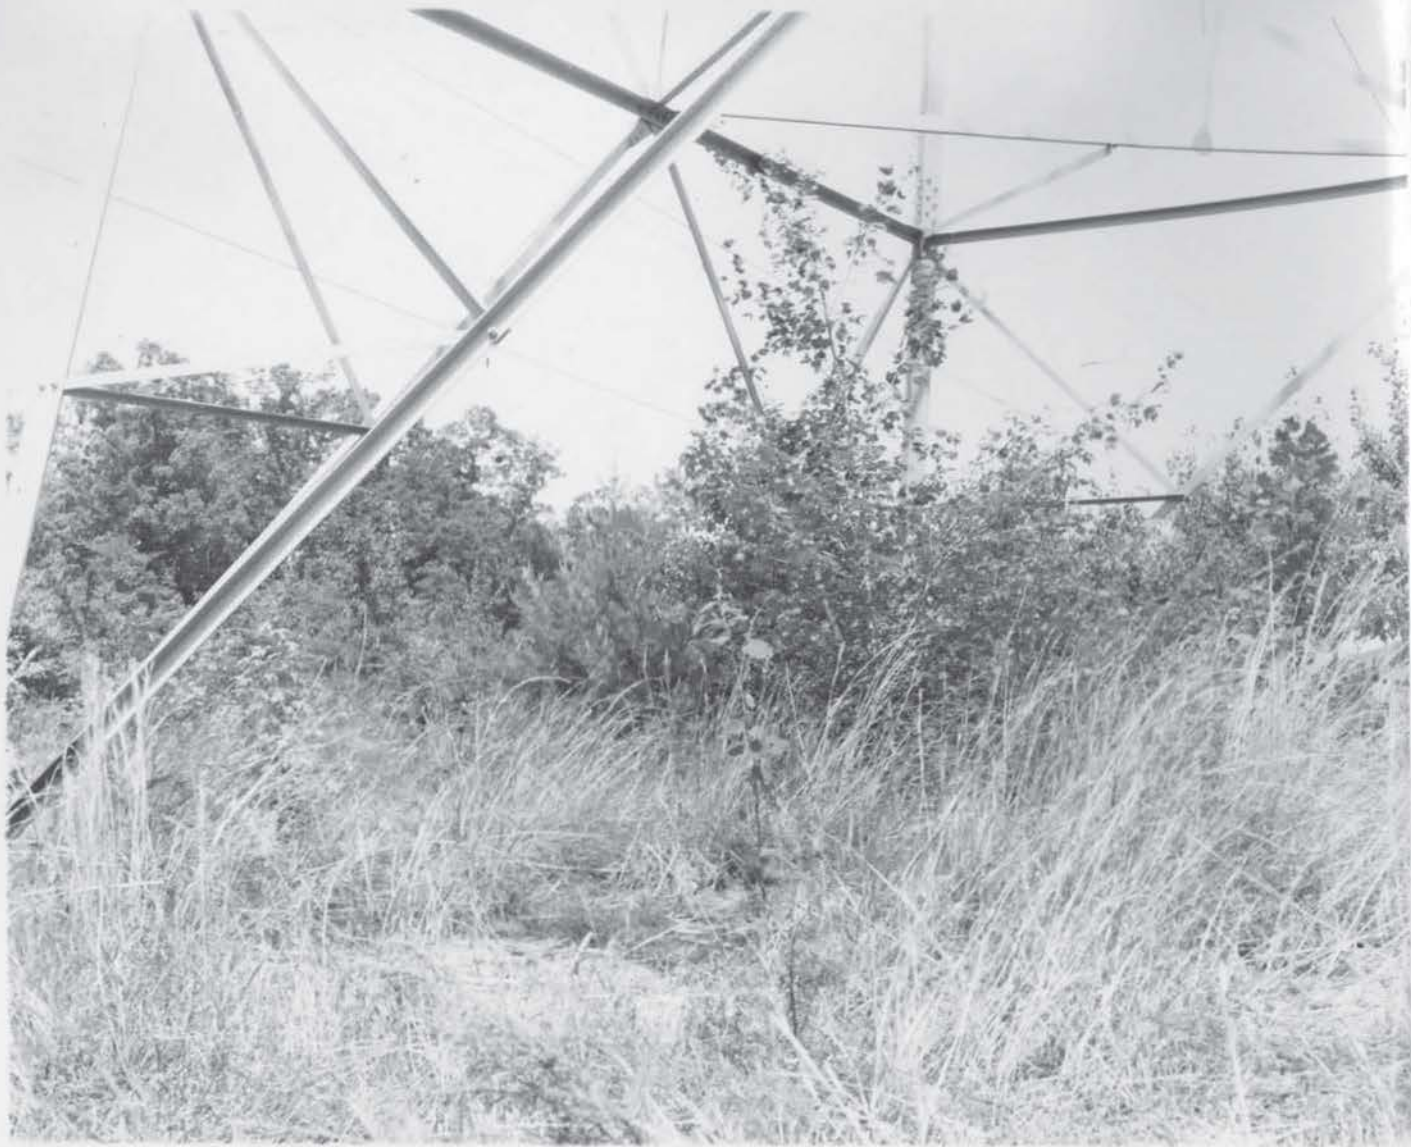
Figure 8 Site showing an *Acer rubrum* next to the far leg of tower. On the right side of this *Acer rubrum*, there is a *Liriodendron tulipifera* (beneath the tower) in front of the background *Populus grandidentata* in the right background. On the left side of this *Acer rubrum*, there is a *Pinus virginiana* and a *Liquidambar styraciflua* (beneath the diagonal beam of the tower's base). A *Populus grandidentata* is shown in front of the *Acer rubrum* among the foreground *Andropogon virginicus*. North view of tower 2365 from Smith Camera Point #IV, Map II.

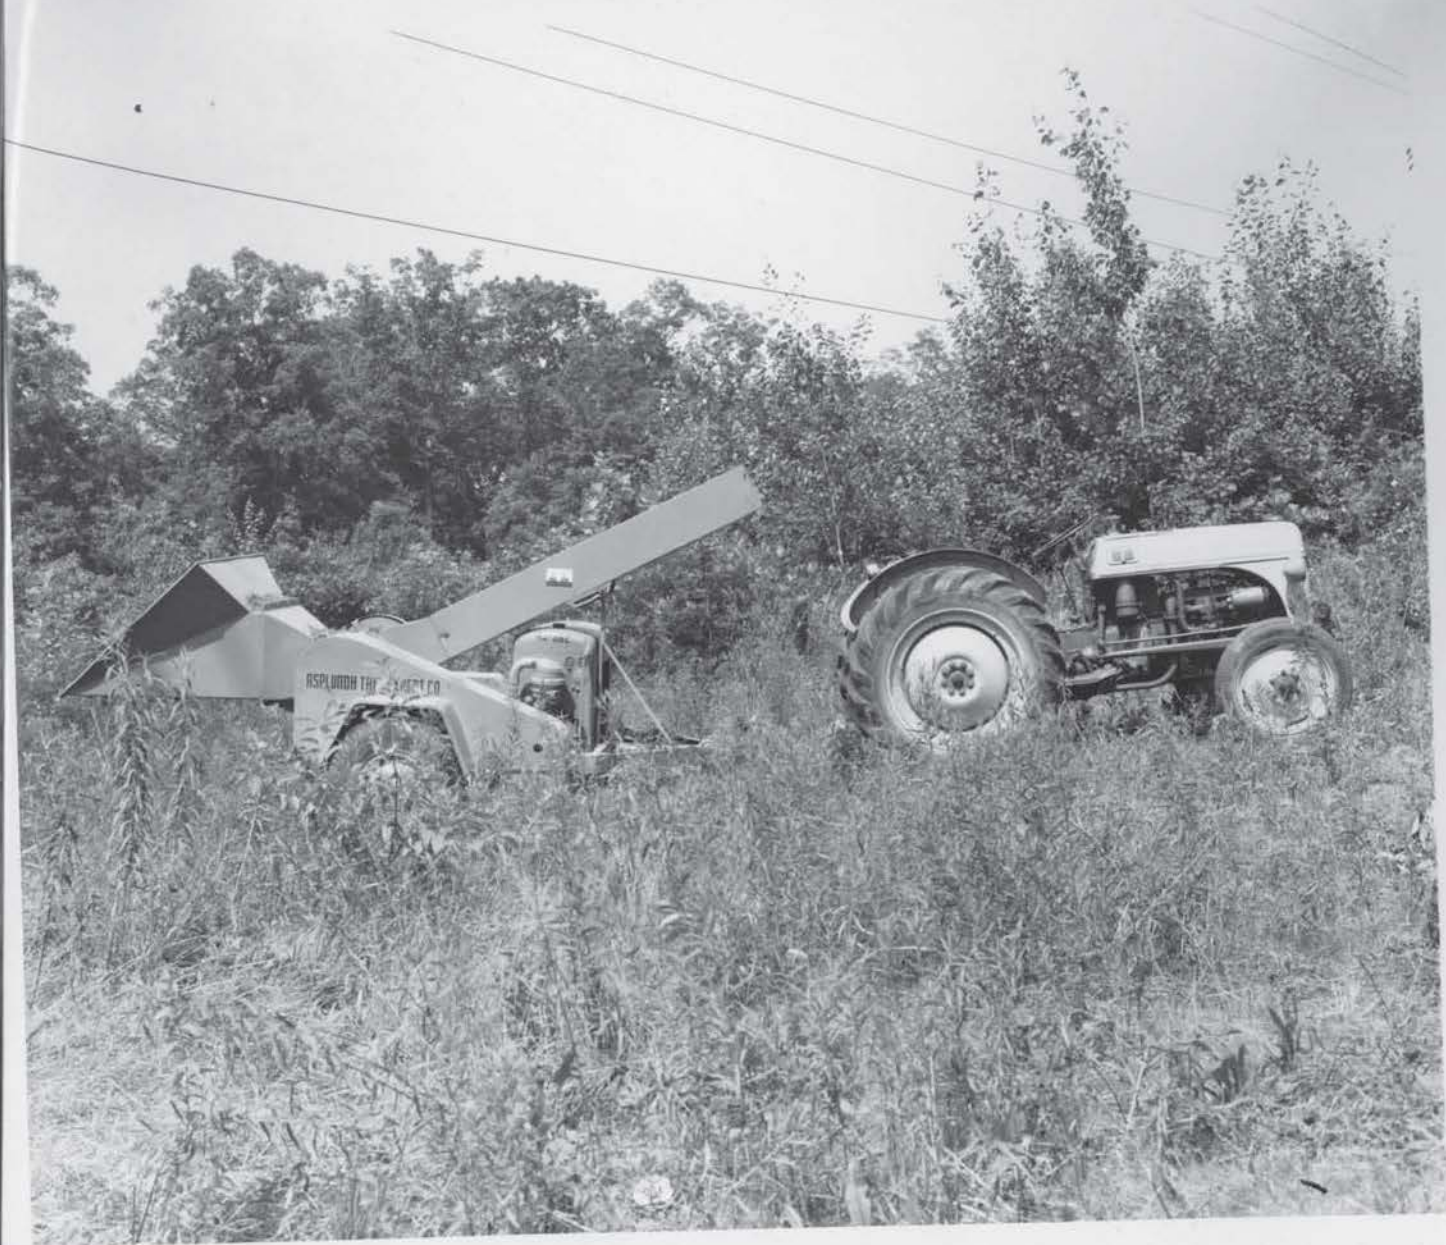
Figure 9 . Photo showing the Ford tractor and Asplundh chipper which was used to chip the cut Pinus spp.
View is east from a point in front of Tower 236S, Map II.

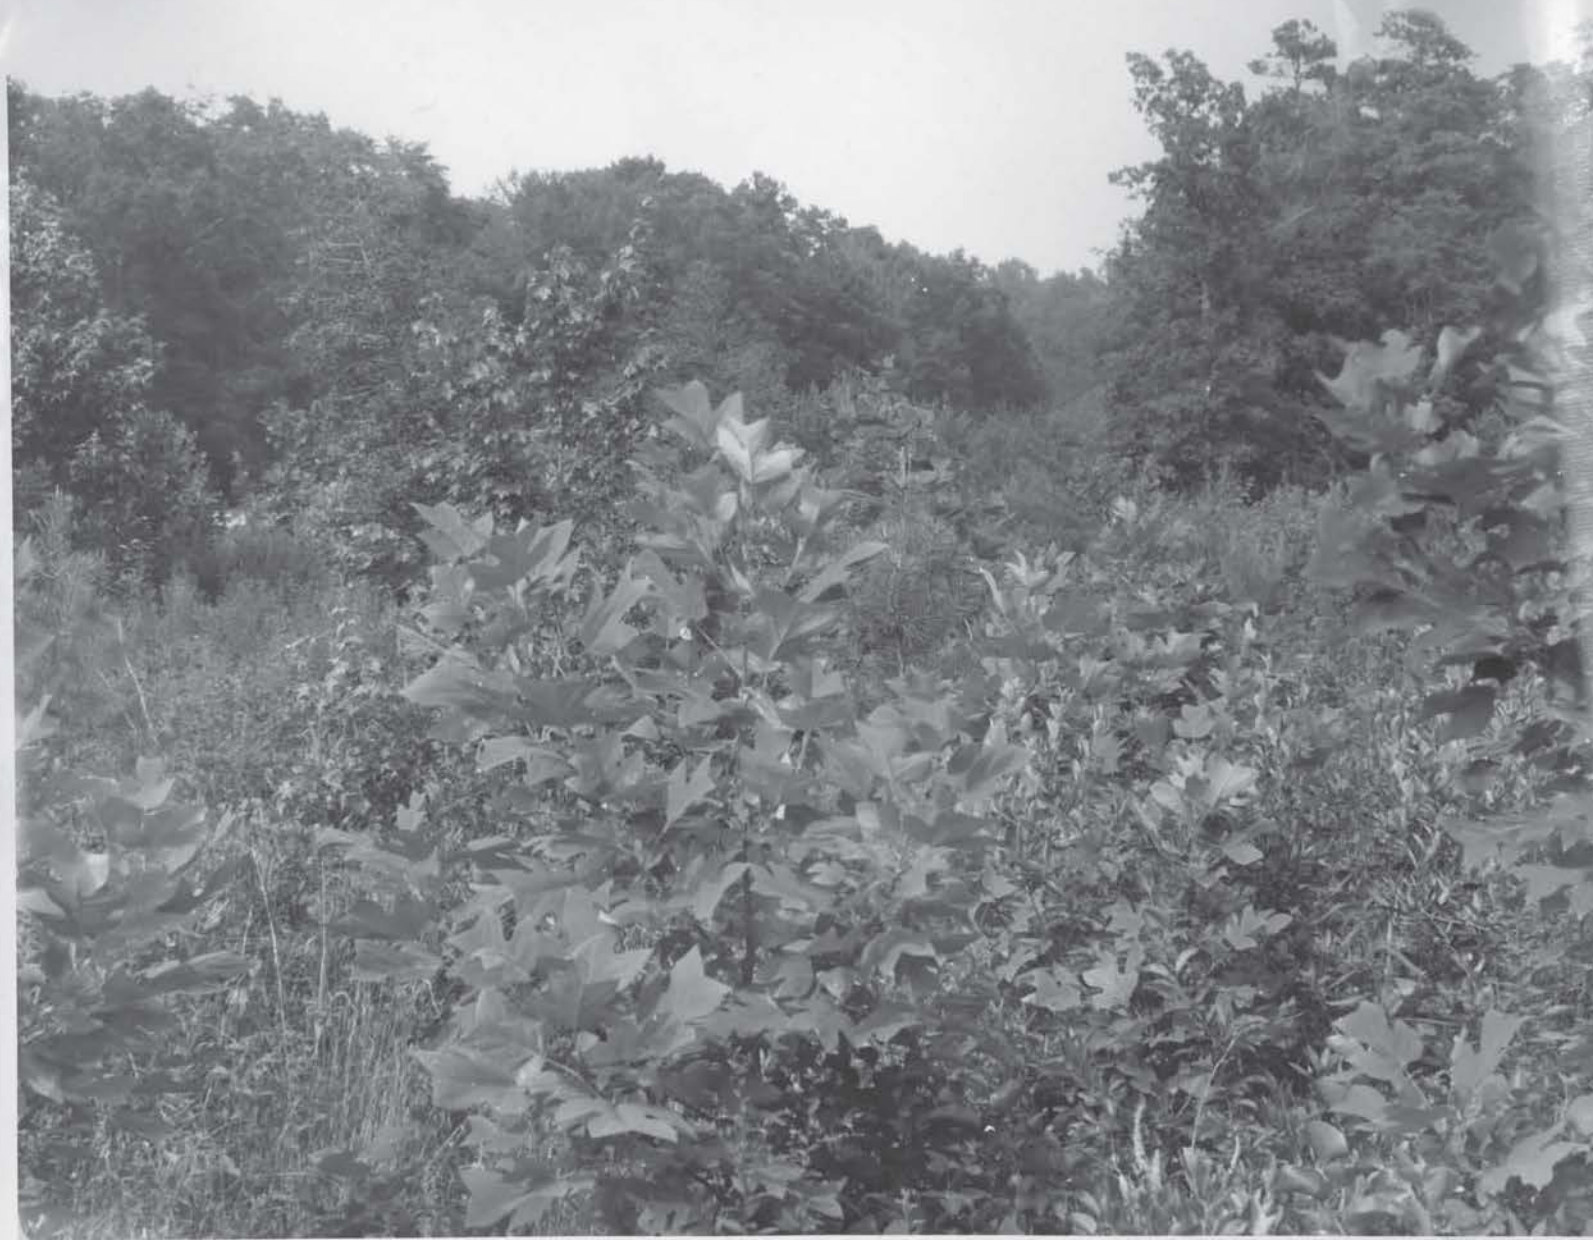
Figure 10 Site dominated by *Acer rubrum*, *Liriodendron tulipifera*, *Liquidambar styraciflua*, and *Pinus* spp. The *Aronia arbutifolia* is among the *Liriodendron tulipifera* in the right foreground. The *Liriodendron tulipifera* are situated in the front foreground. Behind there (from left to right) are a *Liquidambar styraciflua*, an *Acer rubrum*, and a *Pinus* sp. In the left background, next to the road, there is a *Liquidambar styraciflua*. In front of this tree, to the extreme left, there is a *Pinus* sp. In the left background, *Solidago* spp. are present. The entrance road is at the far right. This photo was taken from Higman's Camera Point #1, Map IV, at junction of entrance road and access trail; view northeast.

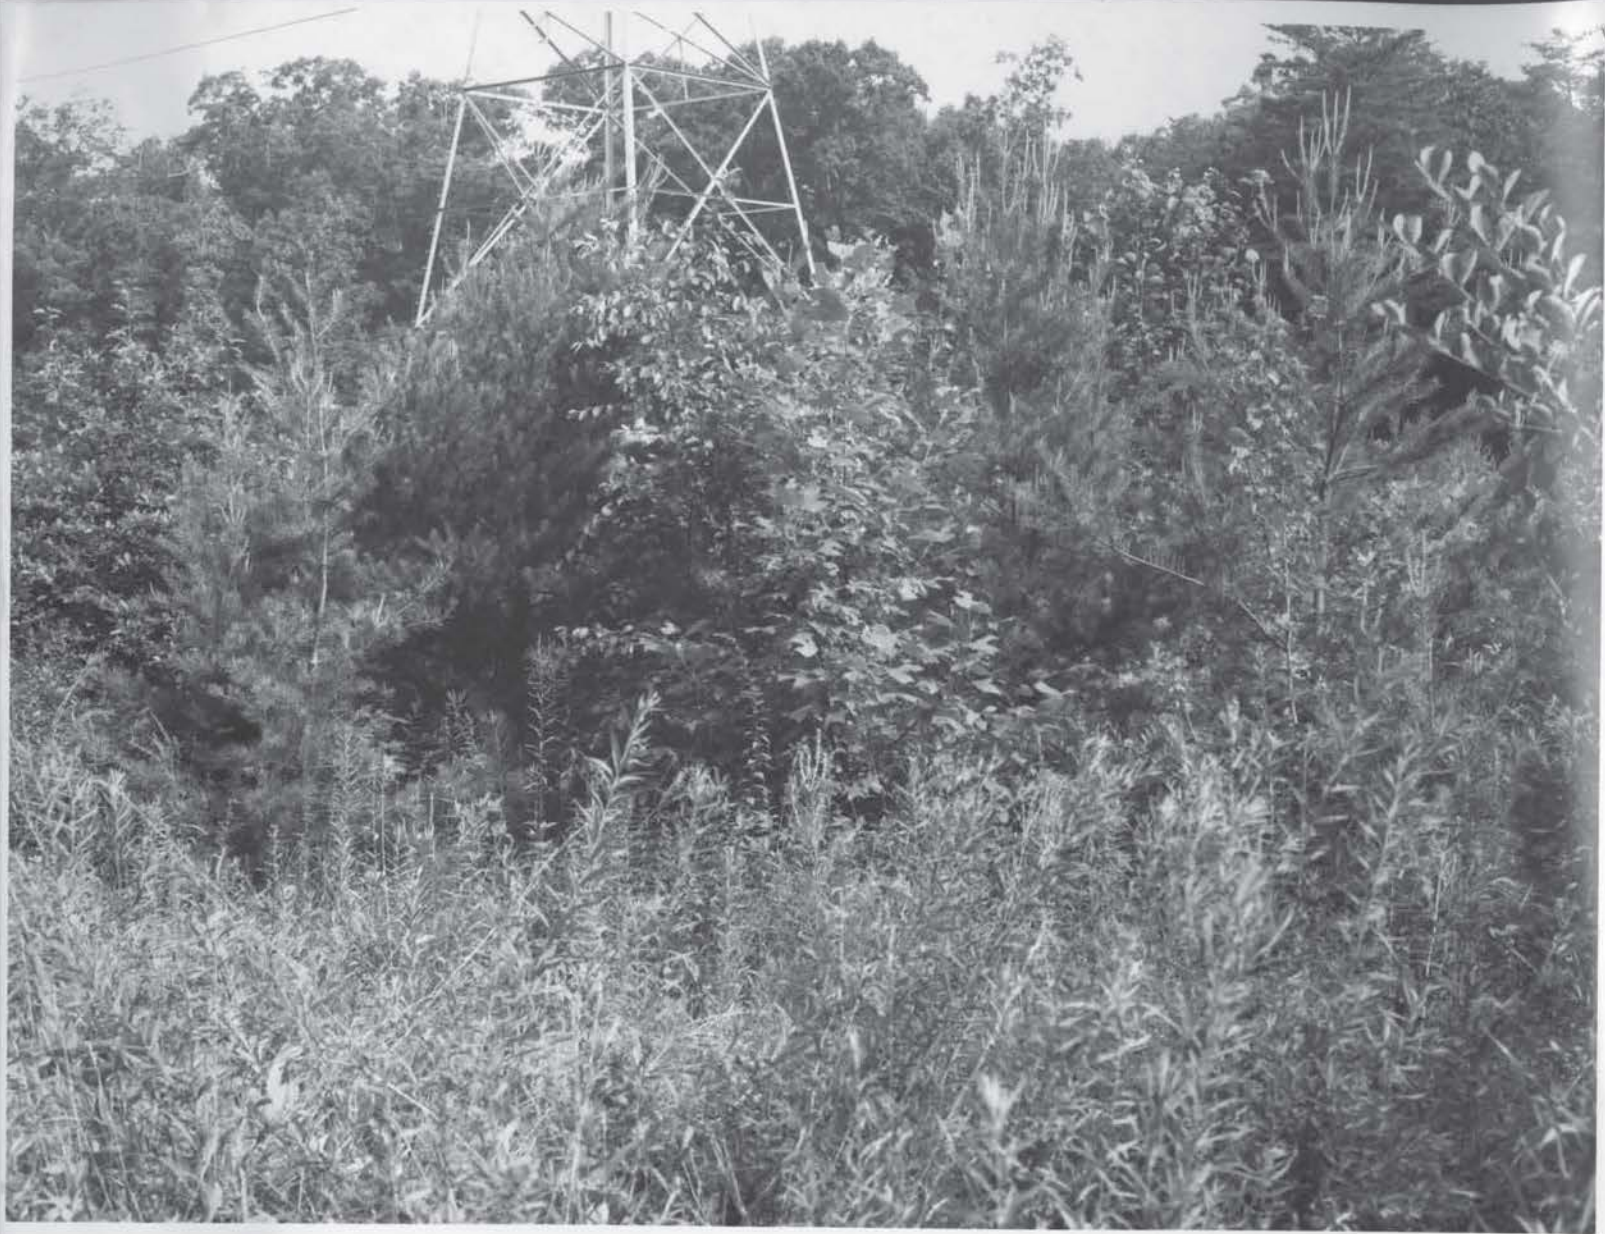
Figure 11 Site dominated by *Pinus* spp., *Nyssa sylvatica*, *Acer rubrum*, *Prunus serotina*, and *Liriodendron tulipifera*. The *Nyssa sylvatica* are in the far left of the photo. An *Amelanchier* tree can be seen between the *Pinus* spp. and *Liriodendron tulipifera* in front of tower. Between the *Pinus* spp., at the right of this photo, there are *Populus grandidentata*. In one of these photos, at the extreme upper right corner, there is an *Aronia arbutifolia*, which leans to the left. The foreground is primarily *Andropogon virginicus* and *Solidago* (*graminifolia*, *junceae*, and *rugosa*). View taken from Higman's Camera Point #2, Map IV, on access trail 100 feet east of tower 2375.

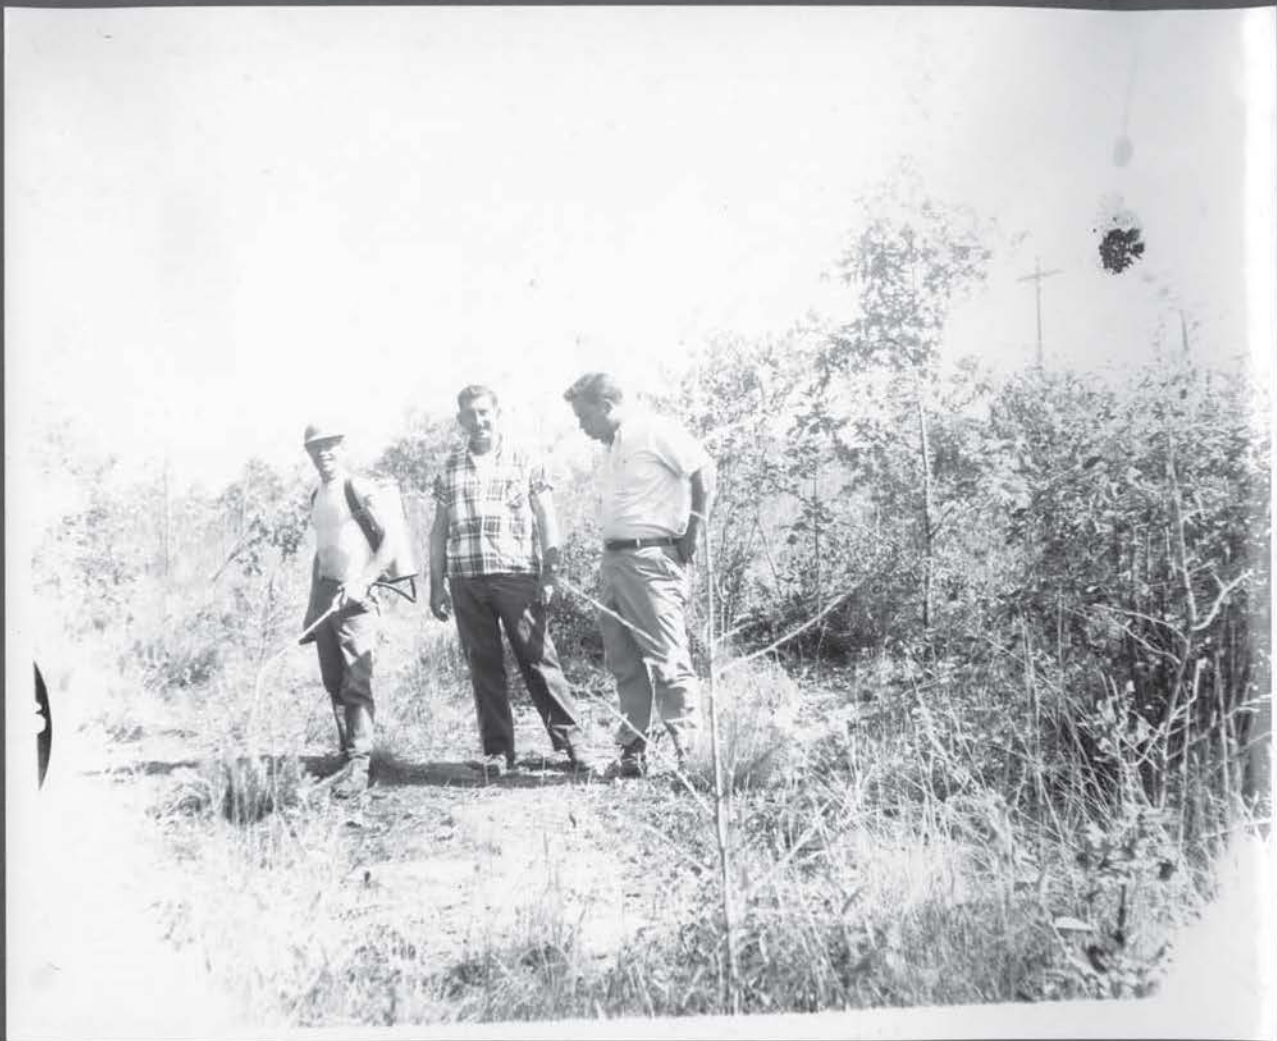
Figure 2. Photo showing three of the Pitch-pines, *Pinus rigida*, which sprouted after they had been cut below the lowest branch. Two of these *Pinus rigida* are on the right and left sides of the three men, and the other one is about 4 feet behind the spray nozzle. View is east, Map IV, on the left side of Access Trail, near entrance gate.
