Photographs of powerline right of way, Patuxent Wildlife Research Center, Summer and Fall of 1968. Taken by David Smith. These photographs were taken mainly from camera points established earlier by Higman. They show the state of the vegetation before and during the selective control work done in 1968 and constitute an integral part of Smith's report.

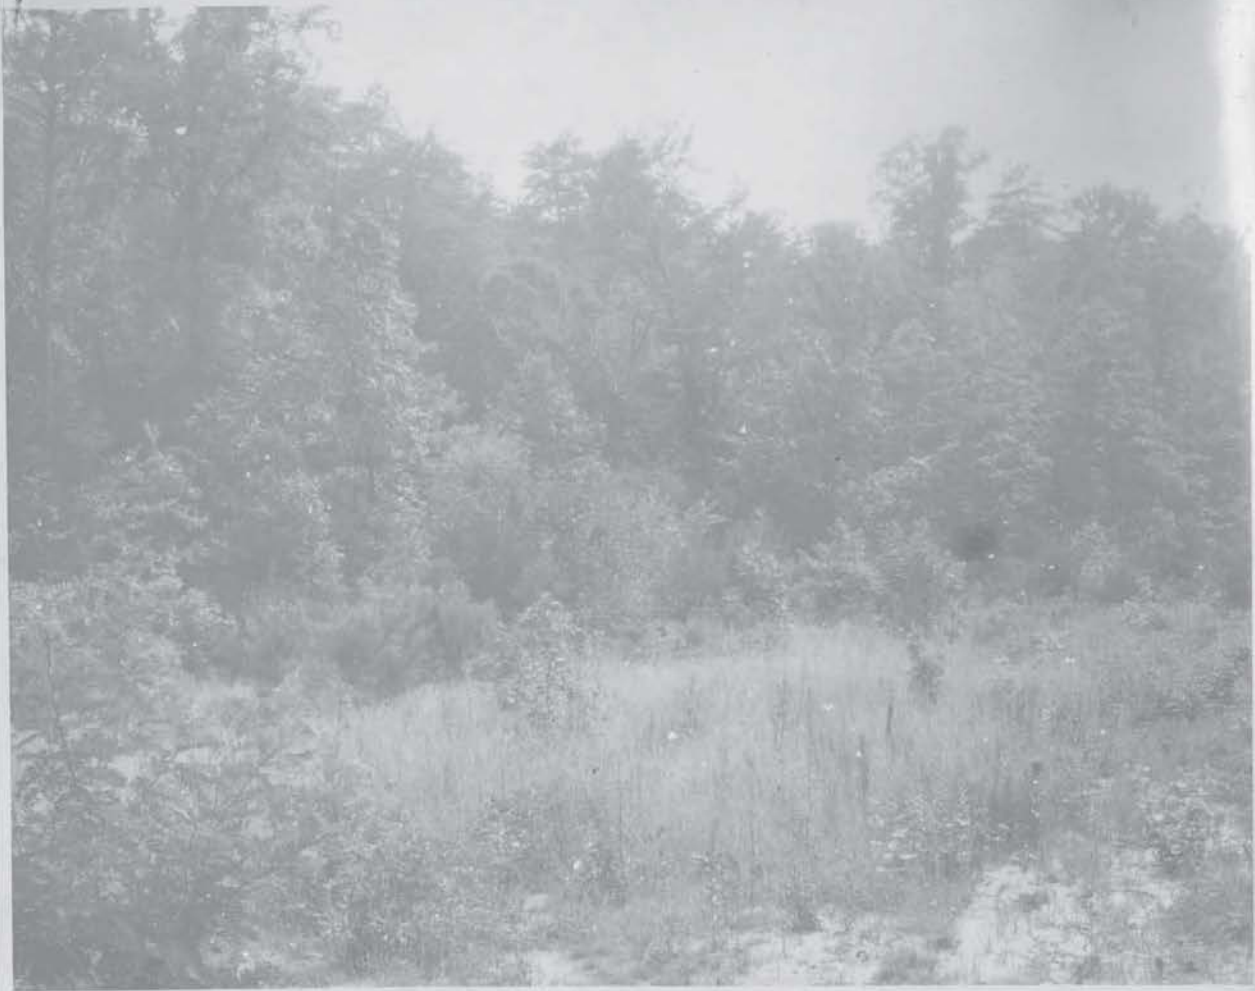
✓
 OK Figure 13 Site dominated by *Potentilla canadensis*, *Danthonia spicata*, *Andropogon virginicus*, *Lespedeza virginica*, and *Solidago* (*juncea*, *puberula*, *graminifolia*, *altissima*, and *rugosa*). Scattered among these herbs are seedlings of *Pinus* spp., *Populus grandidentata*, *Liriodendron tulipifera*, *Acer rubrum*, and *Robinia pseudoacacia*. The *Populus grandidentata*, in the background is next to the *Lespedeza bicolor*. The *Robinia pseudoacacia* is situated in the lower left corner. The bare areas, in the front foreground, are characteristic of this area. View is southeast from Higman's Camera Point #1, Map V, midway between towers 238N and 238S.

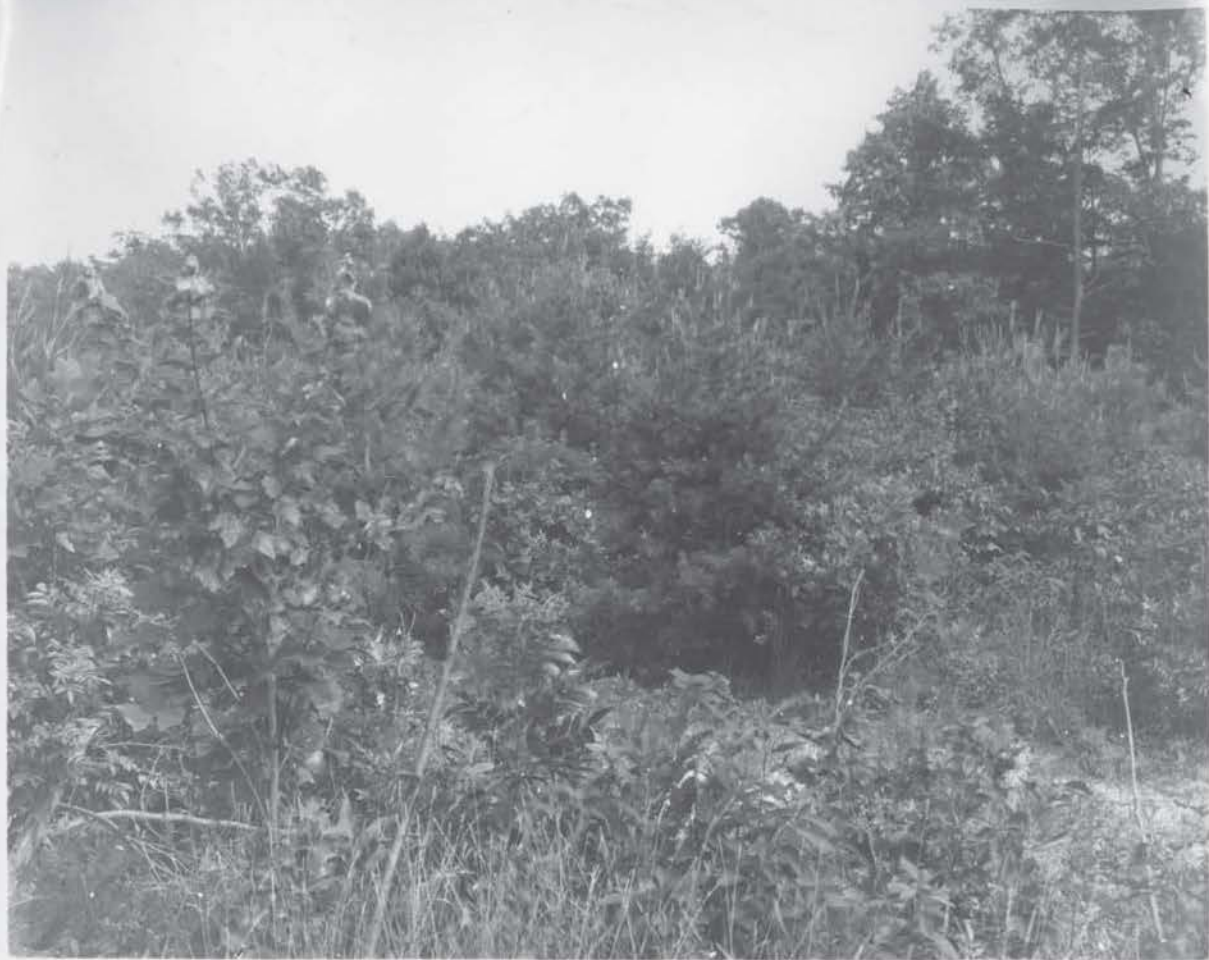
Figure 14. Site dominated by *Pinus* spp. and *Sassafras*. A number of *Sassafras* are situated among the *Pinus* spp. in the right background. An *Acer rubrum* is situated to the right of the *Liriodendron tulipifera* and the *Rhus glabra* which are situated in the lower left foreground. Beside the *Acer rubrum*, from left to right, are a leafless *Aralia spinosa*, a *Rhus glabra*, and a number of *Sassafras*. The herb in the front foreground is primarily *Danthonia spicata*. The view is southeast from Higman's Camera Point #2, Map V, beside the new access trail, 70 feet west of tower 2385.

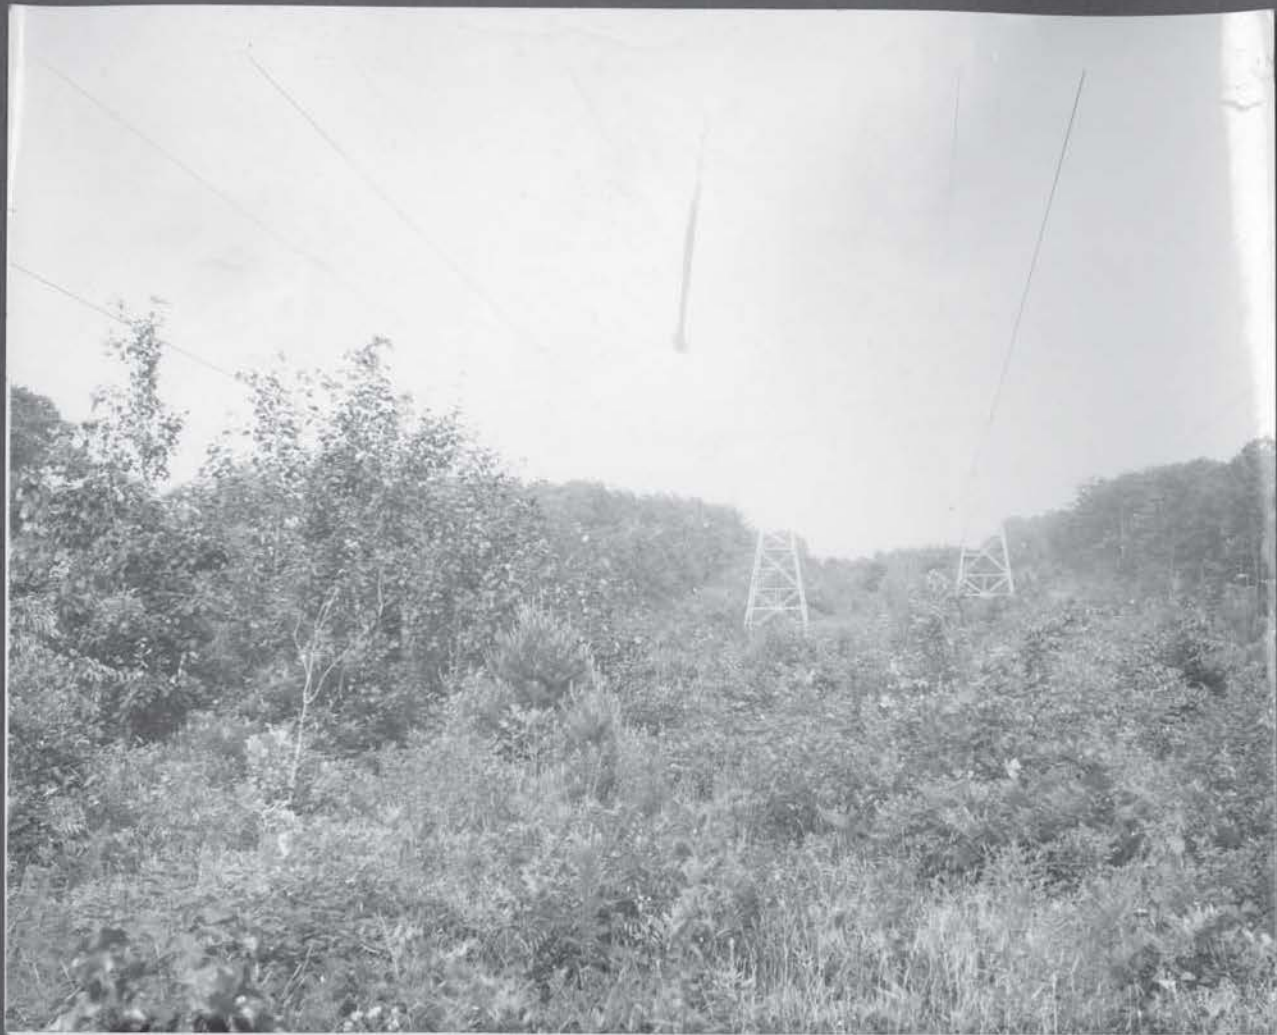
Figure 15 The *Populus grandidentata* is situated in the left foreground. The *Pteridium aquilinum* var. *latiusculum* is situated in the right foreground. The important species other than these are primarily *Nyssa sylvatica* (in the center and right foregrounds), *Andropogon virginicus*, and *Danthonia spicata*. View is west from Higman's Camera Point #4, Map V, 60 feet west of the north corner of tower 238N.

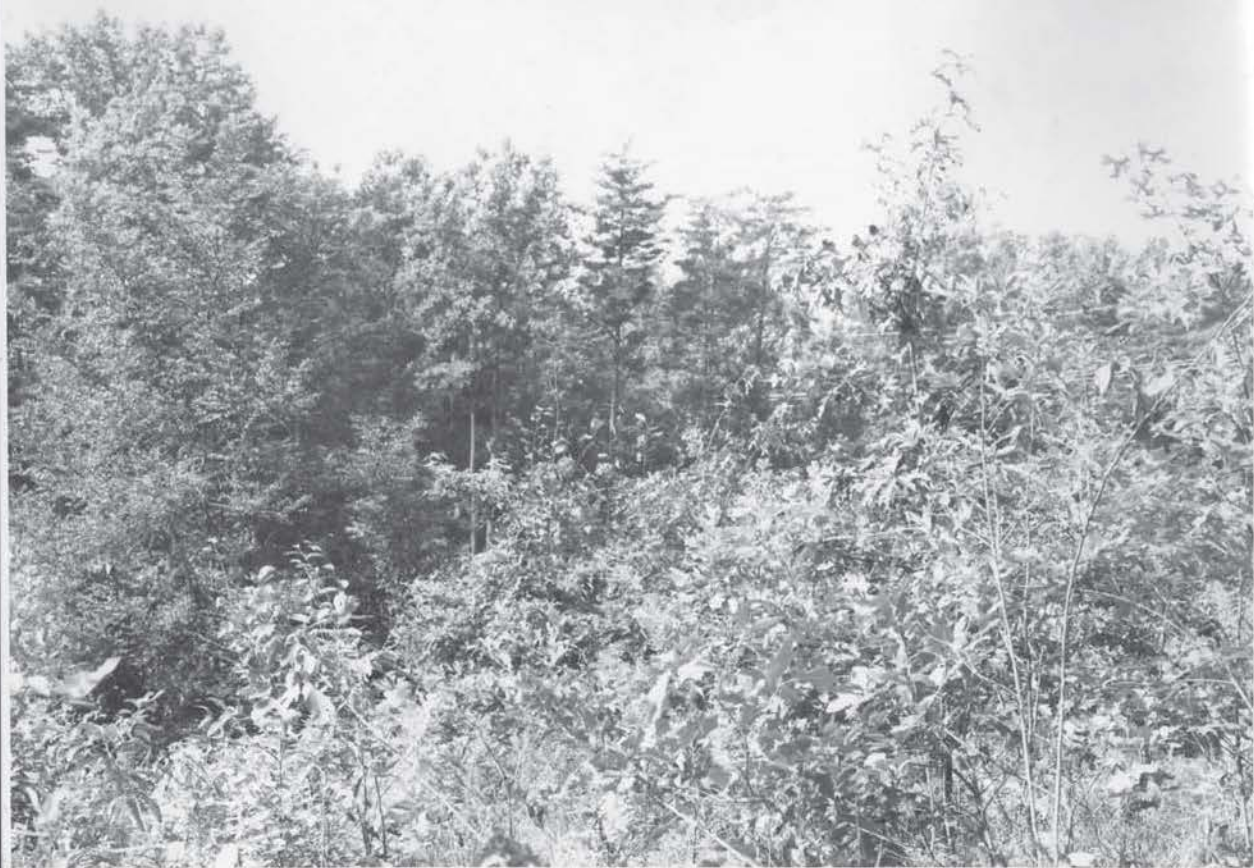
✓
 Figure 16 Photo of site after pines have been cut. In the left foreground, there is a *Robinia pseudoacacia*. To the right of this *Robinia pseudoacacia*, there are *Sassafras albidum*, *Quercus falcata*, *Populus grandidentata*, and *Liriodendron tulipifera*. The small forked tree, in the lower right corner, is a *Sassafras albidum*. Most of the trees that surround this *Sassafras albidum* are *Quercus falcata*. The foreground herb is primarily *Andropogon virginicus*. The view is southwest from Higman's Camera Point #1, Map VI, at the small ditch midway between the old and new access trails and 84 feet north of the telephone pole beside the old trail.

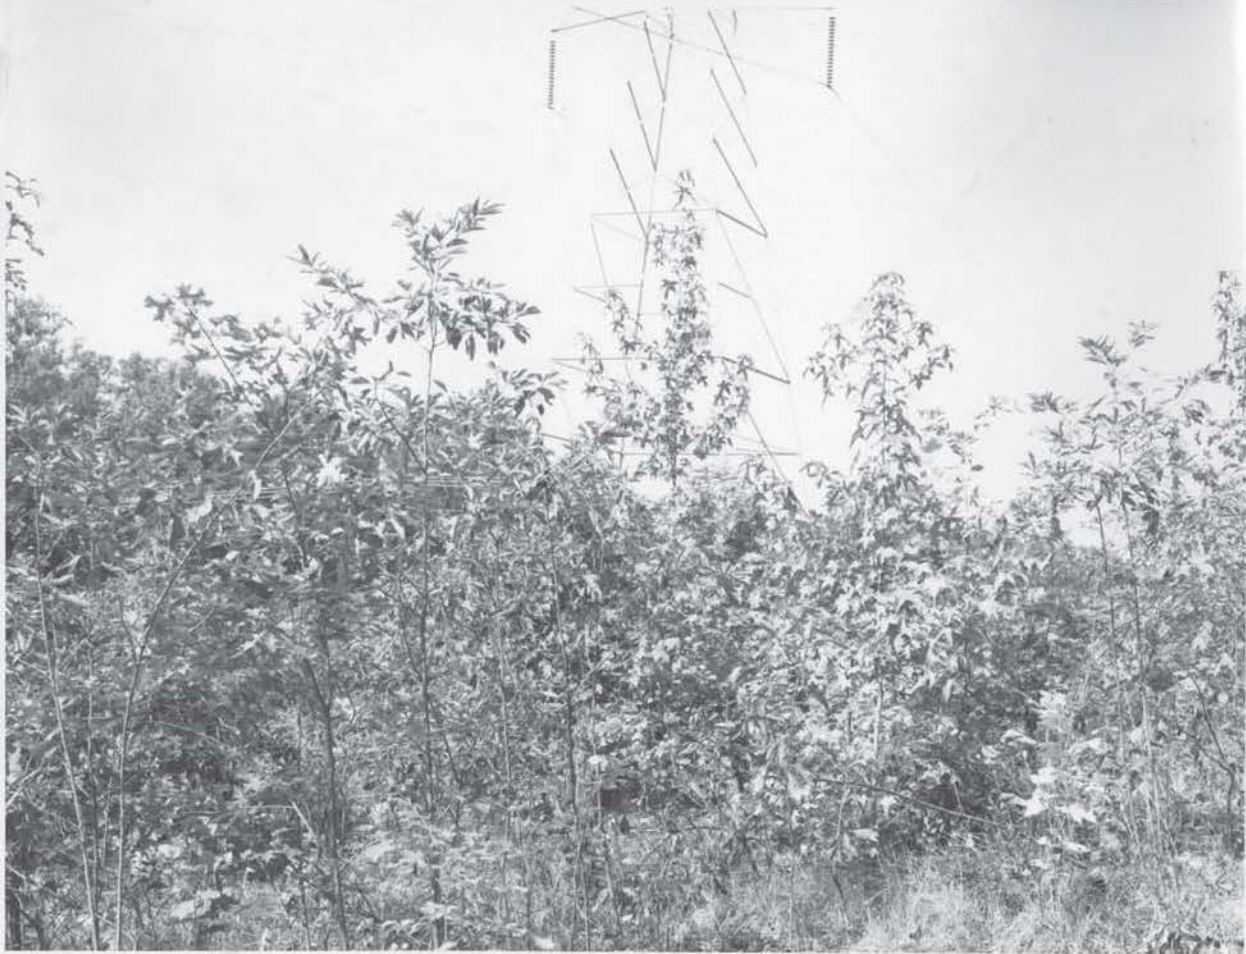
✓ Figure 17 Photo of site after pines have been cut. The foreground trees are primarily *Sassafras albidum* and *Liquidambar styraciflua*. The *Sassafras albidum* and the *Quercus falcata* are primarily on the left side of this photo whereas the *Liquidambar styraciflua* is primarily on the right side of this photo. One *Liquidambar styraciflua* is photographed parallel with the tower. A seedling *Liriodendron tulipifera* is situated in the lower right corner. The foreground herbs are *Andropogon virginicus* and *Danthonia spicata*. The view is west from Higman's Camera Point #2, Map VI, at the same location as Higman's #1 Camera Point, Map VI, looking toward tower 238N. *should be dist. look to 238 S.*

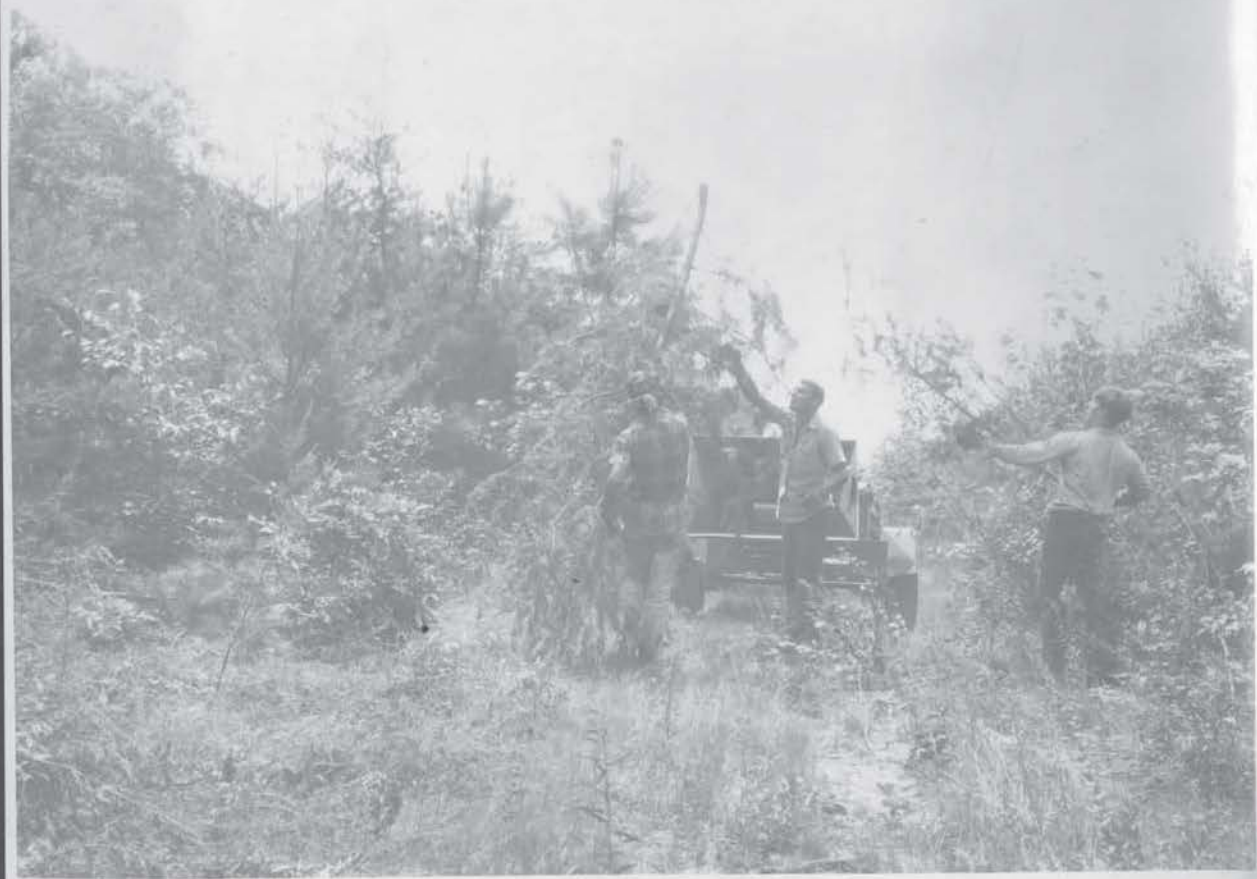
Figure 49. Photo showing the cutting of *Pinus* spp. with a power saw. View is west at a point near the junction of Maps XVII and XVIII.

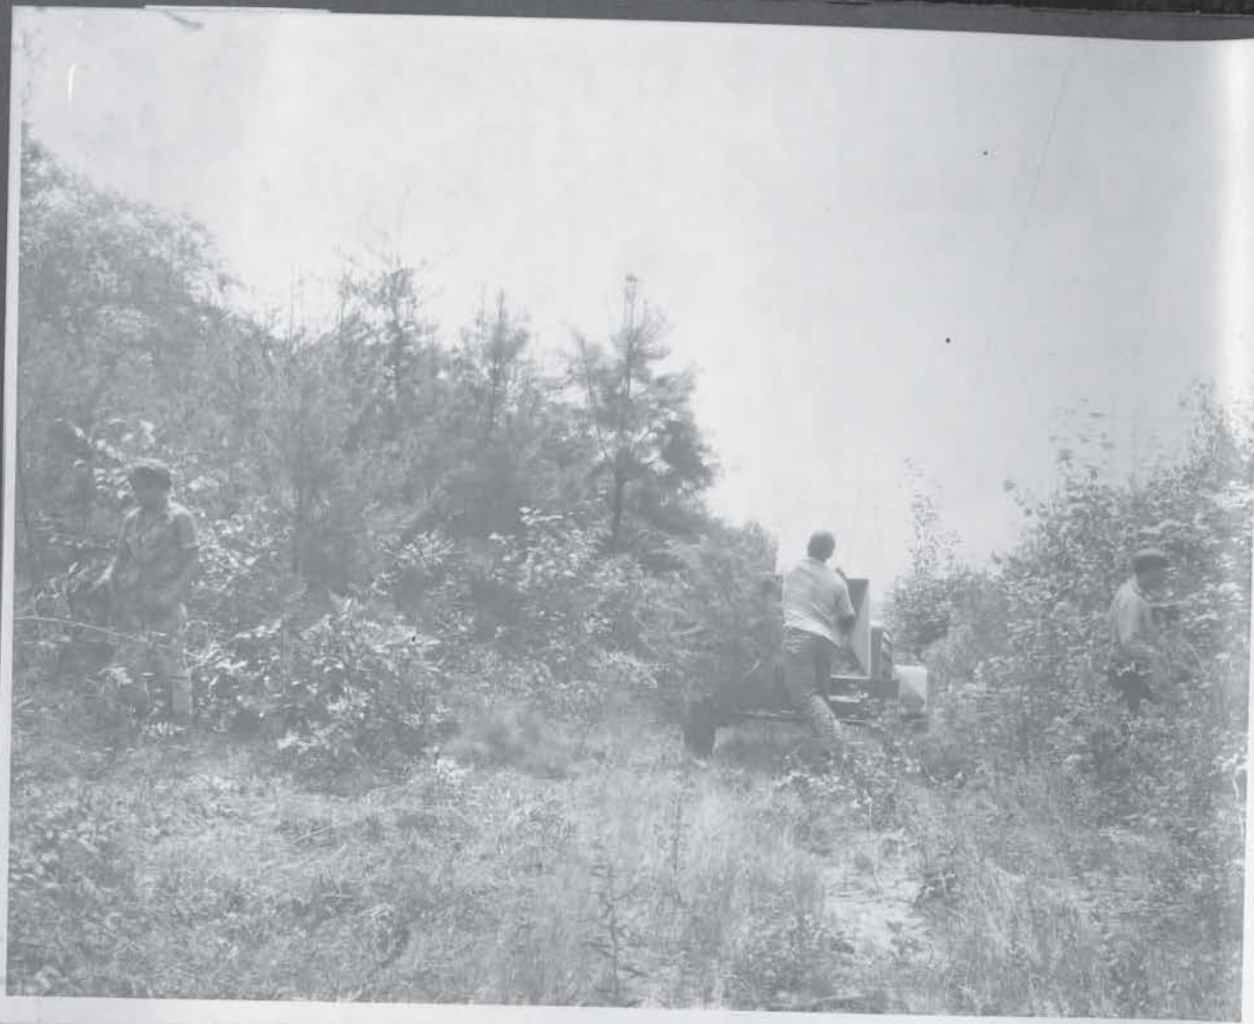
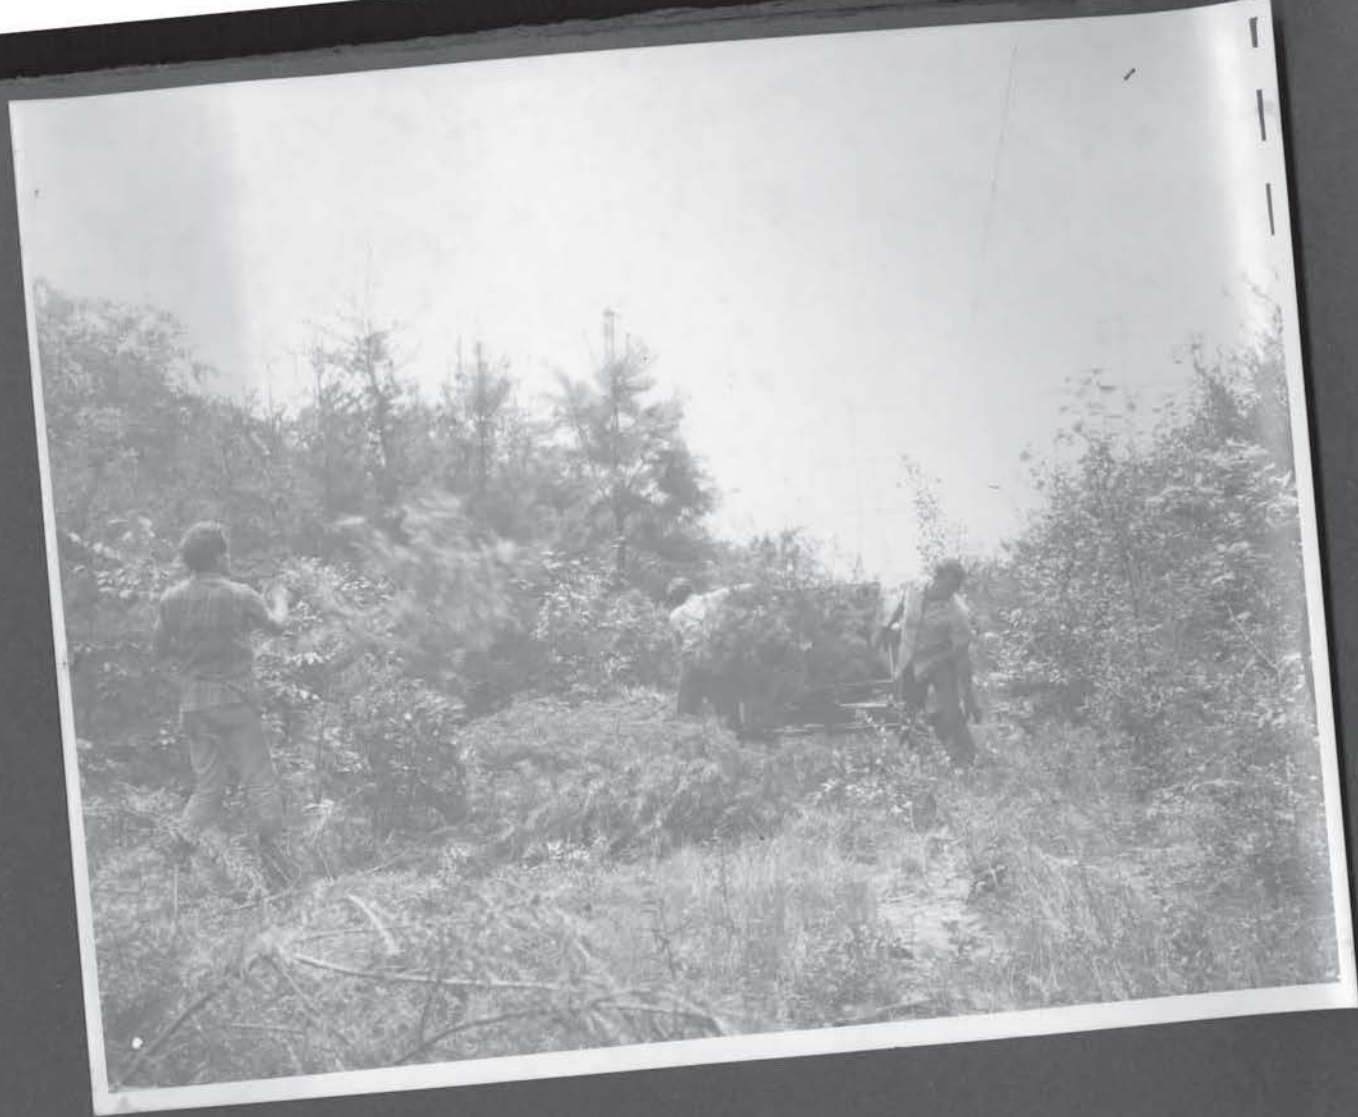
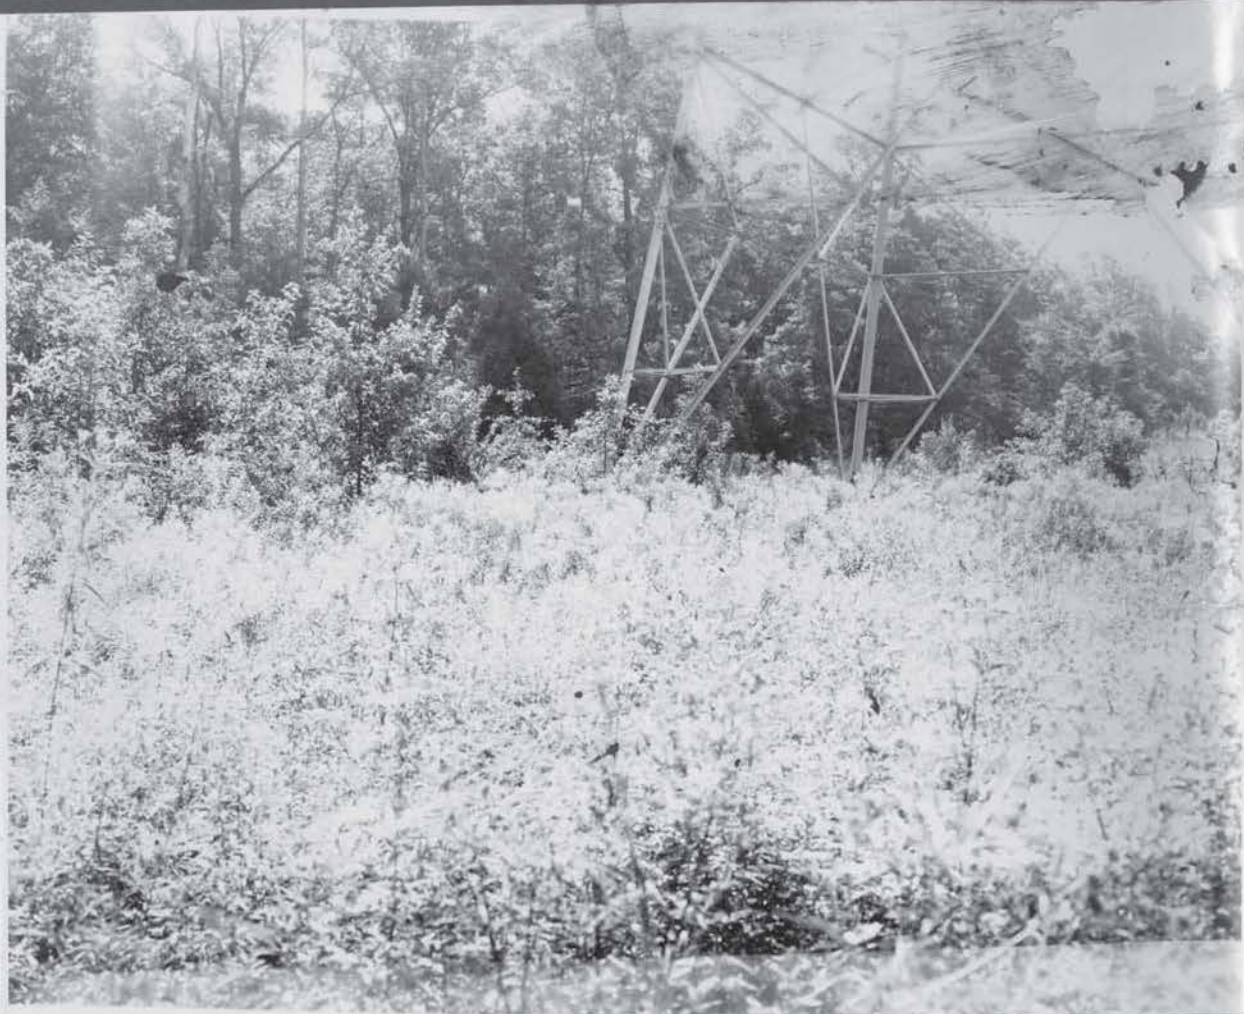
*Not published
1970*
 Figure 50. Photos showing the chipping of cut Pinus spp. View is ~~west~~

South, along access + trail
 at a point near the junction
 of Maps XVII and XVIII.

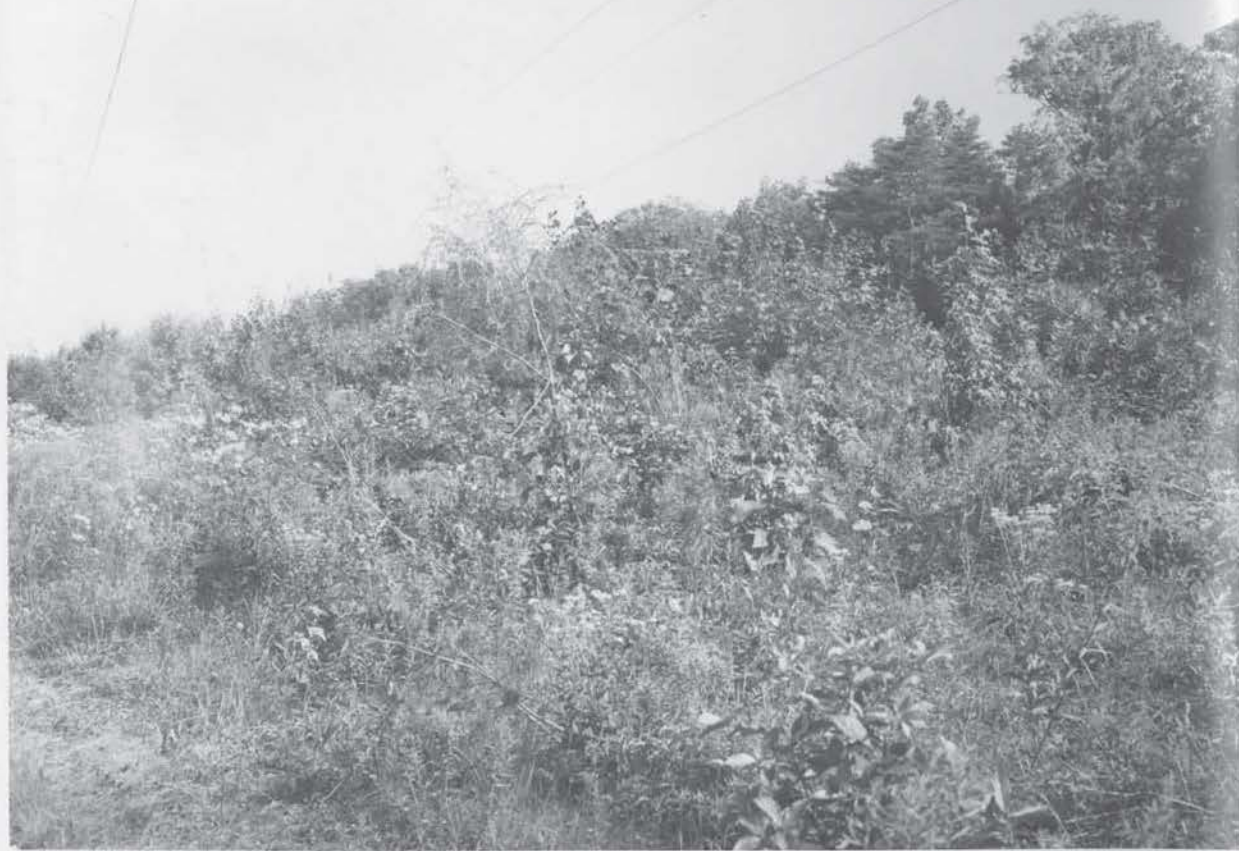
Figure 53. Site dominated by *Populus grandidentata* and *Liquidambar styraciflua*. The *Populus grandidentata* are situated in the right and left backgrounds. The *Liquidambar styraciflua* is situated in the corner next the *Populus grandidentata*. The herbs are primarily *Andropogon virginicus*, *Solidago graminifolia*, and *Bidens polylepis*. The *Solidago graminifolia* and *Bidens polylepis* are in the front foreground. The flowering plants in the left center foreground are the *Bidens polylepis*. The tallest tree in the center is a *Salix nigra*. View is north from Higman's camera point # 3, Map XVIII, on the new Access Trail opposite tower 255N.
