# The Road Inventory of Devils Lake Wetland Management District Devils lake, ND

Prepared By: Federal Highway Administration Central Federal Lands Highway Division June, 2008

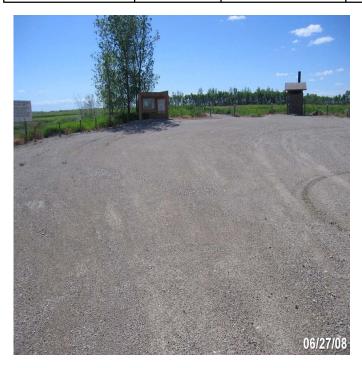
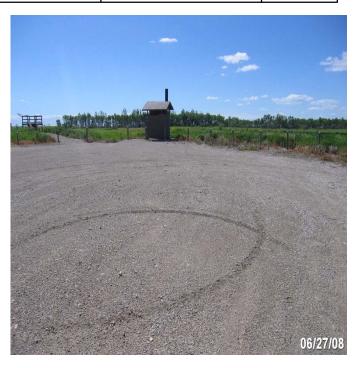
# Route 902: Nikolaisen WPA Parking

Asset Number Date Visited		Surface Type	Area (sq ft)	Condition	Cost to Improve
10044299	6/27/2008	Gravel	10997	Good	\$1500

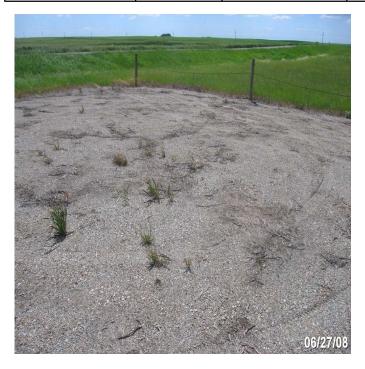
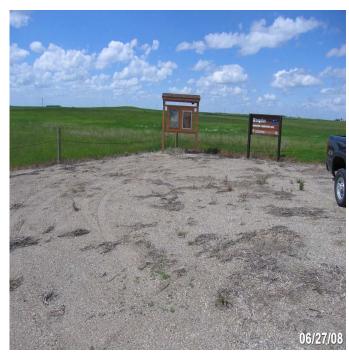
# **Route 910: Wengeler WPA Parking**

Asset Number	Date Visited	Surface Type	Area (sq ft)	Condition	Cost to Improve
10038608	6/27/2008	Gravel	2325	Fair	\$600

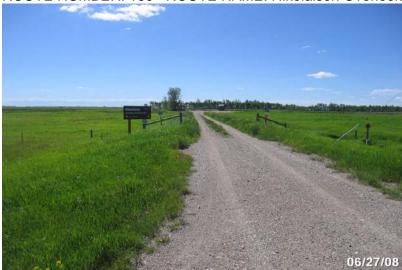
ROUTE NUMBER: 100 ROUTE NAME: Nikolaisen Overlook Access Road

Photo # 4197 - MP 0.00 - Begin Route at Begin Section

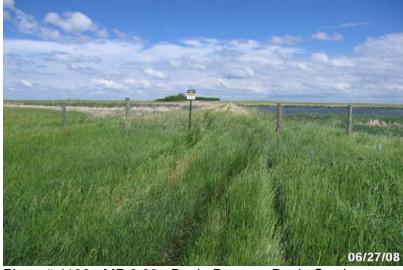
ROUTE NUMBER: 400 ROUTE NAME: Wengeler WPA Access Road

Photo # 4196 - MP 0.00 - Begin Route at Begin Section
