The Road Inventory of Fish Springs National Wildlife Refuge Dugway, UT

Prepared By:
Federal Highway Administration
Central Federal Lands Highway Division
April 2008

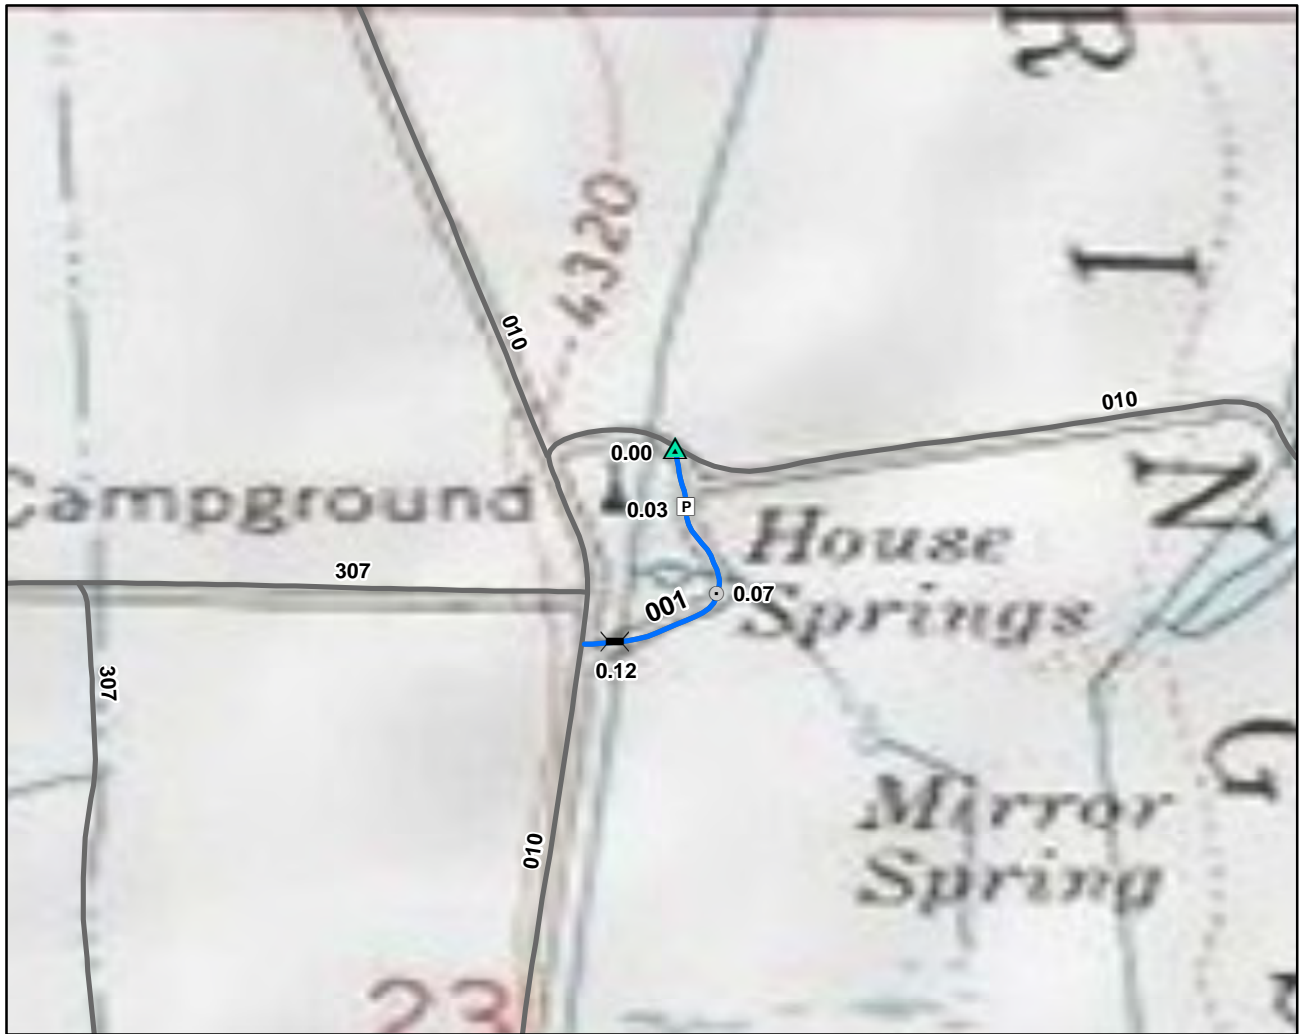
Section Number	011			
Section Length (miles)	0.41			
Inspection Date	4/21/2008			
Section Information				
Surface Type	Gravel			
Number of Lanes	1			
Roadway Width (feet)	12			
Roadway Condition Information				
Condition	Excellent			
Remaining Service Life (years)	8			
Cost Estimate	\$0			
CRV	\$278800

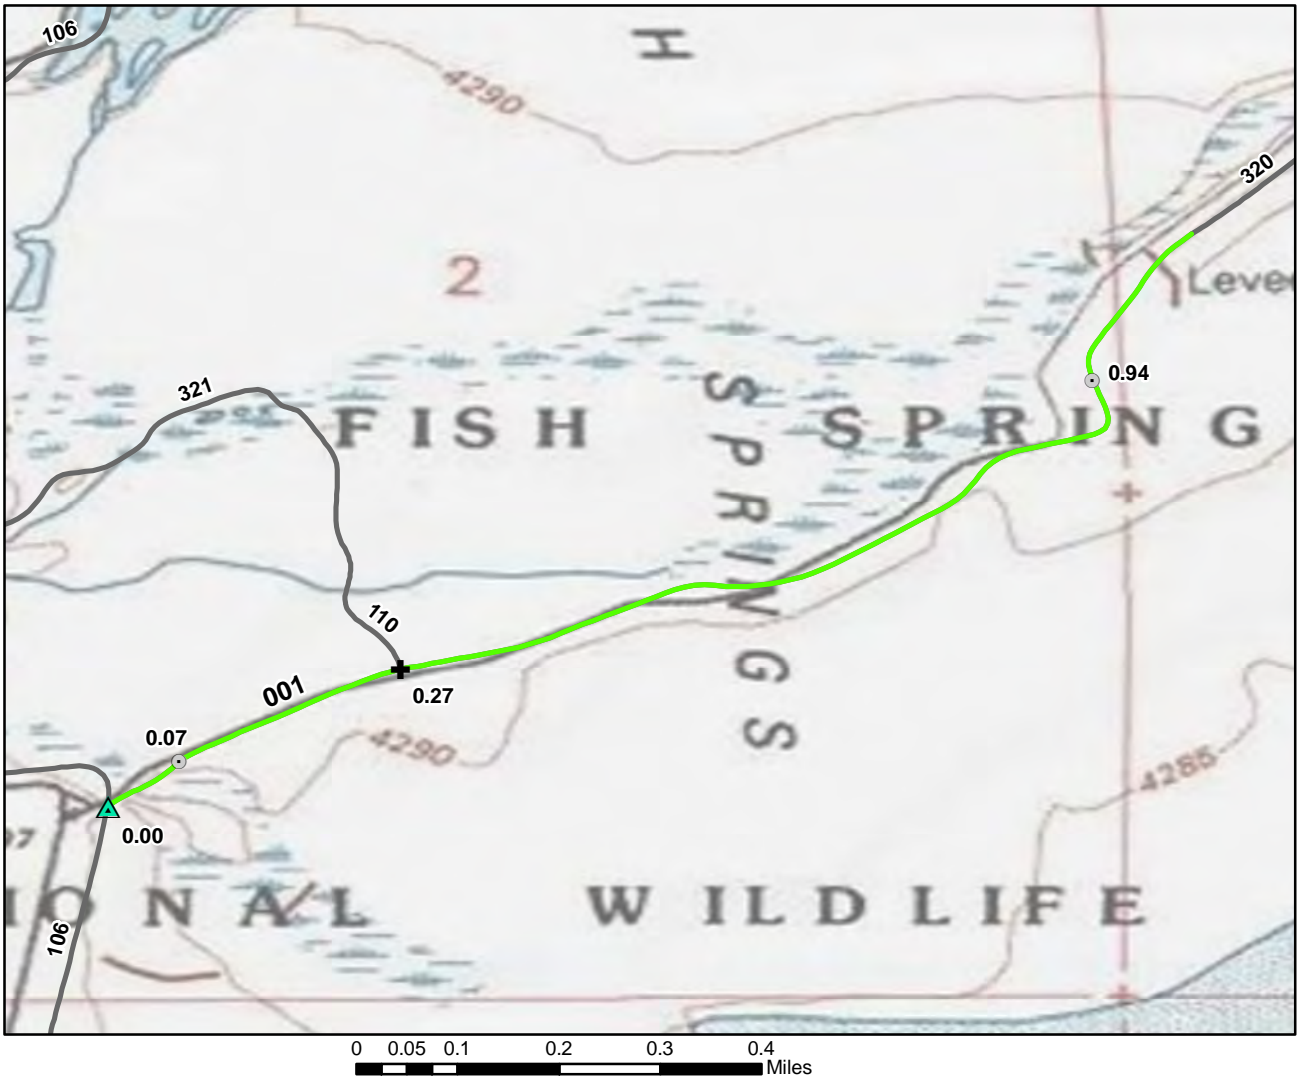
RTE DESCRIPTION: From Harrison Pool Loop (Rte 106) to Harrison Pool Loop (Rte 106)

001	002			
Section Number	001	002			
Section Length (miles)	1.00	0.78			
Inspection Date	4/22/2008	4/22/2008			
Section Information					
Surface Type	Gravel	Gravel			
Number of Lanes	1	1			
Roadway Width (feet)	12	12			
Roadway Condition Information					
Condition	Excellent	Excellent			
Remaining Service Life (years)	9	8			
Cost Estimate	\$0	\$0			
CRV	\$689400	\$533700

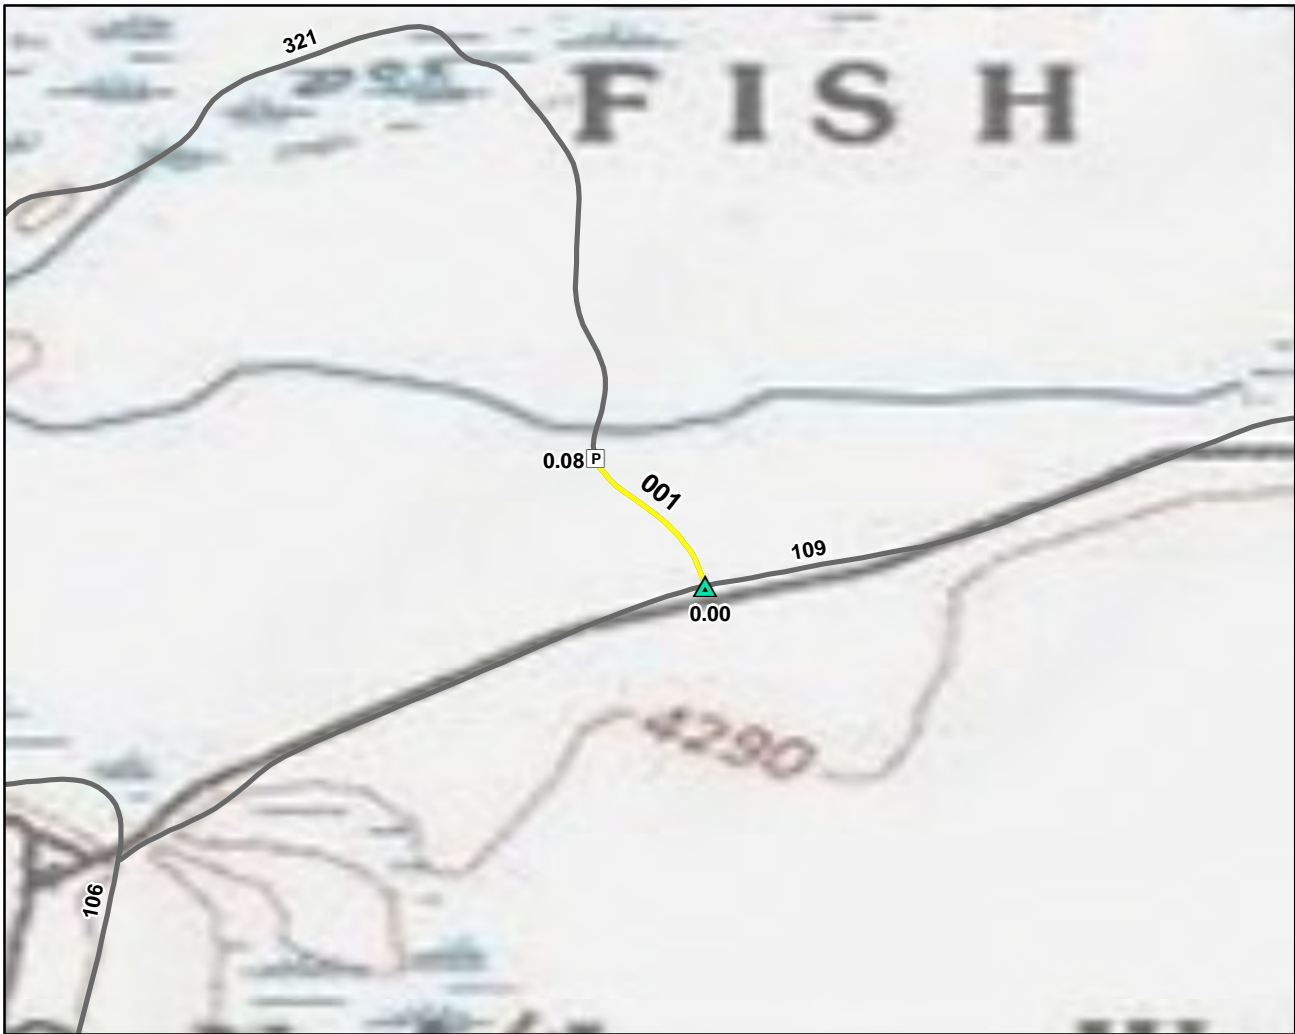
ROUTE: 109 Harrison Interior Road TOTAL LENGTH: 1.09 Miles

RTE DESCRIPTION: From Harrison Pool Loop (Rte 106) to Harrison Interior Administrative Road (Rte 321)

Section Number	001				
Section Length (miles)	1.09				
Inspection Date	4/22/2008				
Section Information					
Surface Type	Gravel				
Number of Lanes	1				
Roadway Width (feet)	12				
Roadway Condition Information					
Condition	Good				
Remaining Service Life (years)	5				
Cost Estimate	\$1800				
CRV	\$748500

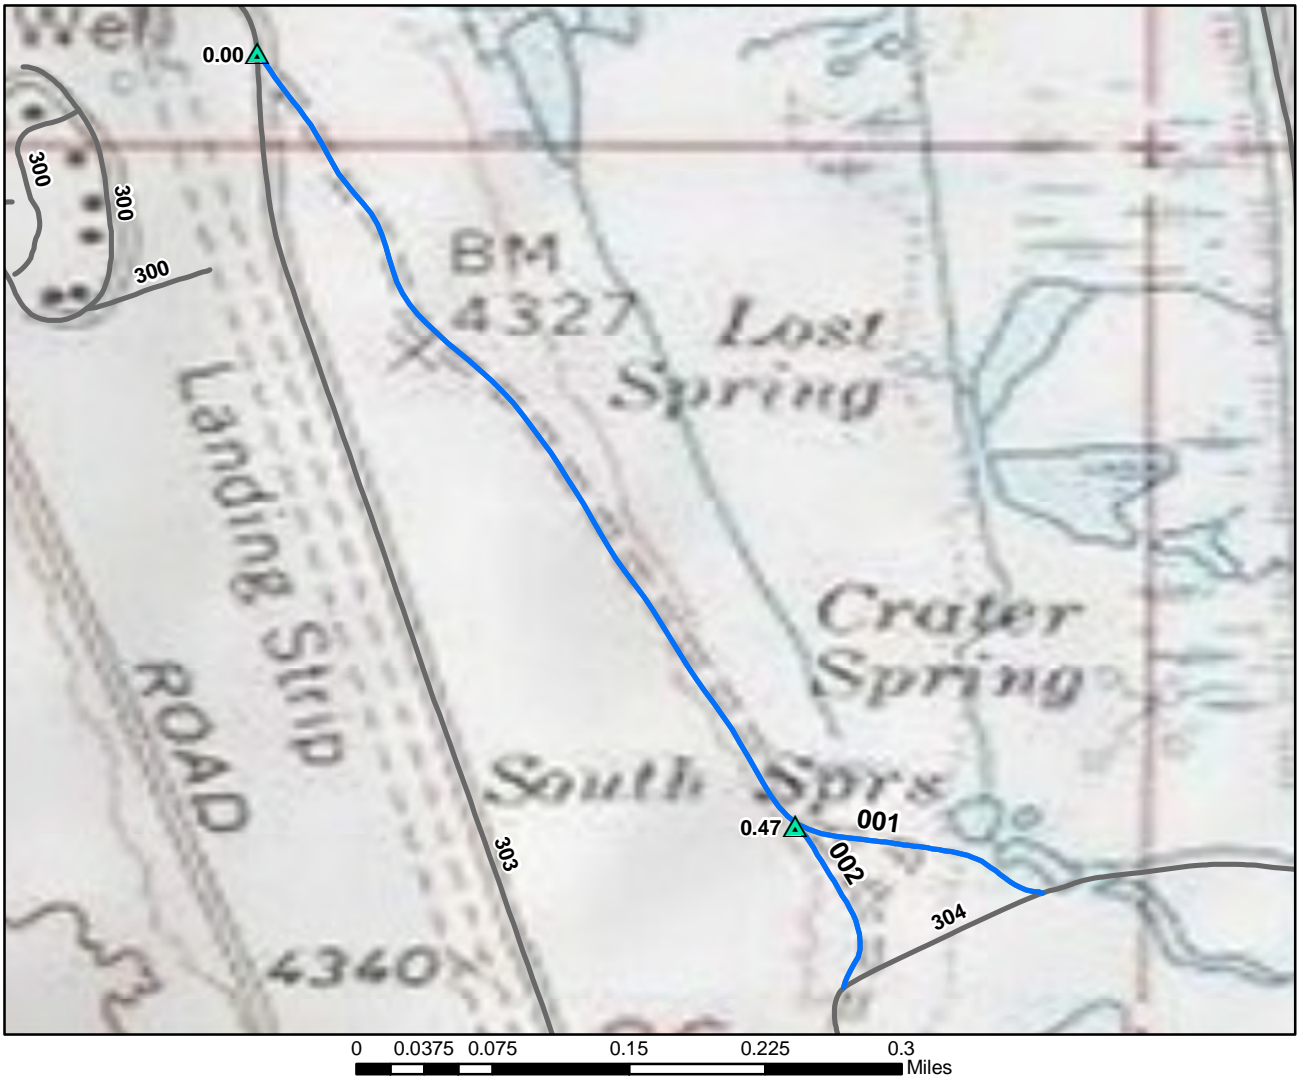
RTE DESCRIPTION: From Spring Unit Road (Rte 304) to Spring Unit Road (Rte 304)

Section Number	001				
Section Length (miles)	0.97				
Inspection Date	4/22/2008				
Section Information					
Surface Type	Gravel				
Number of Lanes	1				
Roadway Width (feet)	12				
Roadway Condition Information					
Condition	Good				
Remaining Service Life (years)	7				
Cost Estimate	\$1600				
CRV	\$665200

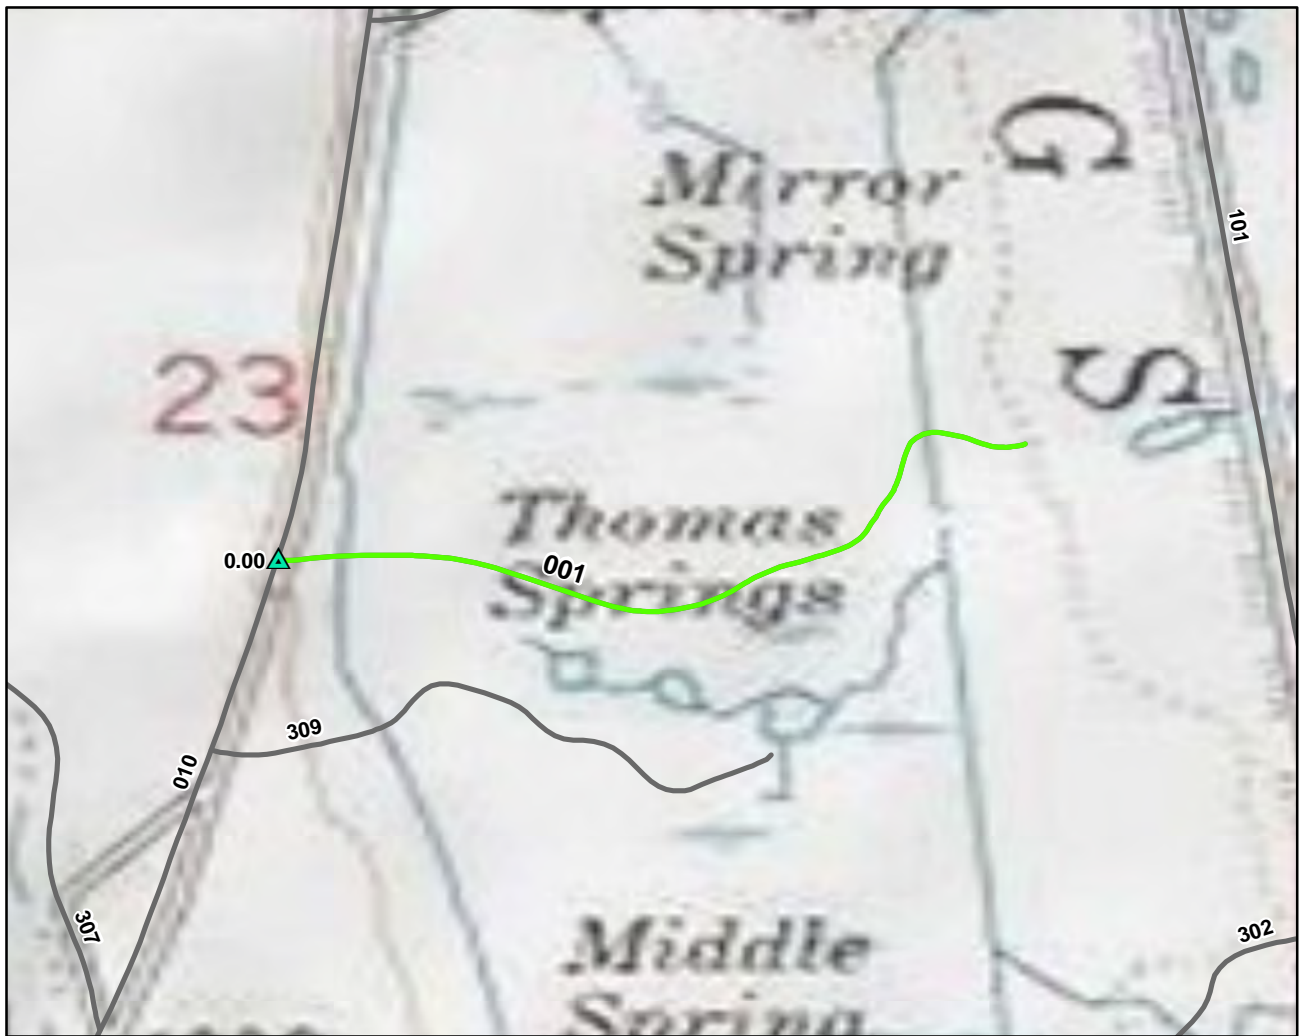
RTE DESCRIPTION: From Auto Tour Route (Rte 010) to Auto Tour Route (Rte 010)

Section Number	001	002		
Section Length (miles)	0.55	0.27		
Inspection Date	4/22/2008	4/22/2008		
Section Information				
Surface Type	Native	Gravel		
Number of Lanes	1	1		
Roadway Width (feet)	10	10		
Roadway Condition Information				
Condition	Excellent	Excellent		
Remaining Service Life (years)	9	10		
Cost Estimate	\$0	\$0		
CRV	\$195000	\$182700

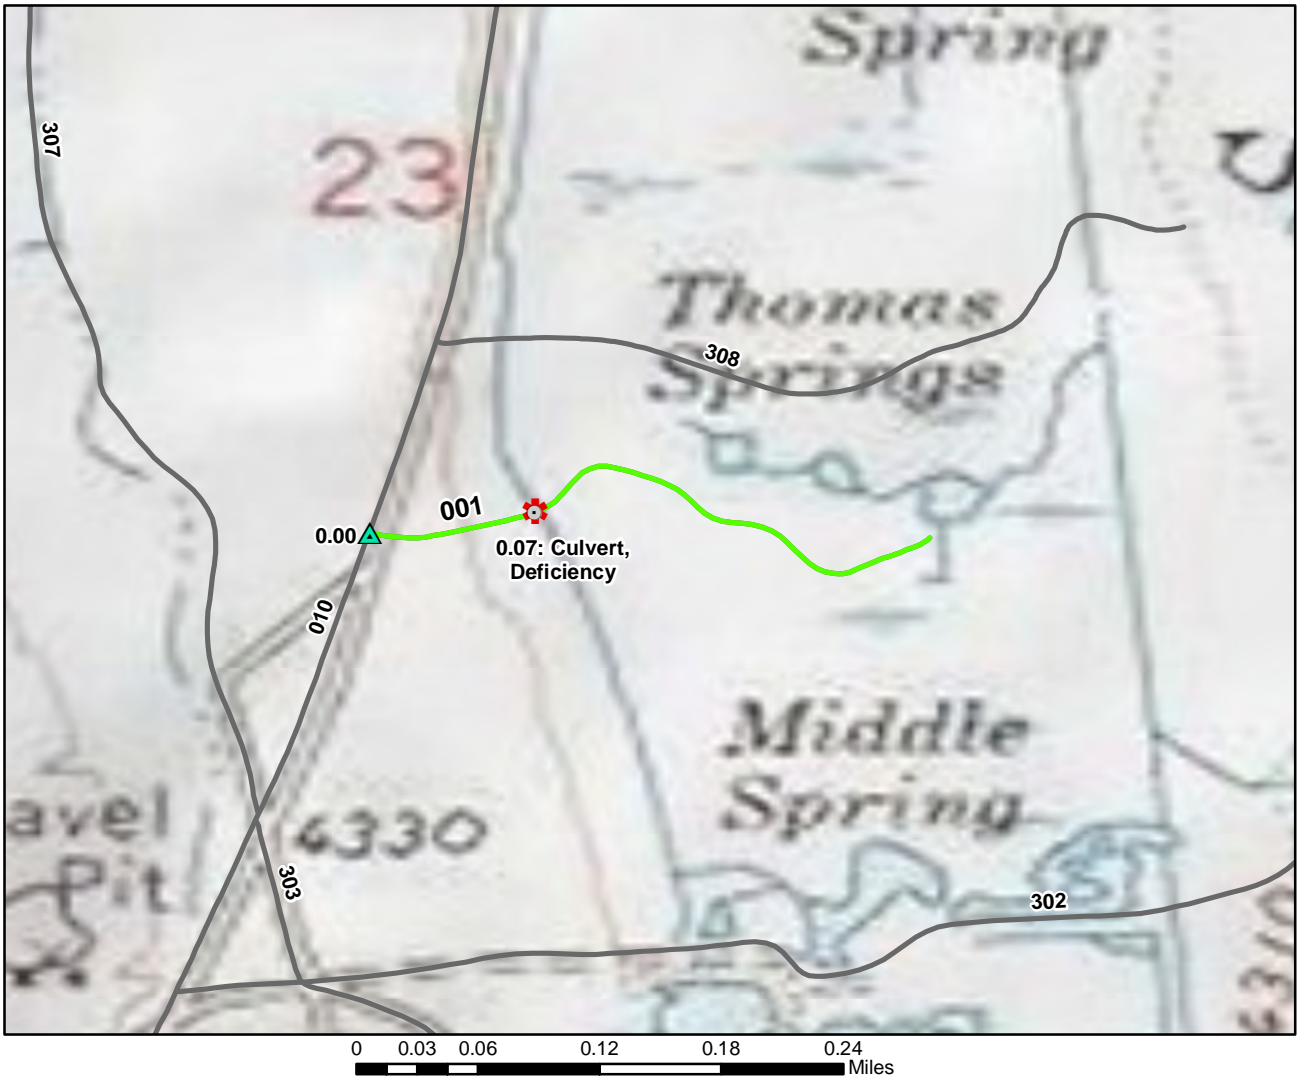
ROUTE: 308 Spring Unit Road #5 TOTAL LENGTH: 0.33 Miles

RTE DESCRIPTION: From Auto Tour Route (Rte 010) to end of route

Section Number	001			
Section Length (miles)	0.33			
Inspection Date	4/22/2008			
Section Information				
Surface Type	Native			
Number of Lanes	1			
Roadway Width (feet)	8			
Roadway Condition Information				
Condition	Good			
Remaining Service Life (years)	7			
Cost Estimate	\$600			
CRV	\$118600

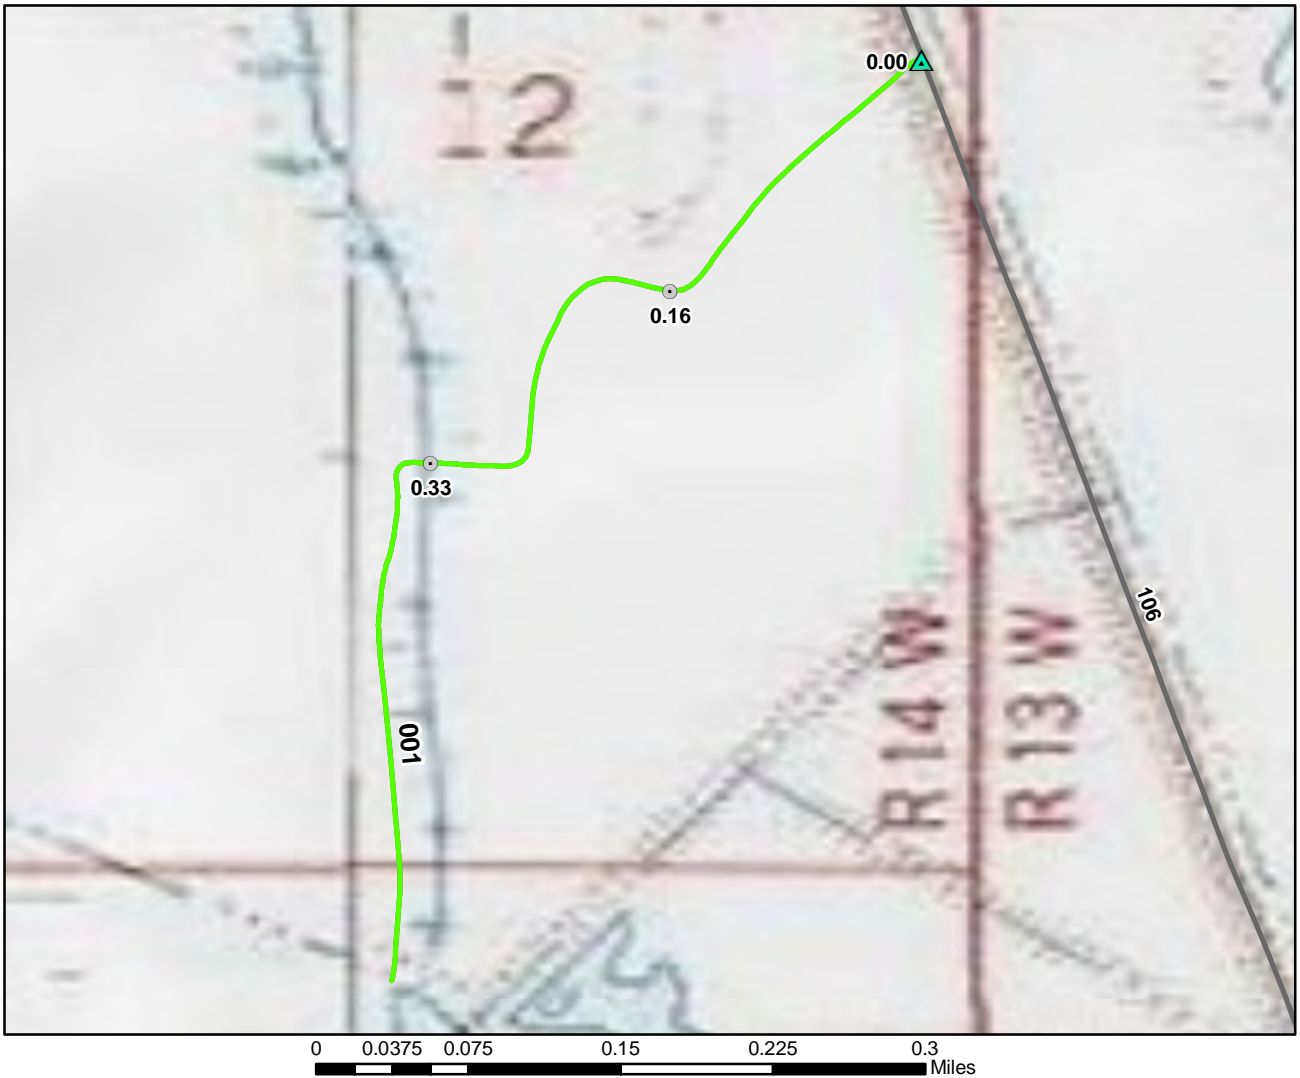
ROUTE: 309 Spring Unit Road #6 TOTAL LENGTH: 0.25 Miles

RTE DESCRIPTION: From Auto Tour Route (Rte 010) to end of route

Section Number	001			
Section Length (miles)	0.25			
Inspection Date	4/22/2008			
Section Information				
Surface Type	Gravel			
Number of Lanes	1			
Roadway Width (feet)	8			
Roadway Condition Information				
Condition	Good			
Remaining Service Life (years)	7			
Cost Estimate	\$400			
CRV	\$170200

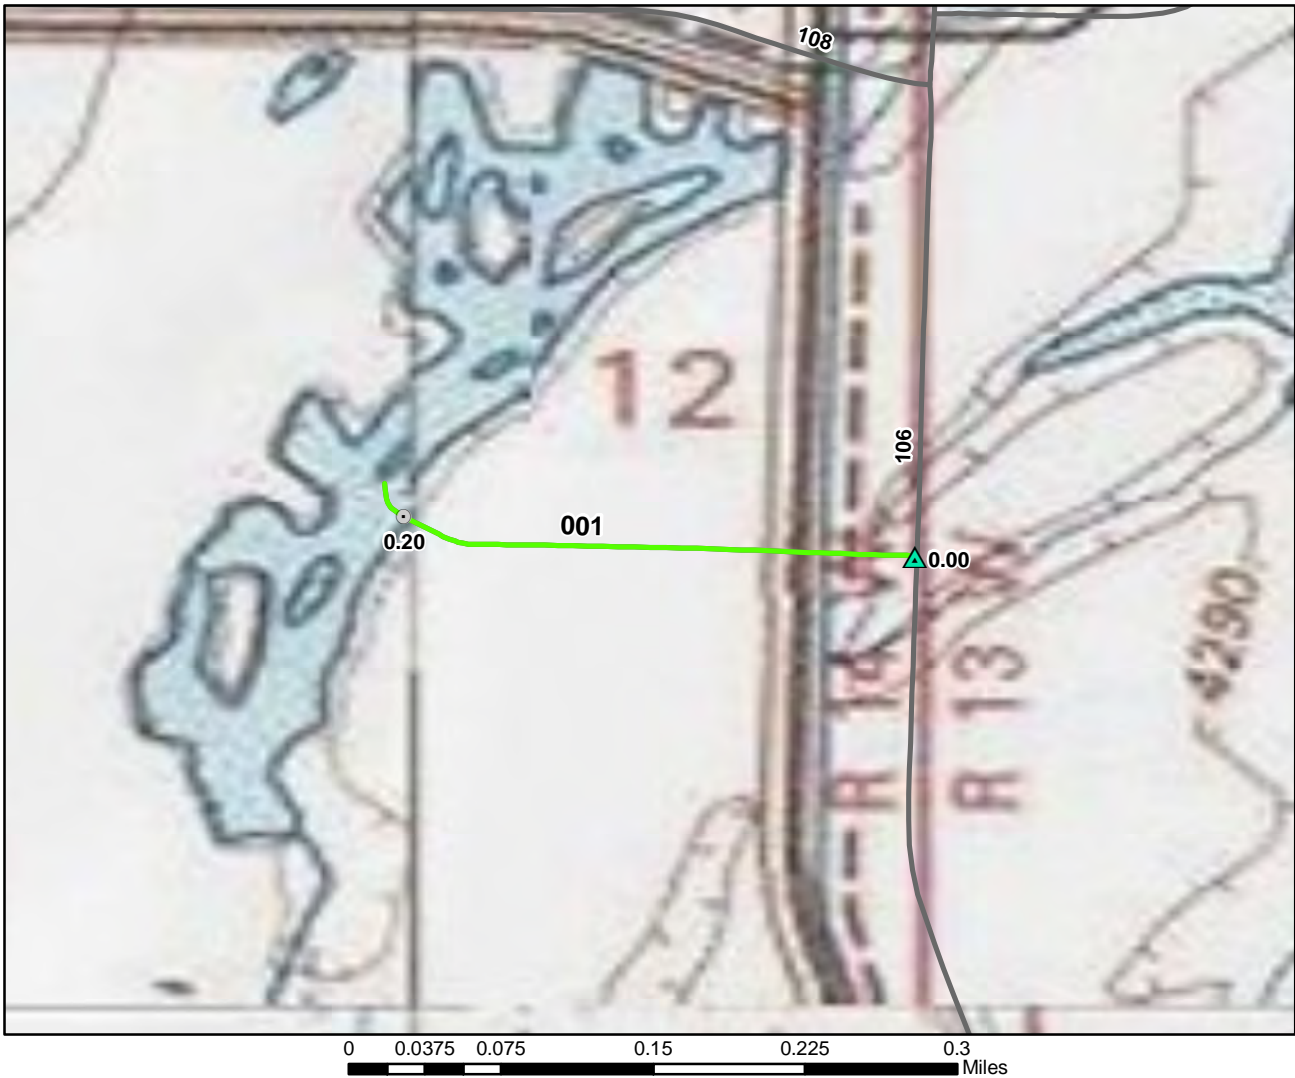
ROUTE: 310 Water Control Structure Route #1 TOTAL LENGTH: 0.58 Miles
 ASSET: 10046011

RTE DESCRIPTION: From Harrison Pool Loop (Rte 106) to end of route

Section Number	001				
Section Length (miles)	0.58				
Inspection Date	4/22/2008				
Section Information					
Surface Type	Native				
Number of Lanes	1				
Roadway Width (feet)	10				
Roadway Condition Information					
Condition	Good				
Remaining Service Life (years)	7				
Cost Estimate	\$1000				
CRV	\$206000

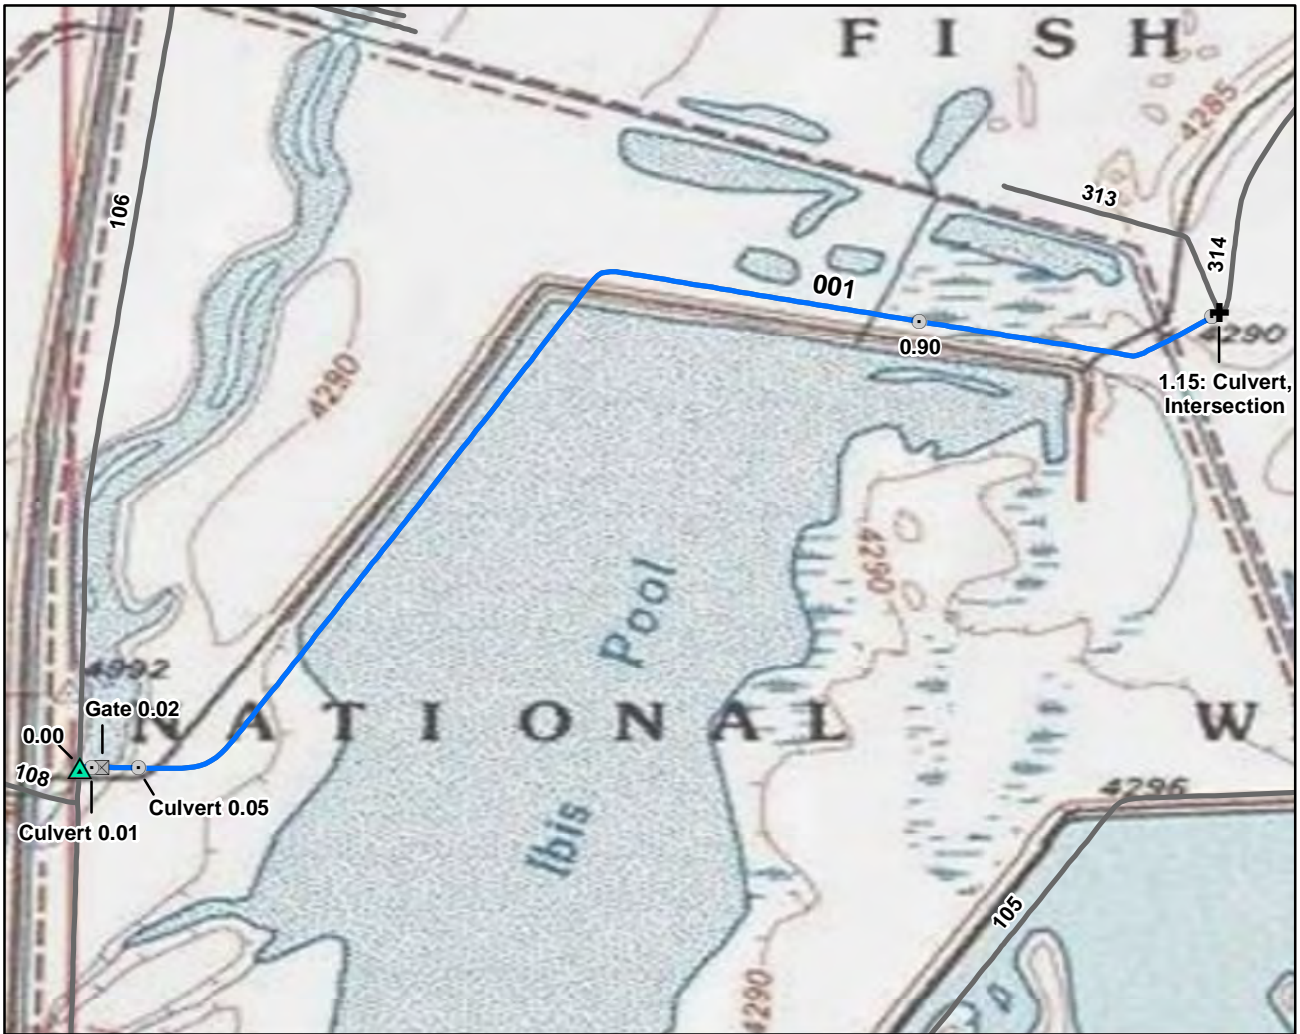
ROUTE: 312 Ibis Administrative Road TOTAL LENGTH: 1.16 Miles

Section Number	001			
Section Length (miles)	1.16			
Inspection Date	4/22/2008			
Section Information				
Surface Type	Gravel			
Number of Lanes	1			
Roadway Width (feet)	10			
Roadway Condition Information				
Condition	Excellent			
Remaining Service Life (years)	9			
Cost Estimate	\$0			
CRV	\$795700

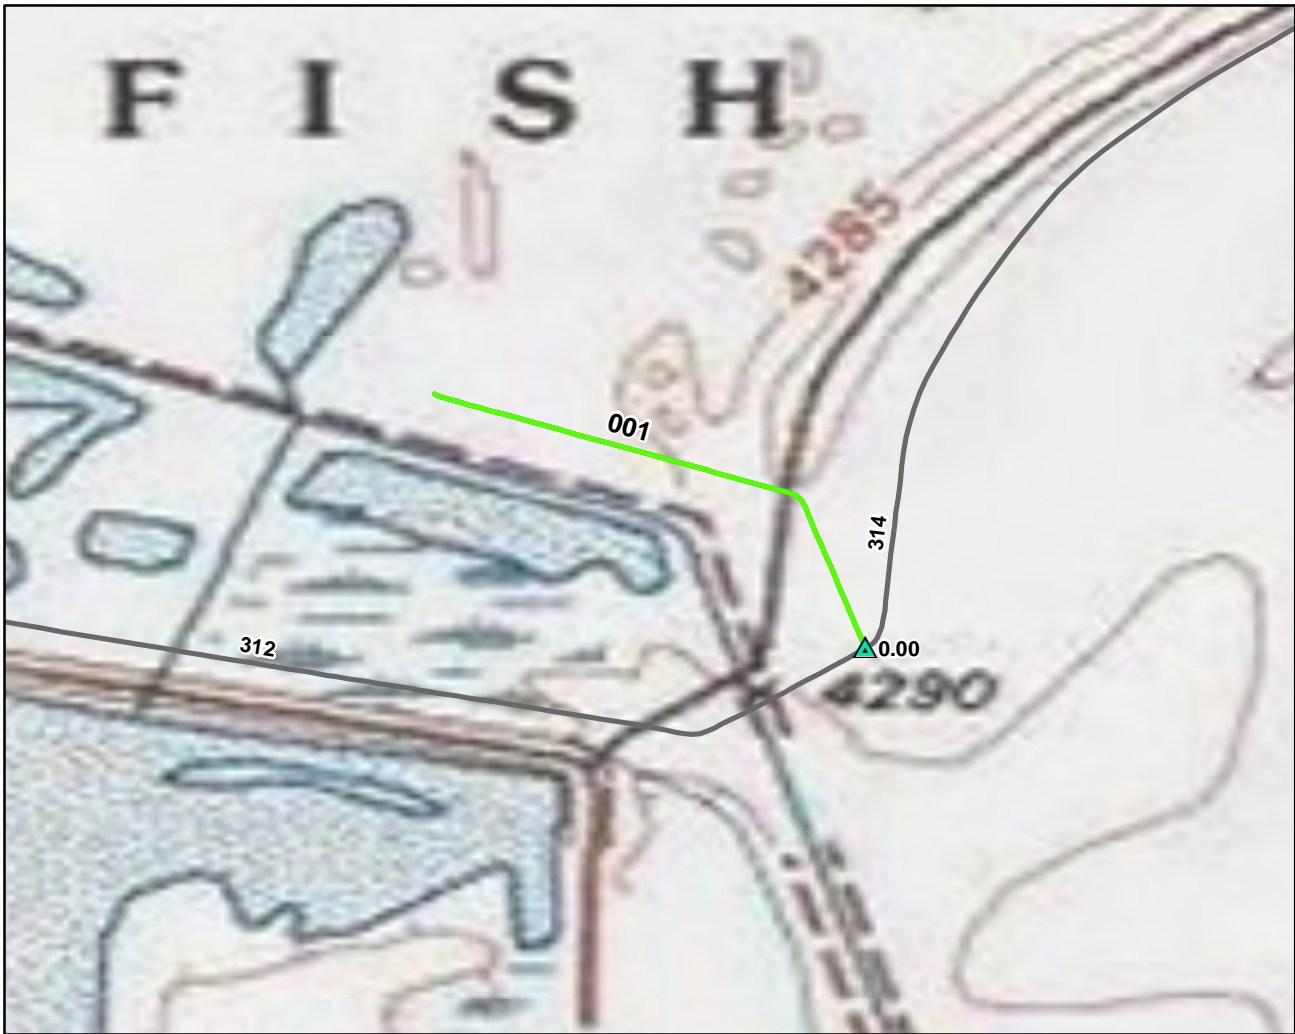
RTE DESCRIPTION: From Harrison Pool Loop (Rte 106) to Gadwall Dike Road (Rte 315)

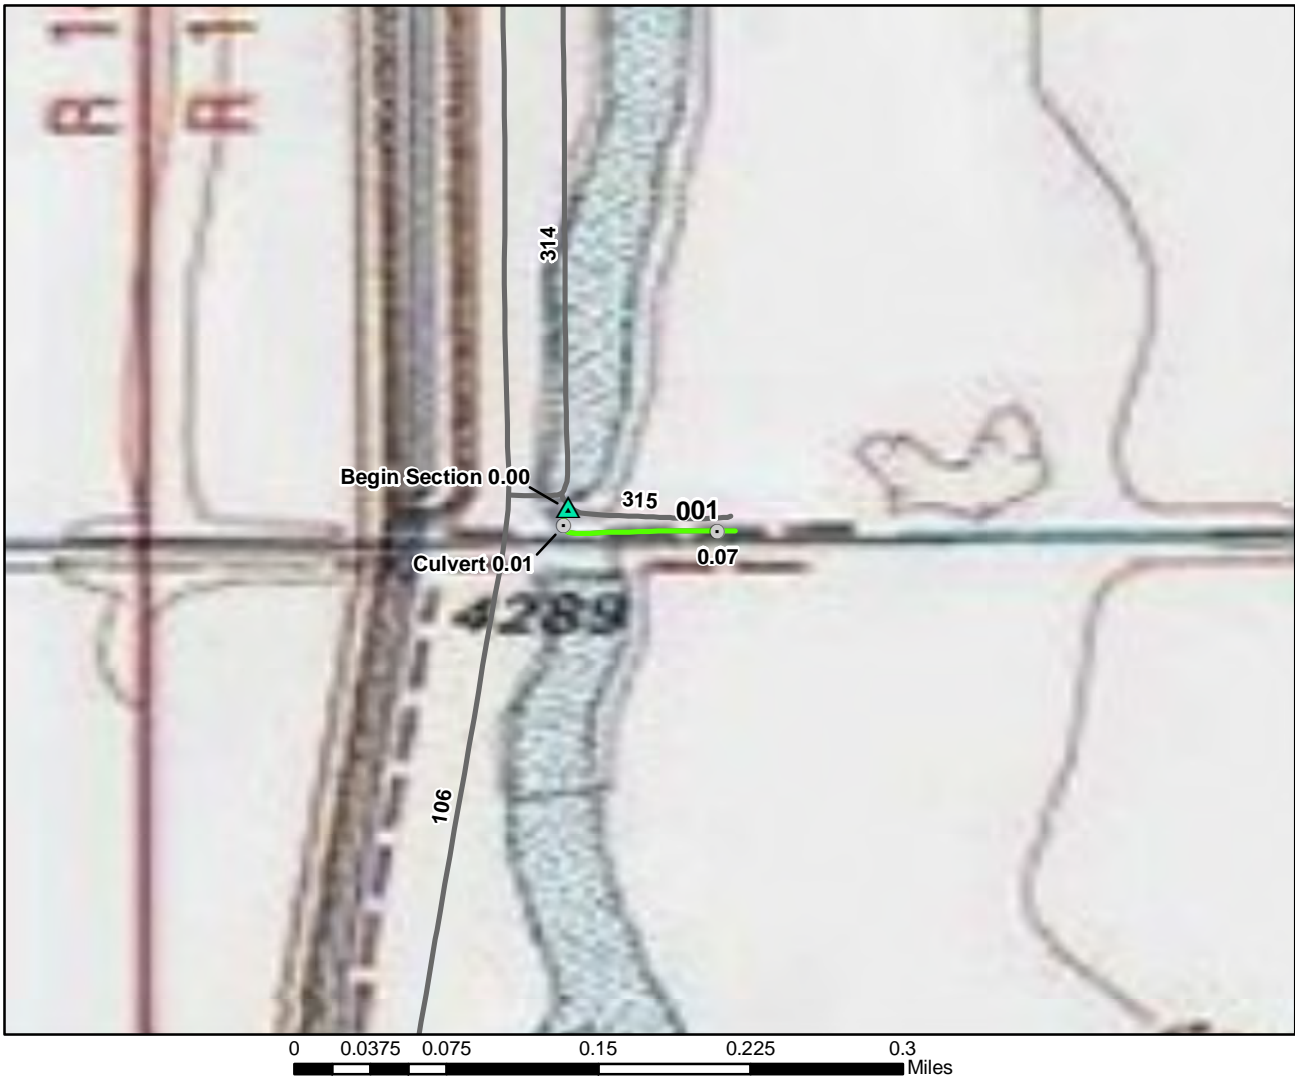
ROUTE: 315 Water Control Structure Road #1 TOTAL LENGTH: 0.07 Miles

RTE DESCRIPTION: From Gadwall Dike Road (Rte 315) to end of route

Section Number	001				
Section Length (miles)	0.07				
Inspection Date	4/22/2008				
Section Information					
Surface Type	Native				
Number of Lanes	1				
Roadway Width (feet)	10				
Roadway Condition Information					
Condition	Excellent				
Remaining Service Life (years)	8				
Cost Estimate	\$0				
CRV	\$24900

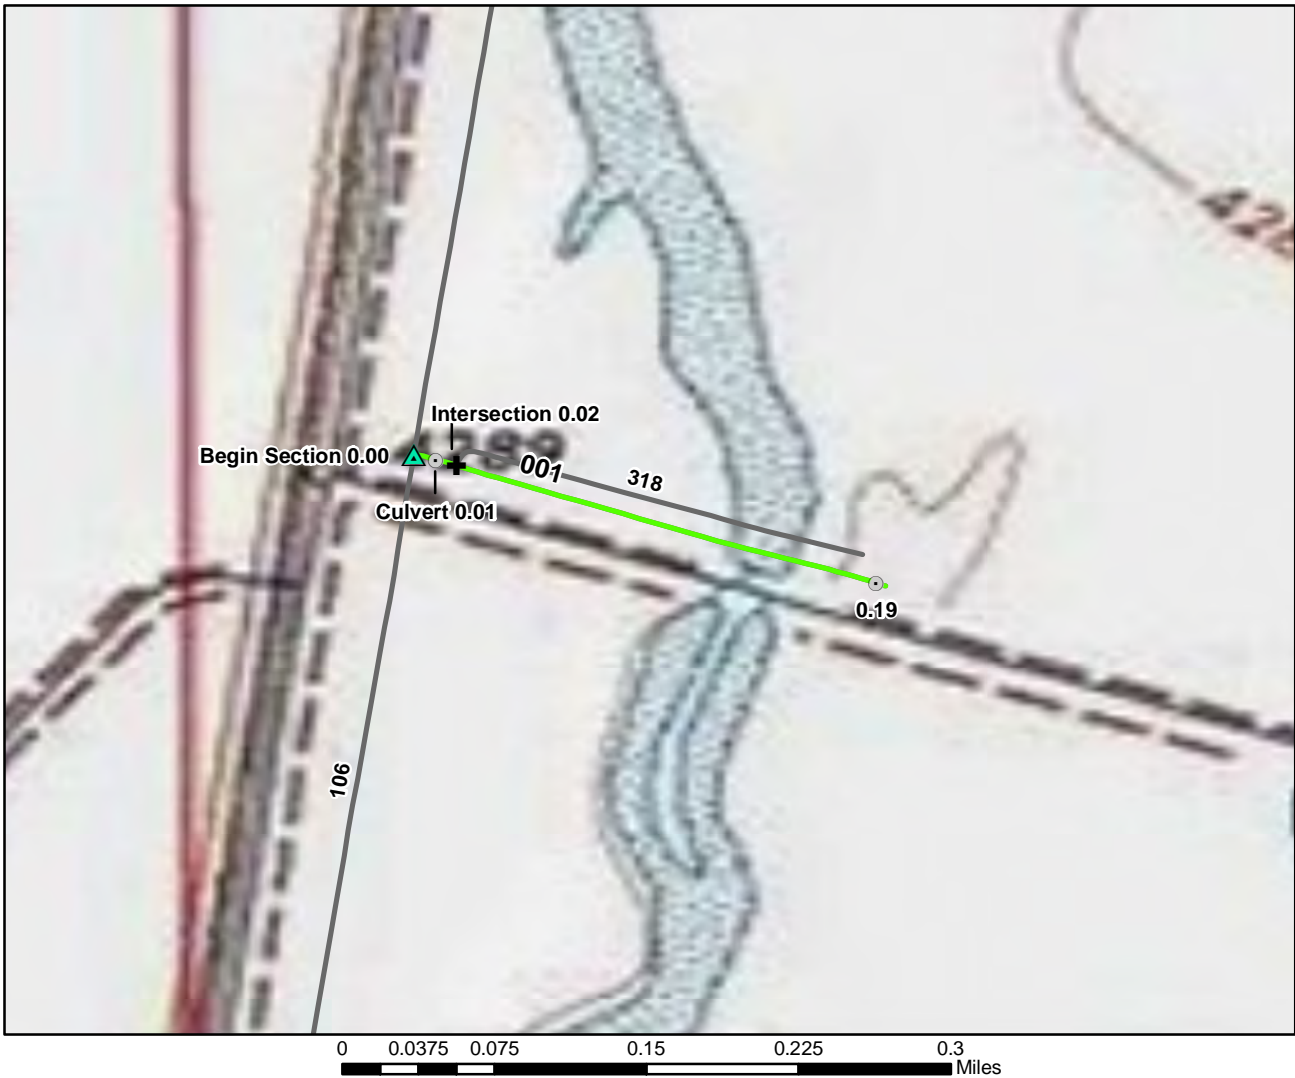
ROUTE: 316 Water Control Structure Road #2 TOTAL LENGTH: 0.08 Miles
 ASSET: 10046011

RTE DESCRIPTION: From Water Control Sturcture Road #1 (Rte 316) to end of route

Section Number	001				
Section Length (miles)	0.08				
Inspection Date	4/22/2008				
Section Information					
Surface Type	Primitive				
Number of Lanes	1				
Roadway Width (feet)	10				
Roadway Condition Information					
Condition	Good				
Remaining Service Life (years)	7				
Cost Estimate	\$0				
CRV	\$0

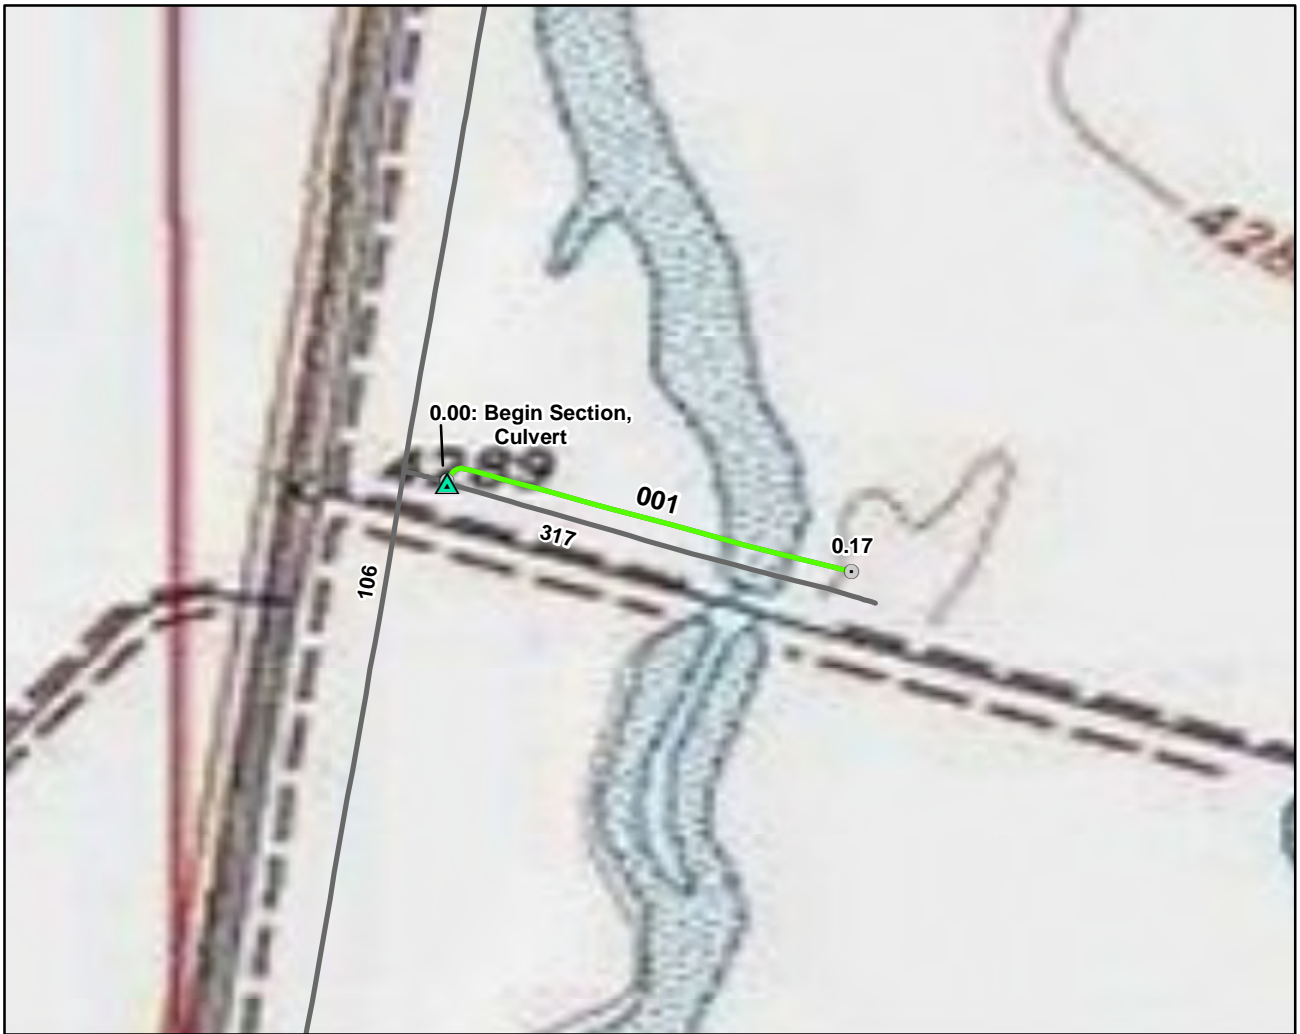
ROUTE: 317 Water Control Structure Road #3 TOTAL LENGTH: 0.19 Miles

RTE DESCRIPTION: From Harrison Pool Loop (Rte 106) to end of route

Section Number	001				
Section Length (miles)	0.19				
Inspection Date	4/22/2008				
Section Information					
Surface Type	Primitive				
Number of Lanes	1				
Roadway Width (feet)	10				
Roadway Condition Information					
Condition	Good				
Remaining Service Life (years)	7				
Cost Estimate	\$100				
CRV	\$0

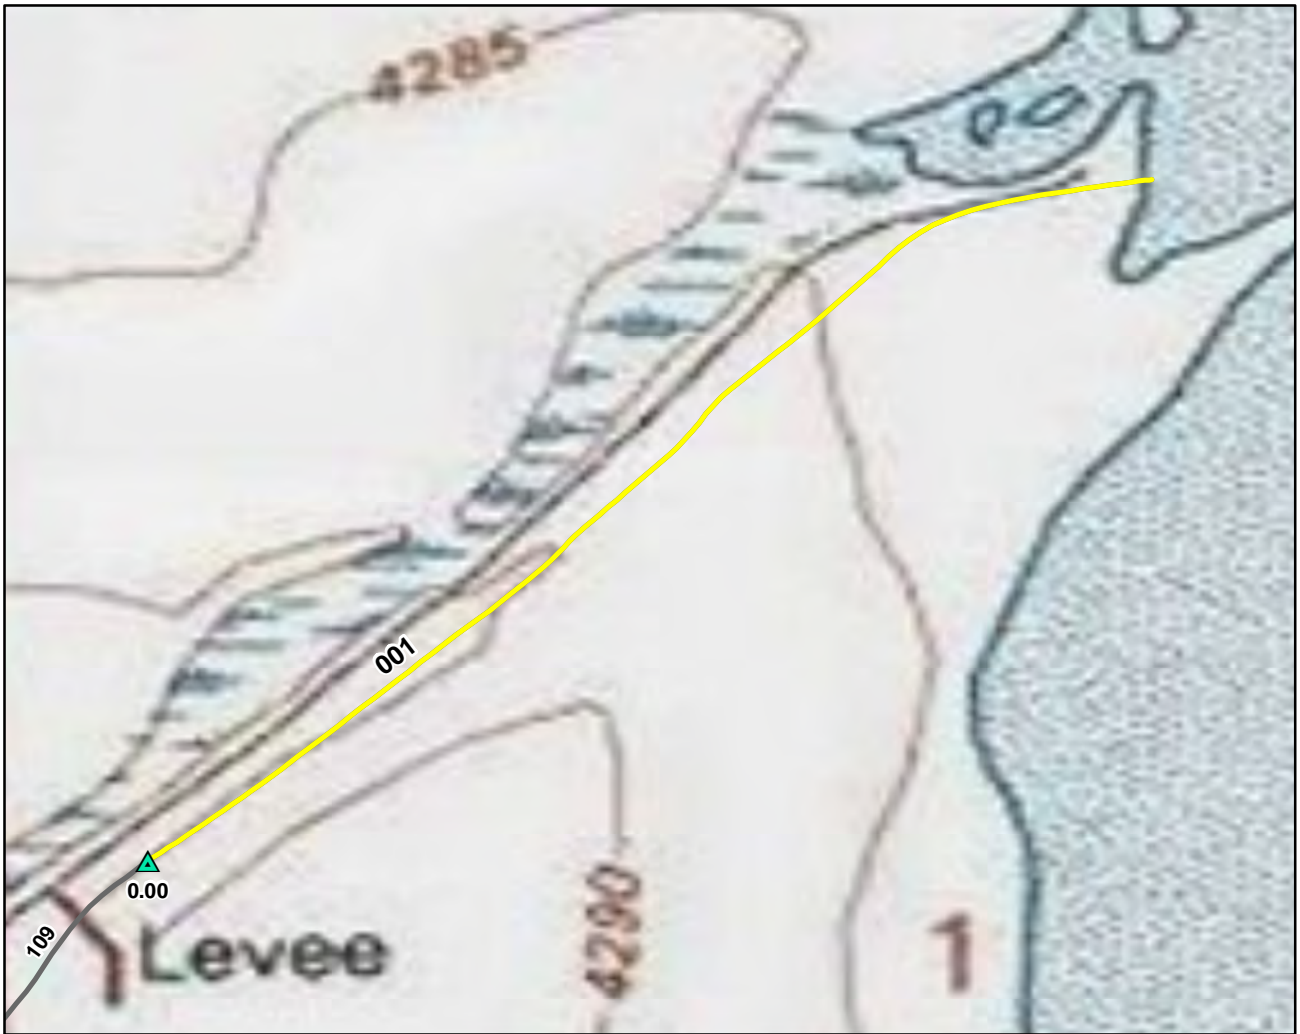
RTE DESCRIPTION: From Pintail Pool Cutoff Road (Rte 108) to end of route

Section Number	001				
Section Length (miles)	0.11				
Inspection Date	4/22/2008				
Section Information					
Surface Type	Primitive				
Number of Lanes	1				
Roadway Width (feet)	8				
Roadway Condition Information					
Condition	Good				
Remaining Service Life (years)	7				
Cost Estimate	\$0				
CRV	\$0

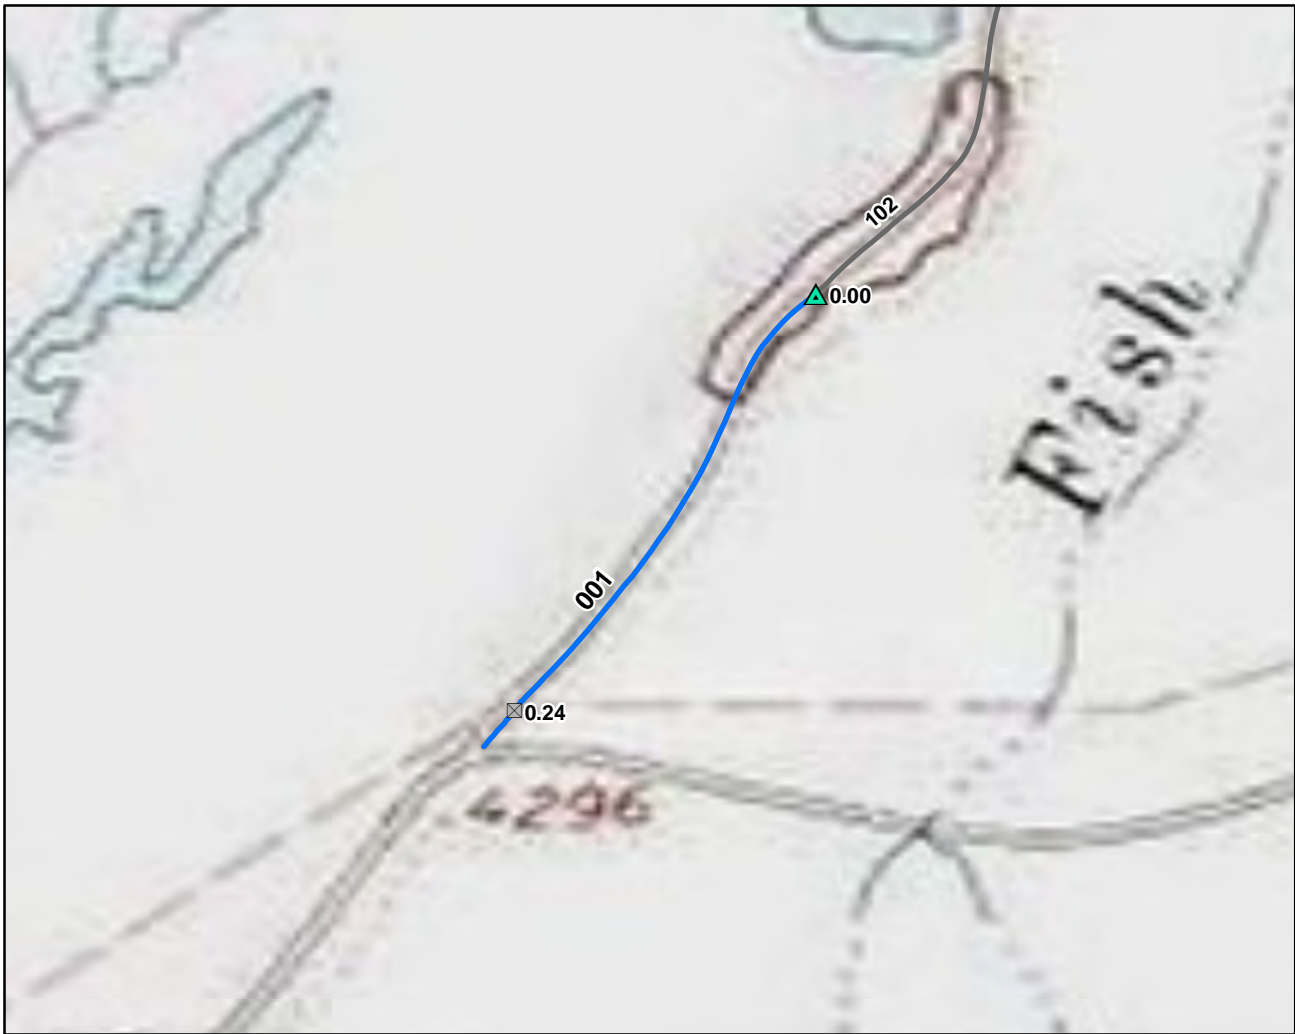
RTE DESCRIPTION: From Harrison Interior East Parking (Rte 908) to end of route

Section Number	001	002		
Section Length (miles)	0.72	0.05		
Inspection Date	4/22/2008	4/22/2008		
Section Information				
Surface Type	Gravel	Gravel		
Number of Lanes	1	1		
Roadway Width (feet)	10	10		
Roadway Condition Information				
Condition	Fair	Fair		
Remaining Service Life (years)	4	4		
Cost Estimate	\$2600	\$200		
CRV	\$493800	\$35300

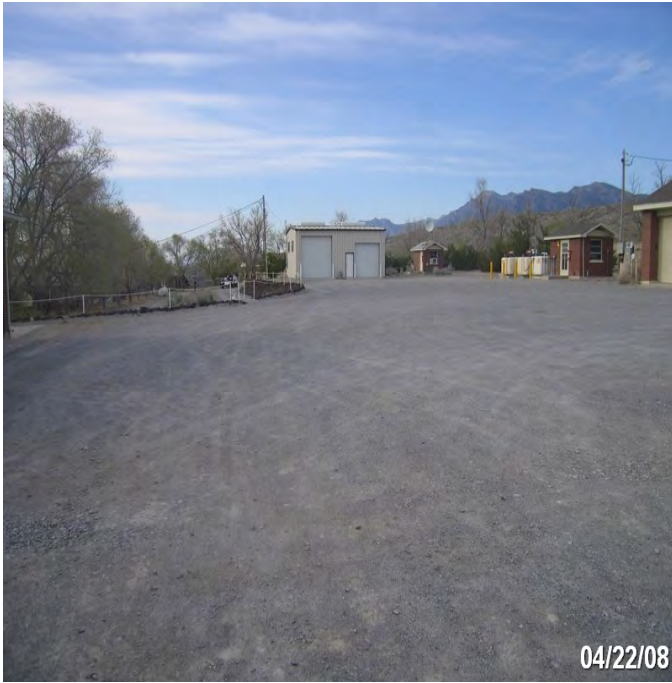
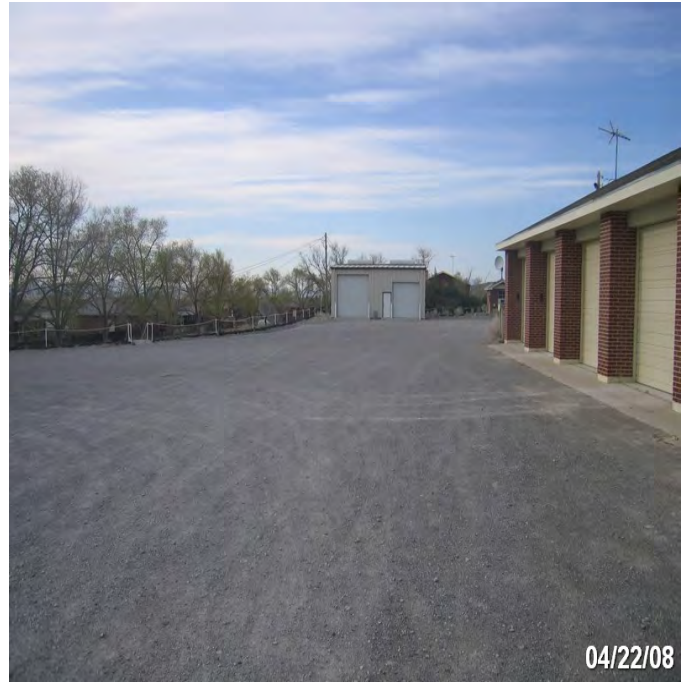
Route 900: Visitor Registration Parking

Asset Number	Date Visited	Surface Type	Area (sq ft)	Condition	Cost to Improve
10050852	4/21/2008	Gravel	1246	Good	\$200
