The Road Inventory of Fish Springs National Wildlife Refuge Dugway, UT

Prepared By:
Federal Highway Administration
Central Federal Lands Highway Division
April 2008

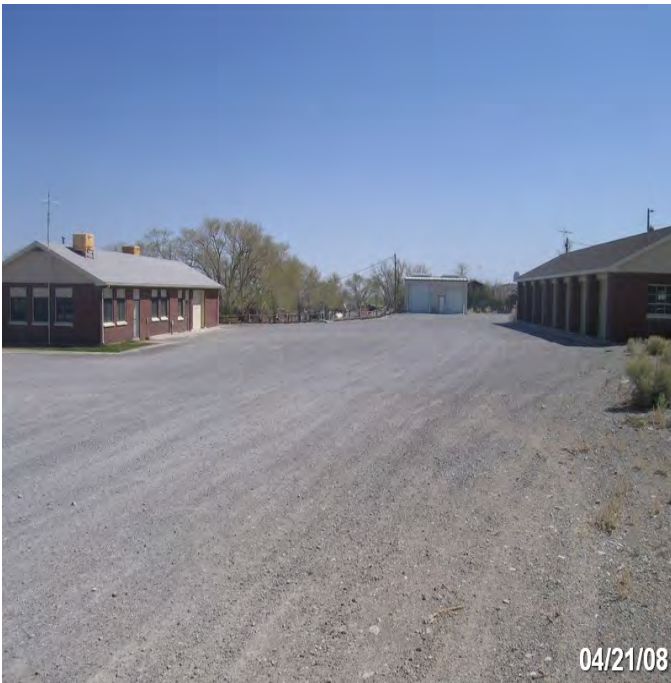
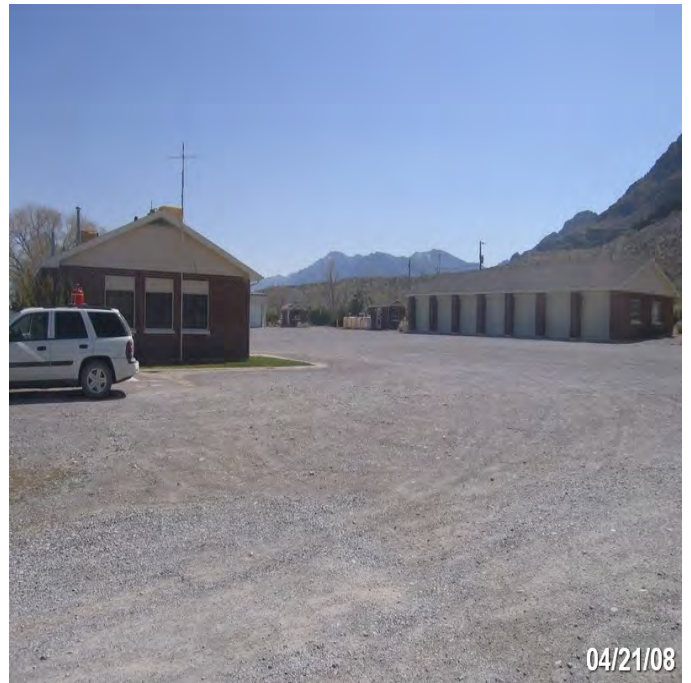
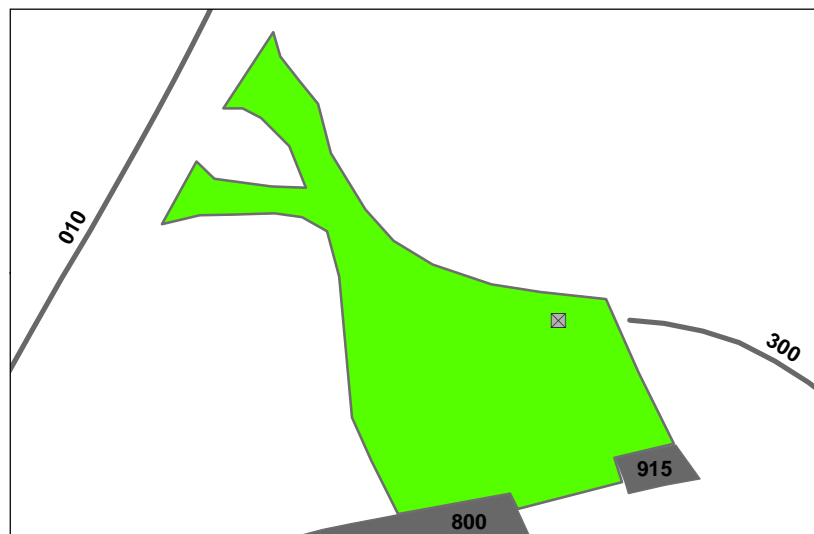
Route 901: Headquarters Parking

Asset Number	Date Visited	Surface Type	Area (sq ft)	Condition	Cost to Improve
10050852	4/21/2008	Gravel	9334	Good	\$1400

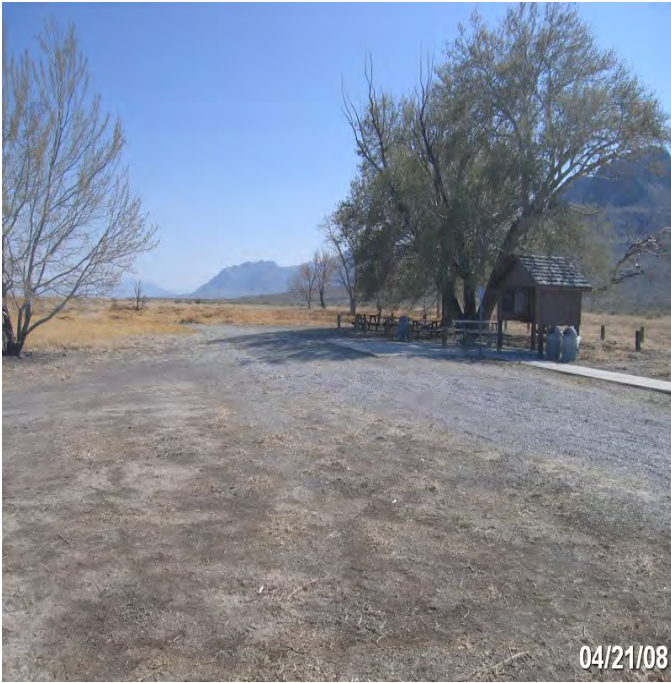
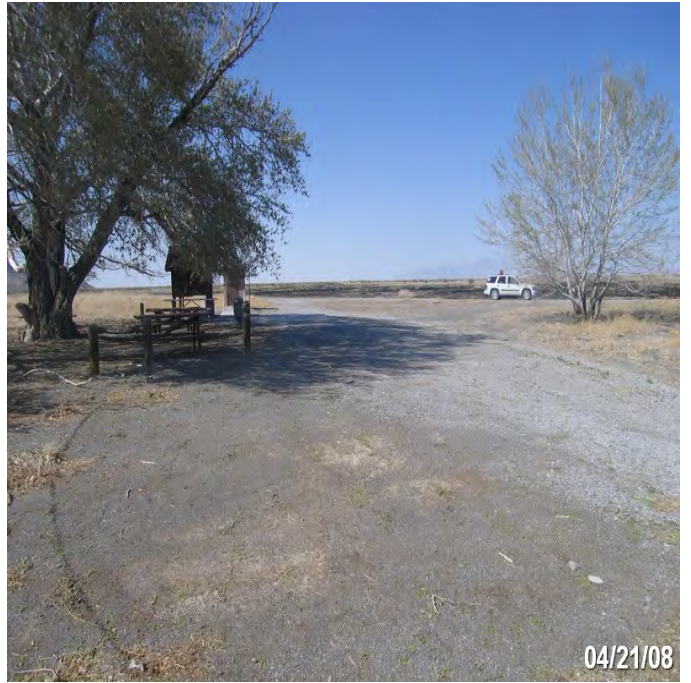
Route 902: Watchable Wildlife Area Parking

Asset Number	Date Visited	Surface Type	Area (sq ft)	Condition	Cost to Improve
10050853	4/21/2008	Gravel	8877	Fair	\$2300

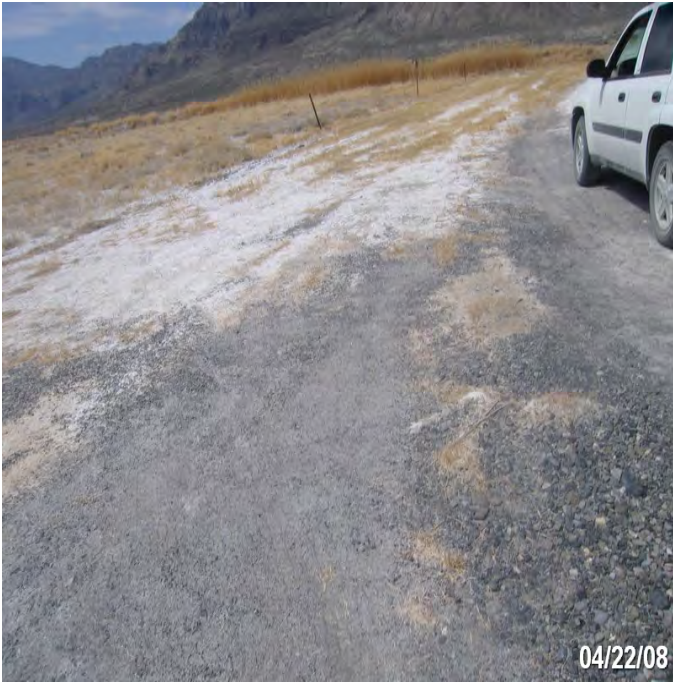
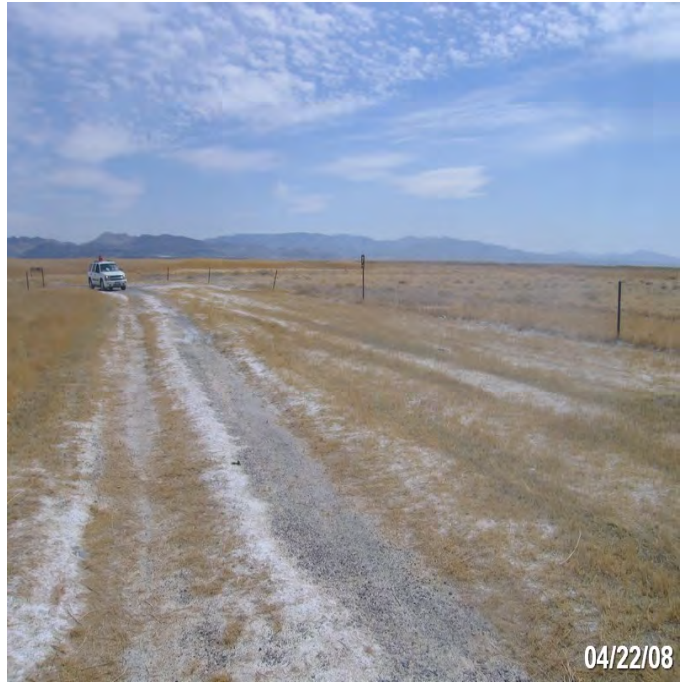
Route 904: South Spring Road Parking #1

Asset Number	Date Visited	Surface Type	Area (sq ft)	Condition	Cost to Improve
10050857	4/21/2008	Native	5749	Poor	\$4700

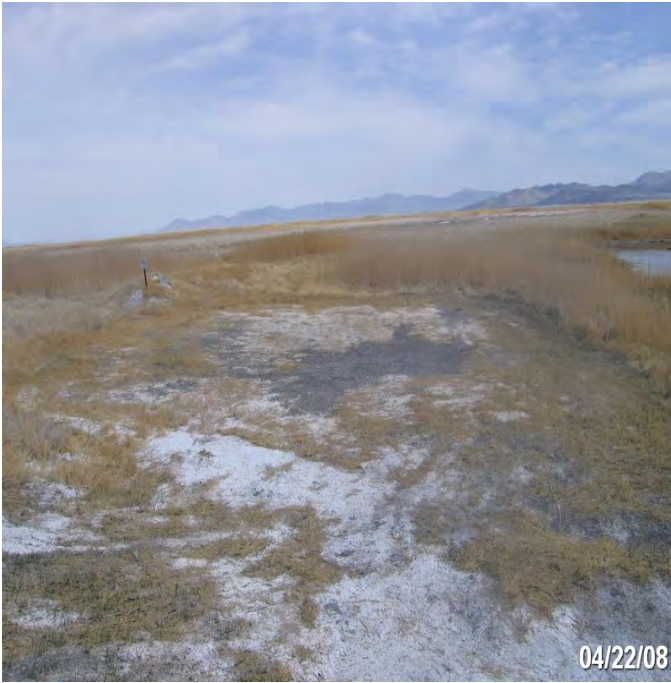
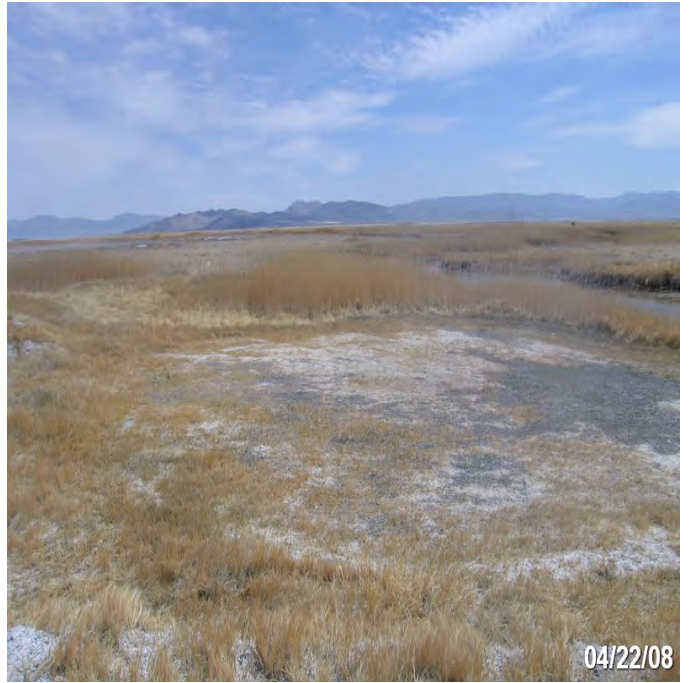
Route 905: South Spring Road Parking #2

Asset Number	Date Visited	Surface Type	Area (sq ft)	Condition	Cost to Improve
10050858	4/21/2008	Gravel	3479	Poor	\$3800

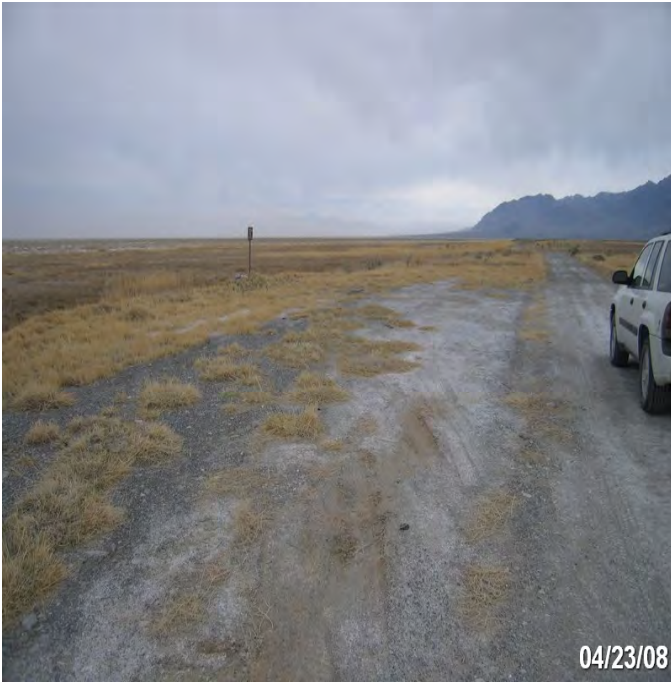
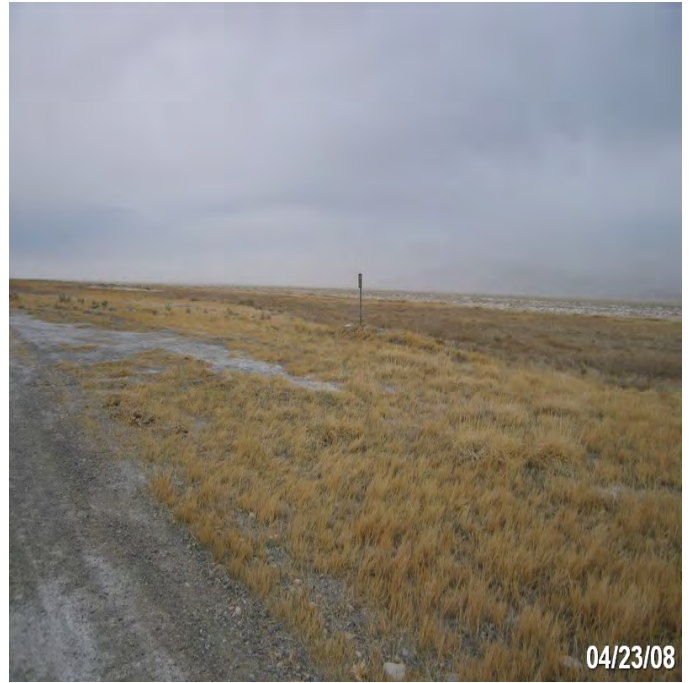
Route 906: Avocet Pool Parking #1

Asset Number	Date Visited	Surface Type	Area (sq ft)	Condition	Cost to Improve
10050860	4/23/2008	Gravel	5126	Poor	\$5600

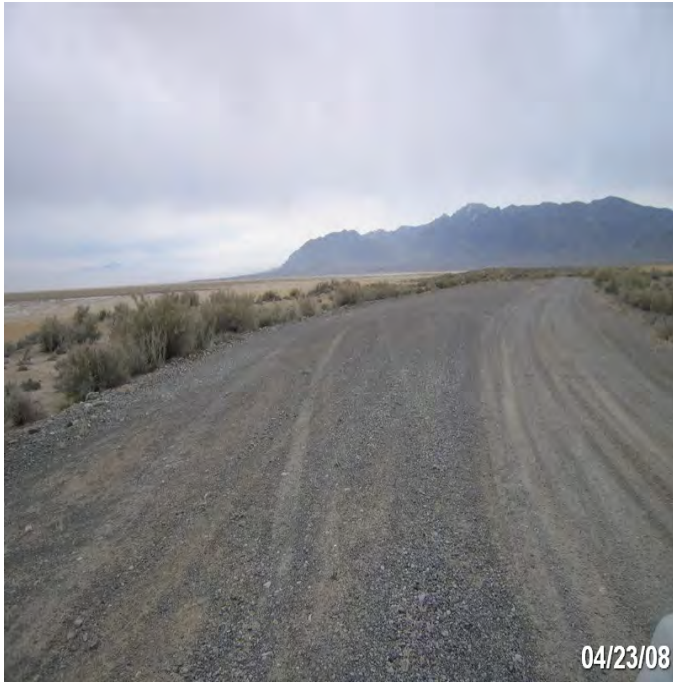
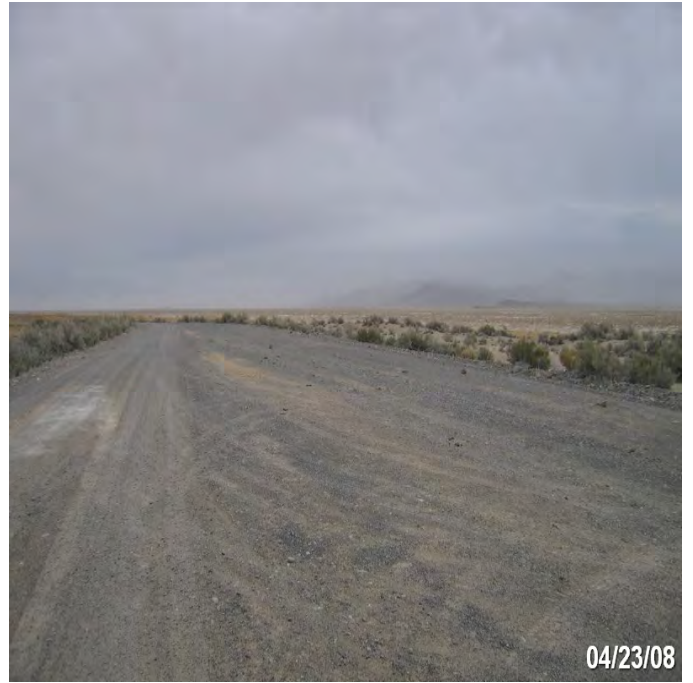
Route 907: Avocet Pool Parking #2

Asset Number	Date Visited	Surface Type	Area (sq ft)	Condition	Cost to Improve
10050861	4/23/2008	Gravel	11245	Good	\$1700

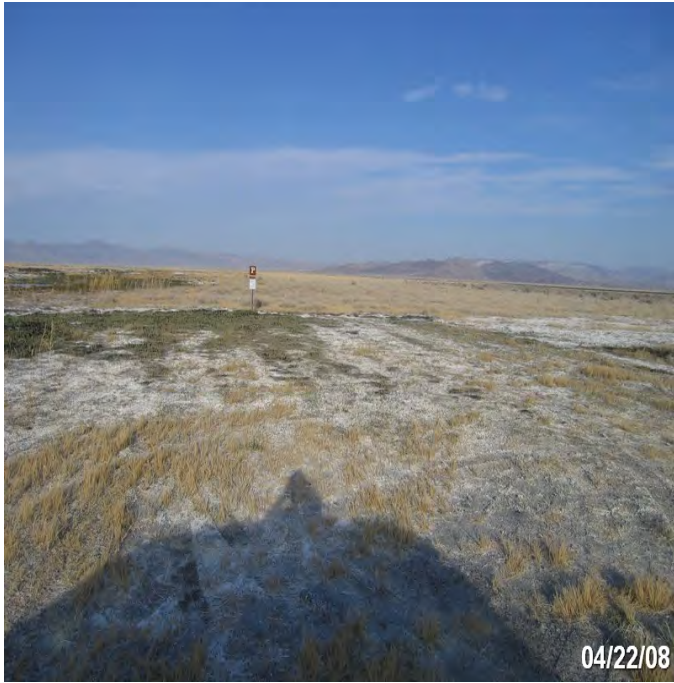
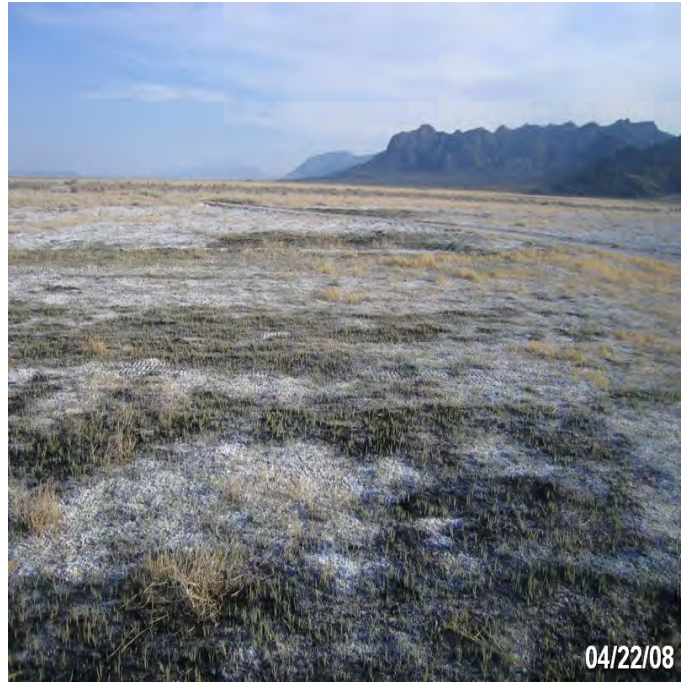
Route 908: Harrison Interior East Parking

Asset Number	Date Visited	Surface Type	Area (sq ft)	Condition	Cost to Improve
10050862	4/22/2008	Native	3605	Poor	\$2900

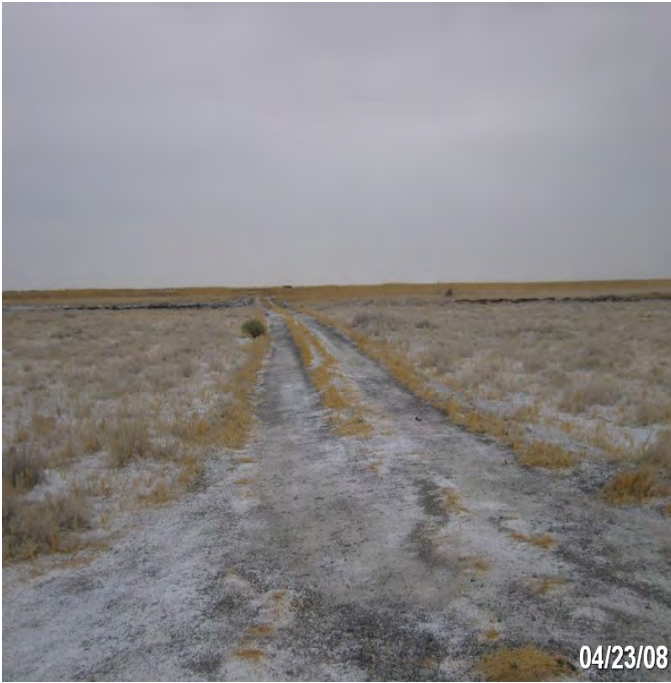
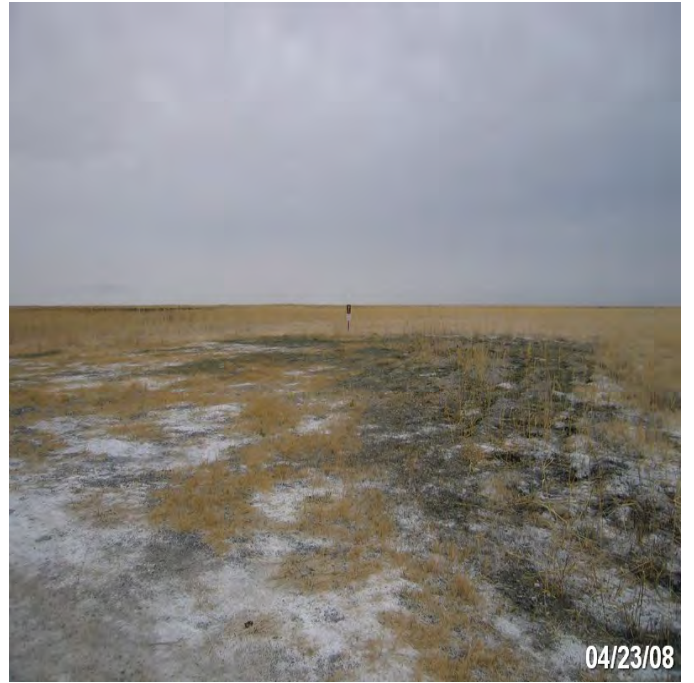
Route 909: Harrison Interior West Parking

Asset Number	Date Visited	Surface Type	Area (sq ft)	Condition	Cost to Improve
10050863	4/23/2008	Gravel	17230	Poor	\$19000

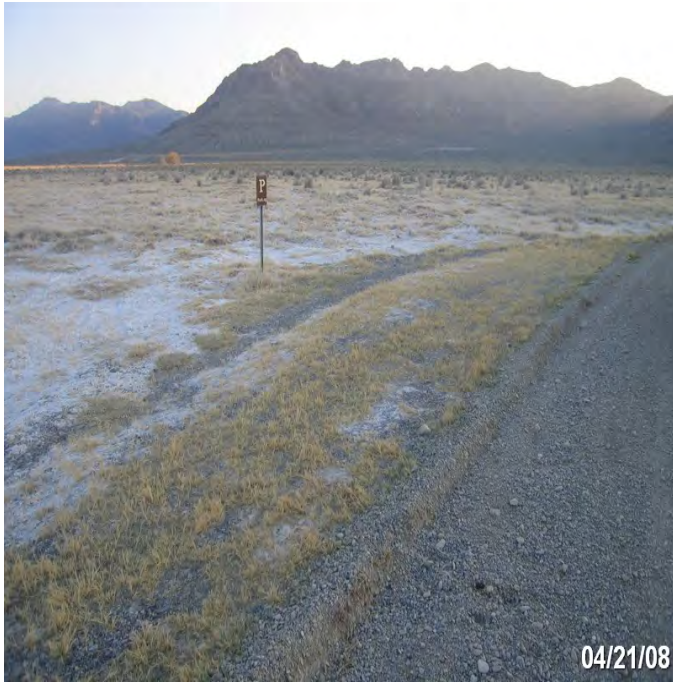
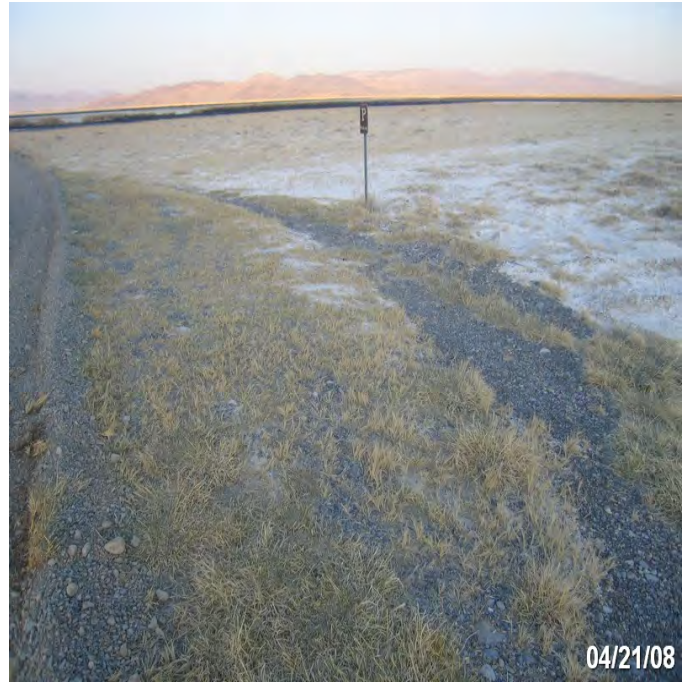
Route 910: Mallard West Parking

Asset Number	Date Visited	Surface Type	Area (sq ft)	Condition	Cost to Improve
10050872	4/21/2008	Gravel	1128	Poor	\$1200

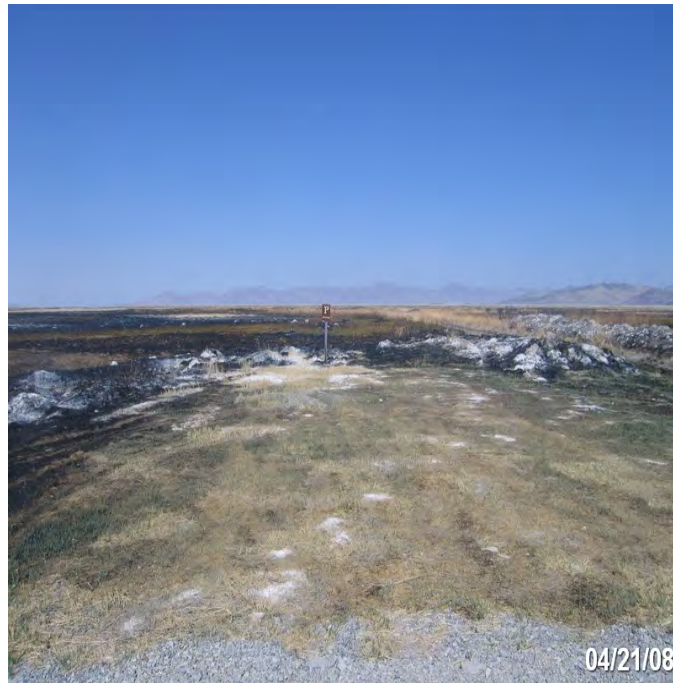
Route 911: Mallard Parking

Asset Number	Date Visited	Surface Type	Area (sq ft)	Condition	Cost to Improve
10050872	4/21/2008	Native	2454	Poor	\$2000

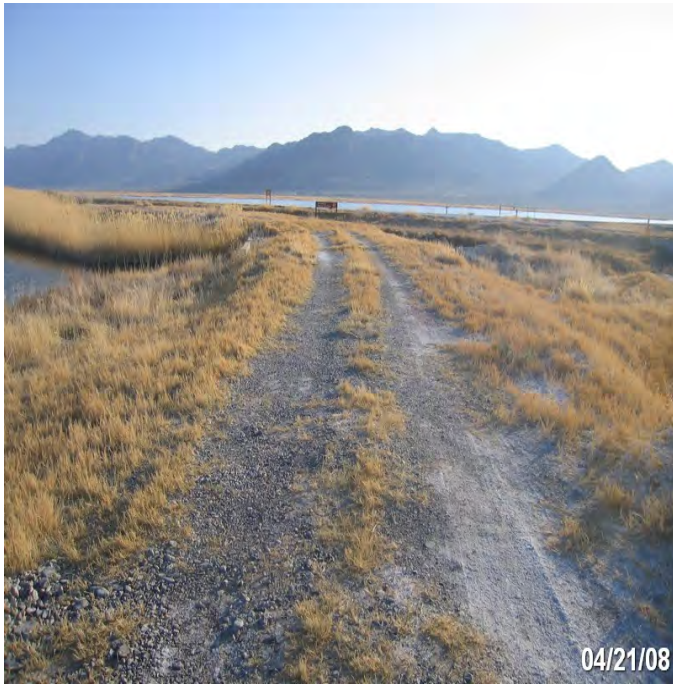
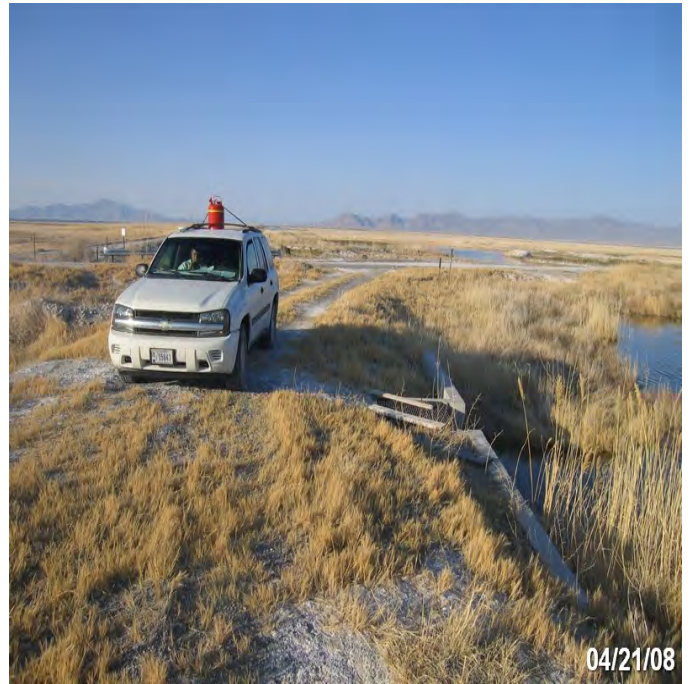
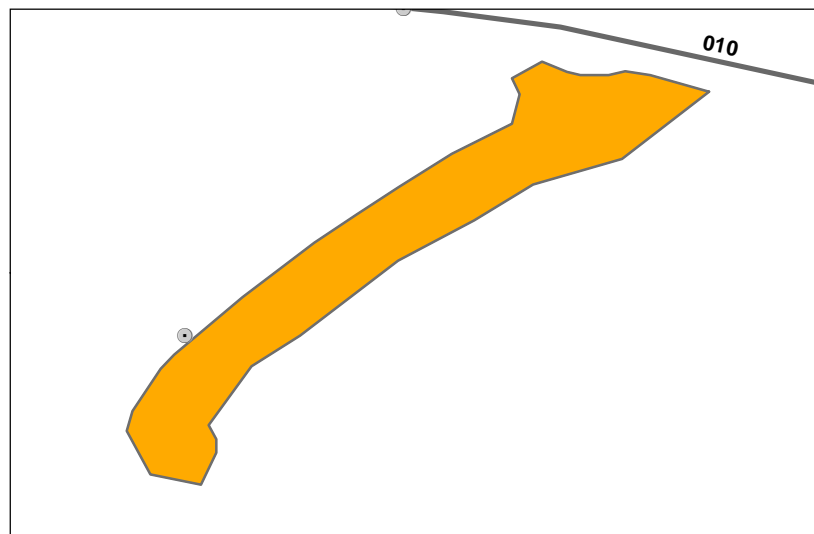
Route 913: Curlew Northwest Parking

Asset Number	Date Visited	Surface Type	Area (sq ft)	Condition	Cost to Improve
10050873	4/21/2008	Gravel	2604	Poor	\$2900

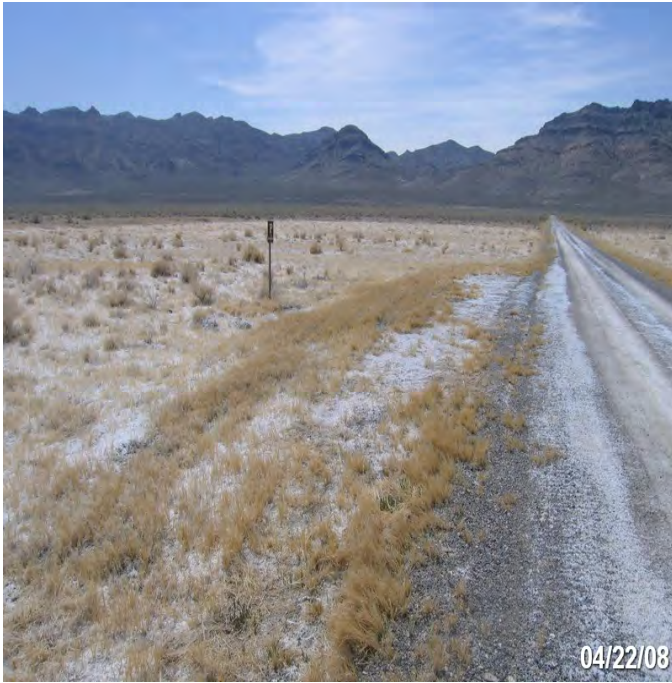
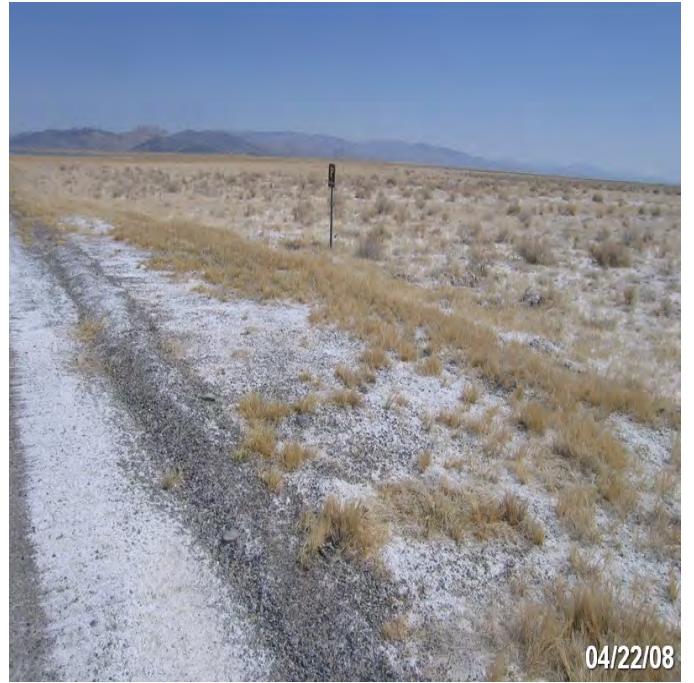
Route 914: Shoveler Pool Parking

Asset Number	Date Visited	Surface Type	Area (sq ft)	Condition	Cost to Improve
10050873	4/22/2008	Gravel	1575	Failed	\$5300

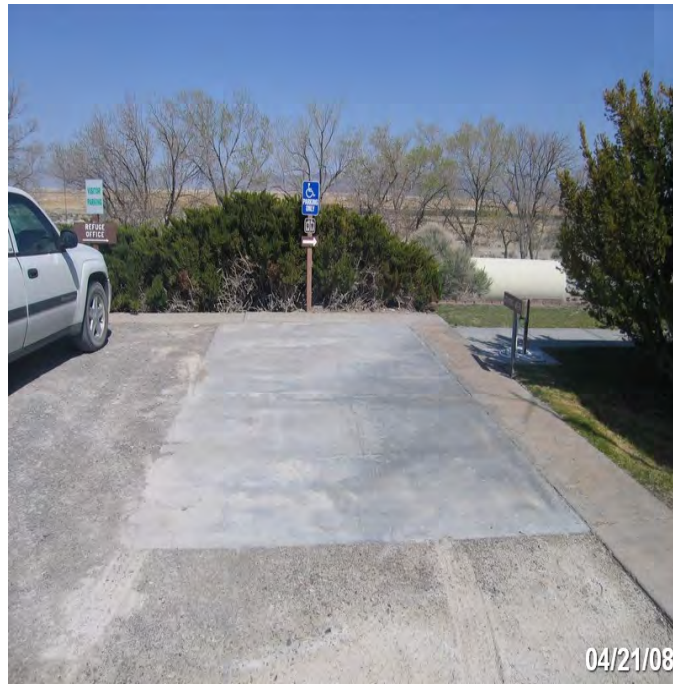
Route 915: Headquarters Handicapped Parking

Asset Number	Date Visited	Surface Type	Area (sq ft)	Condition	Cost to Improve
10050852	4/21/2008	Concrete	301	Excellent	\$0

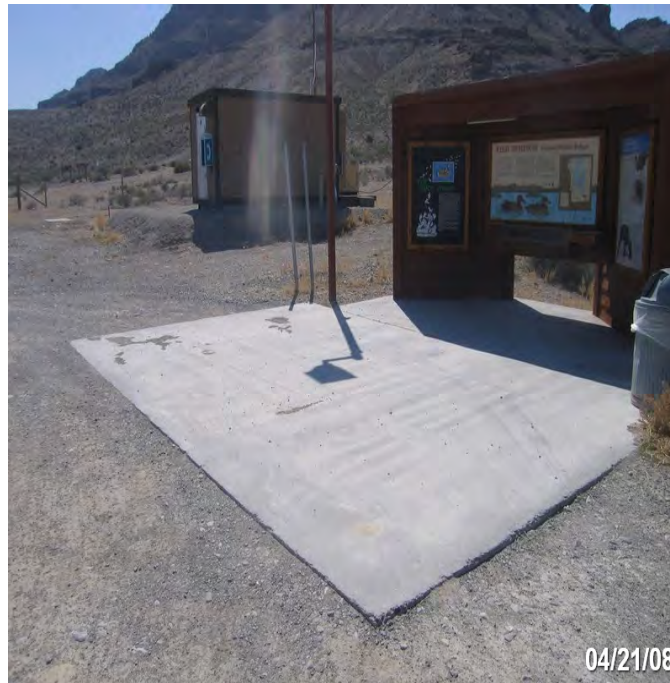
Route 916: Vistor Registration Handicapped Parking

Asset Number	Date Visited	Surface Type	Area (sq ft)	Condition	Cost to Improve
10050852	4/21/2008	Concrete	200	Excellent	\$0

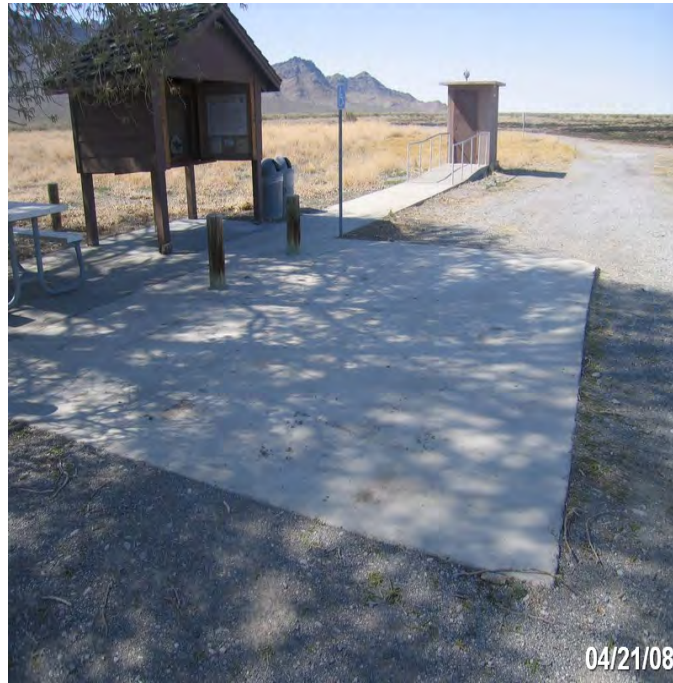
Route 917: Watchable Wildlife Area Handicapped Parking

Asset Number	Date Visited	Surface Type	Area (sq ft)	Condition	Cost to Improve
10050853	4/21/2008	Concrete	267	Excellent	\$0

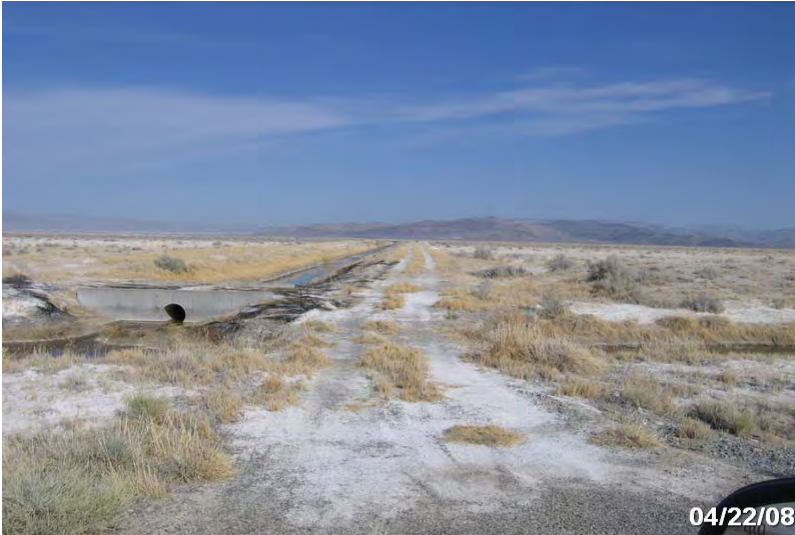
Photo # 3909 - MP 0.00 - Begin Route at Begin Section

ROUTE NUMBER: 317 ROUTE NAME: Water Control Structure Road #3

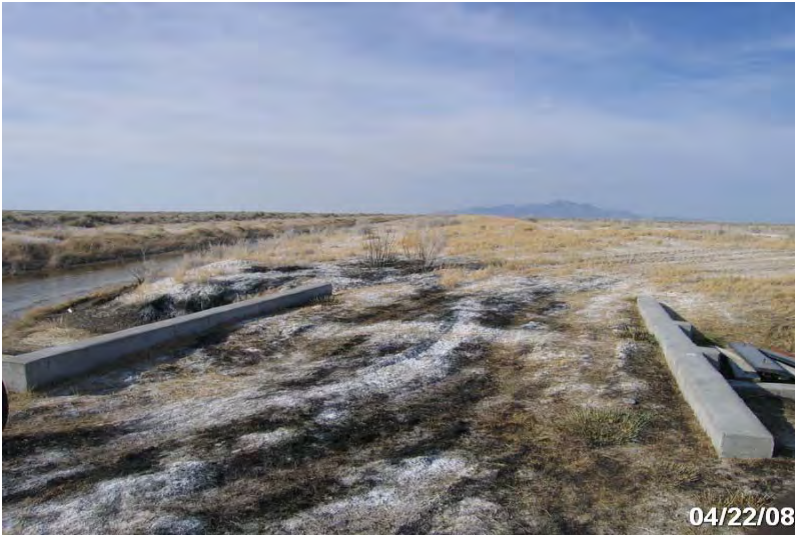
Photo # 3914 - MP 0.00 - Begin Route at Begin Section

ROUTE NUMBER: 318 ROUTE NAME: Water Control Structure Road #4

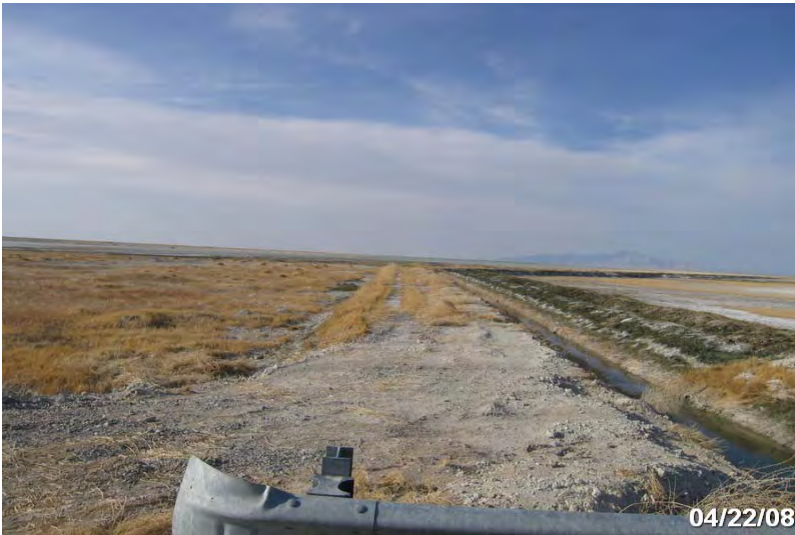
Photo # 3922 - MP 0.00 - Begin Route at Begin Section

ROUTE NUMBER: 319 ROUTE NAME: Water Control Structure Road #5

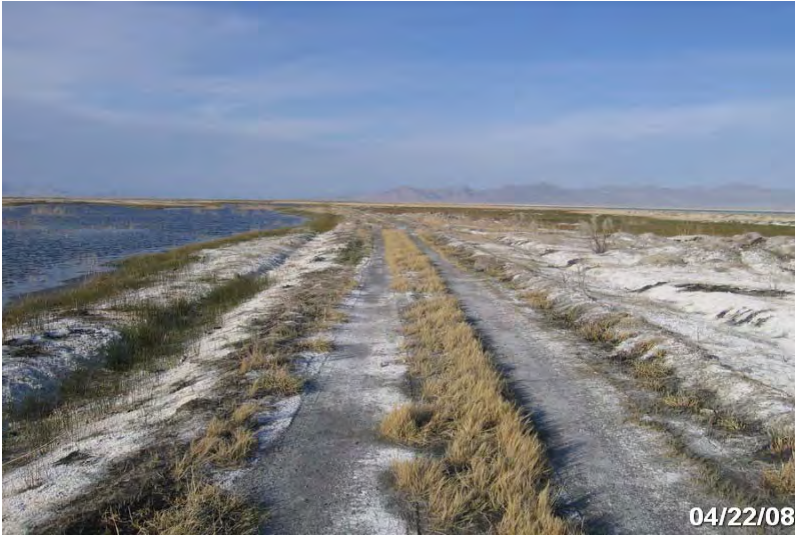
Photo # 3929 - MP 0.00 - Begin Route at Begin Section

ROUTE NUMBER: 320 ROUTE NAME: Harrison Interior Administrative Road

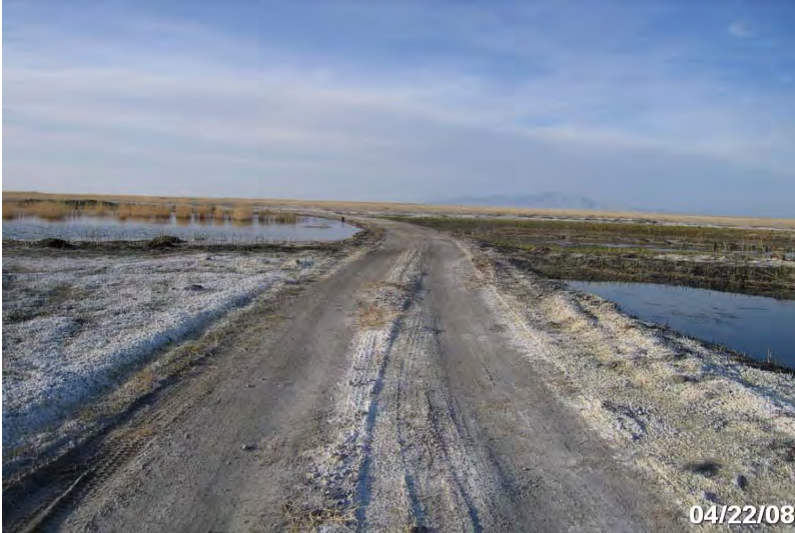
Photo # 3933 - MP 0.00 - Begin Route at Begin Section

ROUTE NUMBER: 321 ROUTE NAME: Harrison Pool Administrative Spur

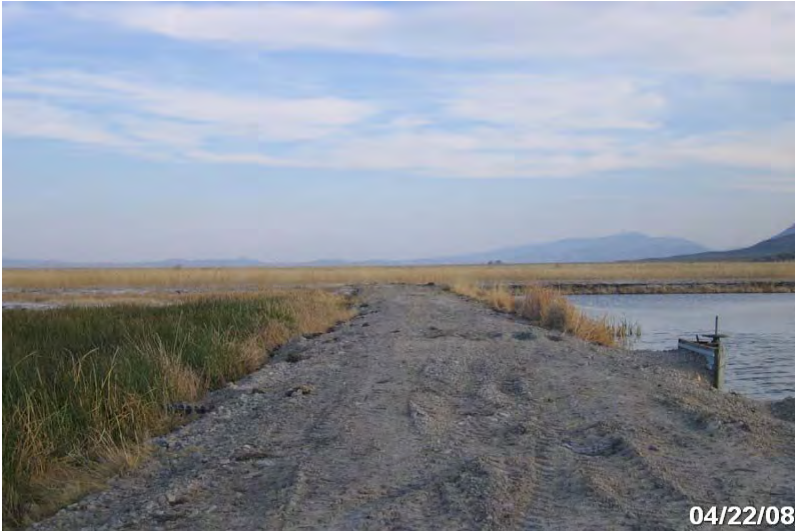
Photo # 3942 - MP 0.59 - Begin Section 002

ROUTE NUMBER: 321 ROUTE NAME: Harrison Pool Administrative Spur

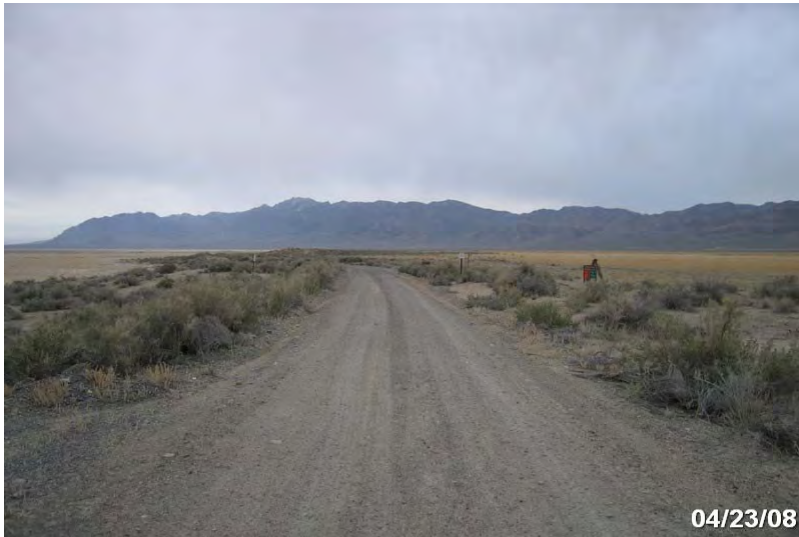
Photo # 4013 - MP 0.00 - Begin Route at Begin Section

ROUTE NUMBER: 322 ROUTE NAME: Avocet Pool Administrative Road
