# **The Road Inventory of Havasu National Wildlife Refuge Needles, CA**

Prepared By:  
Federal Highway Administration  
Central Federal Lands Highway Division  
April 2008

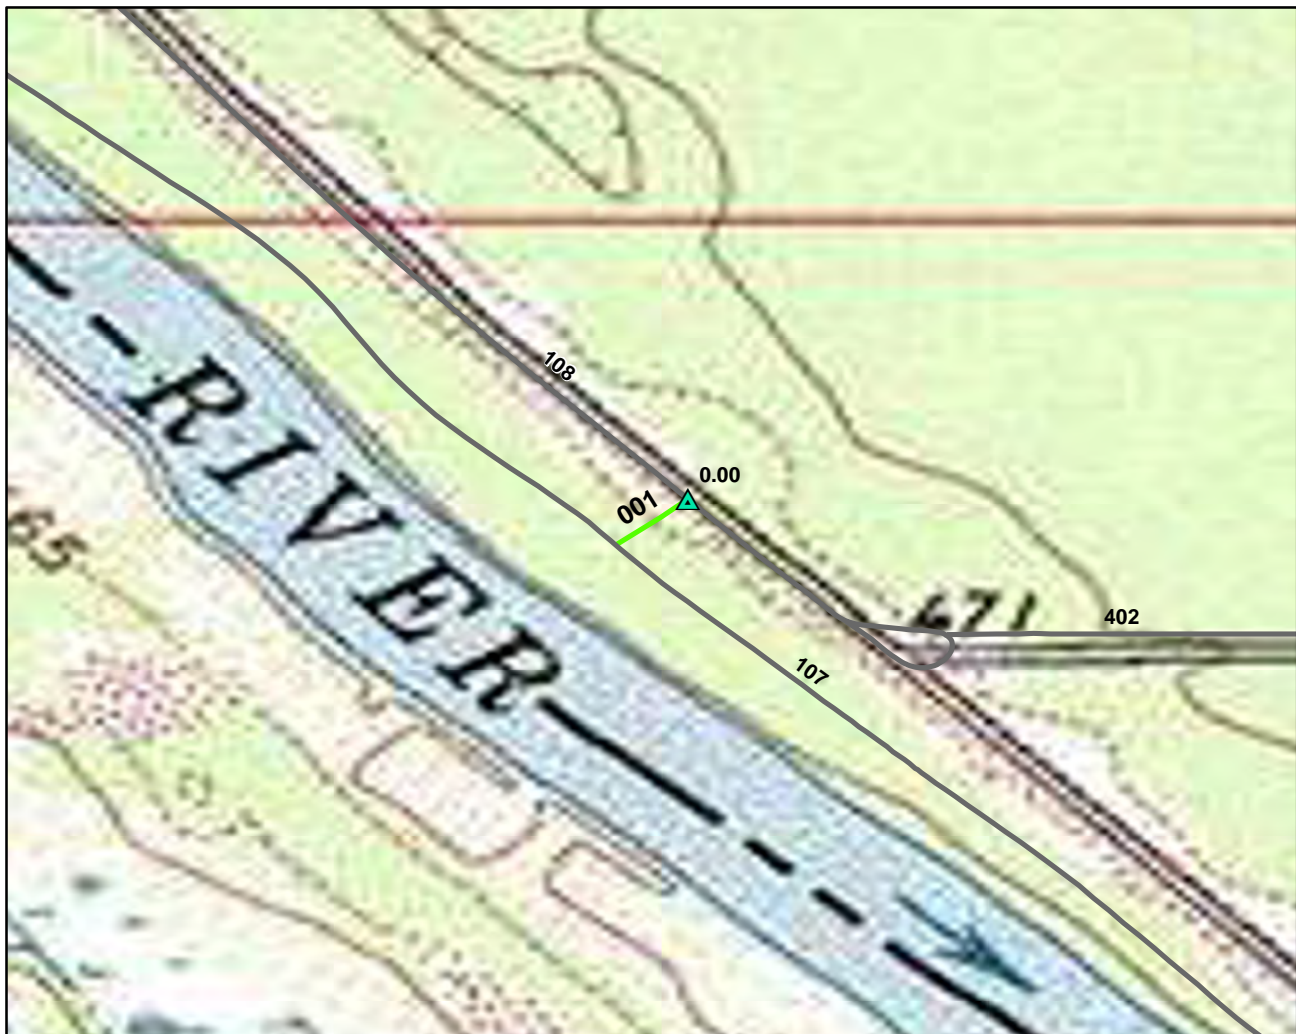
RTE DESCRIPTION: From E AZ-95 Mohave Valley Highway to North Dike Road  
(Route 400) and North Dike Parking Area (Route 903)

Section Number	001				
Section Length (miles)	0.76				
Inspection Date	4/7/2008				
<b>Section Information</b>					
Surface Type	Gravel				
Number of Lanes	2				
Roadway Width (feet)	20				
<b>Roadway Condition Information</b>					
Condition	Good				
Remaining Service Life (years)	5				
Cost Estimate	\$1200				
CRV	\$513500

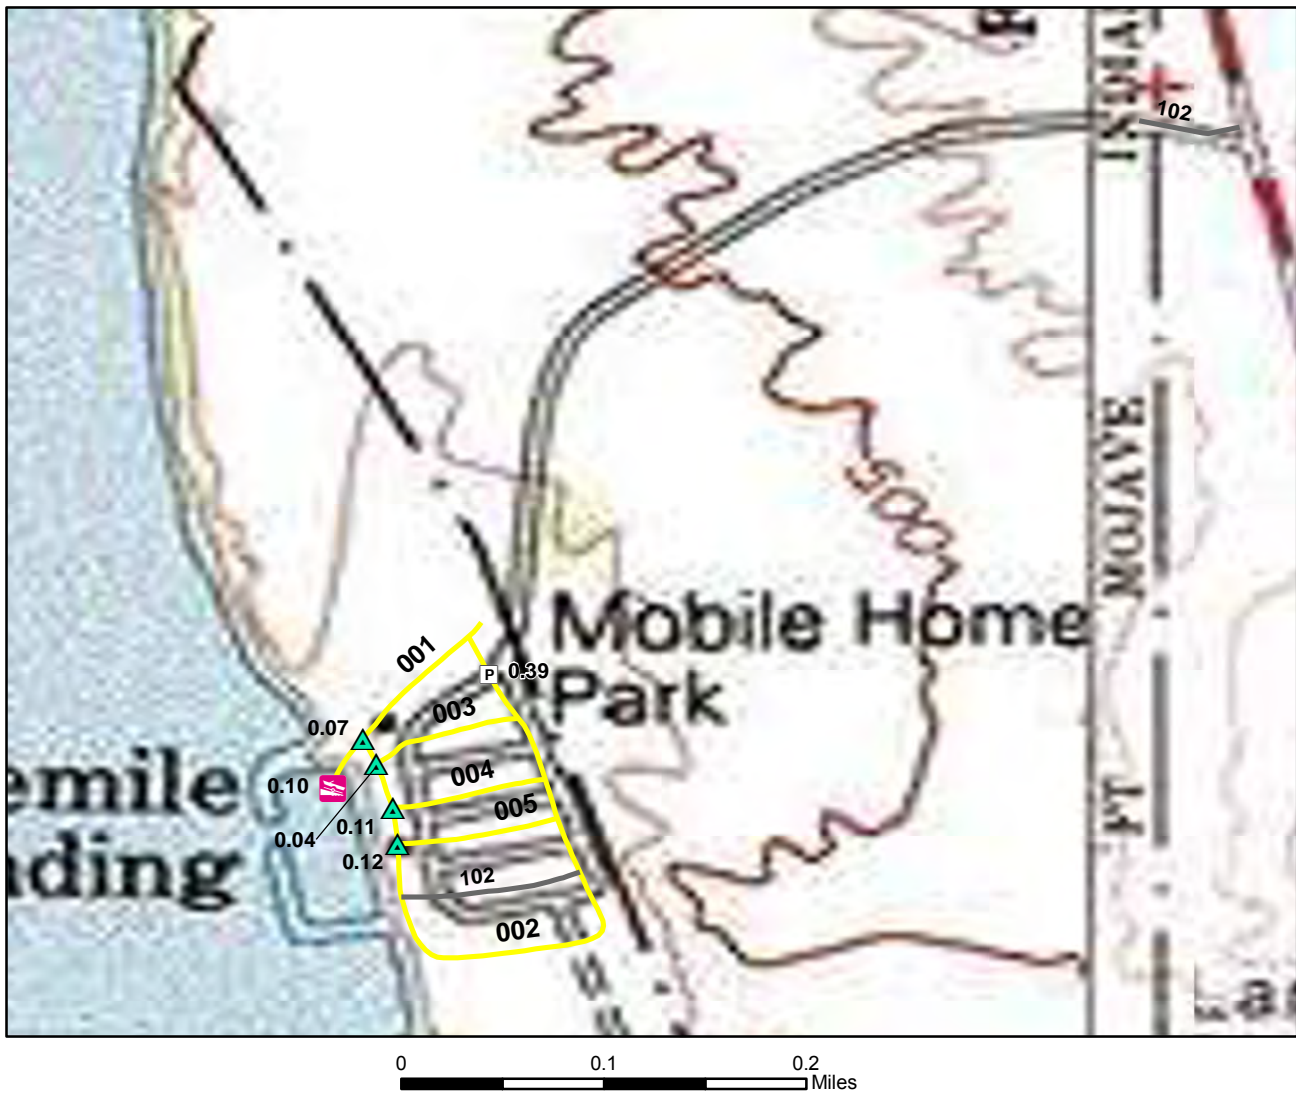
ROUTE: 102      Five Mile Landing Road

Section Number	001	002	003	004	005
Section Length (miles)	0.10	0.34	0.06	0.06	0.07
Inspection Date	4/7/2008	4/7/2008	4/7/2008	4/7/2008	4/7/2008
<b>Section Information</b>					
Surface Type	Native	Native	Native	Native	Native
Number of Lanes	2	1	2	2	2
Roadway Width (feet)	30	14	20	20	20
<b>Roadway Condition Information</b>					
Condition	Fair	Fair	Fair	Fair	Fair
Remaining Service Life (years)	3	3	3	3	3
Cost Estimate	\$200	\$700	\$100	\$100	\$100
CRV	\$35800	\$118300	\$22000	\$22200	\$23100

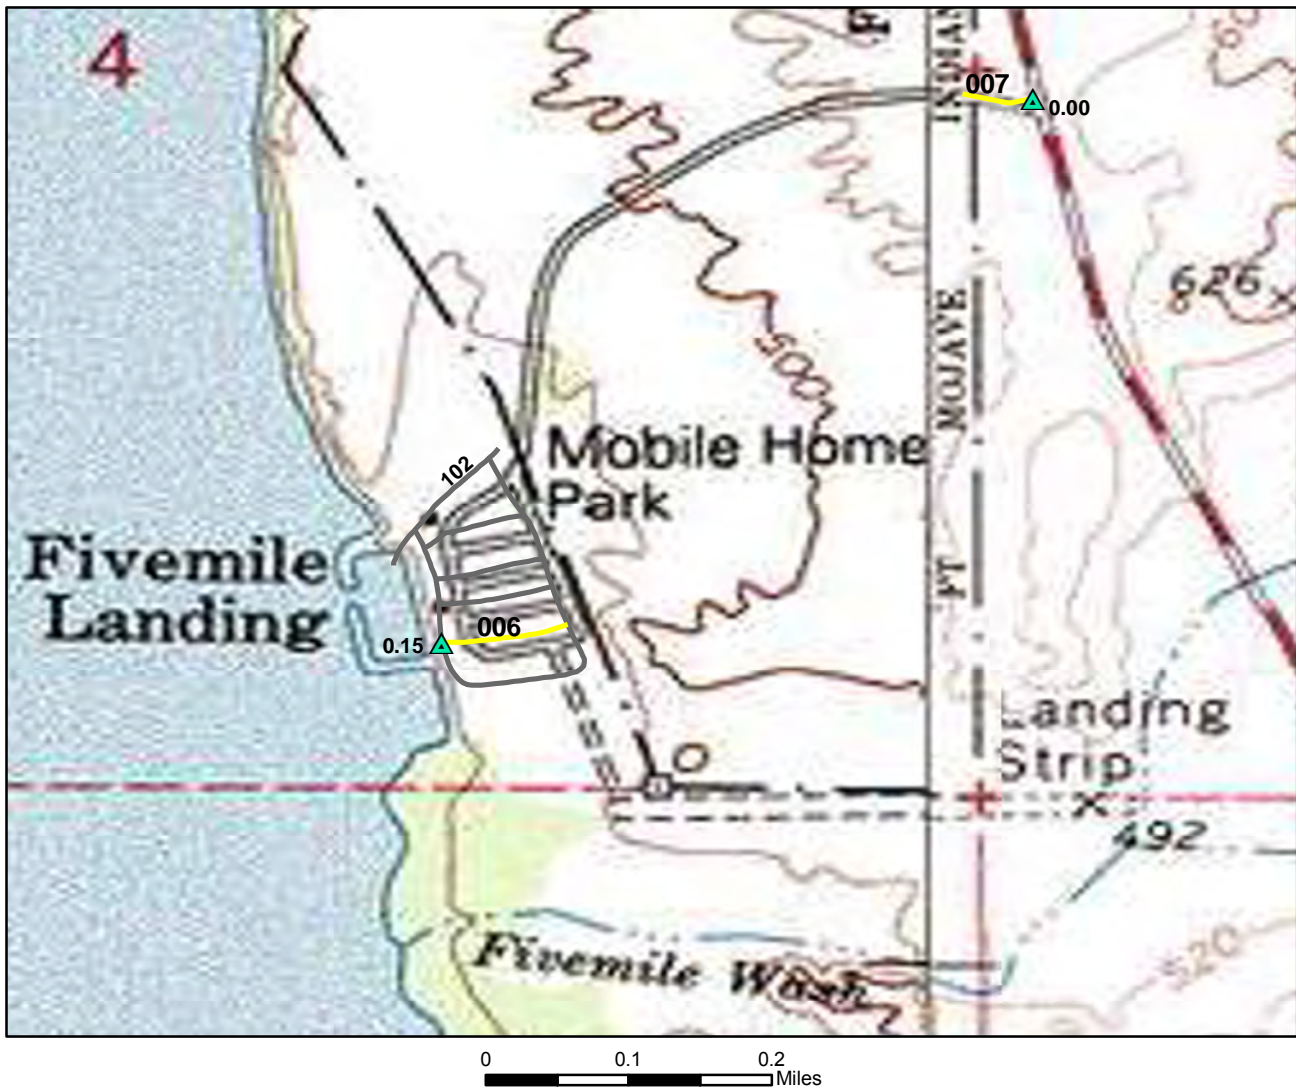
ROUTE: 102 Five Mile Landing Road

RTE DESCRIPTION: Roads in the Five Mile Landing Unit

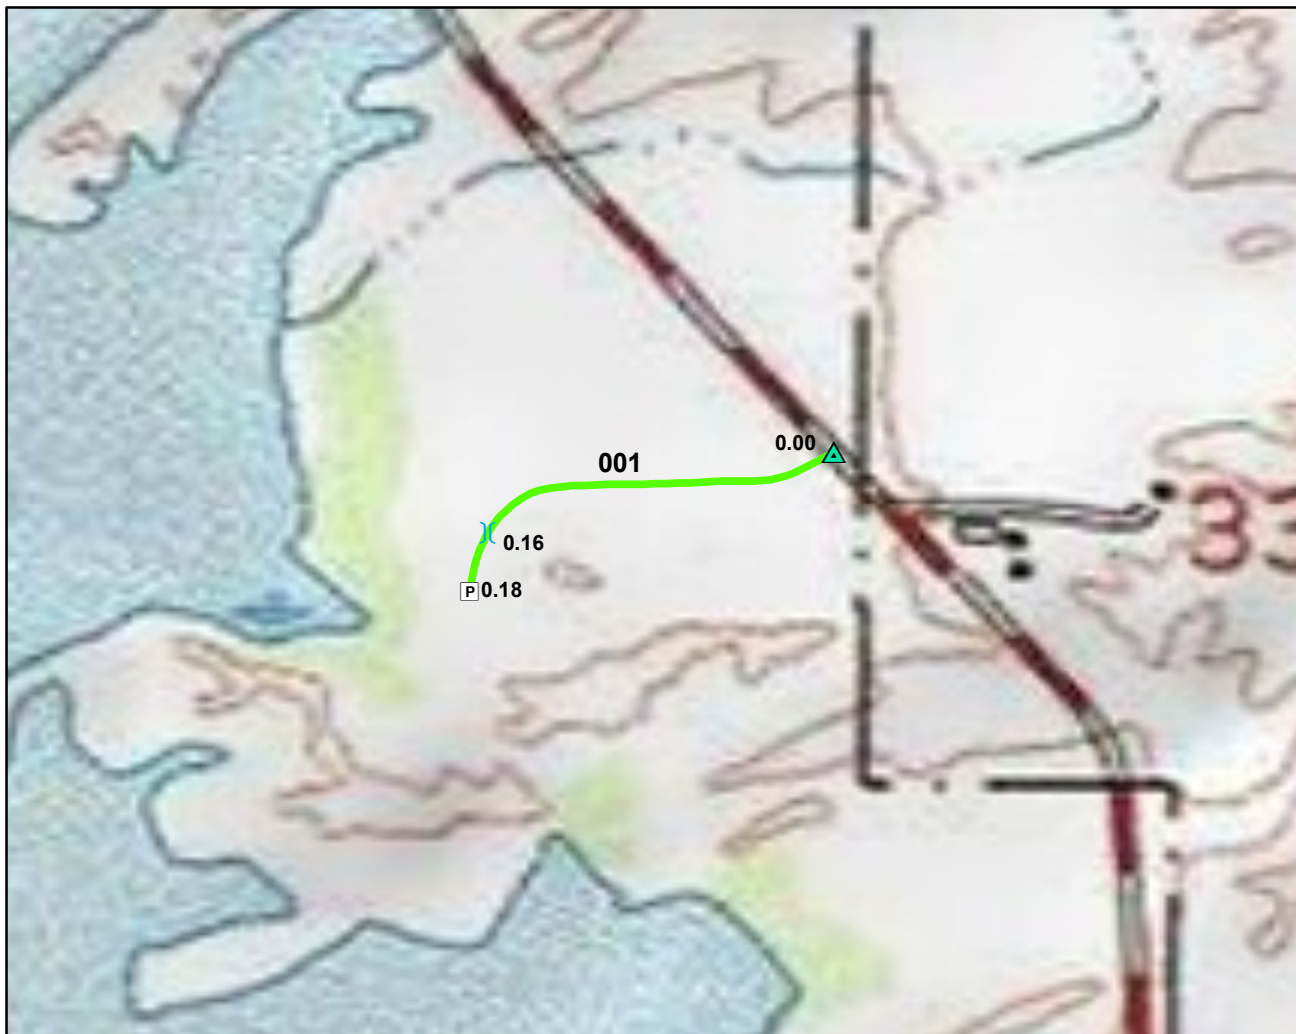
RTE DESCRIPTION: From Vista Road to Casle Rock Parking Area (Route 905)

Section Number	001				
Section Length (miles)	0.16				
Inspection Date	4/7/2008				
<b>Section Information</b>					
Surface Type	Gravel				
Number of Lanes	1				
Roadway Width (feet)	14				
<b>Roadway Condition Information</b>					
Condition	Fair				
Remaining Service Life (years)	3				
Cost Estimate	\$500				
CRV	\$105200

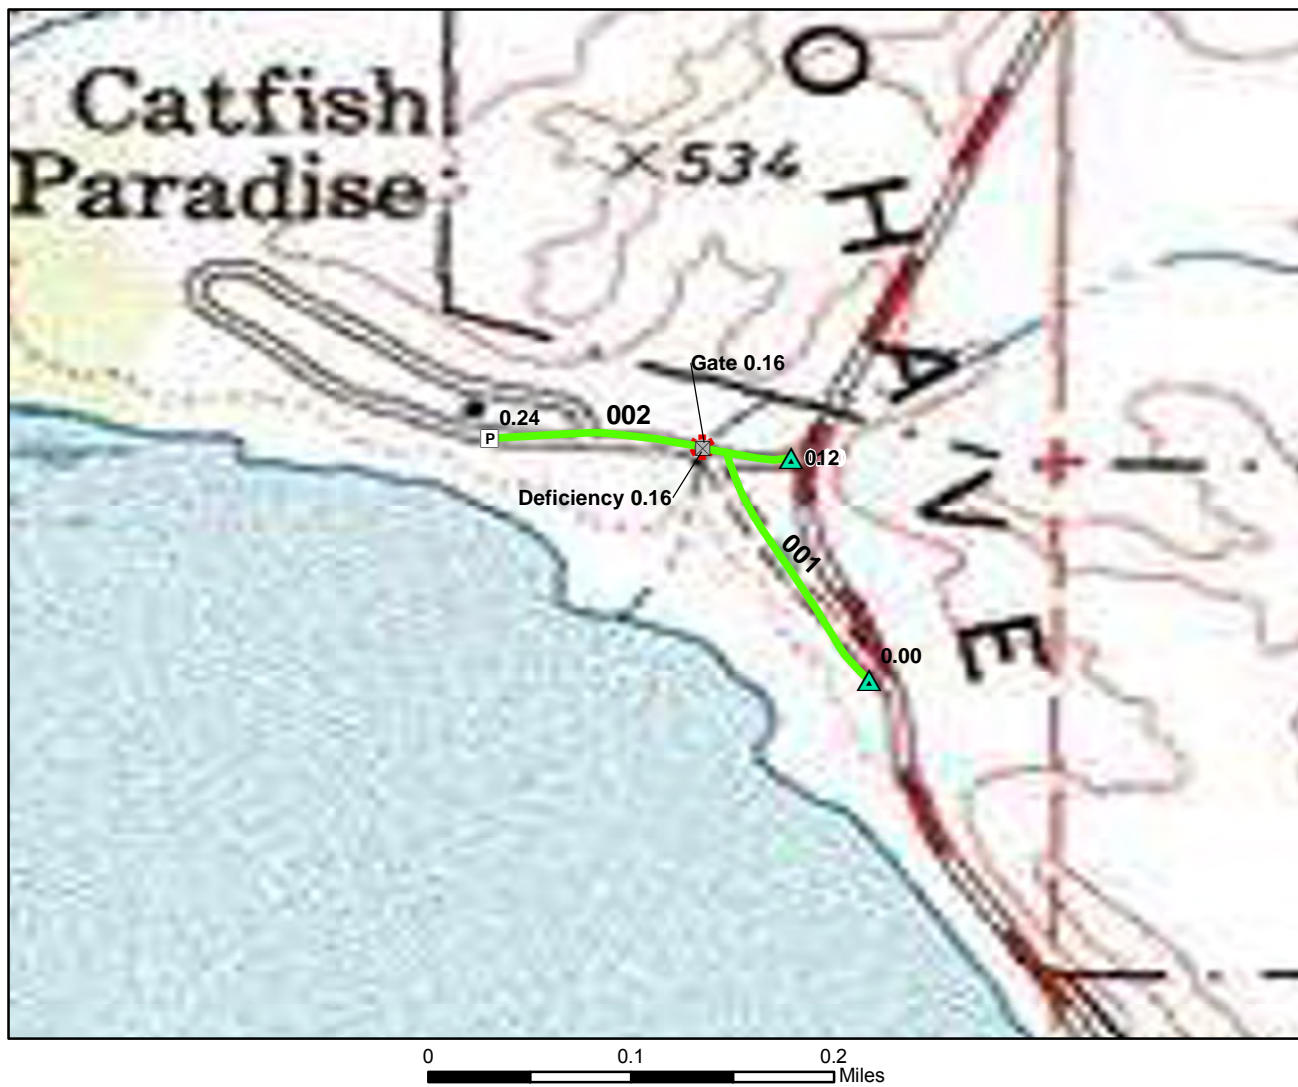
ROUTE: 105 Catfish Paradise Access Road TOTAL LENGTH: 0.25 Miles

Section Number	001	002			
Section Length (miles)	0.12	0.13			
Inspection Date	4/7/2008	4/7/2008			
<b>Section Information</b>					
Surface Type	Gravel	Gravel			
Number of Lanes	1	2			
Roadway Width (feet)	14	20			
<b>Roadway Condition Information</b>					
Condition	Good	Good			
Remaining Service Life (years)	5	5			
Cost Estimate	\$200	\$200			
CRV	\$83300	\$85400

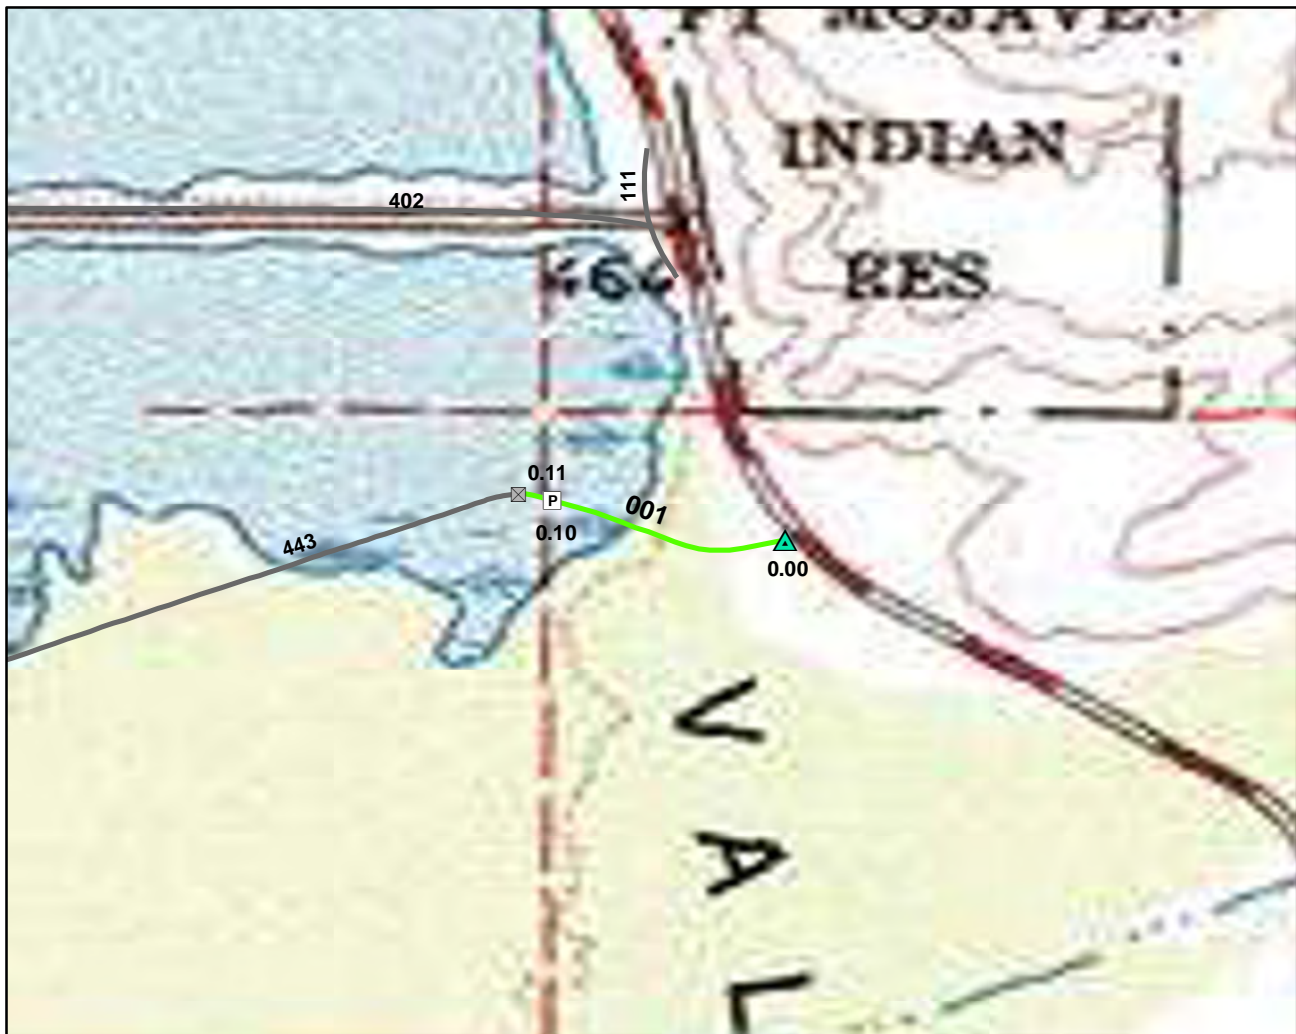
RTE DESCRIPTION: From Oatman-Topock Highway (Old US-66) to Catfish Paradise Parking Area (Route 904)

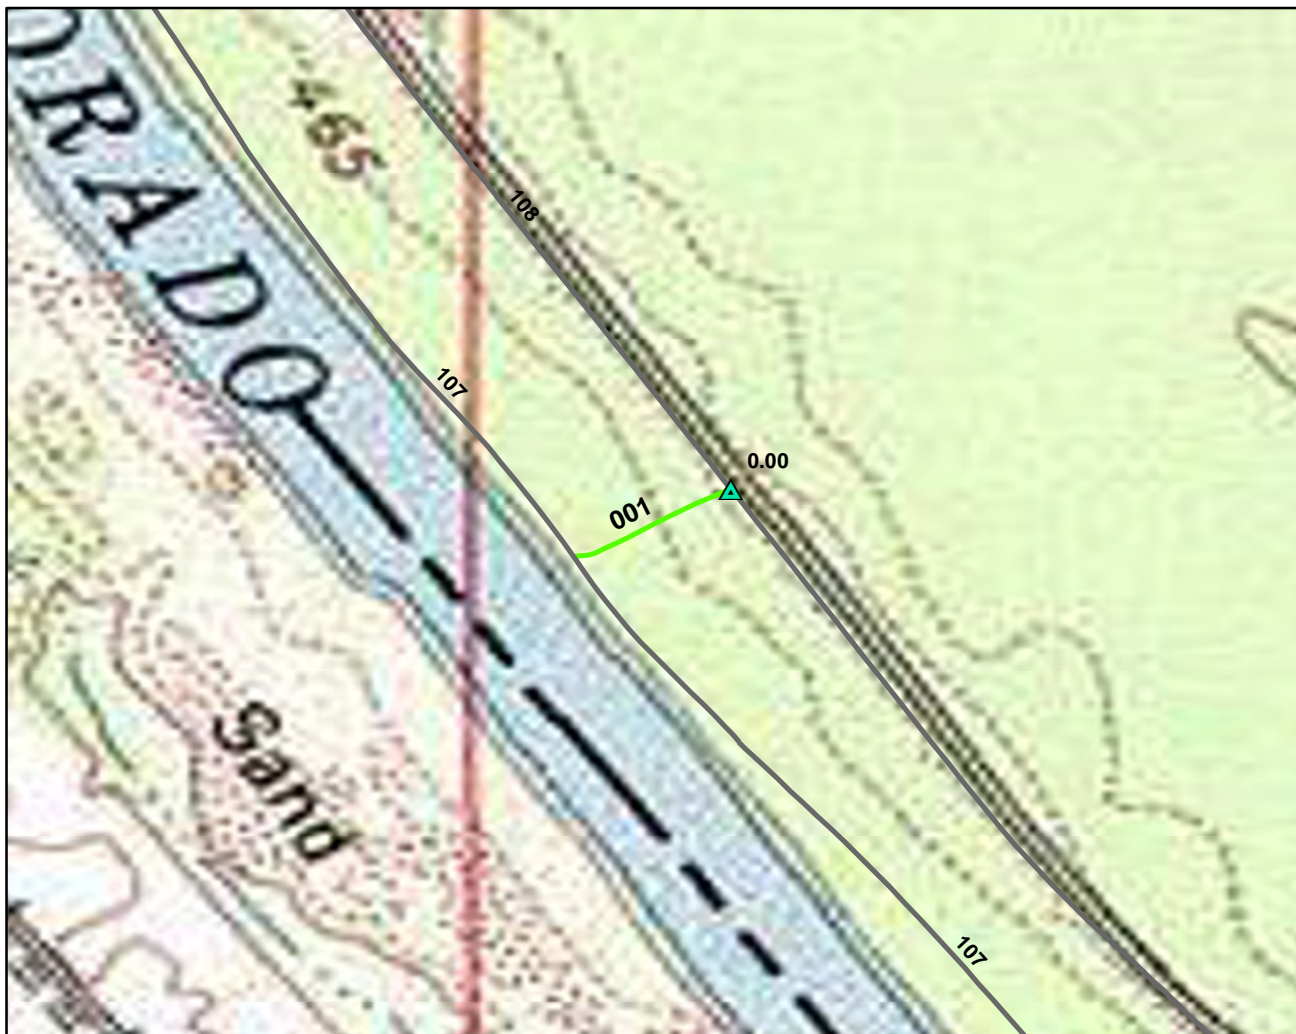
RTE DESCRIPTION: From Oatman-Topock Highway (Old US-66) to Oatman-Topock Highway (Old US-66)

Section Number	001				
Section Length (miles)	0.07				
Inspection Date	4/7/2008				
<b>Section Information</b>					
Surface Type	Gravel				
Number of Lanes	2				
Roadway Width (feet)	18				
<b>Roadway Condition Information</b>					
Condition	Excellent				
Remaining Service Life (years)	8				
Cost Estimate	\$0				
CRV	\$44400

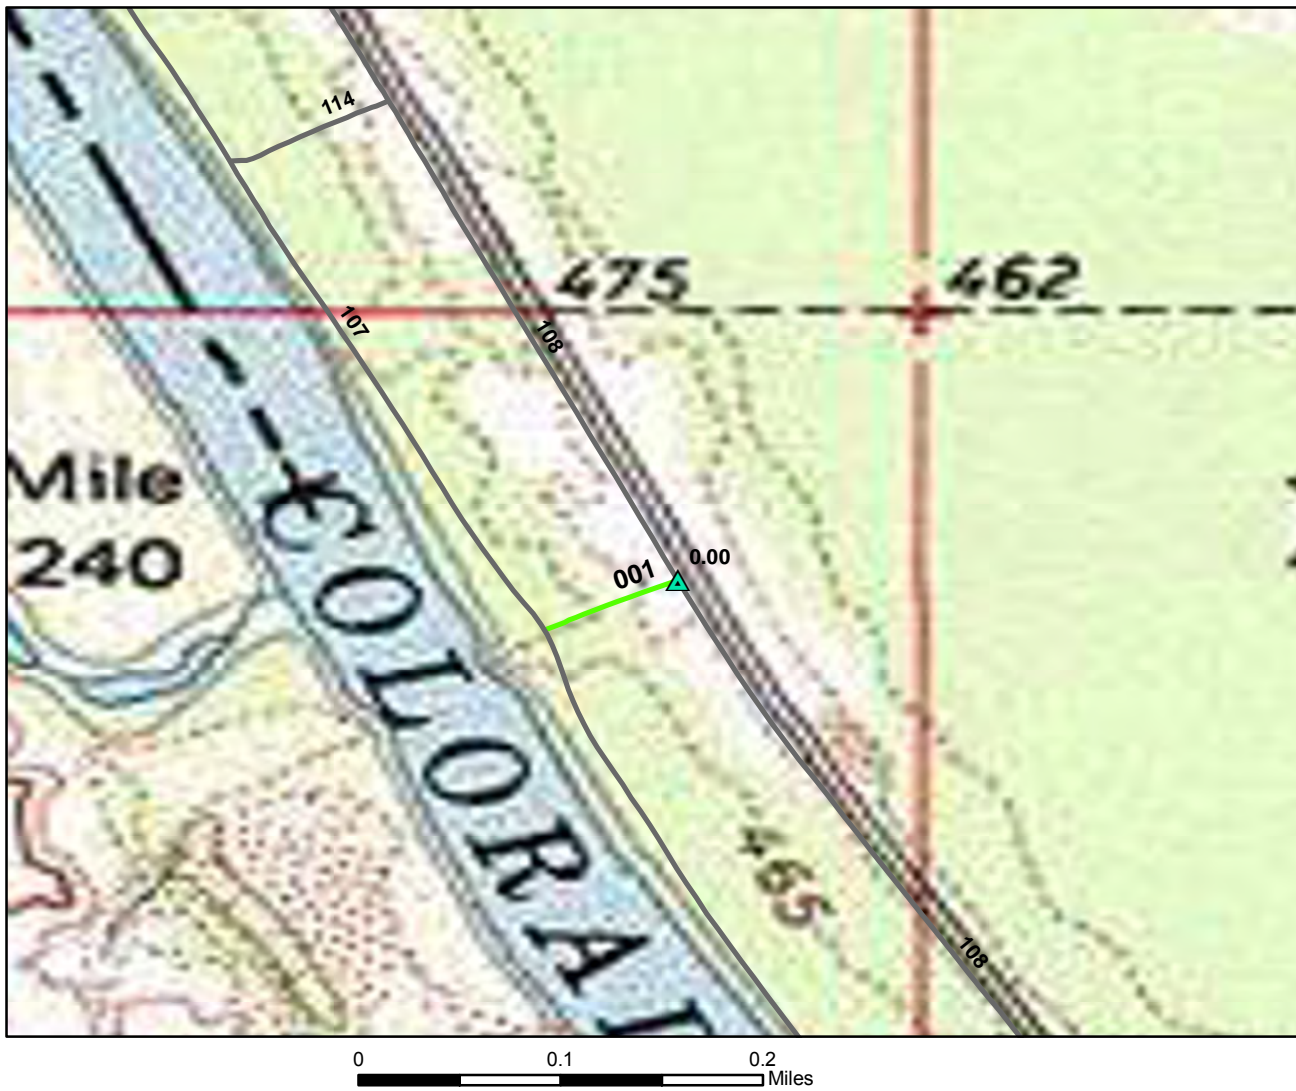
RTE DESCRIPTION: From Upper Levee Road (Route 108) to Lower Levee Road (Route 107)

Section Number	001				
Section Length (miles)	0.07				
Inspection Date	4/8/2008				
<b>Section Information</b>					
Surface Type	Gravel				
Number of Lanes	2				
Roadway Width (feet)	16				
<b>Roadway Condition Information</b>					
Condition	Good				
Remaining Service Life (years)	7				
Cost Estimate	\$100				
CRV	\$48900

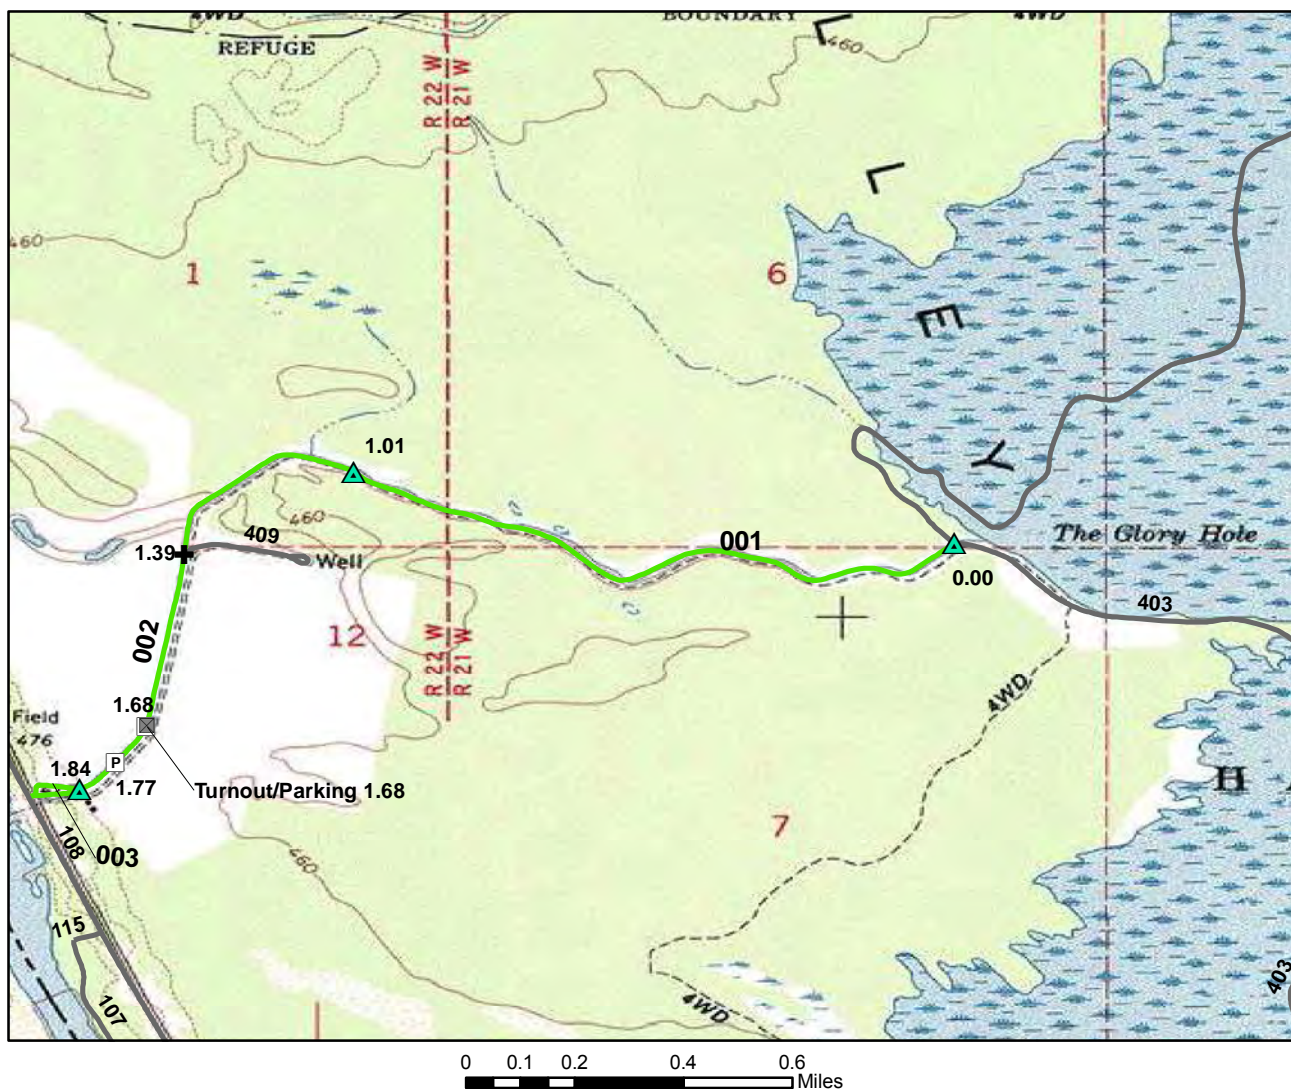
ROUTE: 405 Farm Ditch Road TOTAL LENGTH: 2.01 Miles

Section Number	001	002	003		
Section Length (miles)	1.01	0.92	0.08		
Inspection Date	4/8/2008	4/8/2008	4/8/2008		
<b>Section Information</b>					
Surface Type	Gravel	Gravel	Gravel		
Number of Lanes	2	2	2		
Roadway Width (feet)	20	20	20		
<b>Roadway Condition Information</b>					
Condition	Good	Good	Good		
Remaining Service Life (years)	5	5	7		
Cost Estimate	\$1600	\$1400	\$100		
CRV	\$678700	\$618000	\$56300

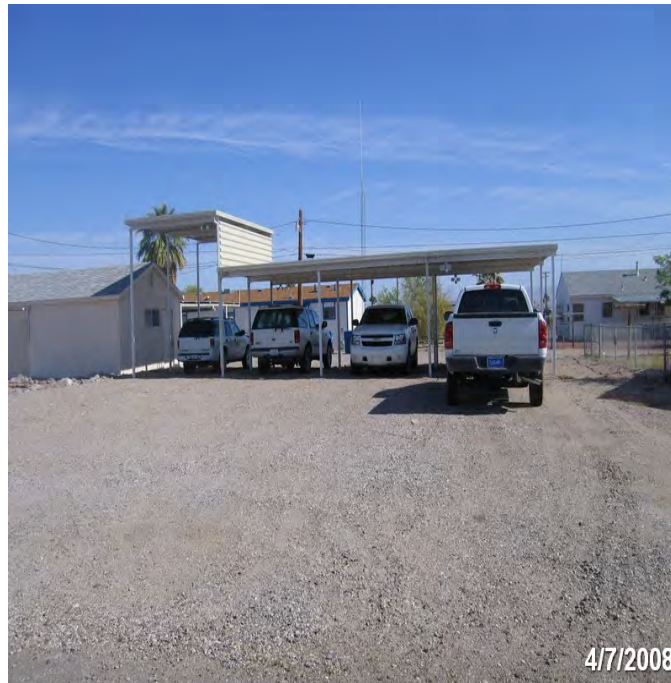
## Route 800: Administrative Parking 1

Asset Number	Date Visited	Surface Type	Area (sq ft)	Condition	Cost to Improve
	4/7/2008	Gravel	6860	Excellent	\$0

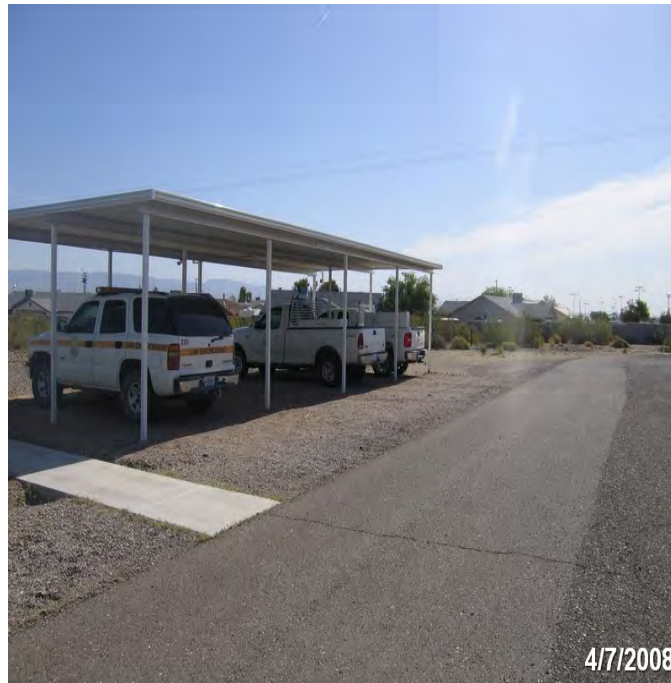
## Route 801: Administrative Parking 2

Asset Number	Date Visited	Surface Type	Area (sq ft)	Condition	Cost to Improve
	4/7/2008	Gravel	3200	Good	\$500

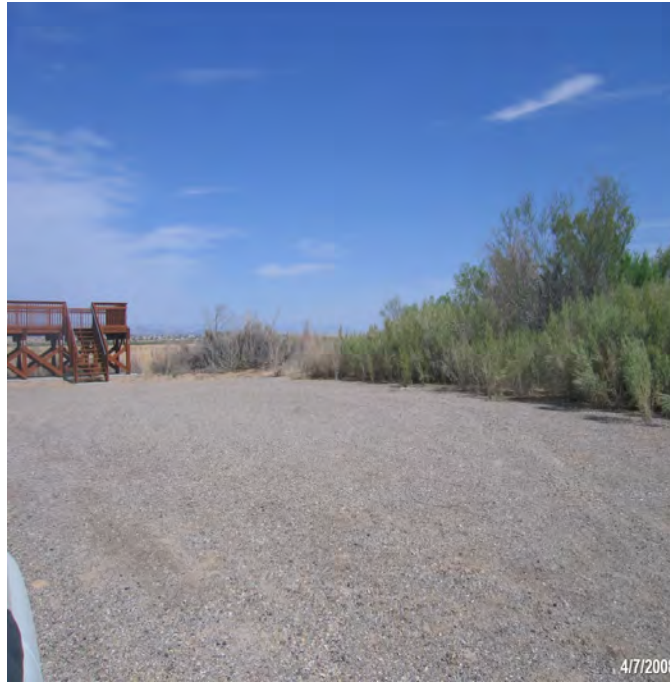
## Route 802: Lake Beal Tower Road Parking

Asset Number	Date Visited	Surface Type	Area (sq ft)	Condition	Cost to Improve
	4/7/2008	Gravel	4198	Excellent	\$0

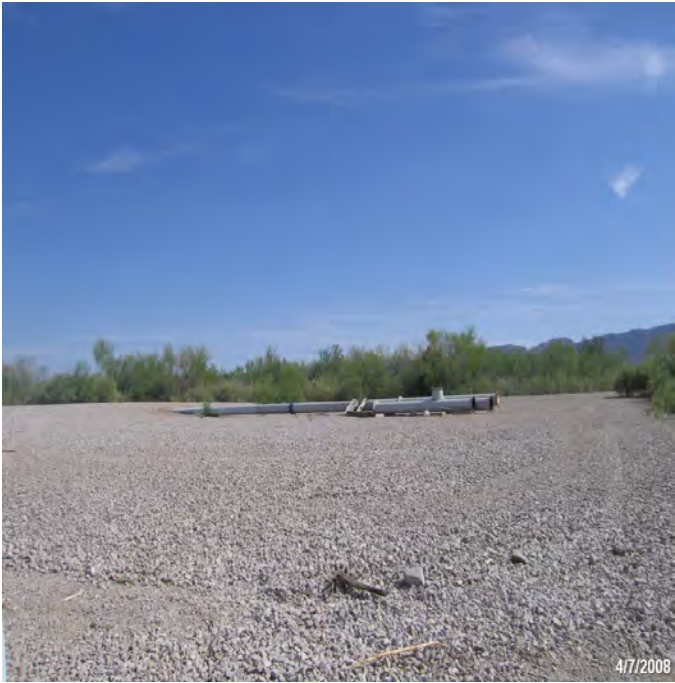
# Route 803: Interior Road Administrative Parking

Asset Number	Date Visited	Surface Type	Area (sq ft)	Condition	Cost to Improve
	4/7/2008	Gravel	17374	Good	\$2500

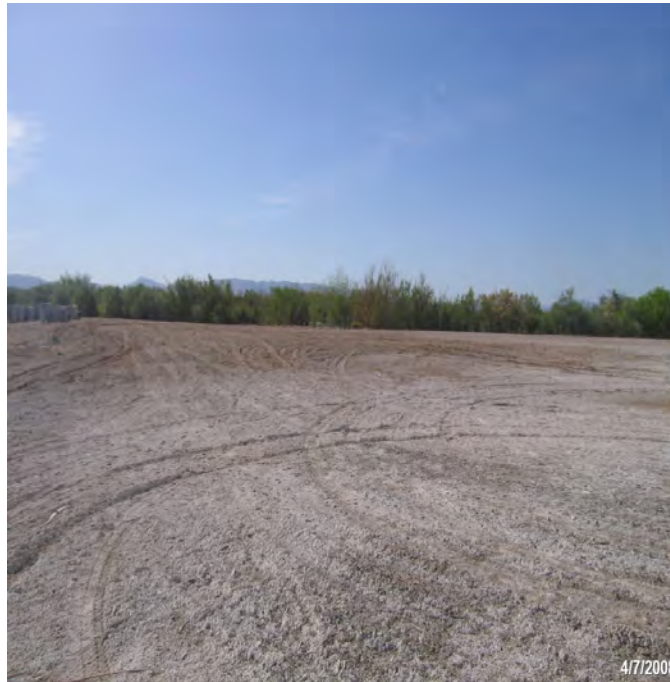
## Route 804: Interior Road Parking

Asset Number	Date Visited	Surface Type	Area (sq ft)	Condition	Cost to Improve
	4/7/2008	Native	24912	Poor	\$19700

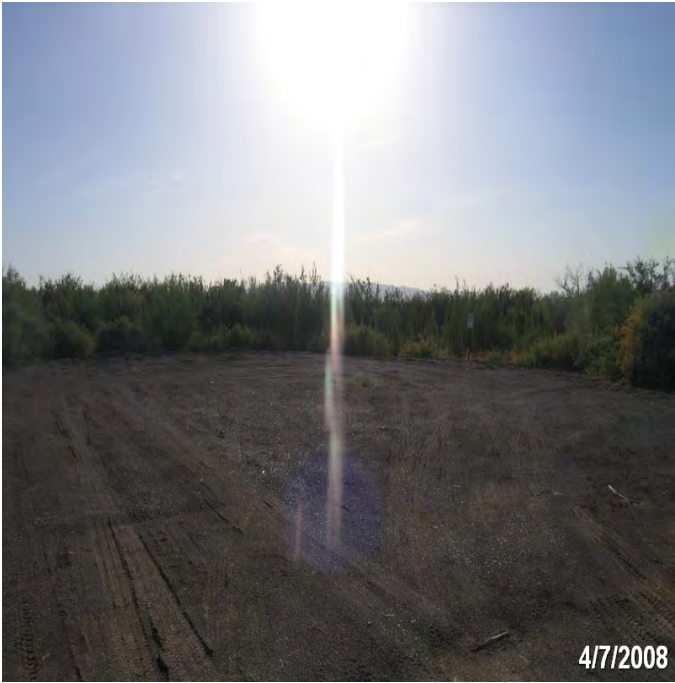
**Route 805: Hunter Unit Parking 1**

Asset Number	Date Visited	Surface Type	Area (sq ft)	Condition	Cost to Improve
	4/7/2008	Gravel	4045	Good	\$600

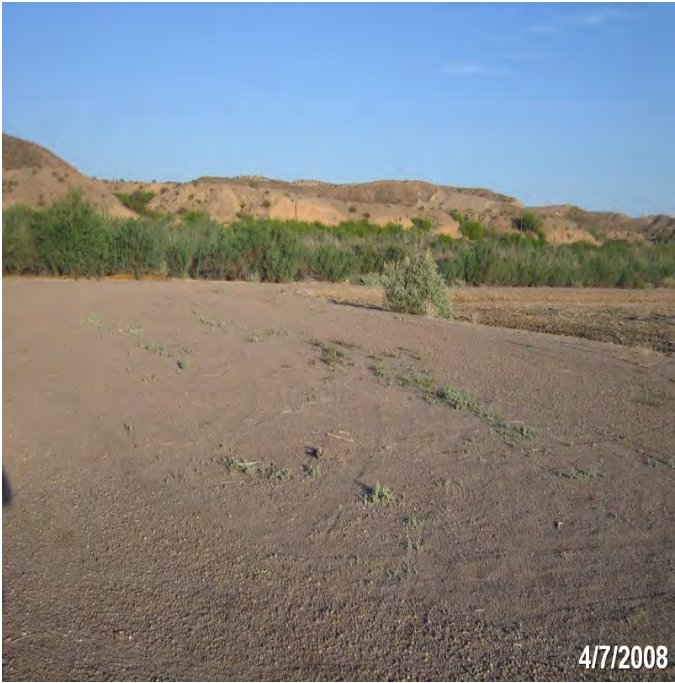
**Route 806: Hunter Unit Parking 2**

Asset Number	Date Visited	Surface Type	Area (sq ft)	Condition	Cost to Improve
	4/7/2008	Gravel	4159	Good	\$600

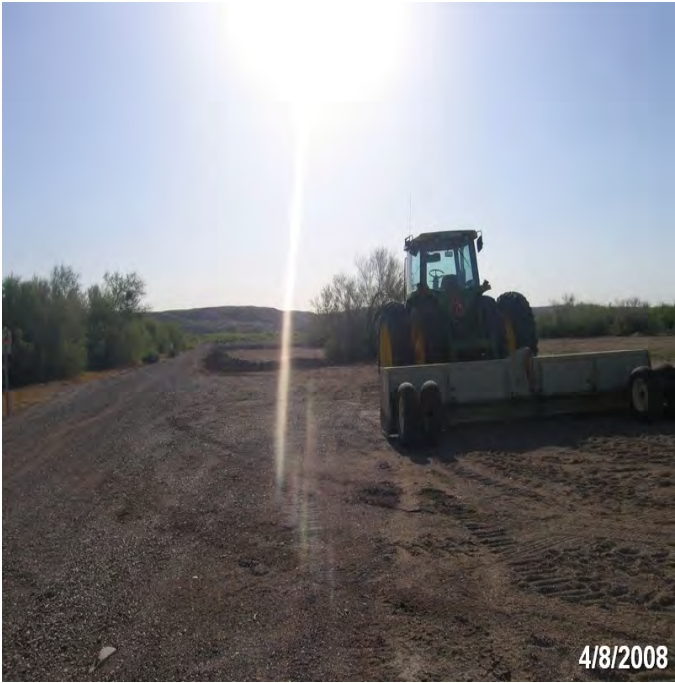
**Route 807: Hunter Unit Parking 3**

Asset Number	Date Visited	Surface Type	Area (sq ft)	Condition	Cost to Improve
	4/8/2008	Gravel	2390	Fair	\$600

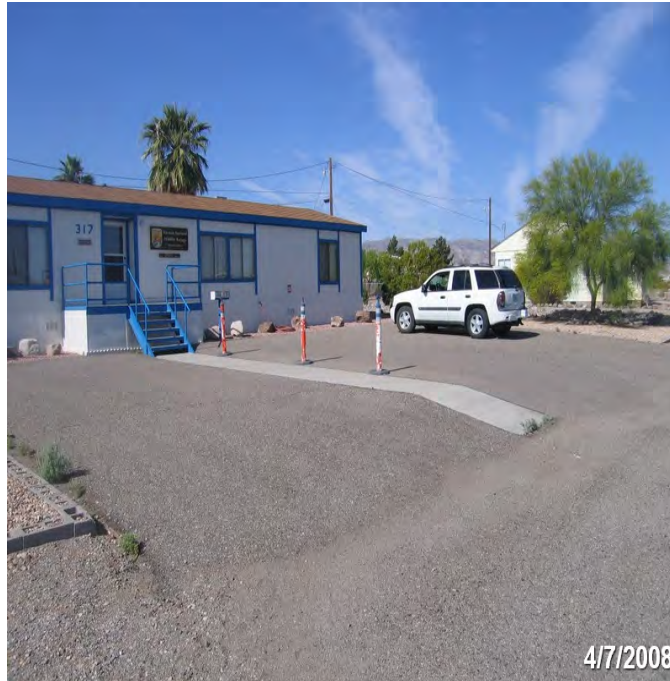
## Route 900: Visitor Center Parking Area

Asset Number	Date Visited	Surface Type	Area (sq ft)	Condition	Cost to Improve
10009810	4/7/2008	Asphalt	2251	Good	\$400

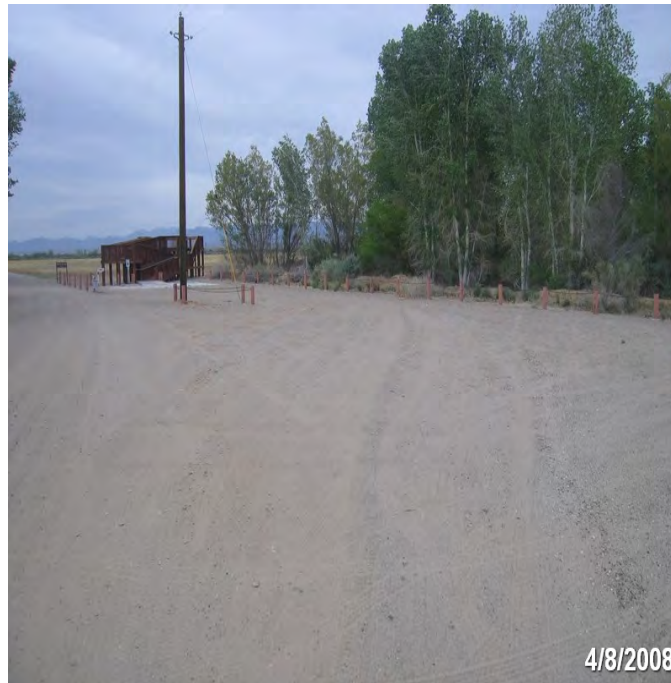
## Route 901: Refuge Farm Parking Area

Asset Number	Date Visited	Surface Type	Area (sq ft)	Condition	Cost to Improve
	4/8/2008	Gravel	8127	Excellent	\$0

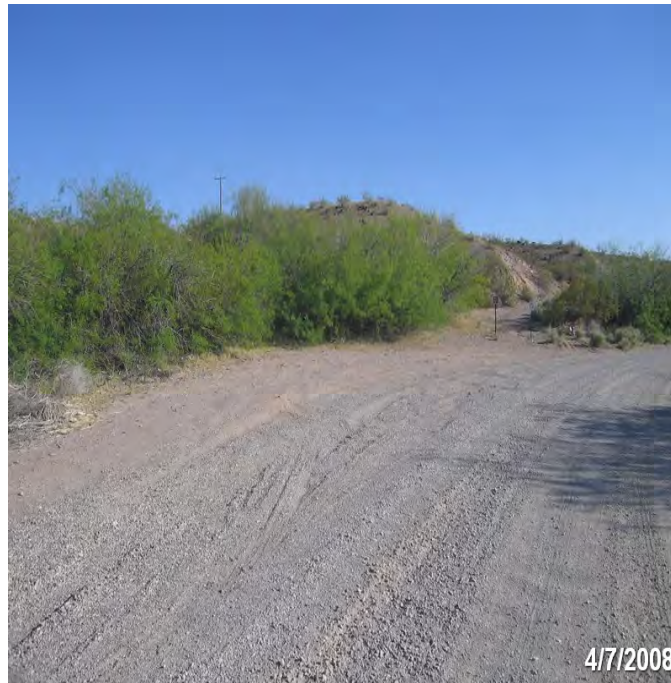
## Route 902: Pintail Slough Parking Area

Asset Number	Date Visited	Surface Type	Area (sq ft)	Condition	Cost to Improve
	4/7/2008	Gravel	2174	Poor	\$2300

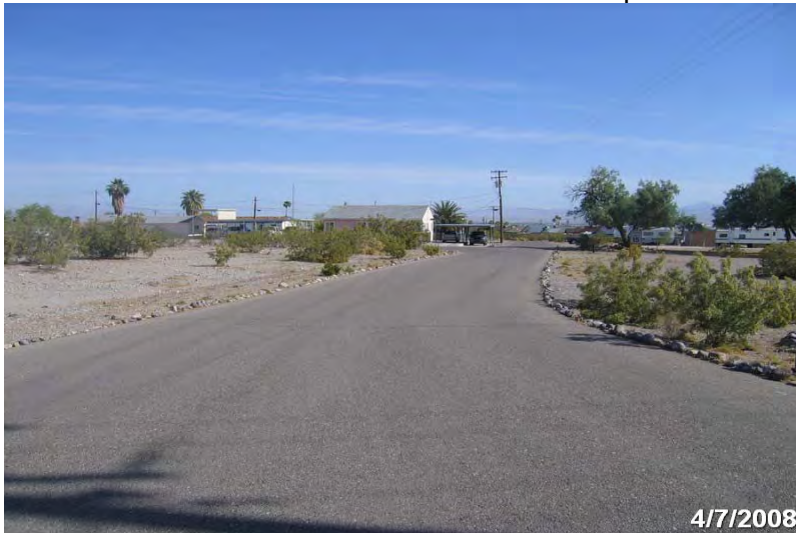
ROUTE NUMBER: 010 ROUTE NAME: Headquarters Drive

Photo # 3497 - MP 0.00 - Begin Route at Begin Section

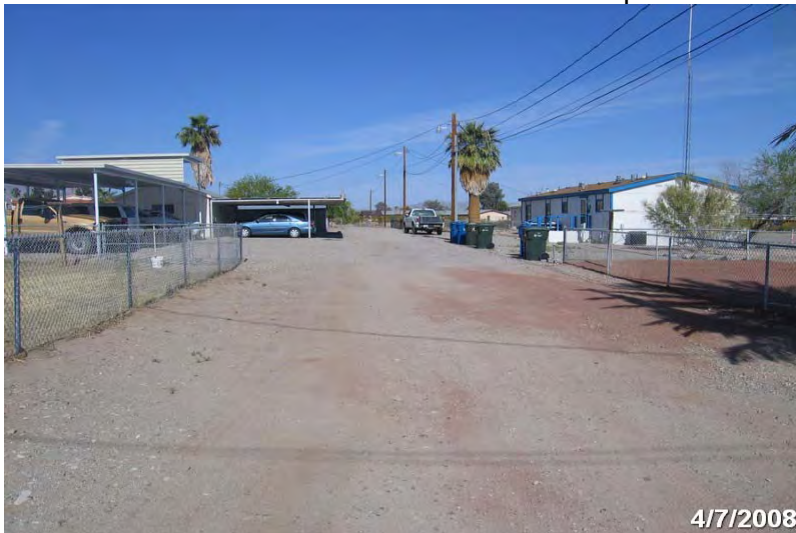
ROUTE NUMBER: 011 ROUTE NAME: Headquarters Drive Connector Road

Photo # 3498 - MP 0.00 - Begin Route at Begin Section

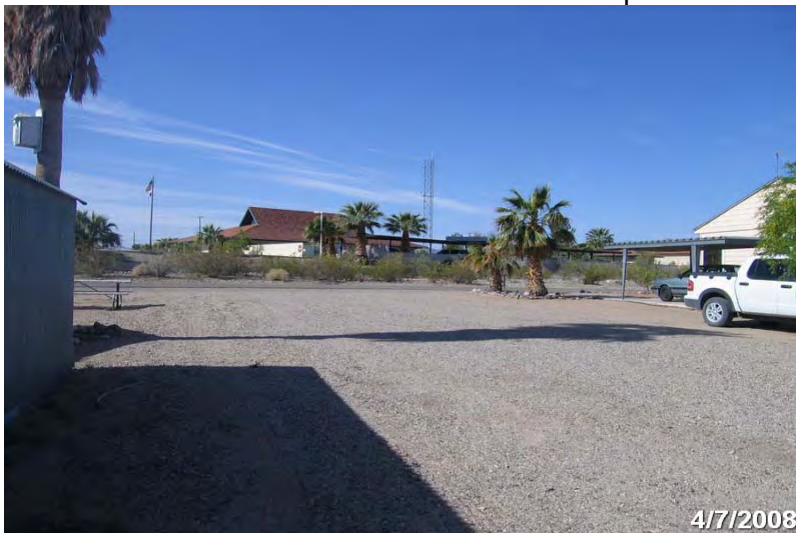
ROUTE NUMBER: 011 ROUTE NAME: Headquarters Drive Connector Road

Photo # 3499 - MP 0.04 - Begin Section 002

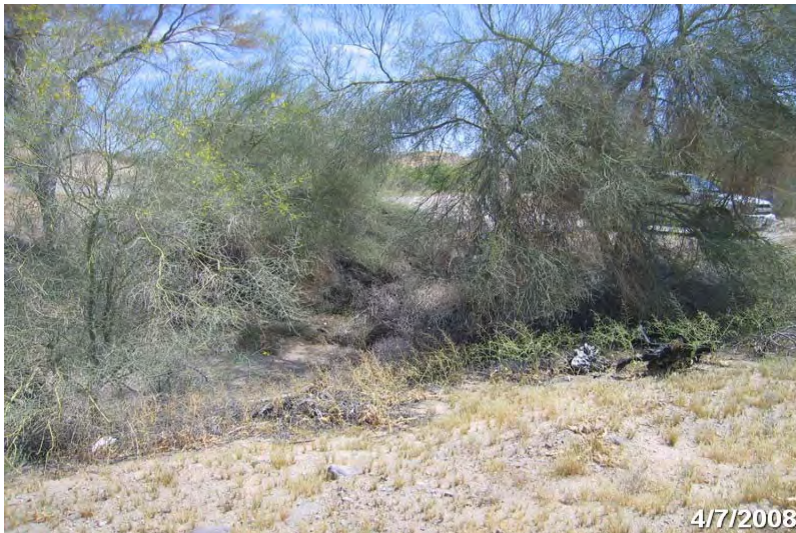
ROUTE NUMBER: 105 ROUTE NAME: Catfish Paradise Access Road

Photo # 3527 - MP 0.16 – Culvert - DEFICIENCY

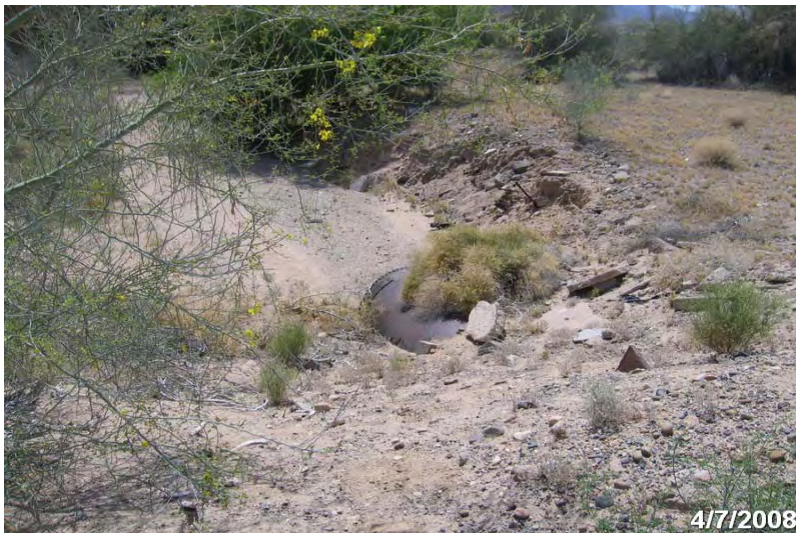
ROUTE NUMBER: 105 ROUTE NAME: Catfish Paradise Access Road

Photo # 3527 - MP 0.00 – Culvert - DEFICIENCY
