The Road Inventory of Imperial National Wildlife Refuge Yuma, AZ

Prepared By:
Federal Highway Administration
Central Federal Lands Highway Division
April 2008

Imperial - 22560 - ROUTE IDENTIFICATION LIST (NUMERIC)

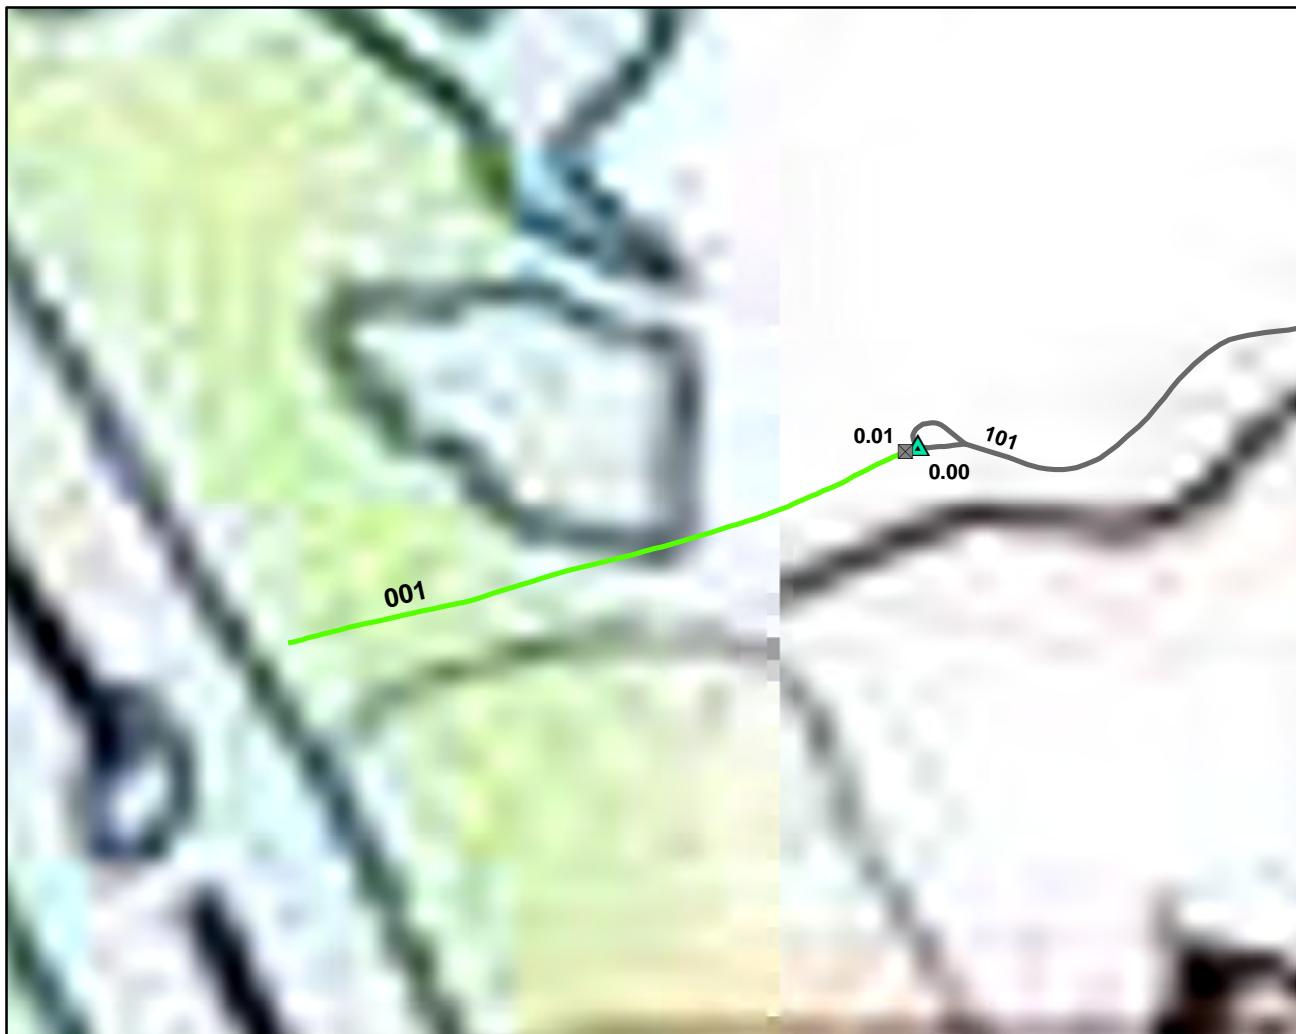
ROUTE: 104 Clear Lake Parking Road

Section Number	001				
Section Length (miles)	0.27				
Inspection Date	4/1/2008				
Section Information					
Surface Type	Native				
Number of Lanes	1				
Roadway Width (feet)	12				
Roadway Condition Information					
Condition	Failed				
Remaining Service Life (years)	0				
Cost Estimate	\$39500				
CRV	\$114700

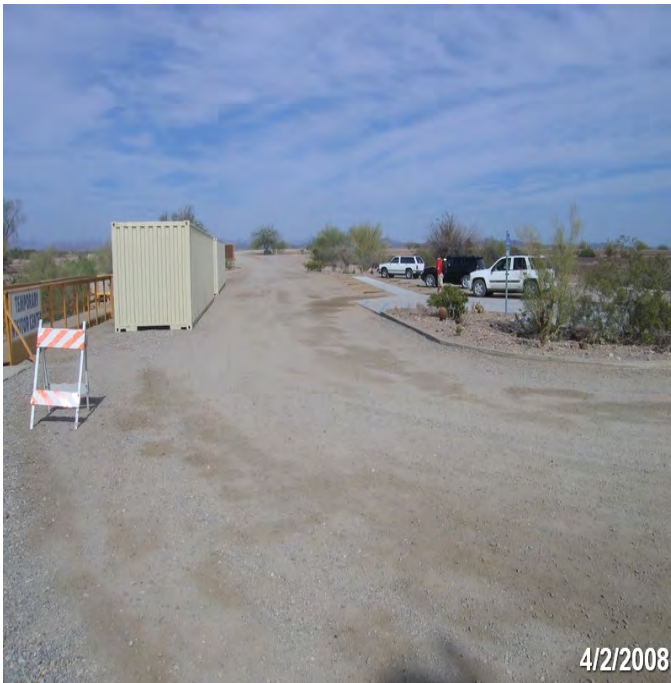
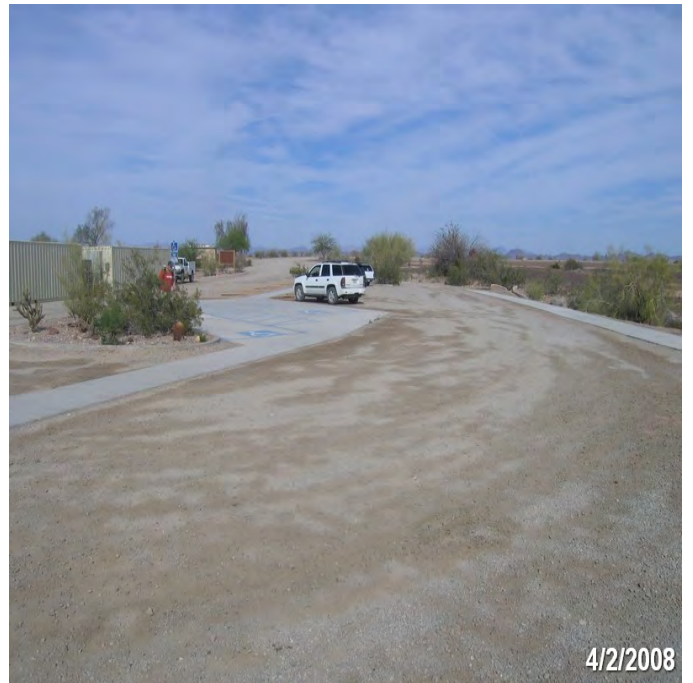
Route 900: Visitor Center Parking

Asset Number	Date Visited	Surface Type	Area (sq ft)	Condition	Cost to Improve
10009912	4/1/2008	Gravel	21656	Good	\$3800

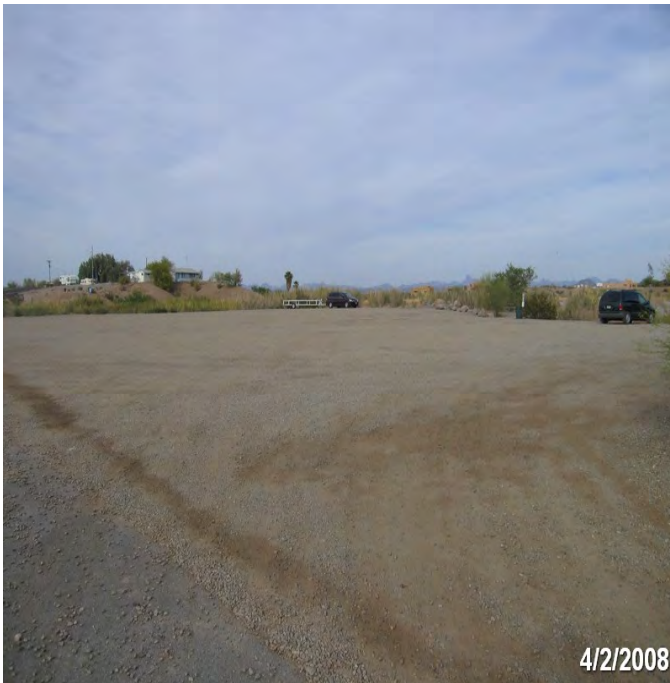
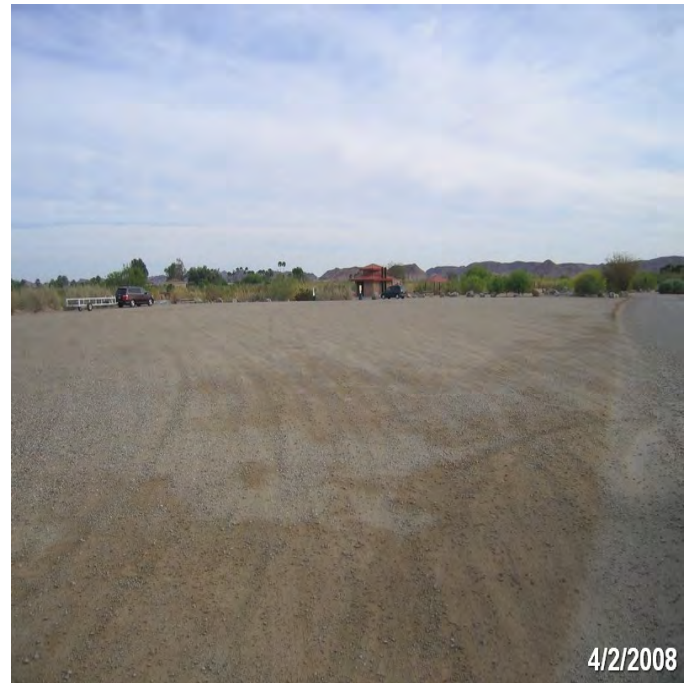
Route 905: Meers Point Boat Ramp Parking

Asset Number	Date Visited	Surface Type	Area (sq ft)	Condition	Cost to Improve
10009916	4/1/2008	Gravel	47698	Good	\$8400
