The Road Inventory of Williams Creek National Fish Hatchery Whitewater, AZ

Prepared By:
Federal Highway Administration
Central Federal Lands Highway Division
April, 2008

Williams Creek National Fish Hatchery ROUTE LOCATION MAP

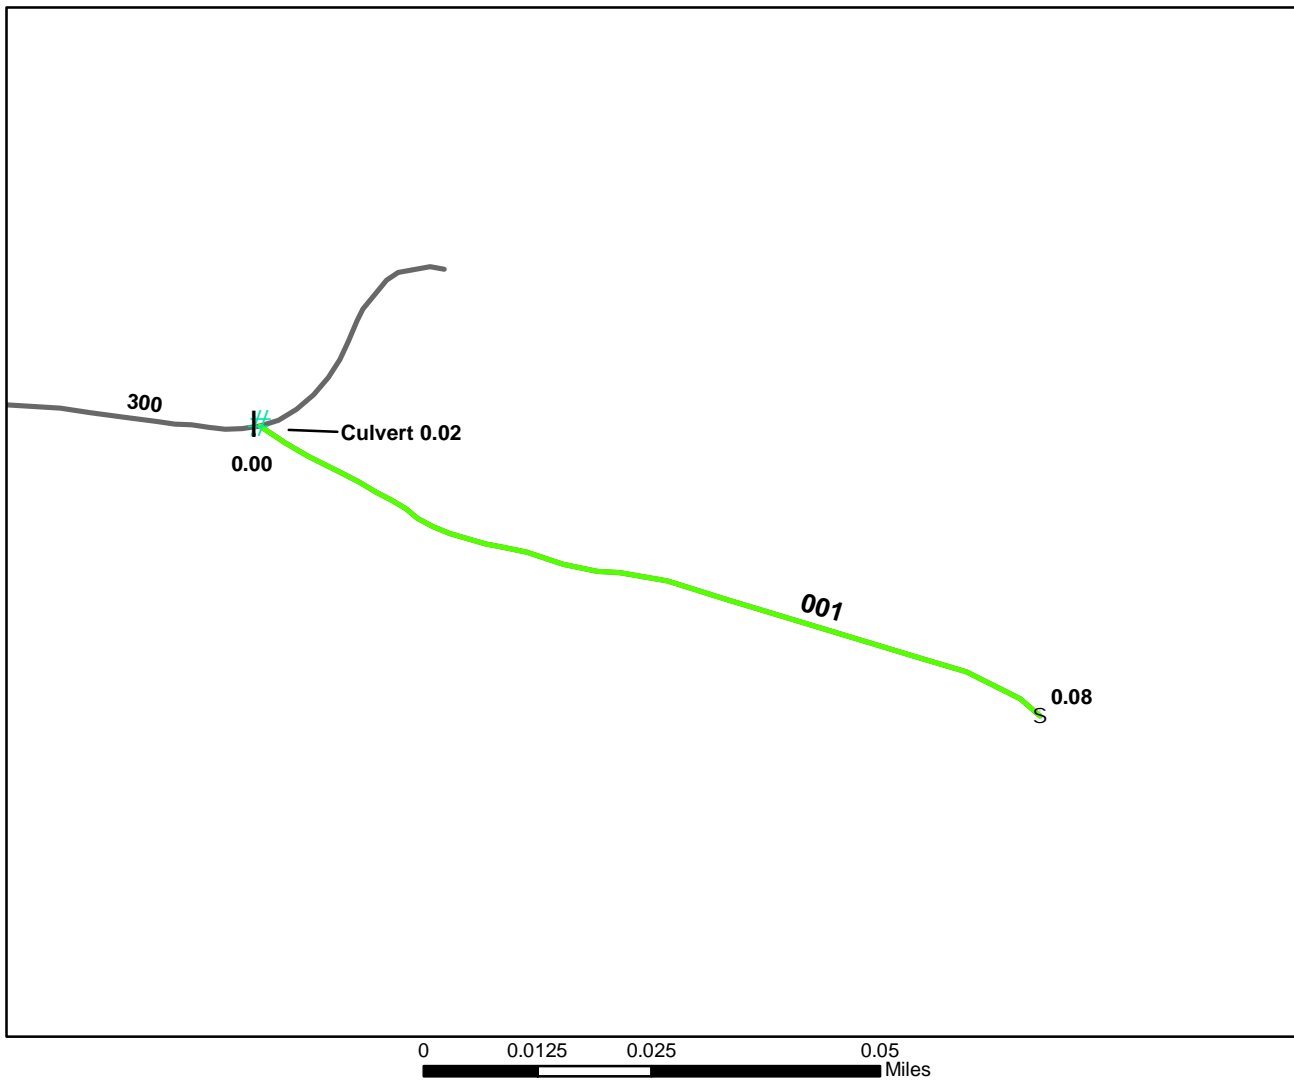
ROUTE: 301 East Gate Road TOTAL LENGTH: 0.08 Miles

RTE DESCRIPTION: From Main Spring Road (Rte 300), to end of route at gate

Section Number	001				
Section Length (miles)	0.08				
Inspection Date	4/9/2008				
Section Information					
Surface Type	Native				
Number of Lanes	1				
Roadway Width (feet)	14				
Roadway Condition Information					
Condition	Good				
Remaining Service Life (years)	7				
Cost Estimate	\$100				
CRV	\$28700

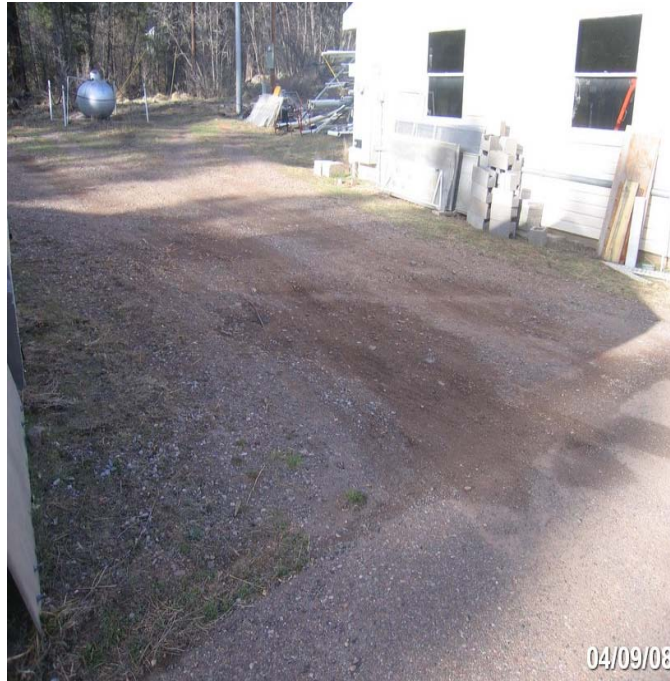
Route 801: Employee Parking

Asset Number	Date Visited	Surface Type	Area (sq ft)	Condition	Cost to Improve
10008663	4/9/2008	Gravel	2093	Good	\$300

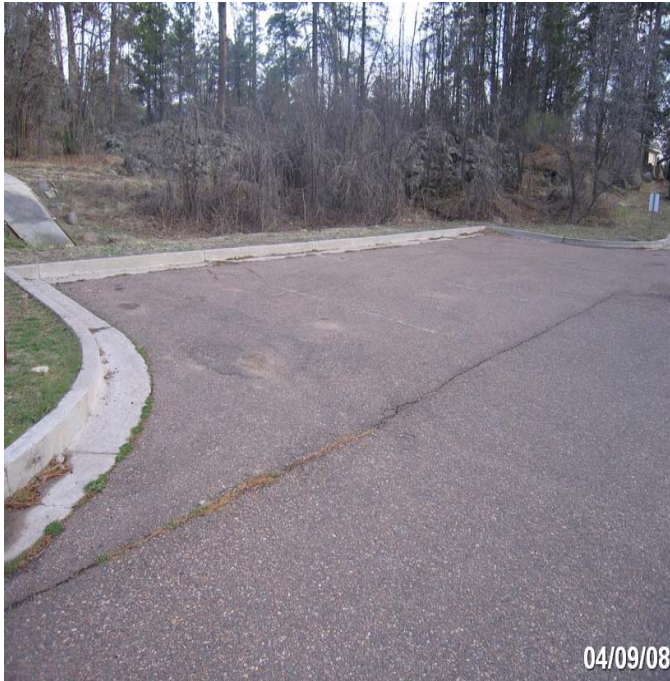
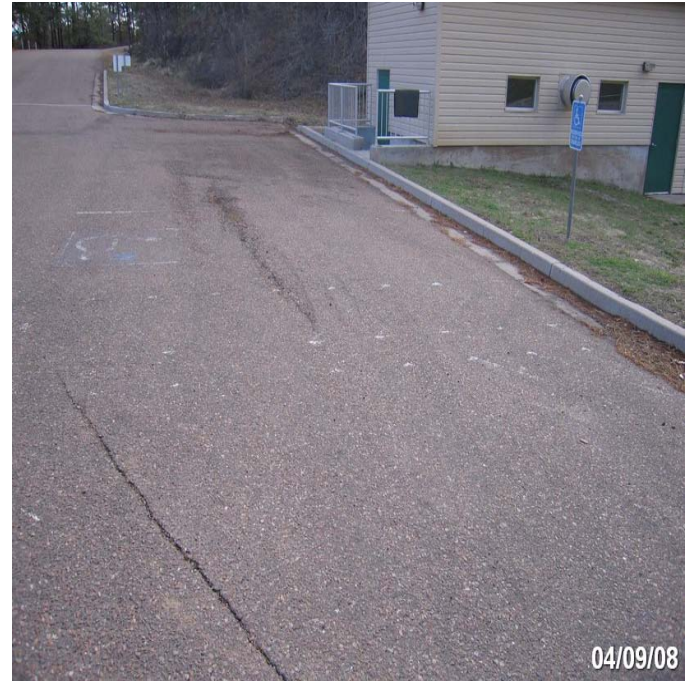
Route 900: Visitor Parking

Asset Number	Date Visited	Surface Type	Area (sq ft)	Condition	Cost to Improve
10008662	4/9/2008	Asphalt	4241	Good	\$800

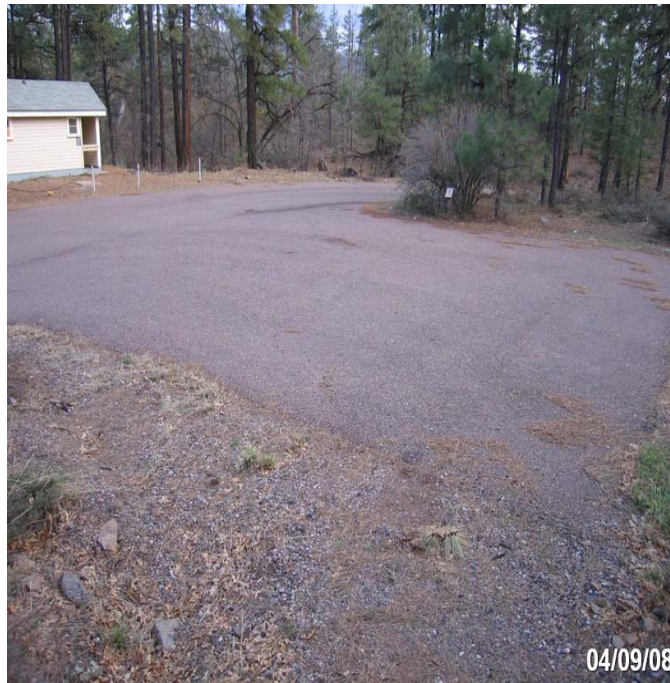
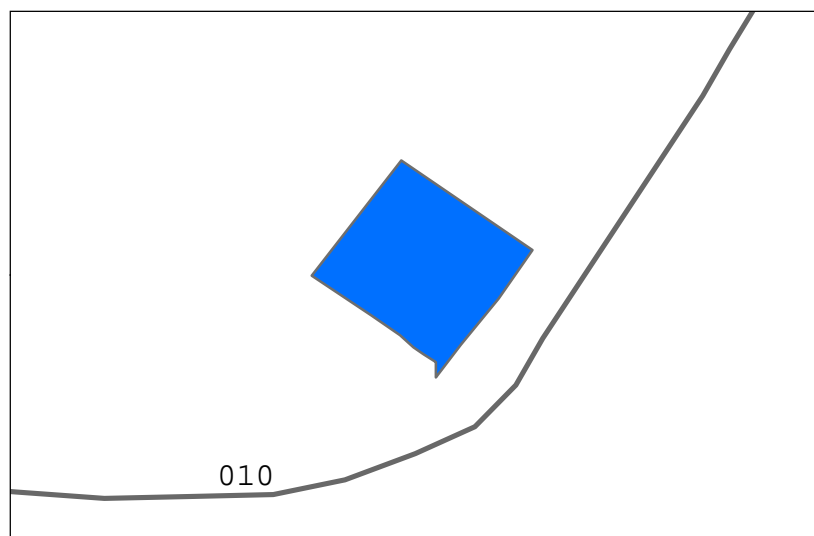
Route 901: Nature Trail Parking

Asset Number	Date Visited	Surface Type	Area (sq ft)	Condition	Cost to Improve
10008662	4/9/2008	Asphalt	1453	Excellent	\$0
