The Road Inventory of Ninepipe National Wildlife Refuge Moiese, Mt

Prepared By:
Federal Highway Administration
Central Federal Lands Highway Division
August 2008

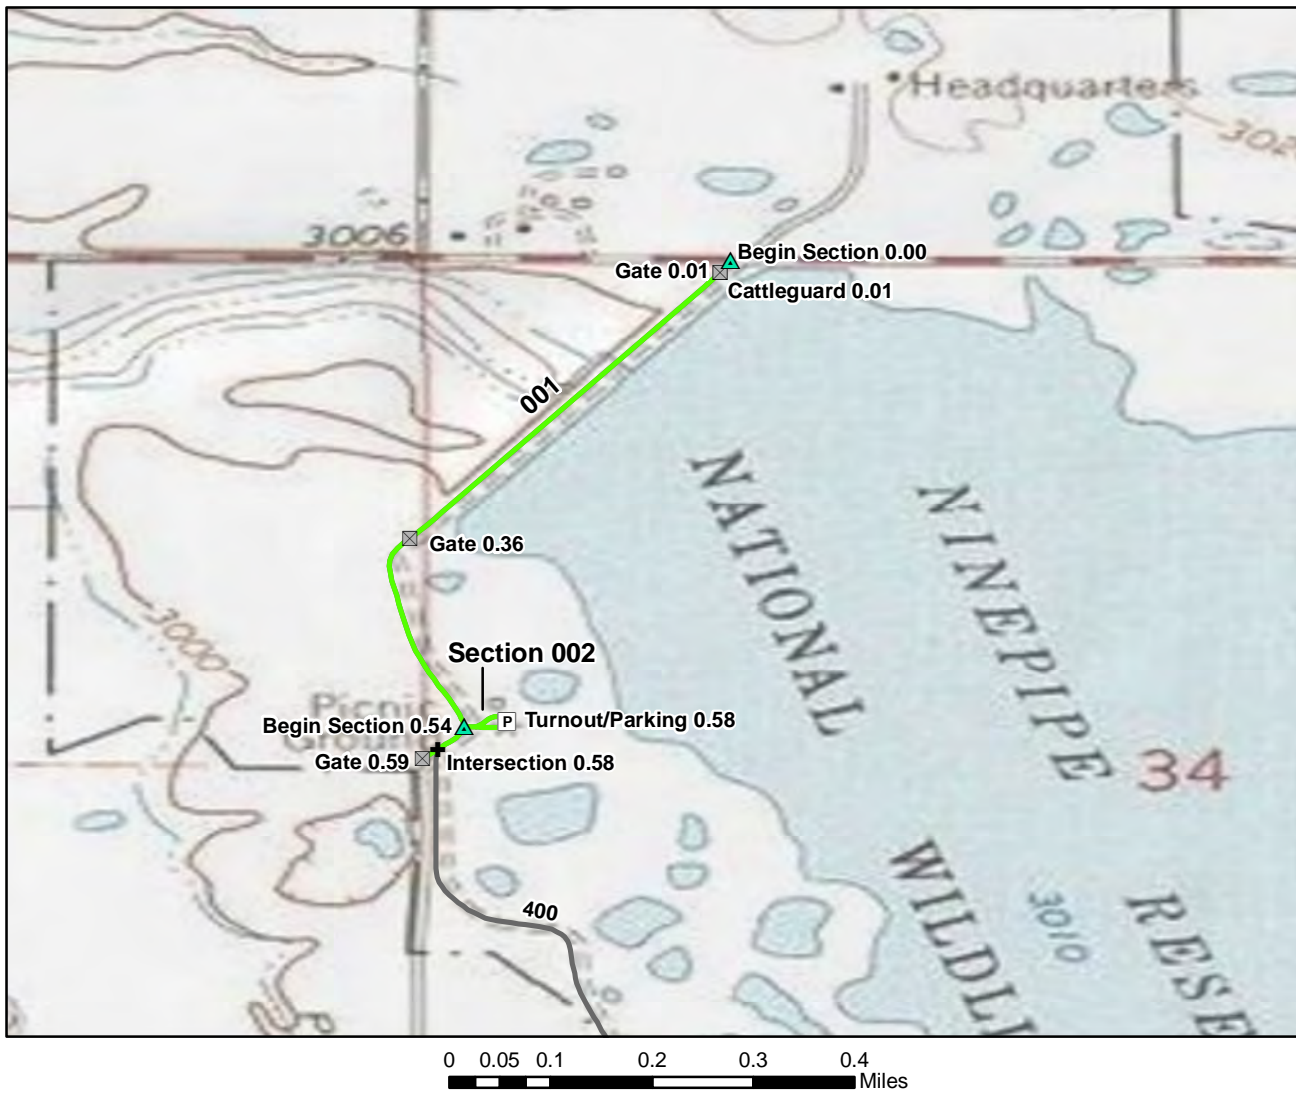
ROUTE: 100 Ninepipe Road

| Condition | Good | Good | | | |
| Remaining Service Life (years) | 5 | 7 | | | |
| Cost Estimate | \$900 | \$100 | | | |

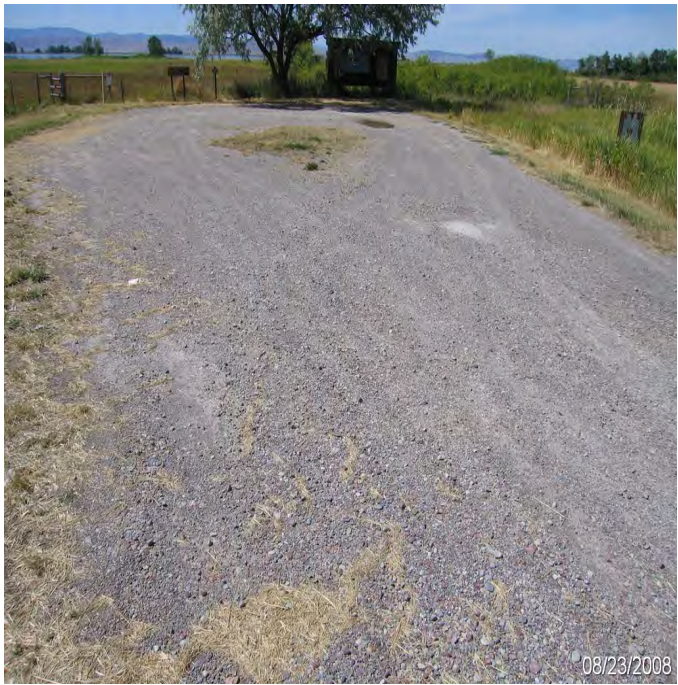
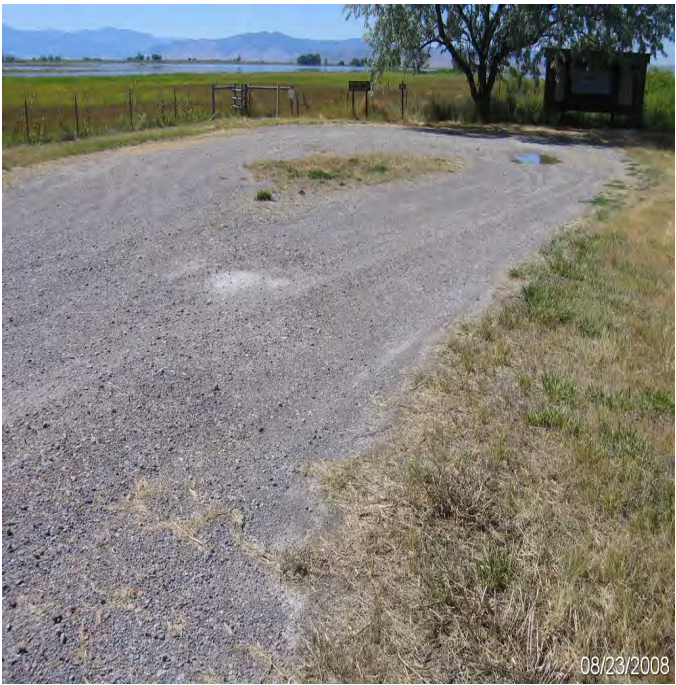
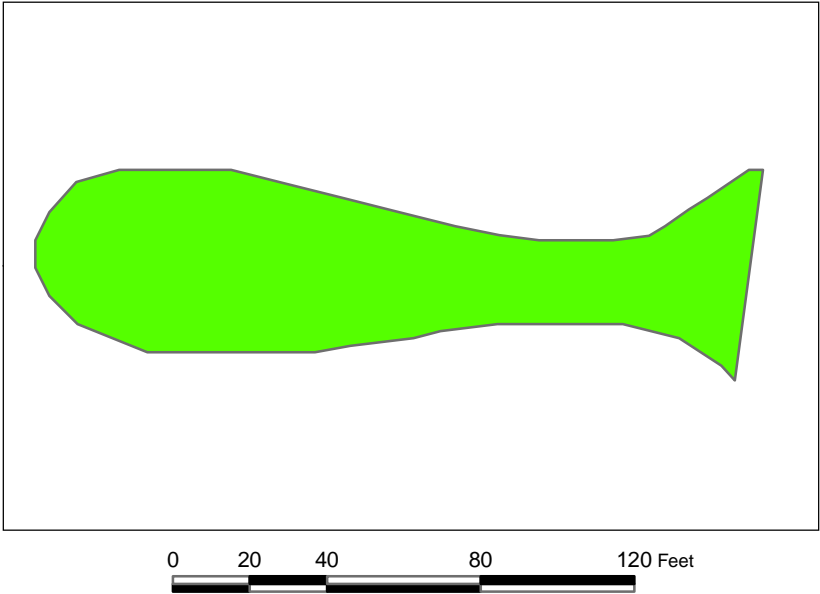
Ninepipe
Route 902: East Access Parking

| Asset Number | Date Visited | Surface Type | Area (sq ft) | Condition | Cost to Improve |
|---|---|---|---|---|---|
| 10026366 | 8/23/2008 | Gravel | 4416 | Good | \$600 |
