# The Road Inventory of Northwest Montana Wetlands Management District Moiese, MT

Prepared By:  
Federal Highway Administration  
Central Federal Lands Highway Division  
August 2008

# Northwest Montana Wetland Management District

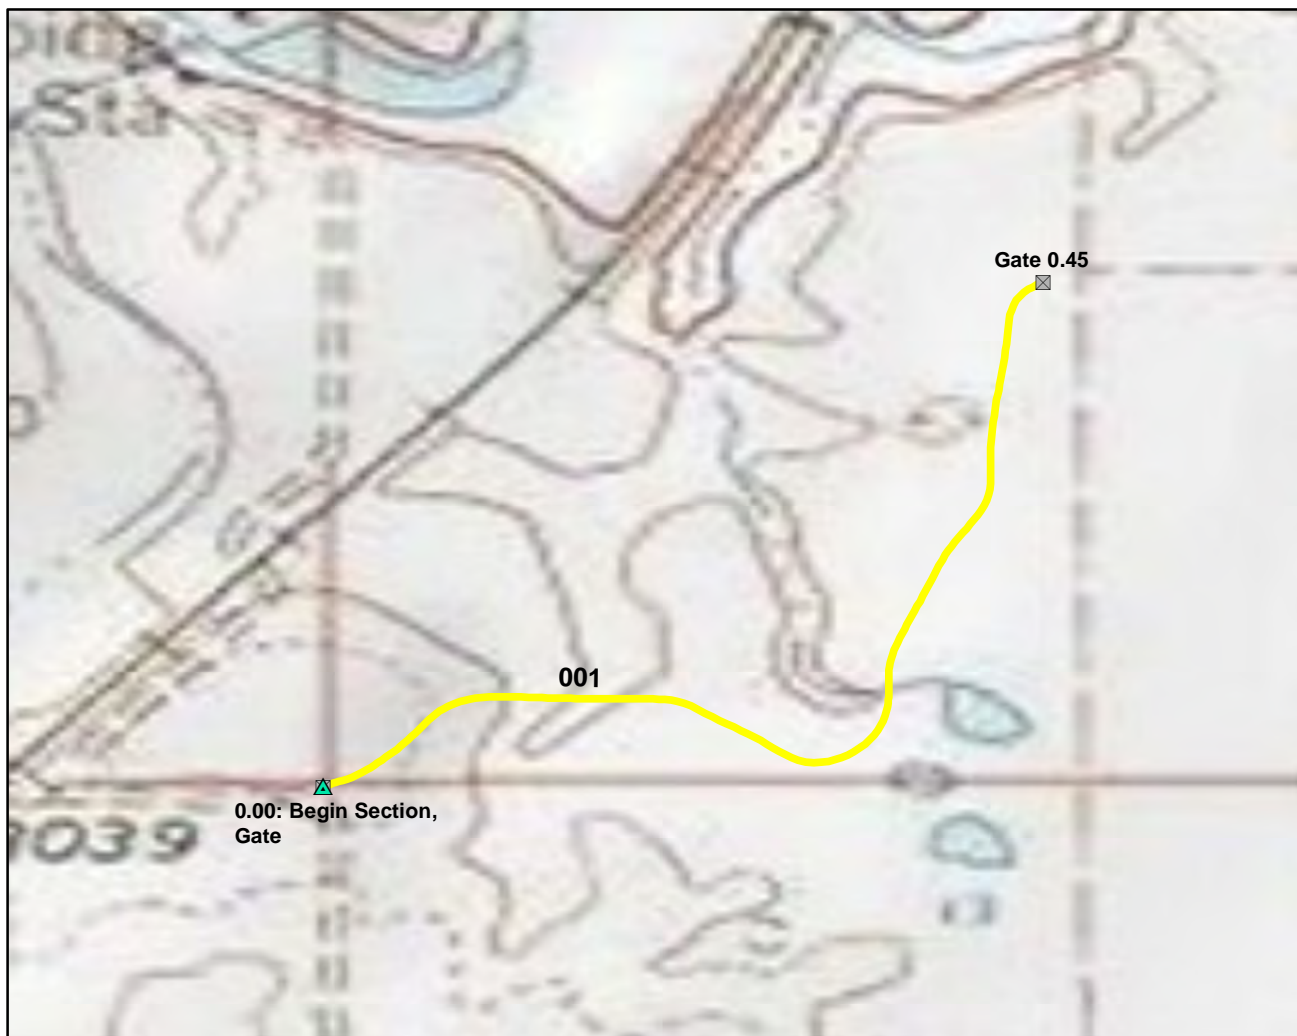
ROUTE: 400 Anderson WPA Access Road TOTAL LENGTH: 0.45 Miles

RTE DESCRIPTION: From Piedalue at WPA Sign through WPA to Private Land

Section Number	001				
Section Length (miles)	0.45				
Inspection Date	8/23/2008				
<b>Section Information</b>					
Surface Type	Native				
Number of Lanes	1				
Roadway Width (feet)	8				
<b>Roadway Condition Information</b>					
Condition	Fair				
Remaining Service Life (years)	3				
Cost Estimate	\$1000				
CRV	\$157400

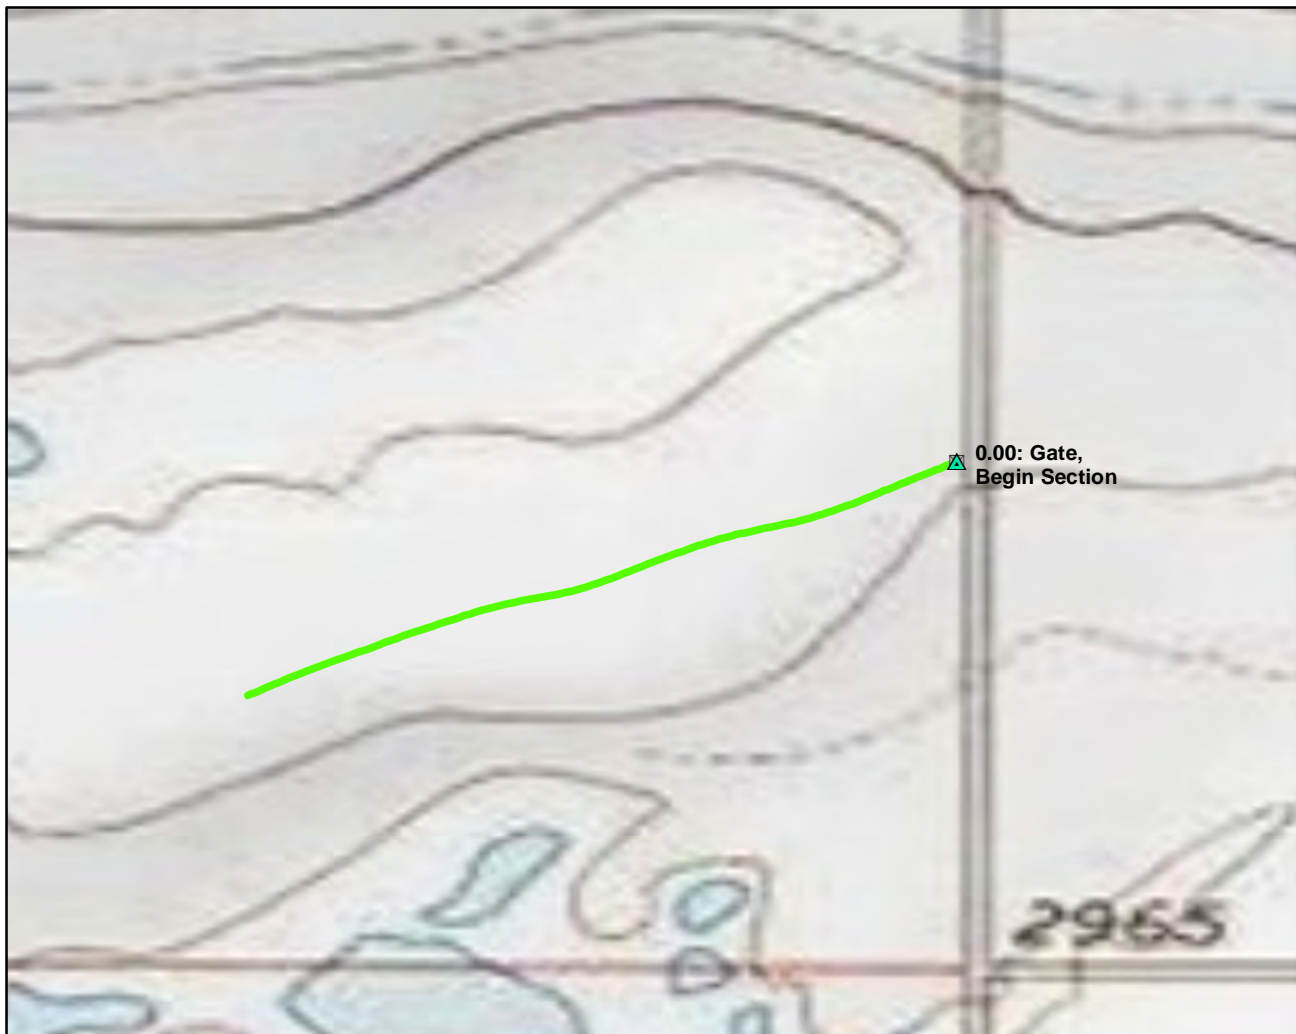
ROUTE: 402 Crow WPA West Access Road TOTAL LENGTH: 0.26 Miles

RTE DESCRIPTION: From Hall Road to end of distinguishable route

Section Number	001				
Section Length (miles)	0.26				
Inspection Date	8/23/2008				
<b>Section Information</b>					
Surface Type	Native				
Number of Lanes	1				
Roadway Width (feet)	8				
<b>Roadway Condition Information</b>					
Condition	Good				
Remaining Service Life (years)	5				
Cost Estimate	\$400				
CRV	\$92000

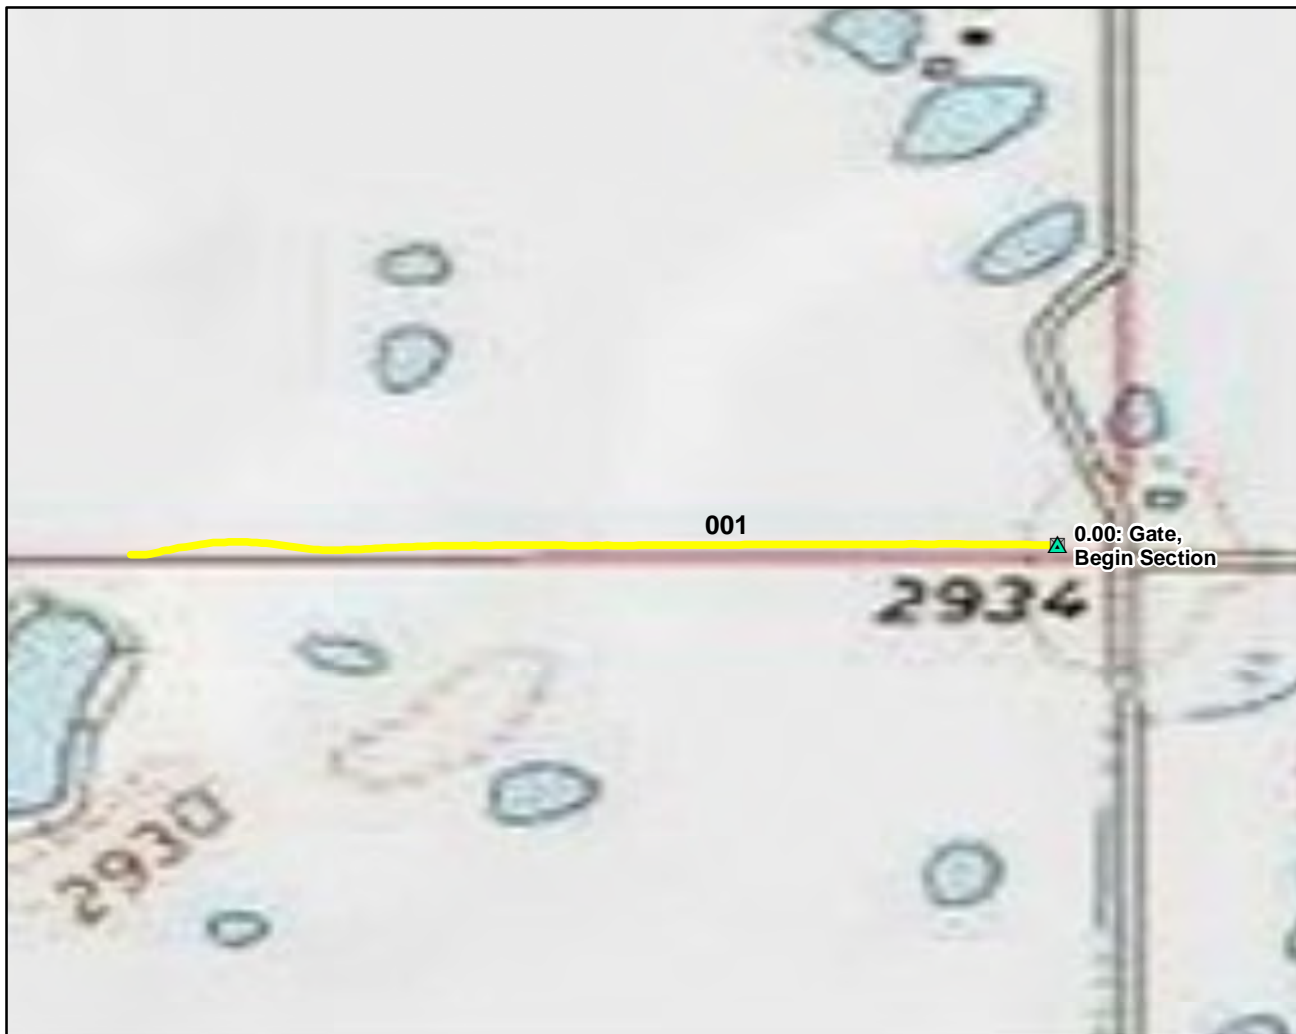
ROUTE: 403 Sandsmark WPA Access Road TOTAL LENGTH: 0.31 Miles

RTE DESCRIPTION: From Ninepipe Road to end of distinguishable route

Section Number	001				
Section Length (miles)	0.31				
Inspection Date	8/23/2008				
<b>Section Information</b>					
Surface Type	Native				
Number of Lanes	1				
Roadway Width (feet)	8				
<b>Roadway Condition Information</b>					
Condition	Fair				
Remaining Service Life (years)	3				
Cost Estimate	\$700				
CRV	\$108300

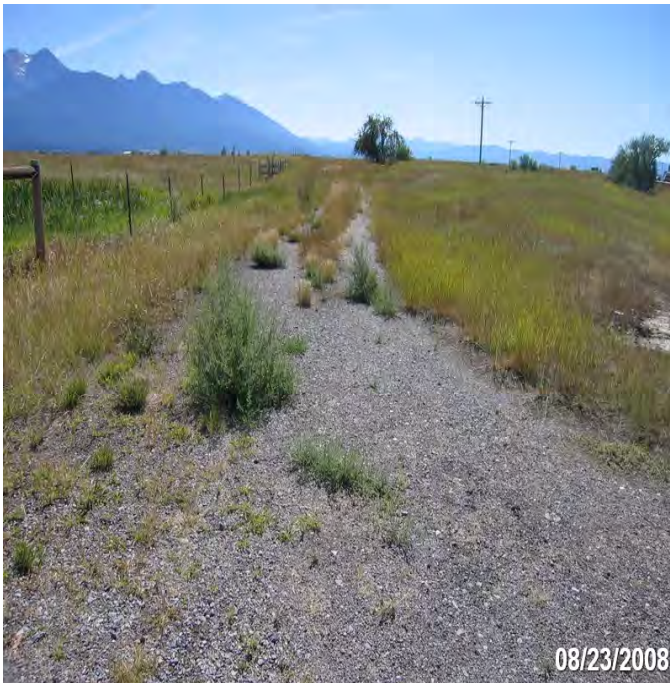
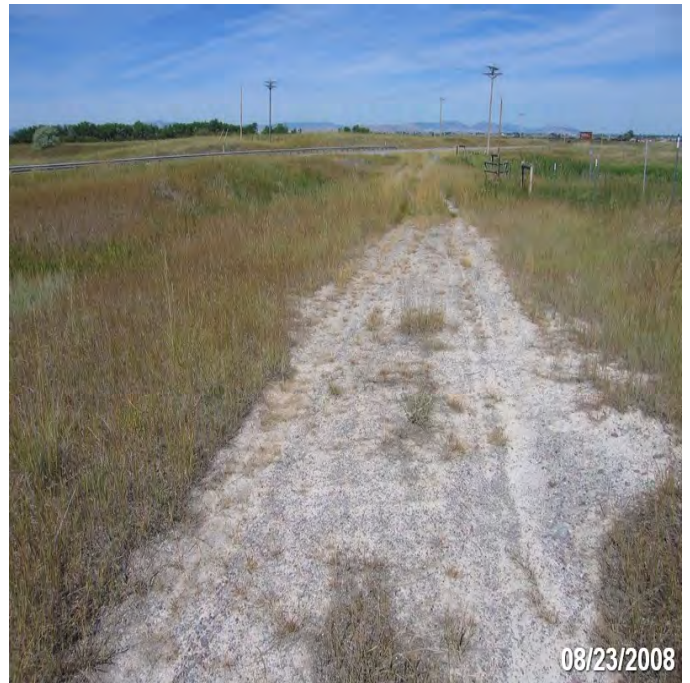
## Route 920: Kicking Horse WPA Parking

Asset Number	Date Visited	Surface Type	Area (sq ft)	Condition	Cost to Improve
10050881	8/23/2008	Gravel	3867	Fair	\$1000

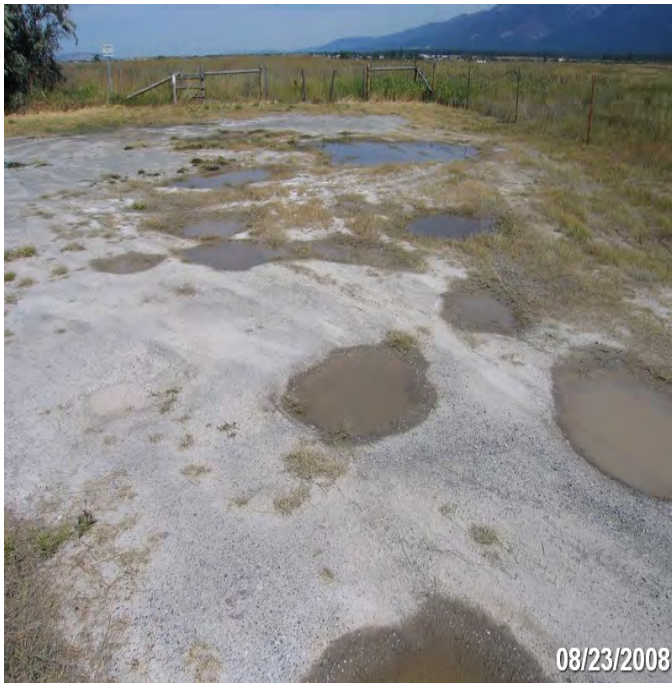
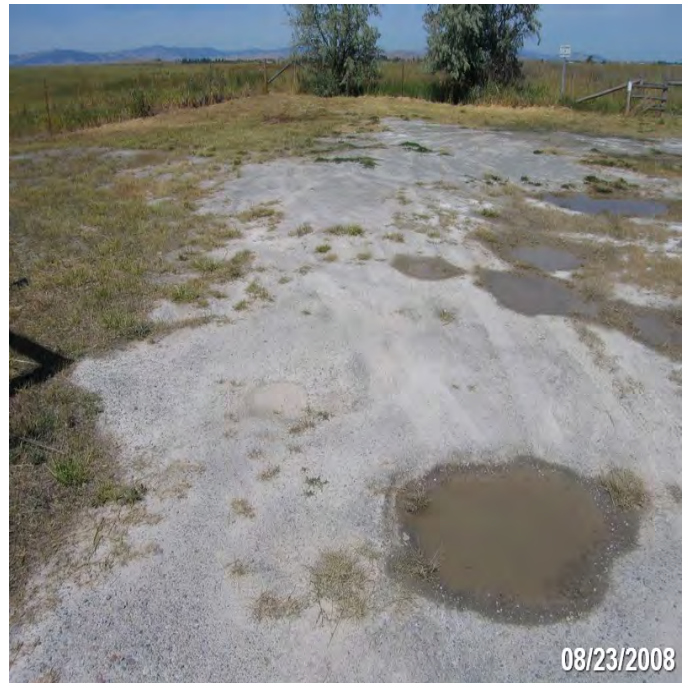
## Route 928: Duck Road Parking

Asset Number	Date Visited	Surface Type	Area (sq ft)	Condition	Cost to Improve
10050843	8/23/2008	Gravel	8483	Failed	\$28100

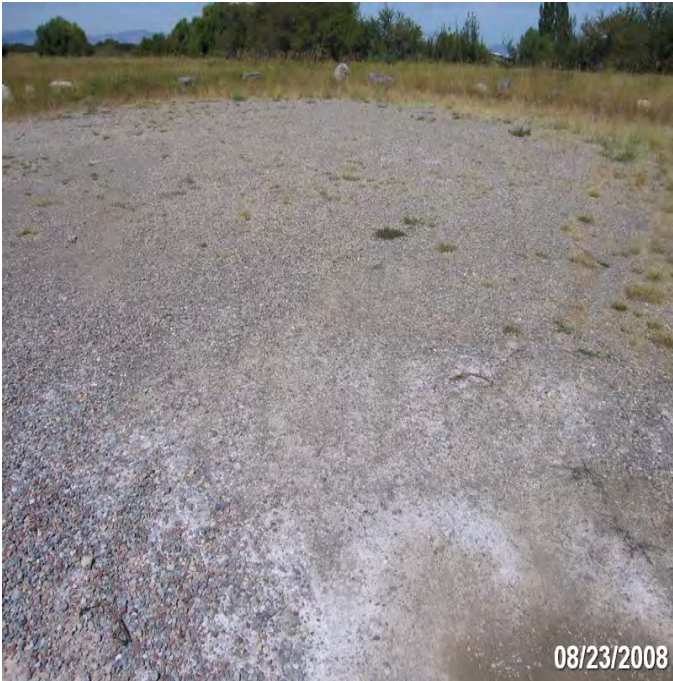
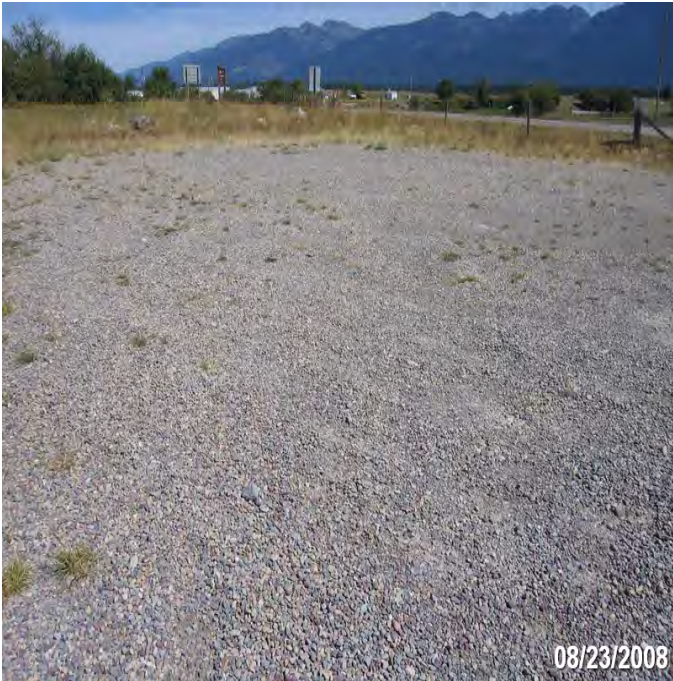
## Route 930: Ereaux WPA Parking

Asset Number	Date Visited	Surface Type	Area (sq ft)	Condition	Cost to Improve
	8/23/2008	Gravel	5470	Excellent	\$0
