# The Road Inventory of Chautauqua National Wildlife Refuge Havana, IL

Prepared By:  
Federal Highway Administration  
Central Federal Lands Highway Division  
December 2009

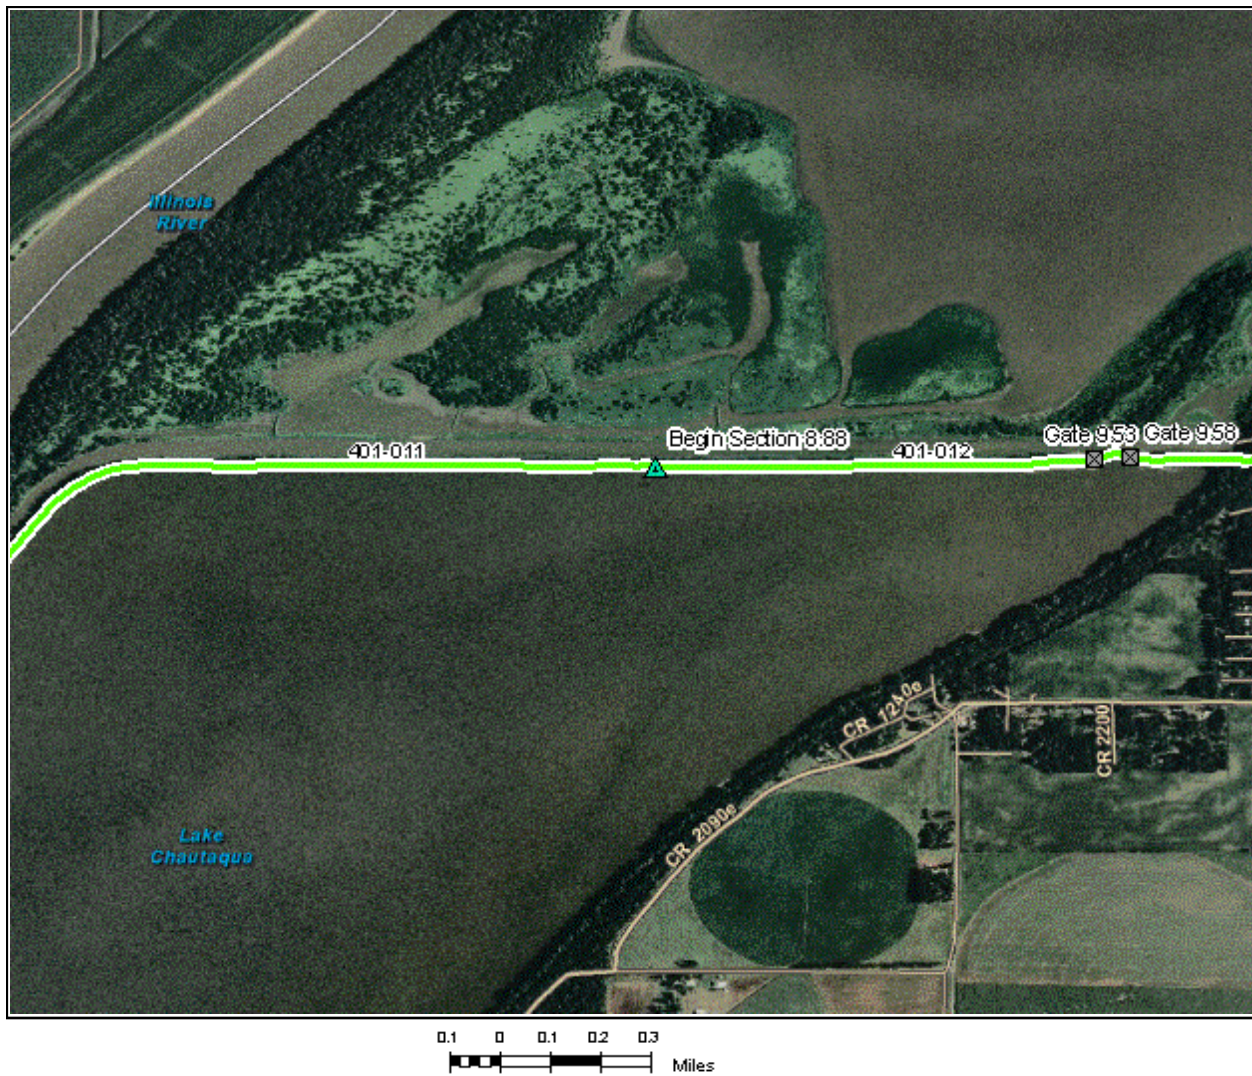
Route: 401 South Lake Chautauqua Lake Wildlife Drive

Asset Number	10013961	10013961
Section Number	011	012
Section Length (miles)	1.06	0.90
Inspection Date	10/09/2009	10/09/2009
<b>Section Information</b>		
Surface Type	Gravel	Gravel
Number of Lanes	1	1
Roadway Width (feet)	12.00	12.00
<b>Roadway Condition Information</b>		
Condition	Good	Good
Remaining Service Life (years)	5	5
Cost Estimate	1,900	1,700
CRV	831,200.00	705,000.00

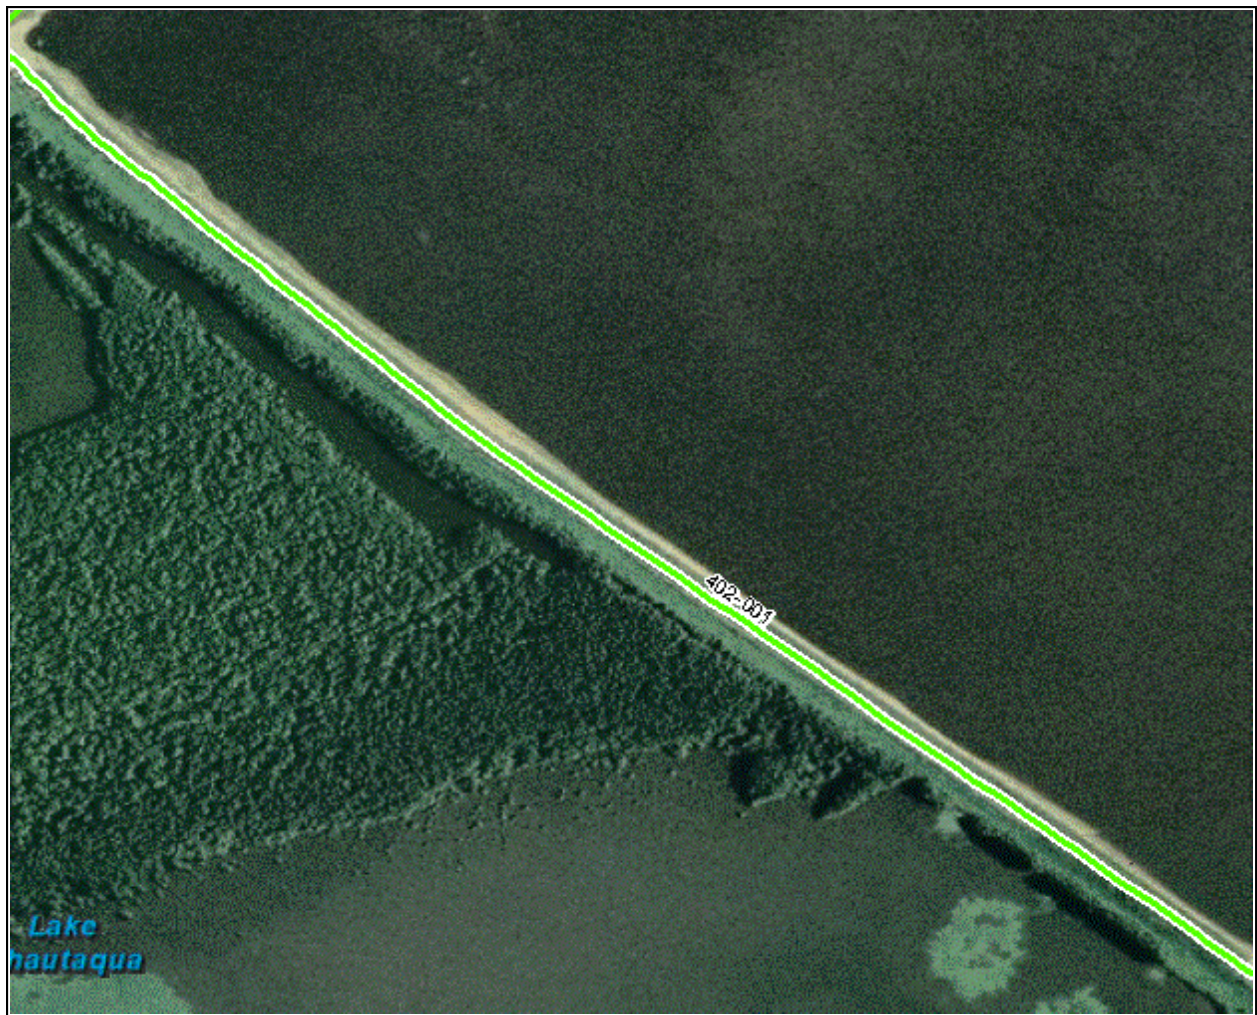
Route: 402 Cross Dike Road

Asset Number	10013969
Section Number	001
Section Length (miles)	0.85
Inspection Date	10/09/2009
<b>Section Information</b>	
Surface Type	Gravel
Number of Lanes	1
Roadway Width (feet)	12.00
<b>Roadway Condition Information</b>	
Condition	Good
Remaining Service Life (years)	7
Cost Estimate	1,600
CRV	664,900.00

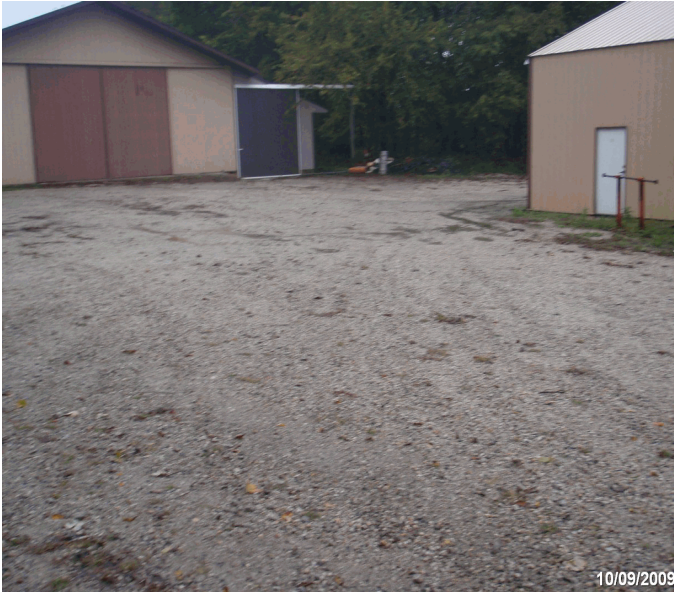
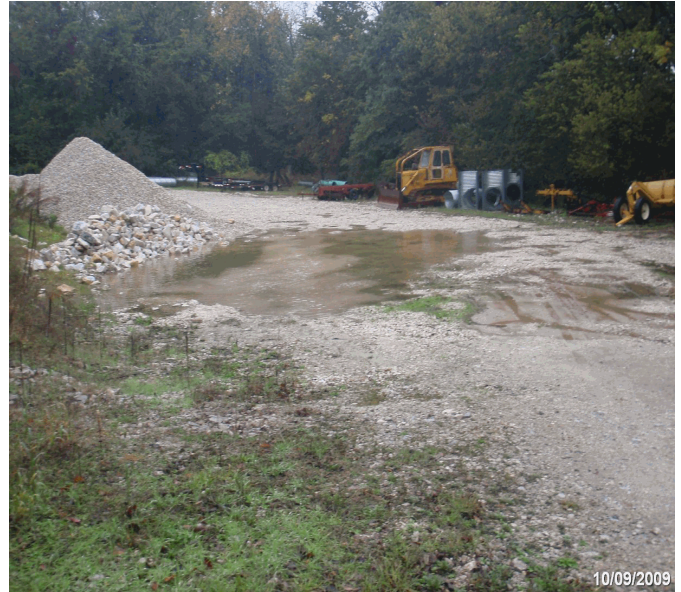
## 800: Boneyard Parking

Asset Number	Date Visited	Surface Type	Area (Sq Ft)	Condition	Cost to Improve
	10/09/2009	Gravel	39,818	Fair	11,900

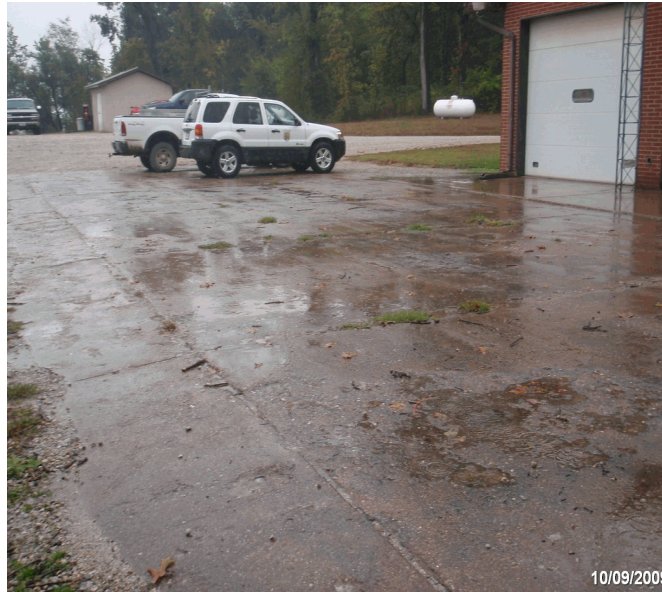
### 803: Staff Concrete Parking

Asset Number	Date Visited	Surface Type	Area (Sq Ft)	Condition	Cost to Improve
	10/09/2009	Concrete	1,776	Fair	3,700

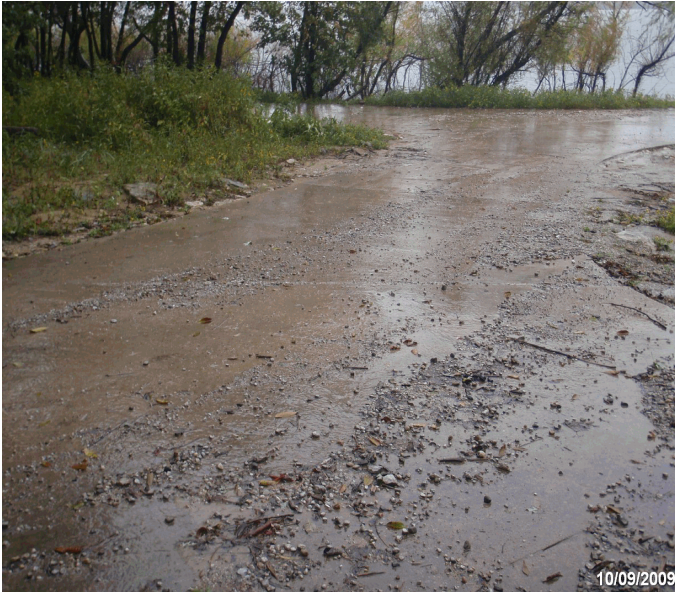
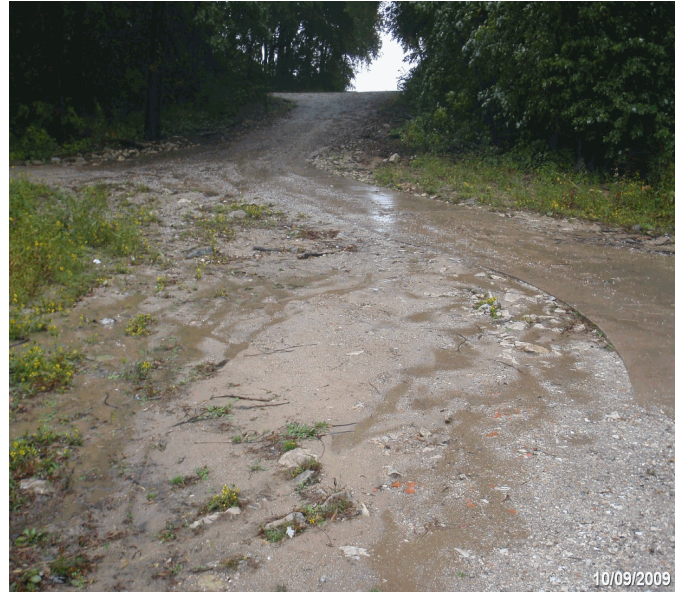
## 902: Eagle Bluff Boatramp Parking

Asset Number	Date Visited	Surface Type	Area (Sq Ft)	Condition	Cost to Improve
10036207	10/09/2009	Concrete	4,824	Fair	9,900

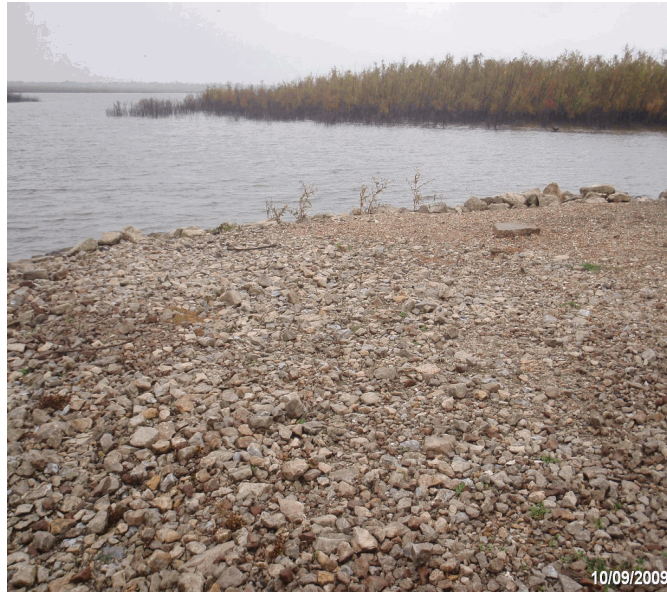
## 906: Auto Tour Parking A

Asset Number	Date Visited	Surface Type	Area (Sq Ft)	Condition	Cost to Improve
10043091	10/09/2009	Gravel	1,319	Fair	400

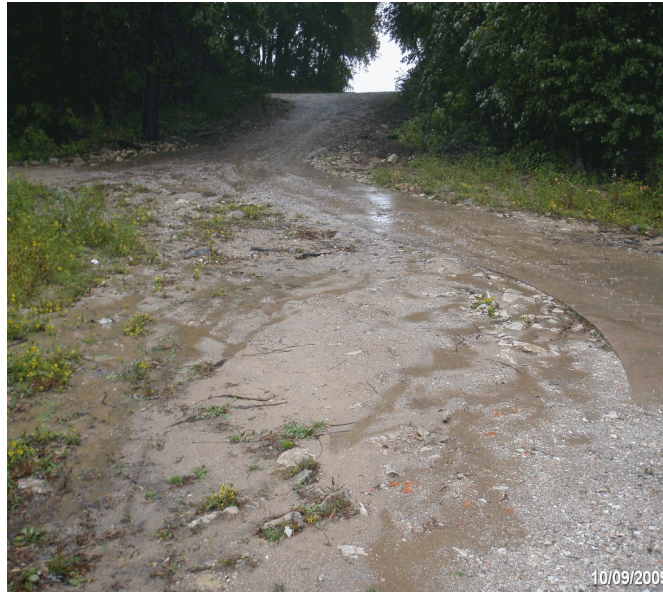
### 910: Eagle Bluff Gravel Entrance Parking

Asset Number	Date Visited	Surface Type	Area (Sq Ft)	Condition	Cost to Improve
	10/09/2009	Gravel	1,072	Fair	300
