# The Road Inventory of Rydell National Wildlife Refuge Erskine, MN

Prepared By:  
Federal Highway Administration  
Central Federal Lands Highway Division  
December 2009

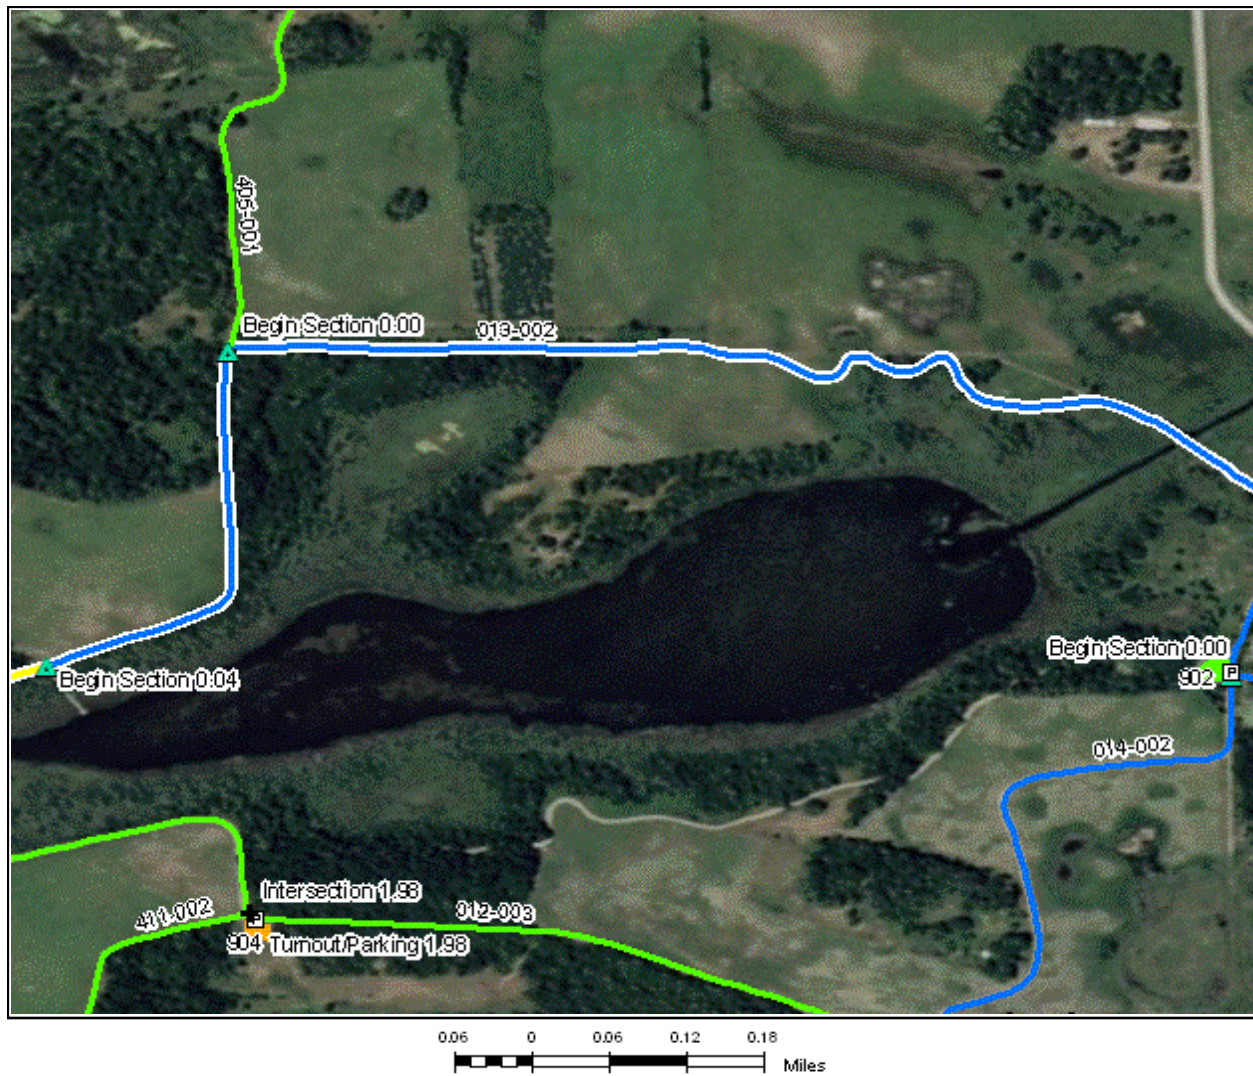
Route: 013 Auto Tour Road

Route Description: From Church Lake Road (Route 012) to Tamarac Trail Road (Route 014)

Asset Number	10043695	10043695
Section Number	001	002
Section Length (miles)	0.04	0.91
Inspection Date	08/03/2009	08/03/2009
<b>Section Information</b>		
Surface Type	Asphalt	Gravel
Number of Lanes	1	1
Roadway Width (feet)	10.00	10.00
<b>Roadway Condition Information</b>		
Condition	Fair	Excellent
Remaining Service Life (years)	10	8
Cost Estimate	4,300	0
CRV	47,200.00	583,300.00

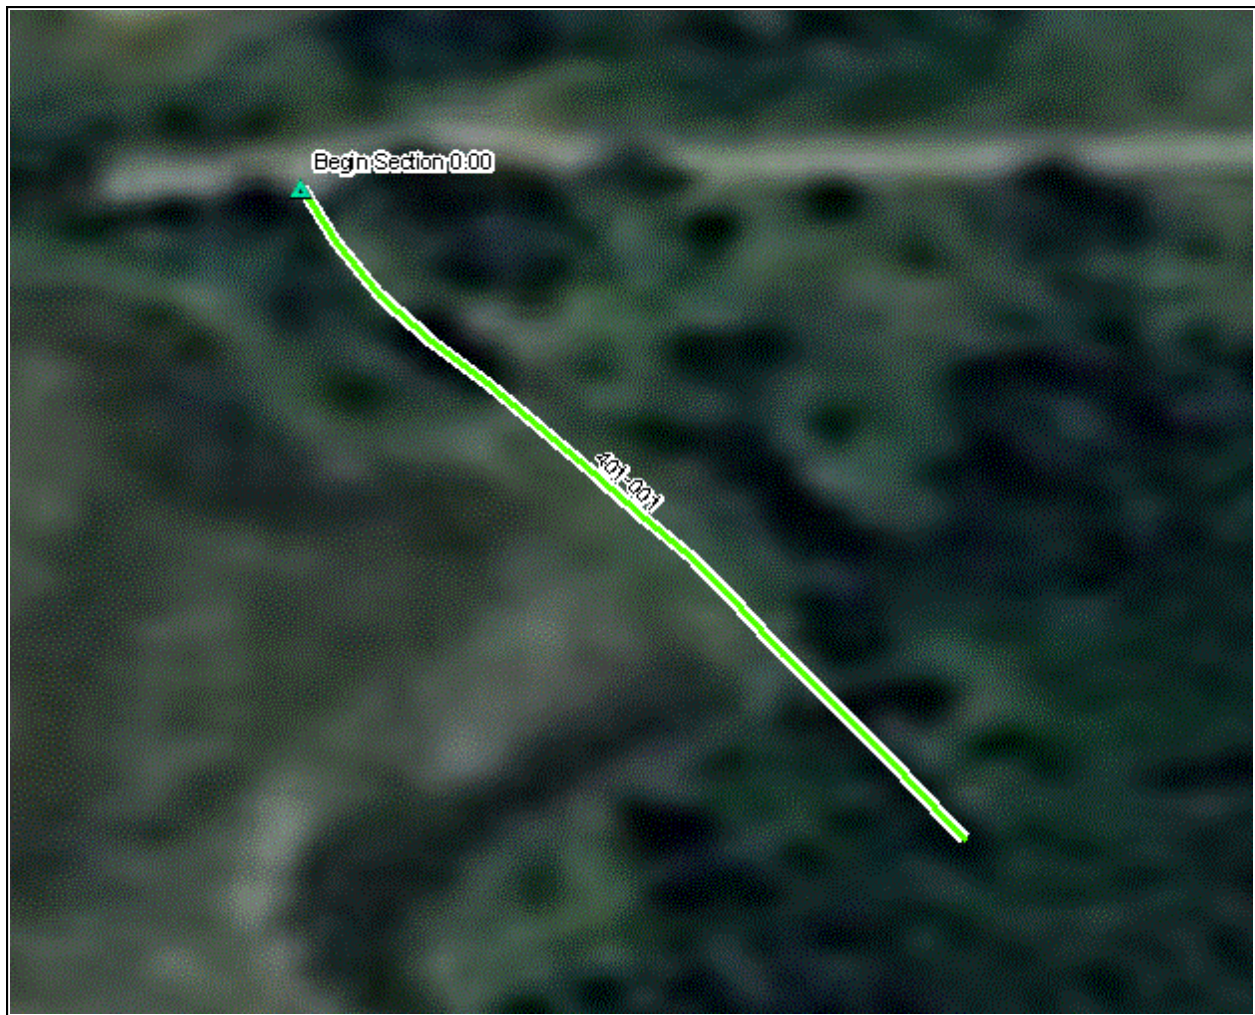
Asset Number	10053164
Section Number	001
Section Length (miles)	0.10
Inspection Date	07/28/2009
<b>Section Information</b>	
Surface Type	Gravel
Number of Lanes	1
Roadway Width (feet)	12.00
<b>Roadway Condition Information</b>	
Condition	Excellent
Remaining Service Life (years)	10
Cost Estimate	0
CRV	61,000.00

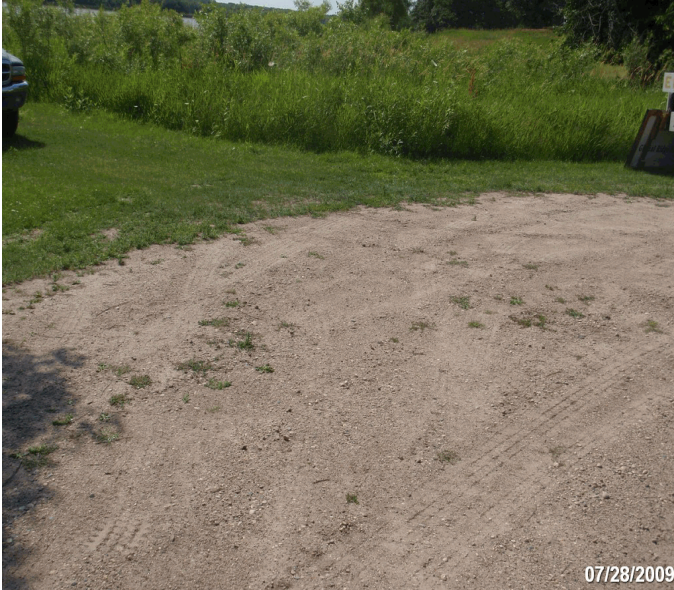
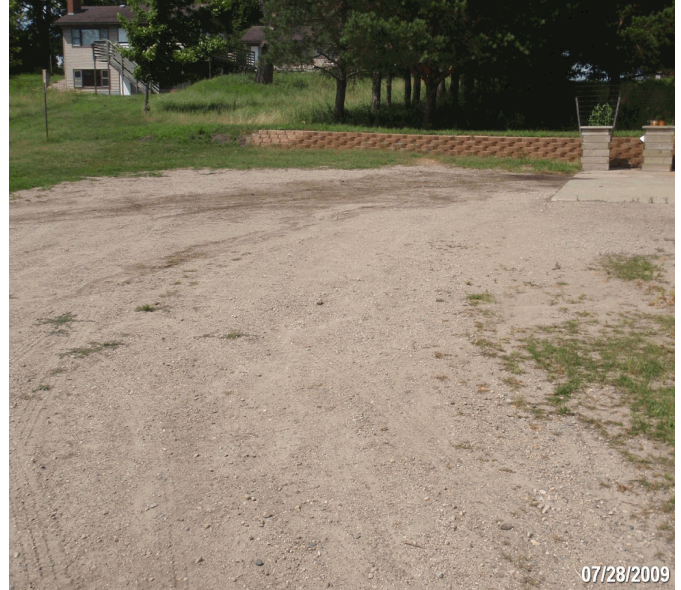
## 800: Shop Parking

Asset Number	Date Visited	Surface Type	Area (Sq Ft)	Condition	Cost to Improve
	07/28/2009	Gravel	4,350	Good	600

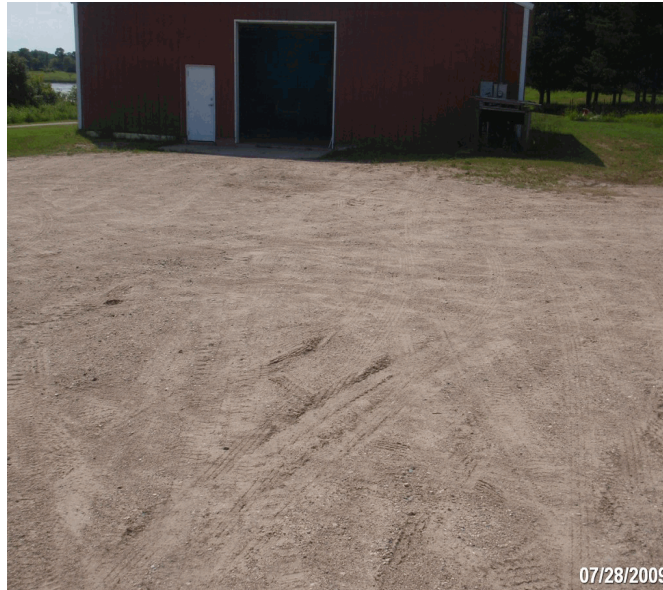
## 801: Shop Parking #2

Asset Number	Date Visited	Surface Type	Area (Sq Ft)	Condition	Cost to Improve
	07/28/2009	Gravel	5,191	Good	700

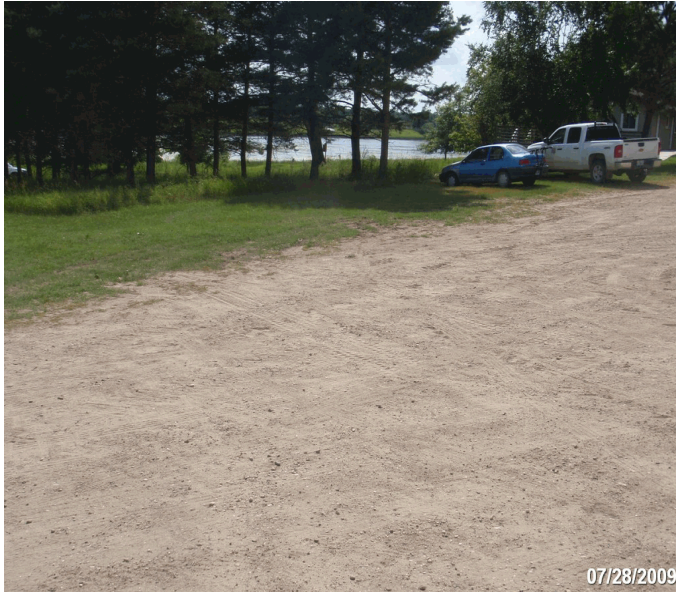
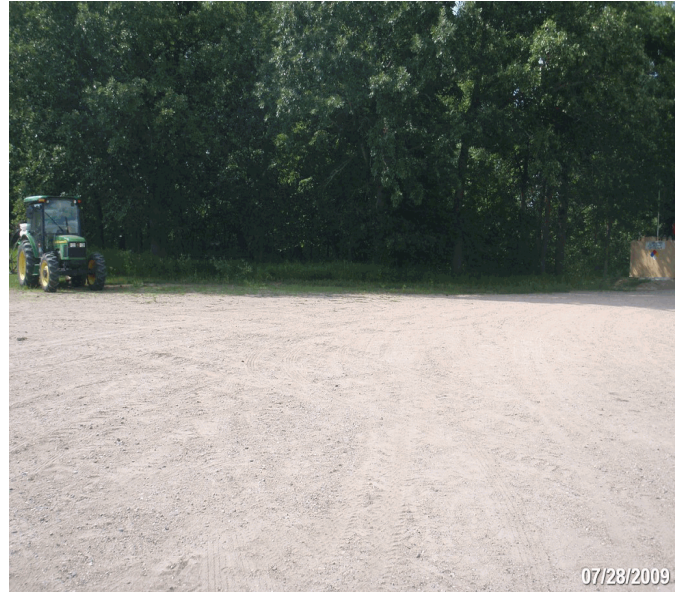
### 802: Shop Parking #3

Asset Number	Date Visited	Surface Type	Area (Sq Ft)	Condition	Cost to Improve
	07/28/2009	Gravel	8,643	Good	1,200

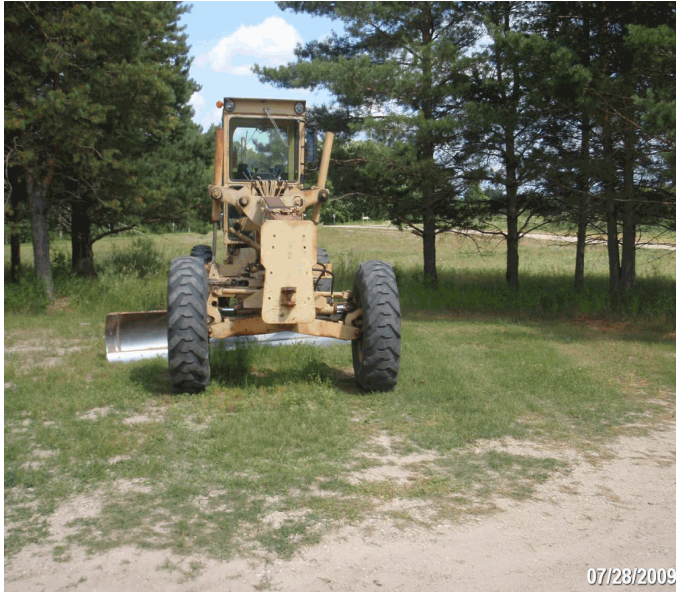
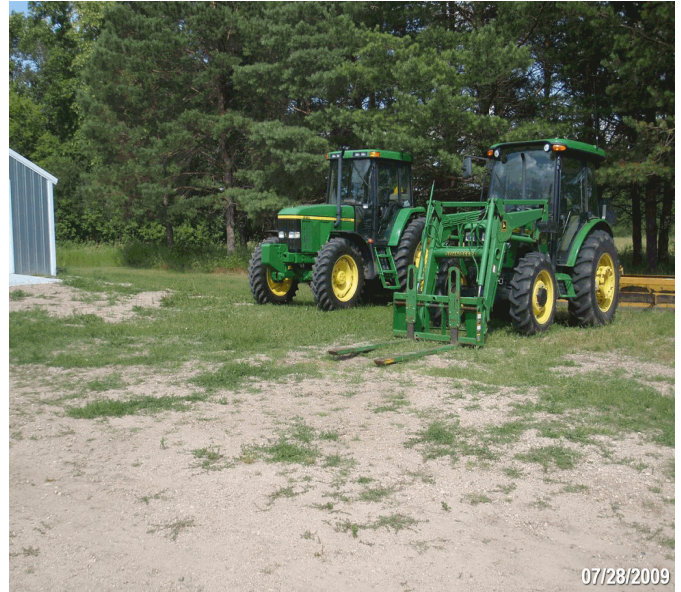
### 803: Shop Parking #4

Asset Number	Date Visited	Surface Type	Area (Sq Ft)	Condition	Cost to Improve
	07/28/2009	Gravel	3,111	Good	400

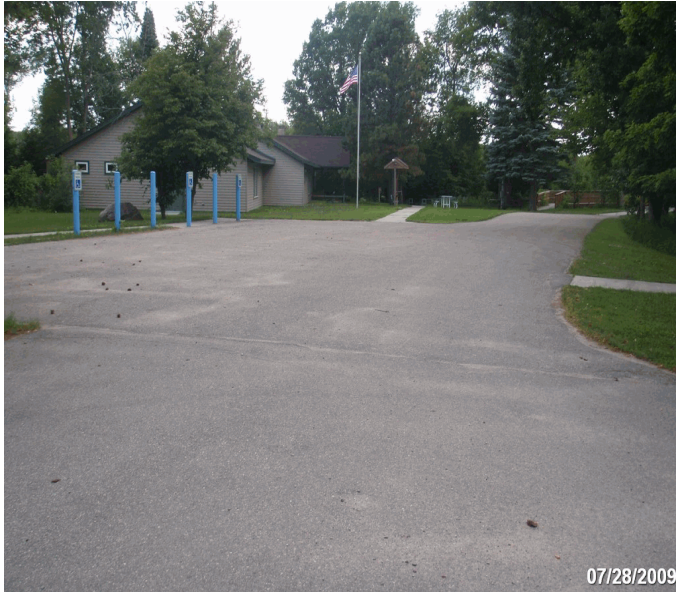
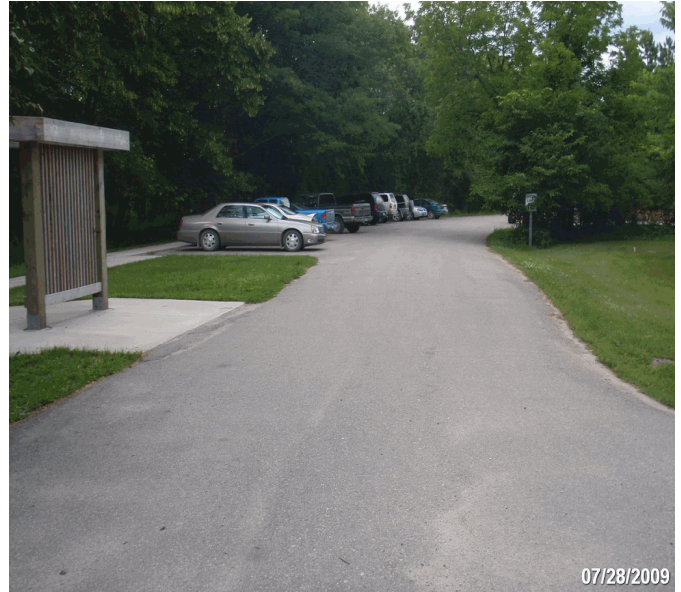
### 900: Headquarters Parking

Asset Number	Date Visited	Surface Type	Area (Sq Ft)	Condition	Cost to Improve
10012049	07/28/2009	Asphalt	15,732	Good	2,700

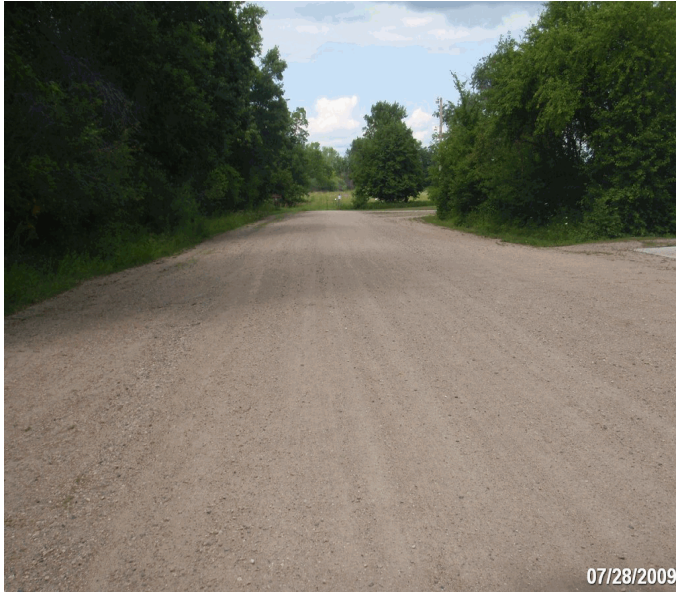
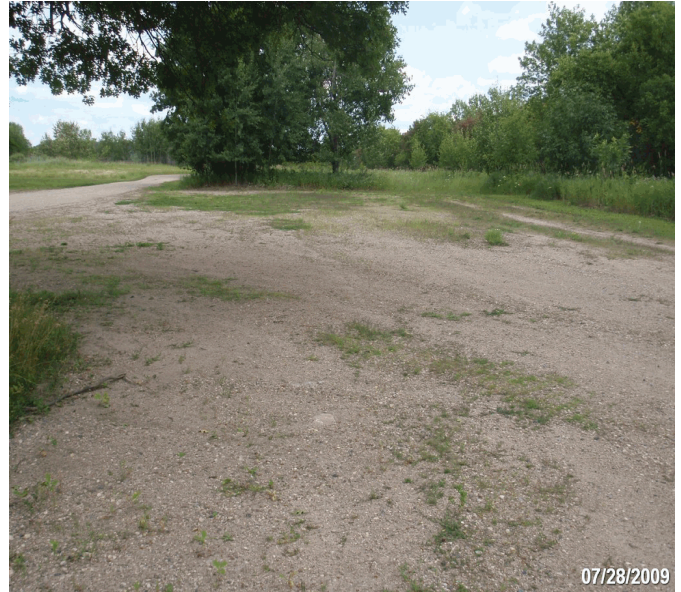
## 901: Overflow Parking

Asset Number	Date Visited	Surface Type	Area (Sq Ft)	Condition	Cost to Improve
10043698	07/28/2009	Gravel	22,089	Fair	5,400

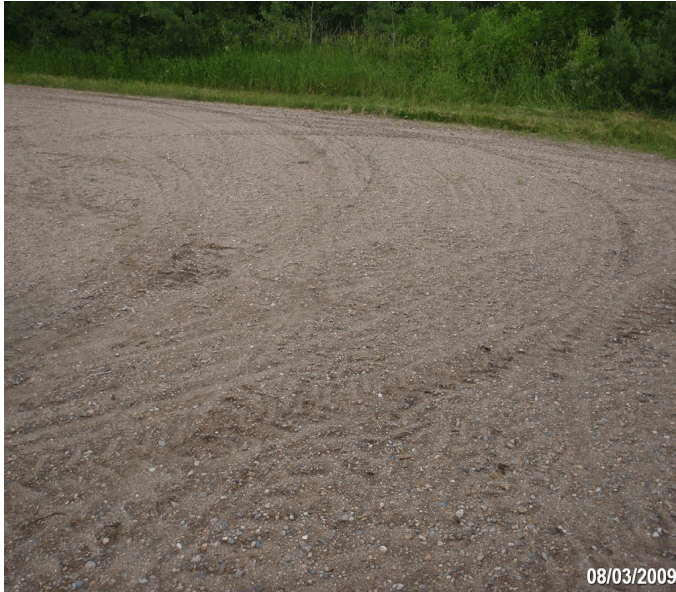
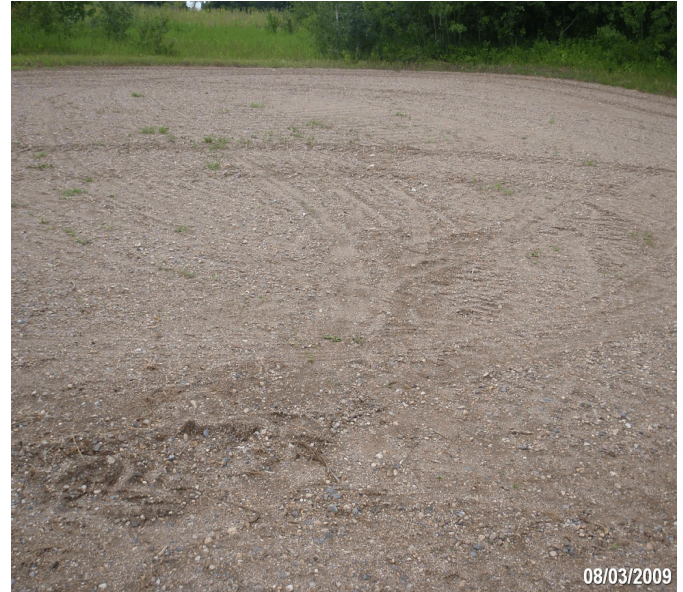
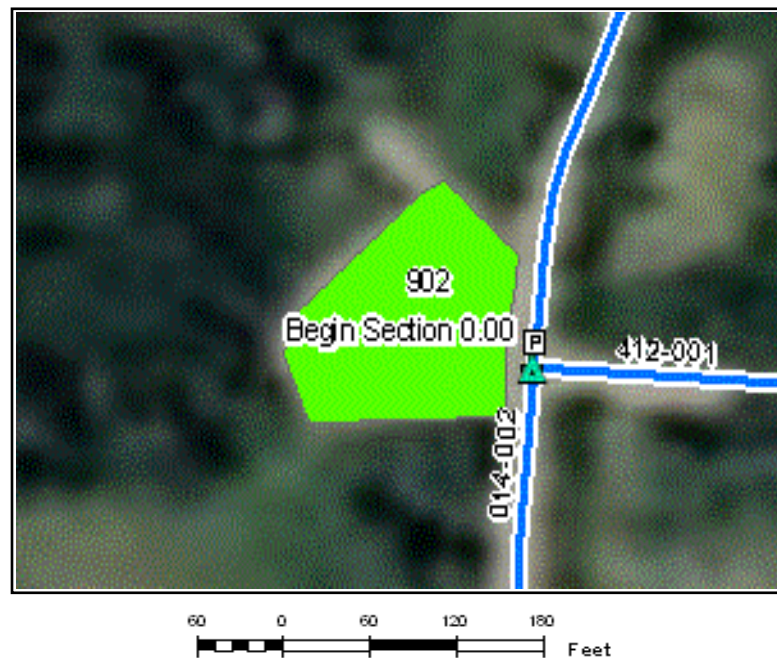
# 902: Auto Tour Parking #1

Asset Number	Date Visited	Surface Type	Area (Sq Ft)	Condition	Cost to Improve
10043699	06/17/2005	Gravel	8,393	Good	1,200

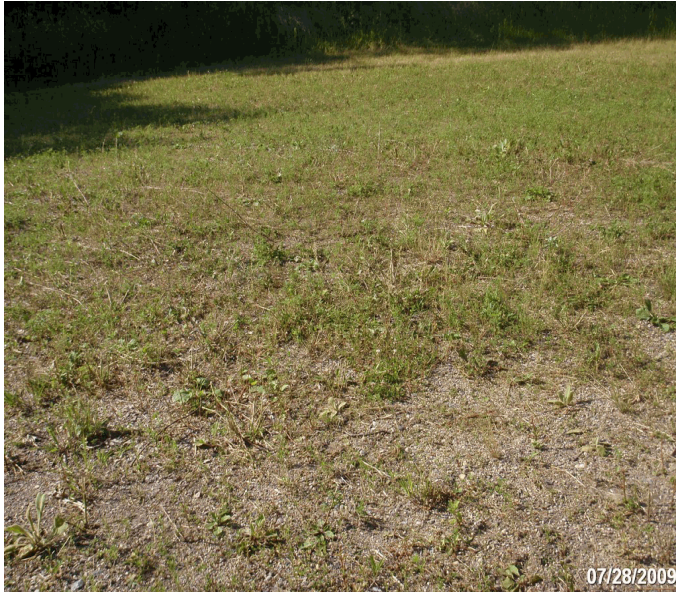
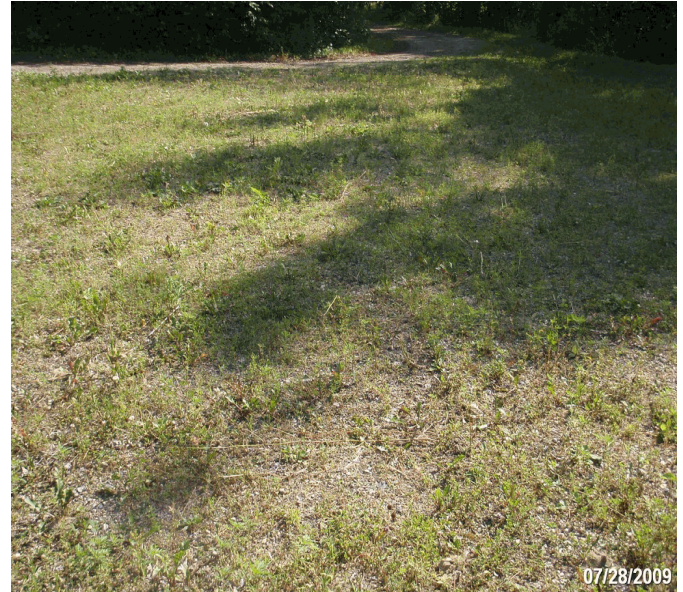
### 903: Auto Tour Parking #2

Asset Number	Date Visited	Surface Type	Area (Sq Ft)	Condition	Cost to Improve
10043699	07/28/2009	Gravel	4,839	Fair	1,200

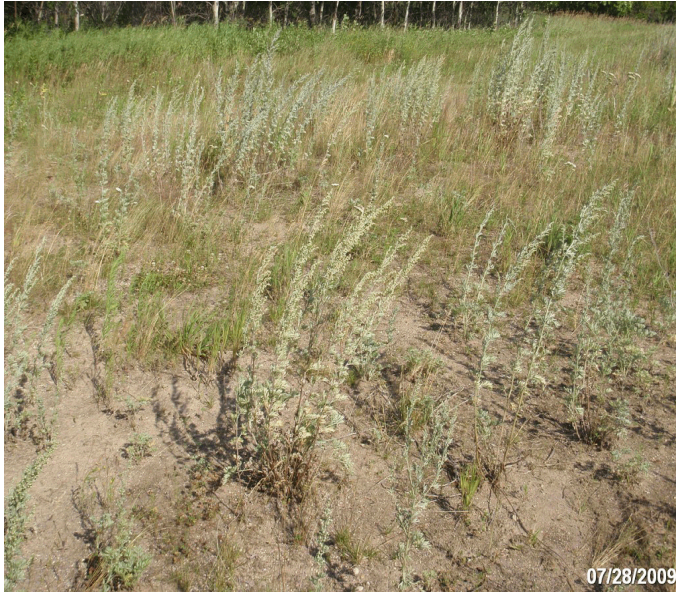
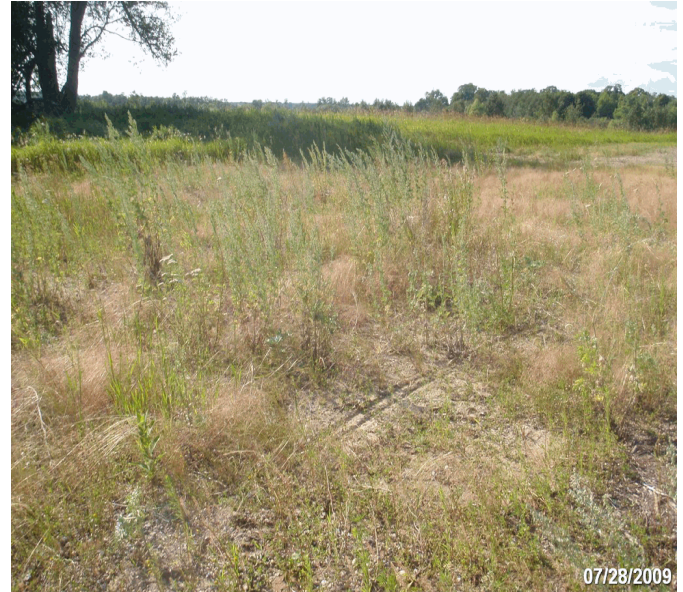
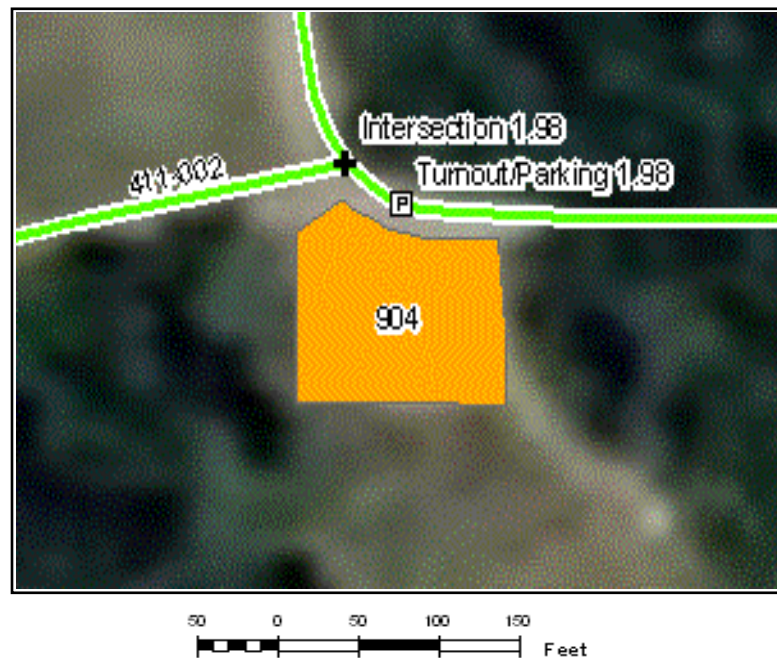
### 904: Auto Tour Parking #3

Asset Number	Date Visited	Surface Type	Area (Sq Ft)	Condition	Cost to Improve
10043699	07/28/2009	Gravel	6,023	Poor	6,200

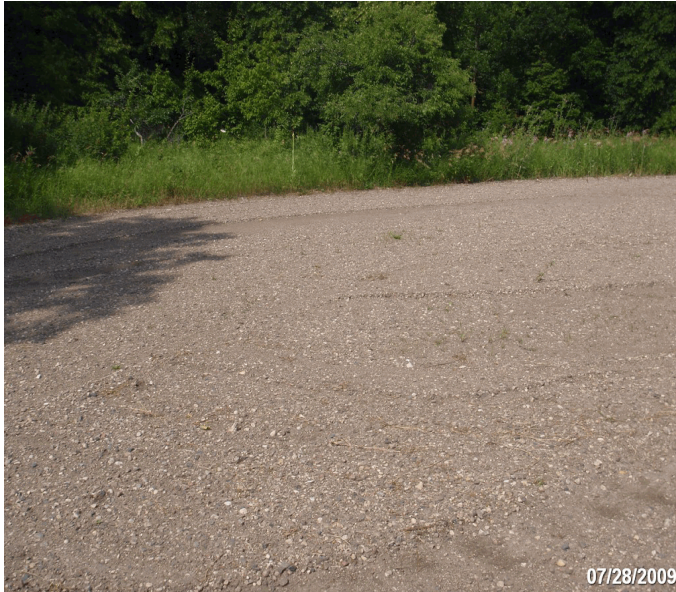
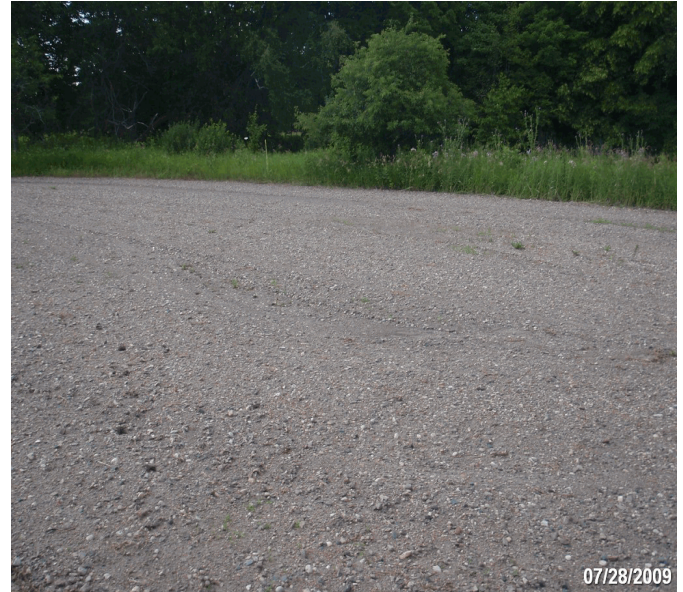
## 905: Church Lake Parking

Asset Number	Date Visited	Surface Type	Area (Sq Ft)	Condition	Cost to Improve
10043700	07/28/2009	Gravel	5,136	Fair	1,300

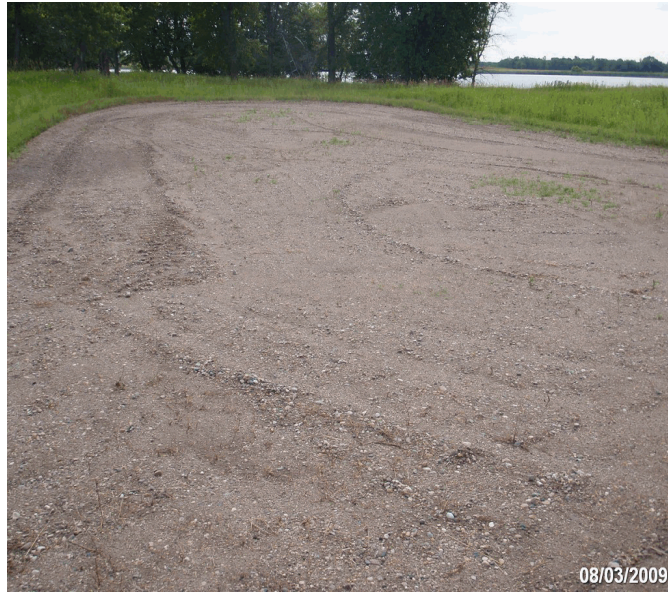
## 906: Clifford Lake Parking

Asset Number	Date Visited	Surface Type	Area (Sq Ft)	Condition	Cost to Improve
10043701	08/03/2009	Gravel	7,718	Good	1,100

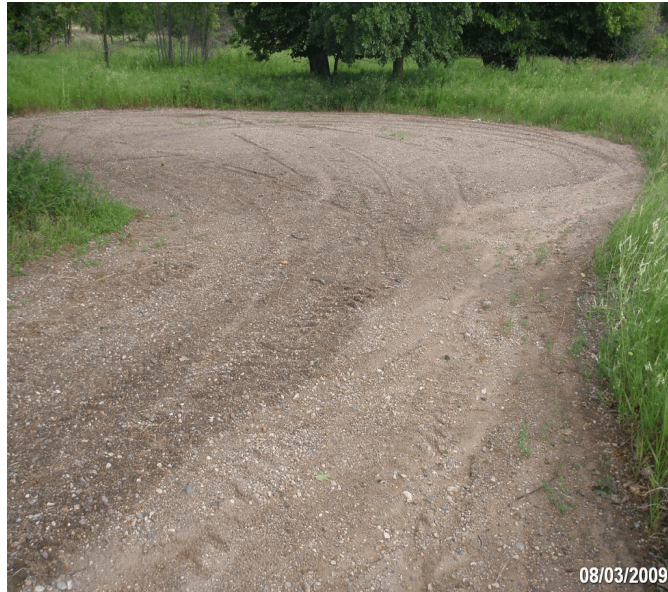
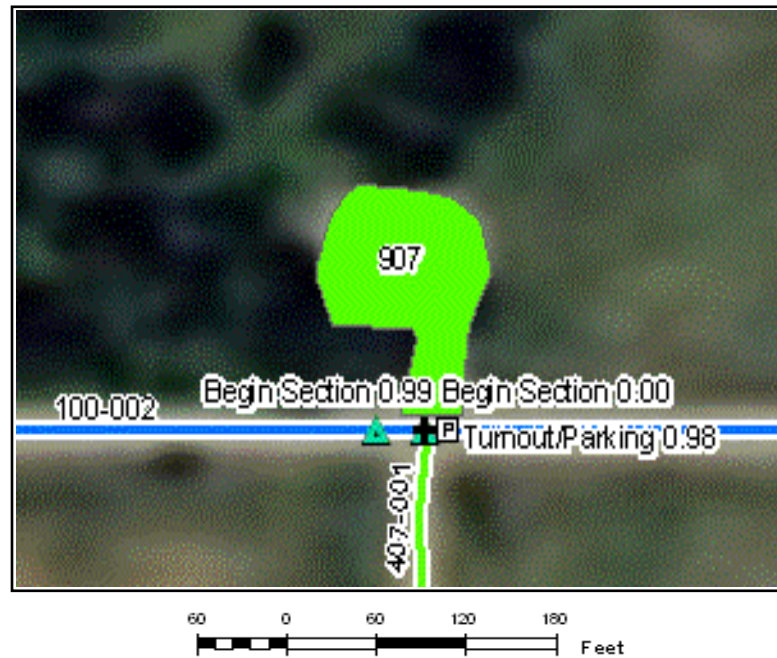
## 907: Route 100 Parking

Asset Number	Date Visited	Surface Type	Area (Sq Ft)	Condition	Cost to Improve
10043702	08/03/2009	Gravel	5,021	Good	700

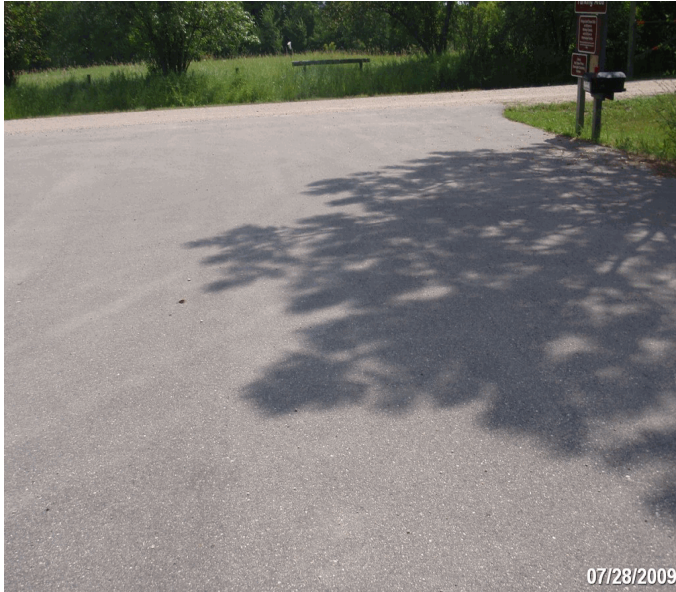
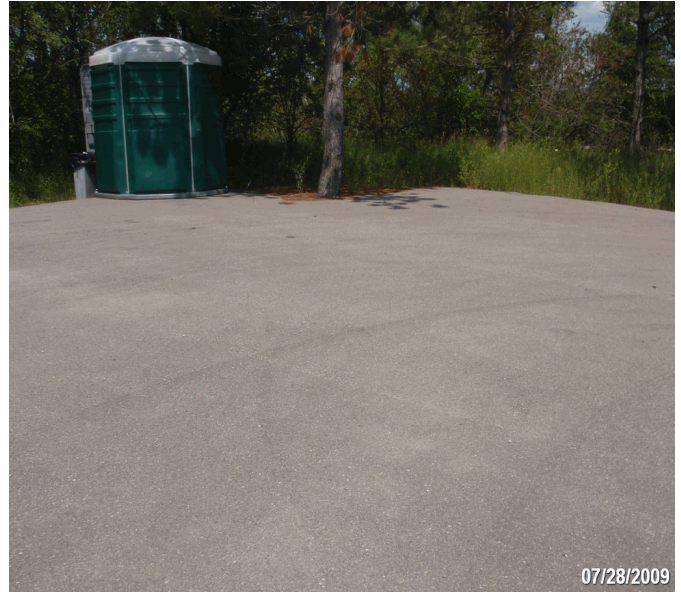
## 908: Front Gate Parking

Asset Number	Date Visited	Surface Type	Area (Sq Ft)	Condition	Cost to Improve
	07/28/2009	Asphalt	3,801	Excellent	0

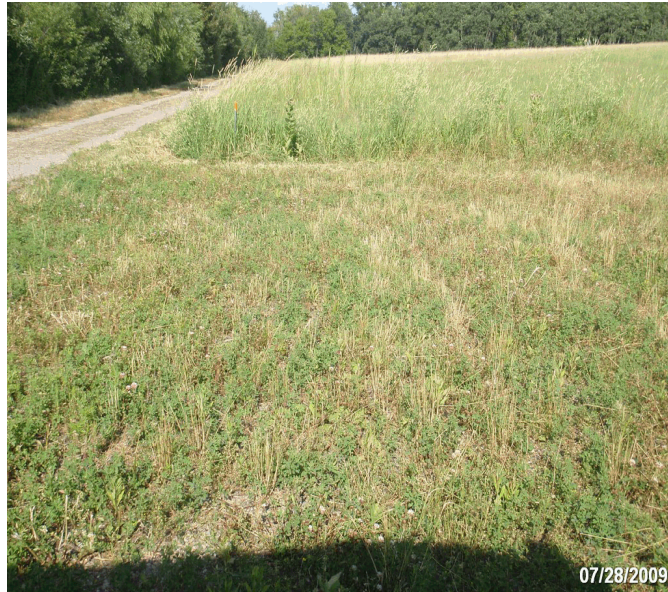
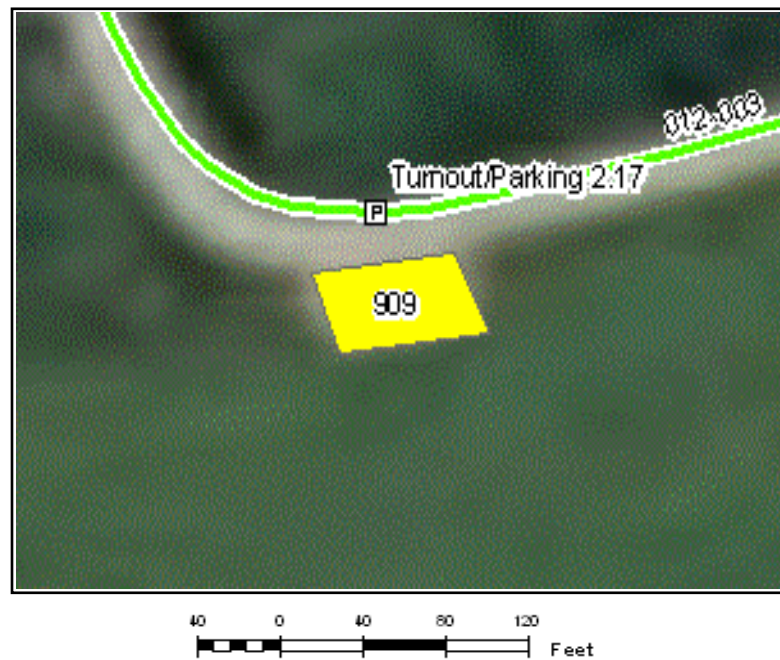
# 909: Auto Tour Parking #4

Asset Number	Date Visited	Surface Type	Area (Sq Ft)	Condition	Cost to Improve
10053163	07/28/2009	Gravel	1,249	Fair	300

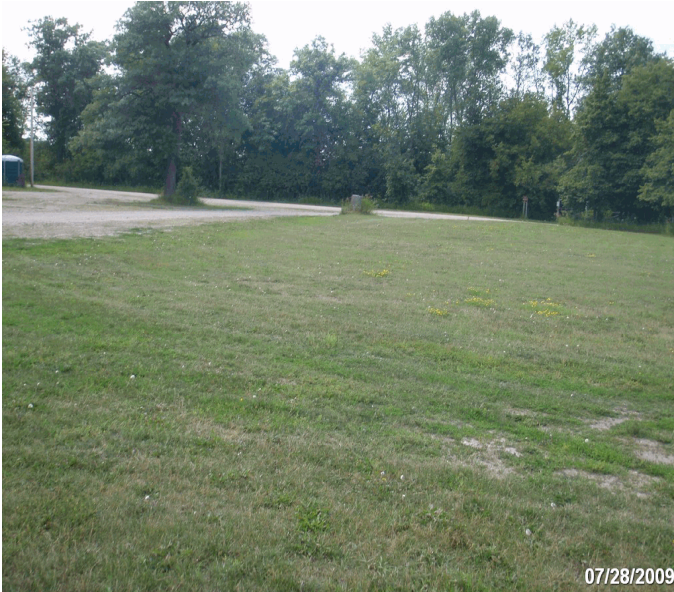
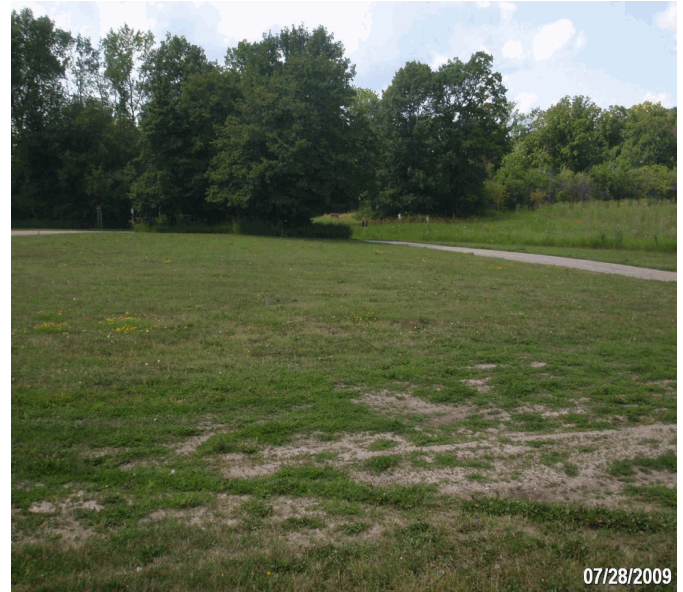
## 910: Overflow RV/Bus Parking

Asset Number	Date Visited	Surface Type	Area (Sq Ft)	Condition	Cost to Improve
	07/28/2009	Native	17,367	Fair	4,300
