# The Road Inventory of Seney National Wildlife Refuge Seney, MI

Prepared By:  
Federal Highway Administration  
Central Federal Lands Highway Division  
December 2009

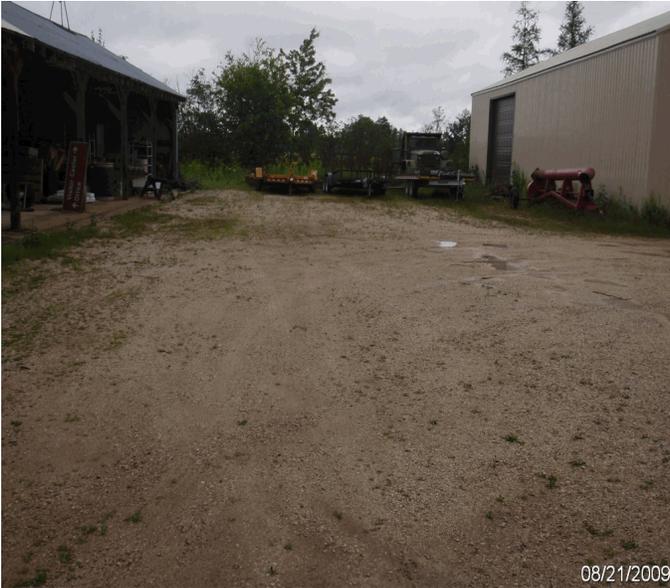
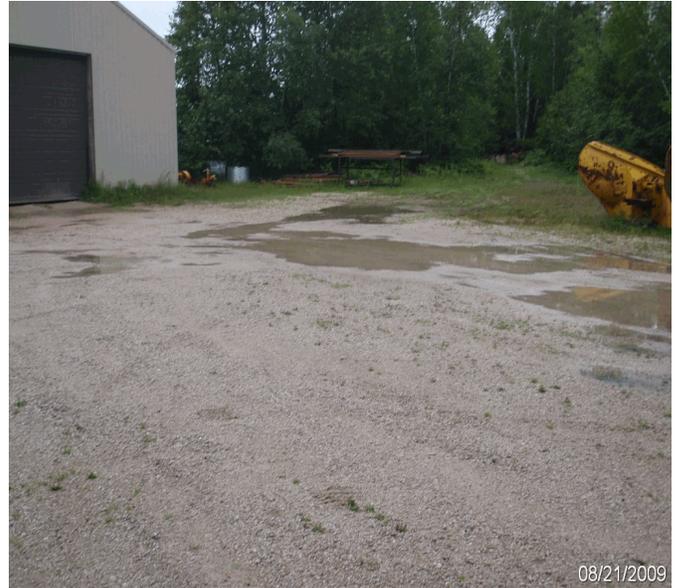
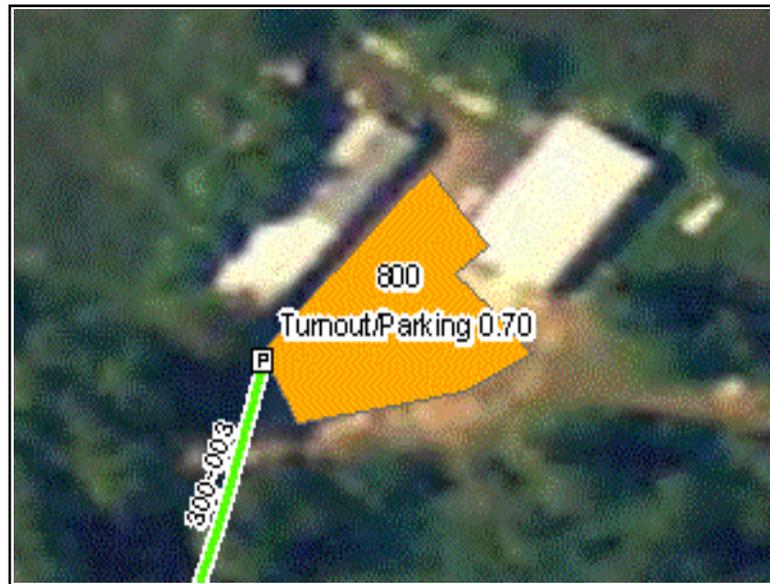
| Asset Number | Date Visited | Surface Type | Area (Sq Ft) | Condition | Cost to Improve |
|---|---|---|---|---|---|
| 10060628 | 08/21/2009 | Gravel | 7,700 | Poor | 8,000 |

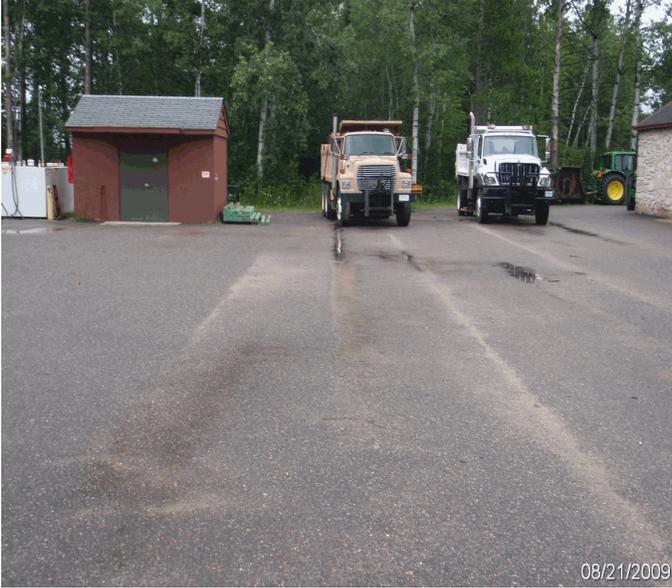
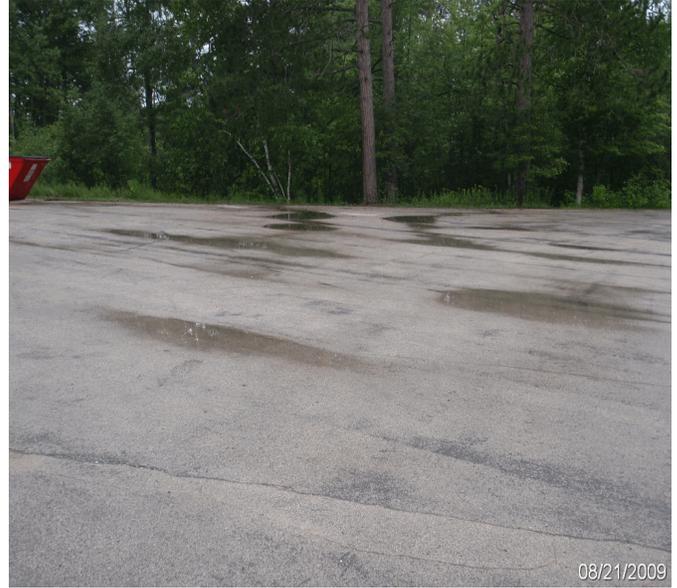
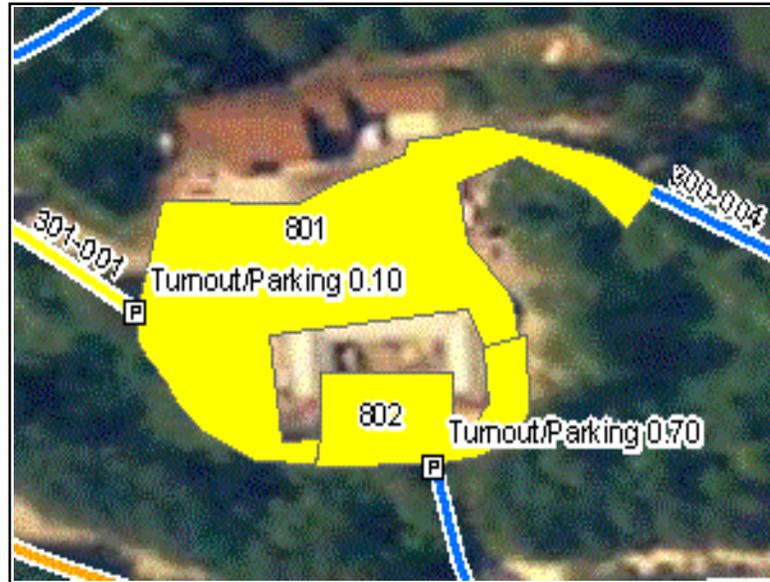
### 801: Shop Parking

| Asset Number | Date Visited | Surface Type | Area (Sq Ft) | Condition | Cost to Improve |
|---|---|---|---|---|---|
| 10058628 | 08/21/2009 | Asphalt | 27,850 | Fair | 22,400 |

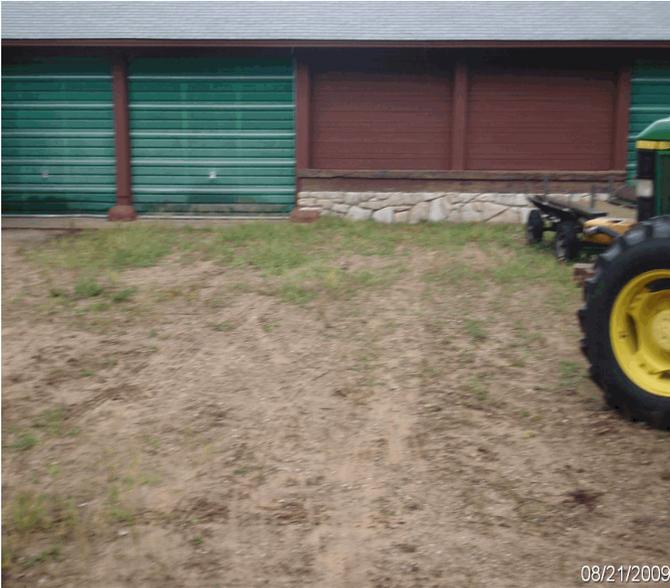
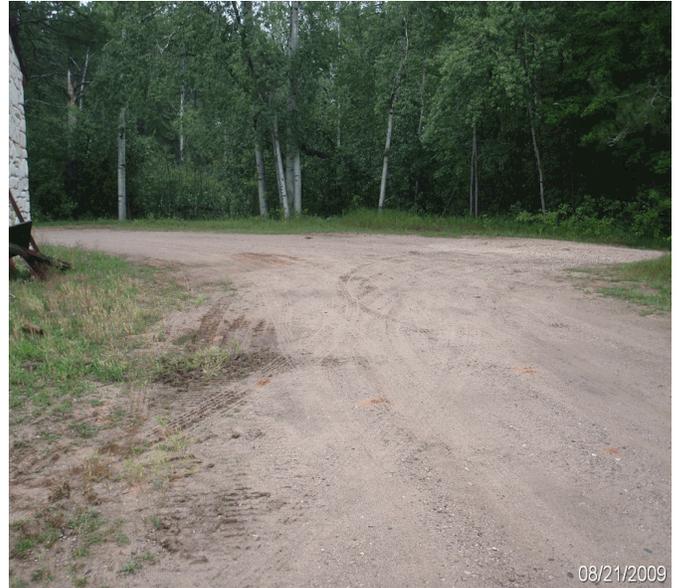
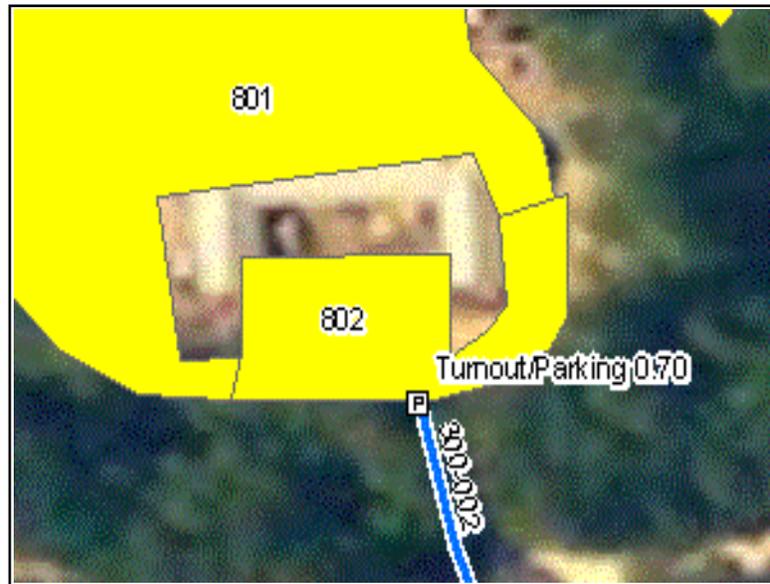
### 802: Shop Gravel Parking

| Asset Number | Date Visited | Surface Type | Area (Sq Ft) | Condition | Cost to Improve |
|---|---|---|---|---|---|
| | 08/21/2009 | Gravel | 6,913 | Fair | 1,700 |

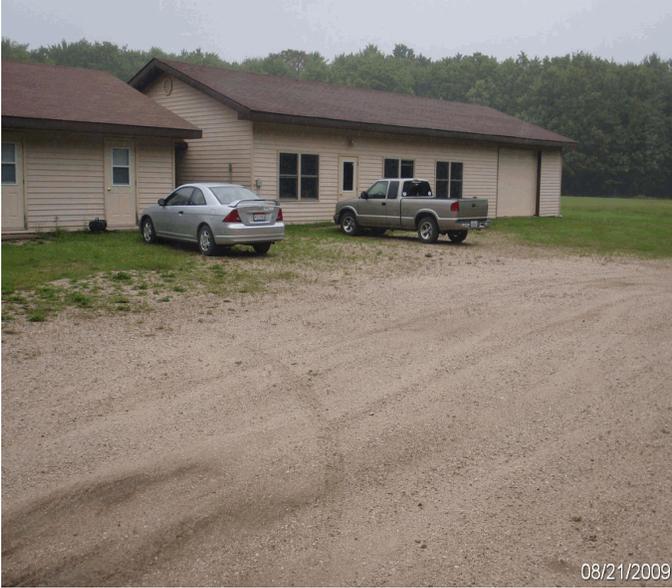
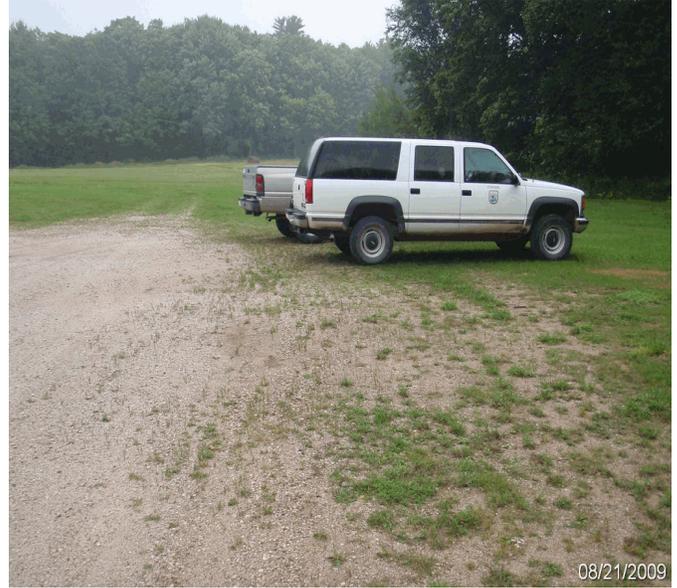
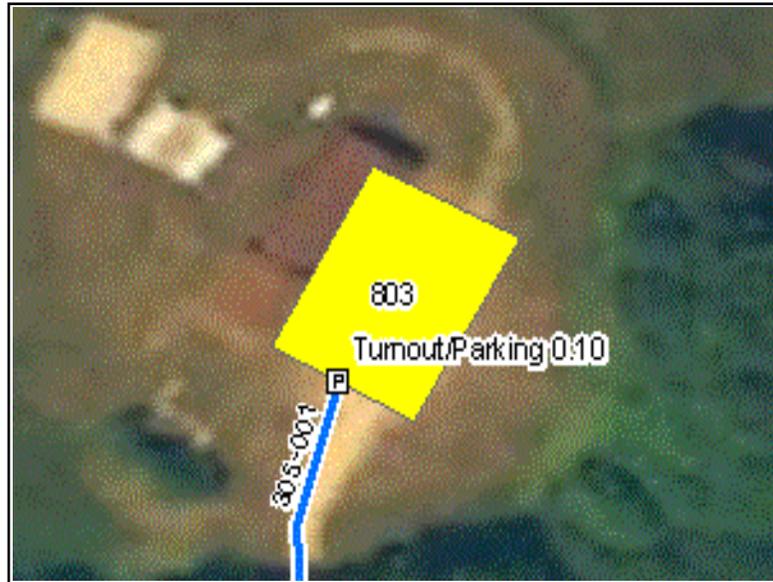
### 803: Bunkhouse Parking

| Asset Number | Date Visited | Surface Type | Area (Sq Ft) | Condition | Cost to Improve |
|---|---|---|---|---|---|
| 10056127 | 08/21/2009 | Gravel | 7,194 | Fair | 1,800 |

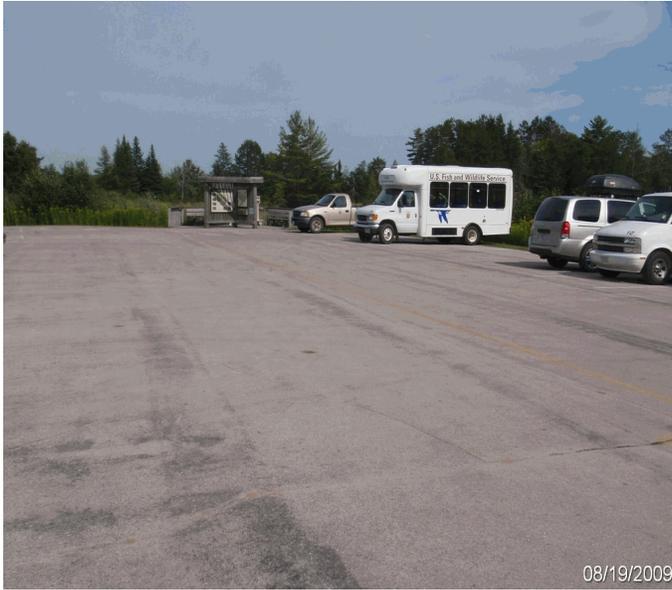
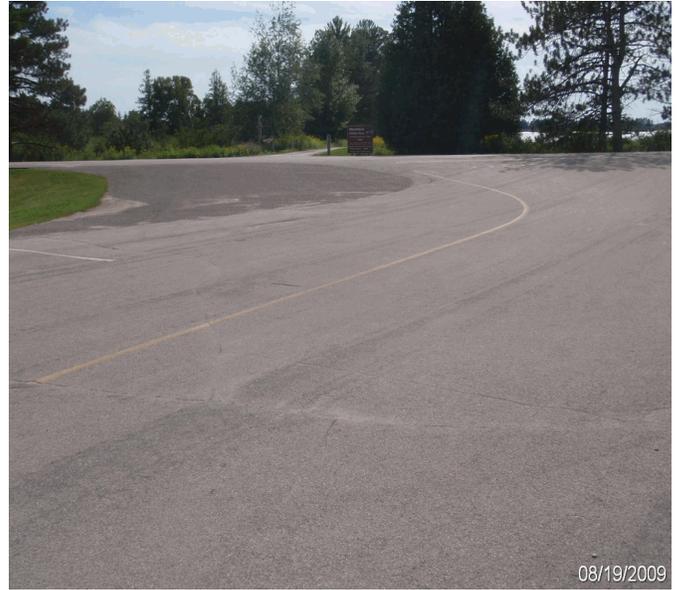
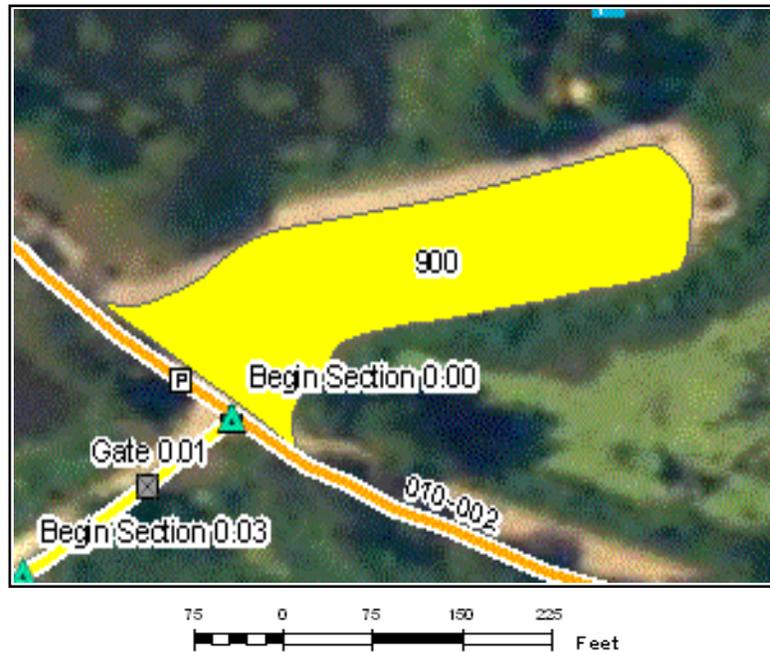
### 900: Visitor Center Parking

| Asset Number | Date Visited | Surface Type | Area (Sq Ft) | Condition | Cost to Improve |
|---|---|---|---|---|---|
| 10043703 | 08/19/2009 | Asphalt | 21,961 | Fair | 17,700 |

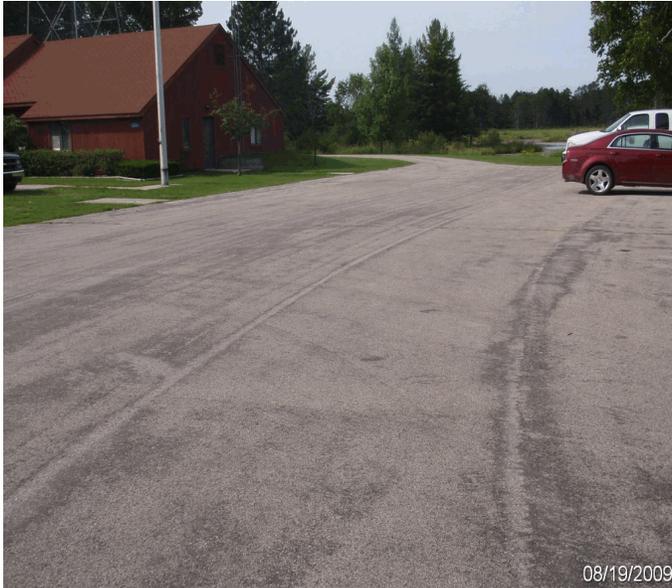
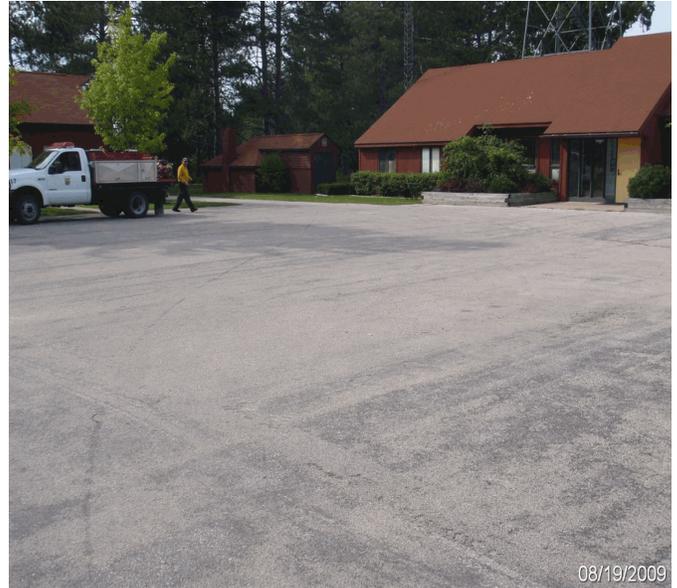
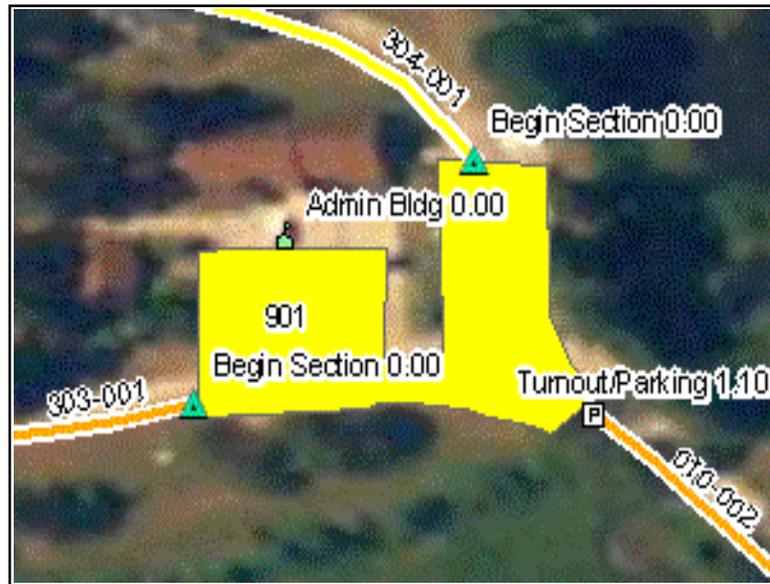
### 901: Refuge Office Parking

| Asset Number | Date Visited | Surface Type | Area (Sq Ft) | Condition | Cost to Improve |
|---|---|---|---|---|---|
| 10043704 | 08/19/2009 | Asphalt | 15,785 | Fair | 12,700 |

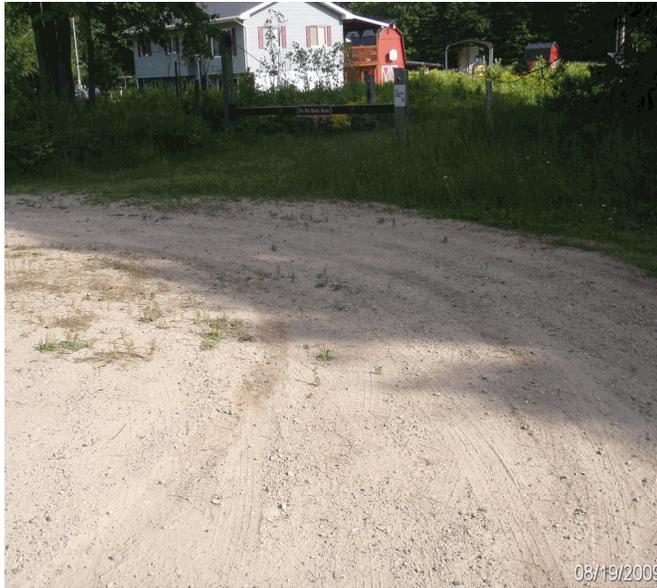
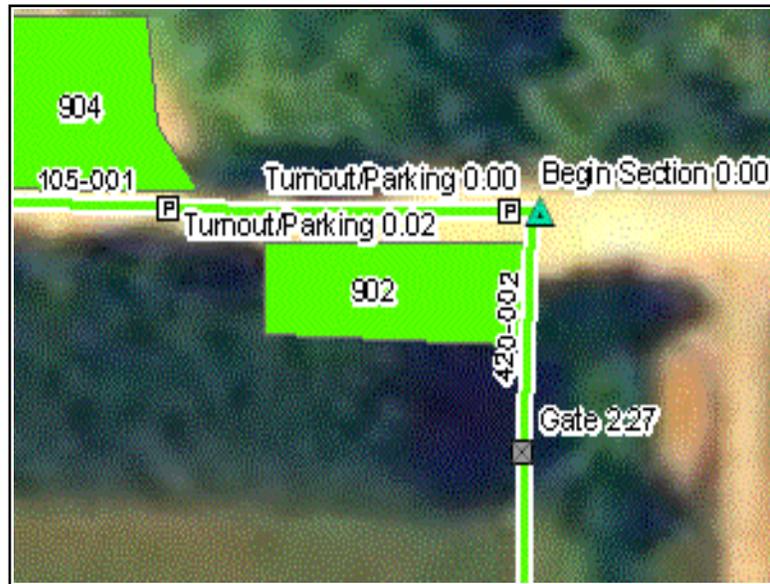
### 902: Shay Road Parking

| Asset Number | Date Visited | Surface Type | Area (Sq Ft) | Condition | Cost to Improve |
|---|---|---|---|---|---|
| 10043705 | 08/19/2009 | Gravel | 2,584 | Good | 400 |

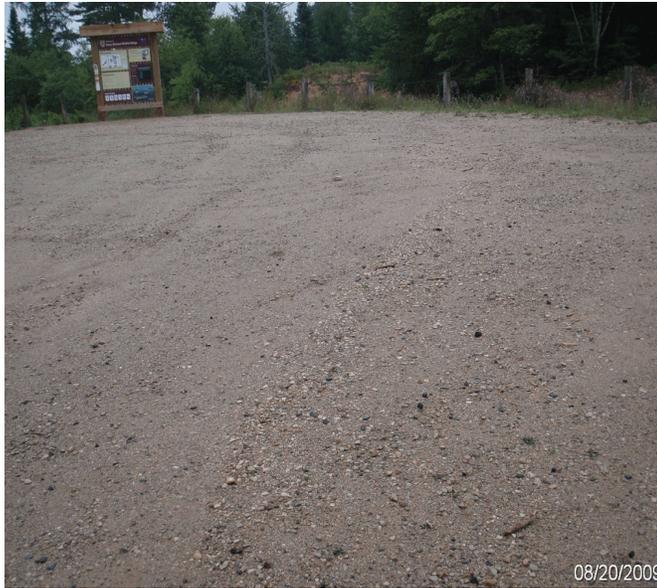
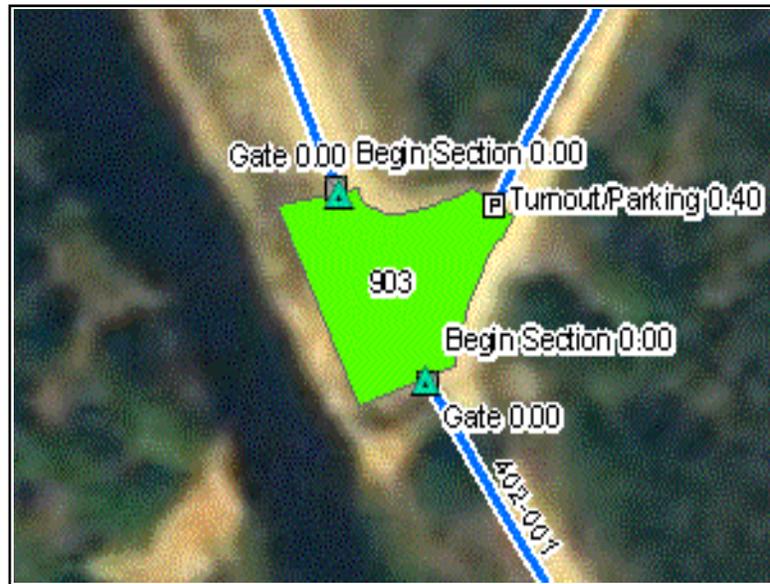
903: C-3 Pool Road Parking

| Asset Number | Date Visited | Surface Type | Area (Sq Ft) | Condition | Cost to Improve |
|---|---|---|---|---|---|
| | 08/20/2009 | Gravel | 5,292 | Good | 700 |

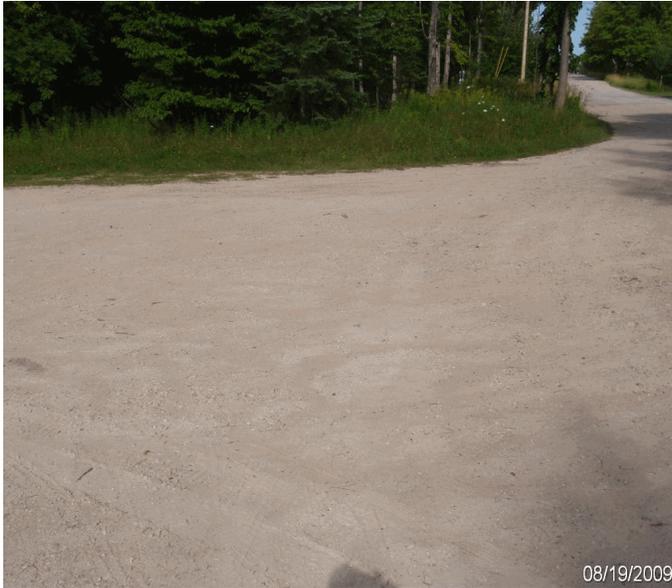
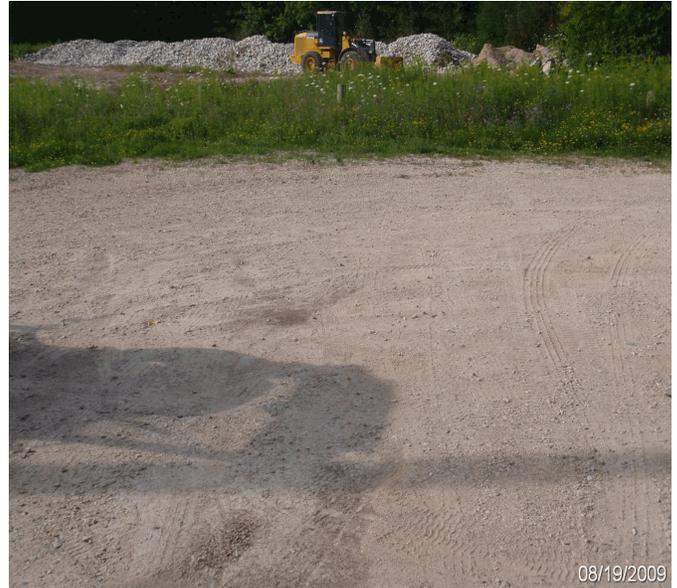
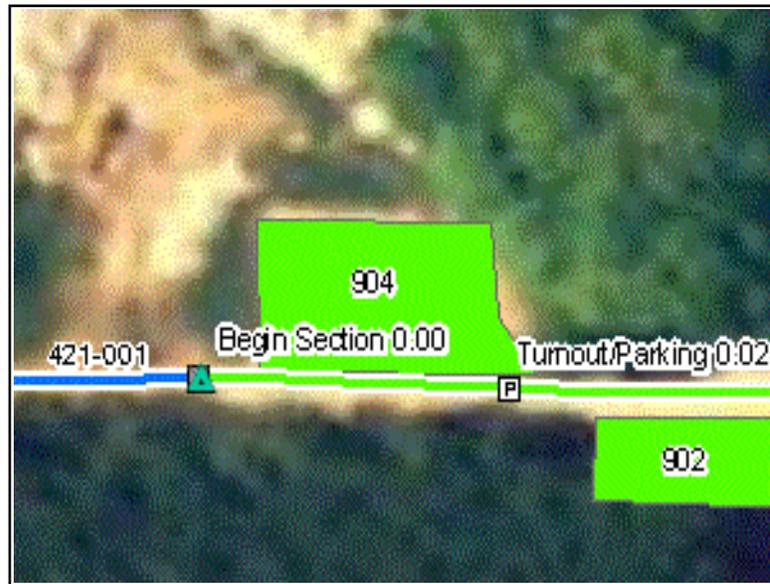
904: Northern Hardwoods Cross-Country Ski Parking

| Asset Number | Date Visited | Surface Type | Area (Sq Ft) | Condition | Cost to Improve |
|---|---|---|---|---|---|
| 10043705 | 08/19/2009 | Gravel | 4,851 | Good | 700 |

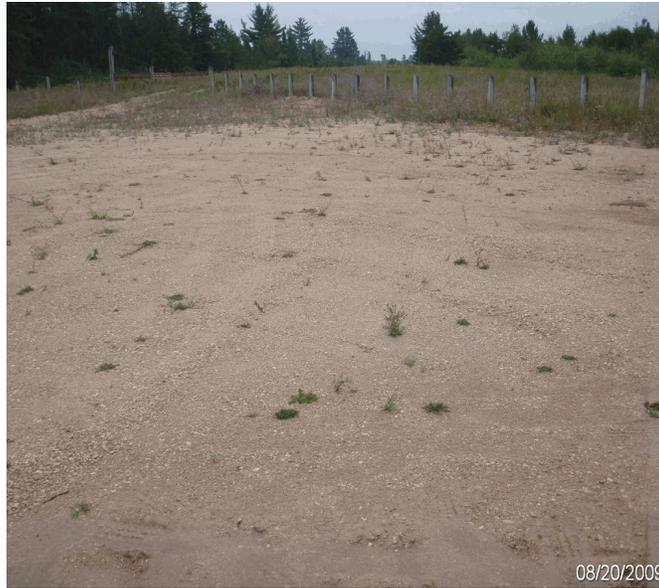
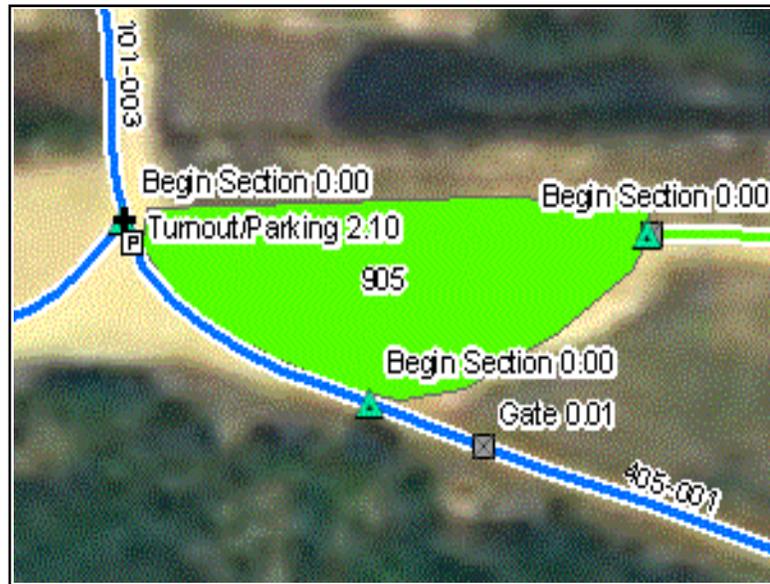
### 905: Driggs River Hunter Access Parking

| Asset Number | Date Visited | Surface Type | Area (Sq Ft) | Condition | Cost to Improve |
|---|---|---|---|---|---|
| 10010462 | 08/20/2009 | Gravel | 11,813 | Good | 1,700 |

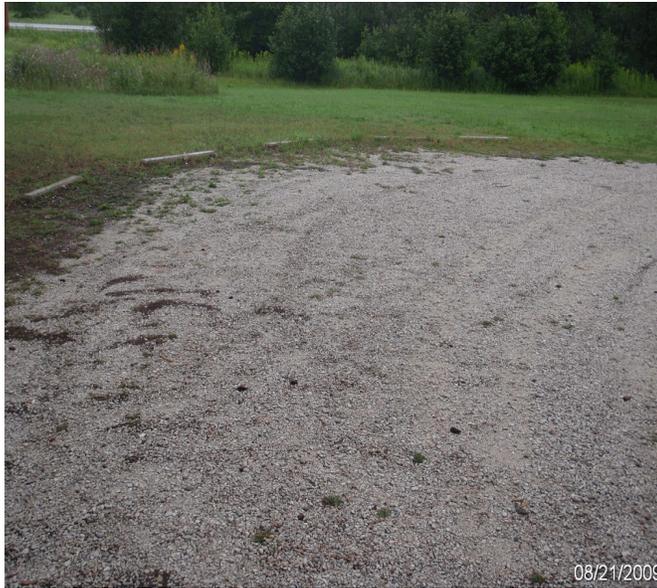
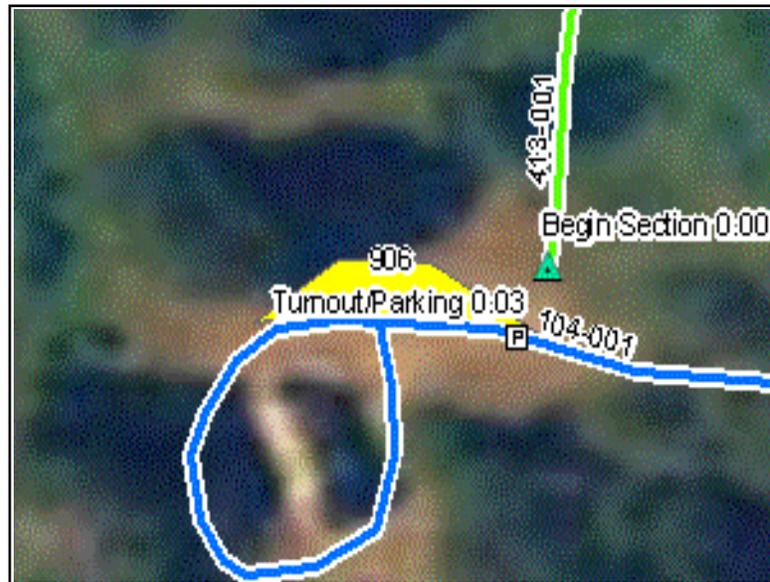
### 906: Wigwam Picnic Parking

| Asset Number | Date Visited | Surface Type | Area (Sq Ft) | Condition | Cost to Improve |
|---|---|---|---|---|---|
| | 08/21/2009 | Gravel | 958 | Fair | 200 |
