The Road Inventory of Trempealeau National Wildlife Refuge Trempealeau, WI

Prepared By:
Federal Highway Administration
Central Federal Lands Highway Division
December 2009

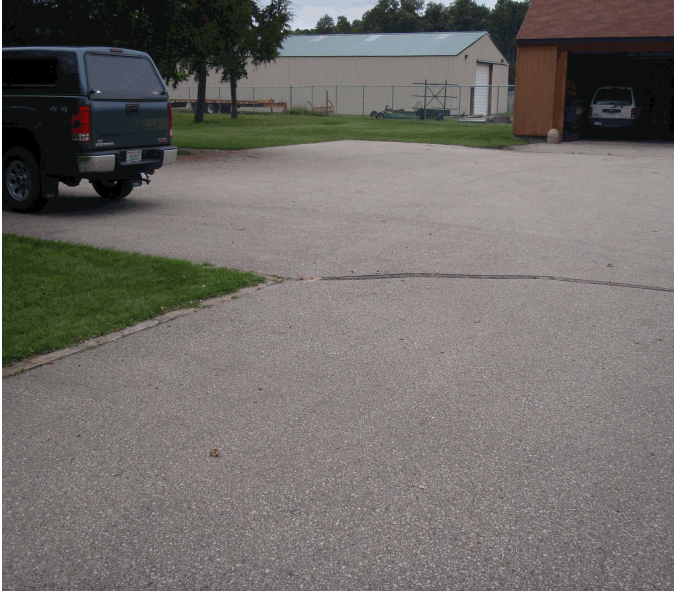
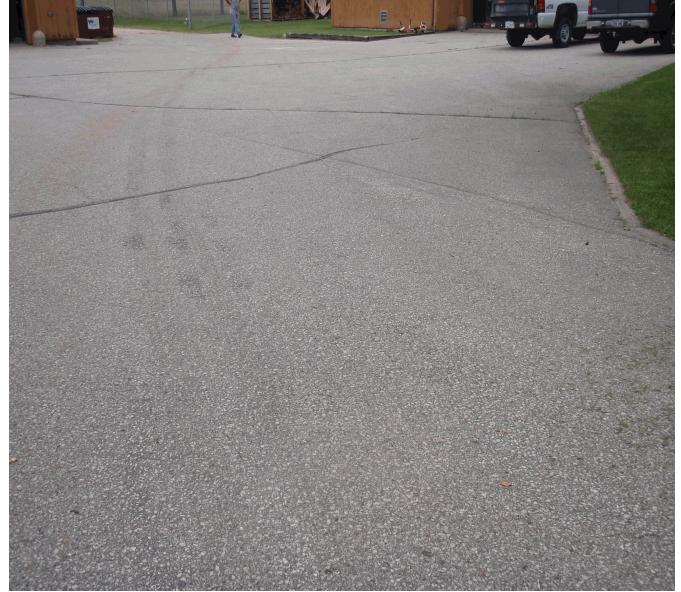
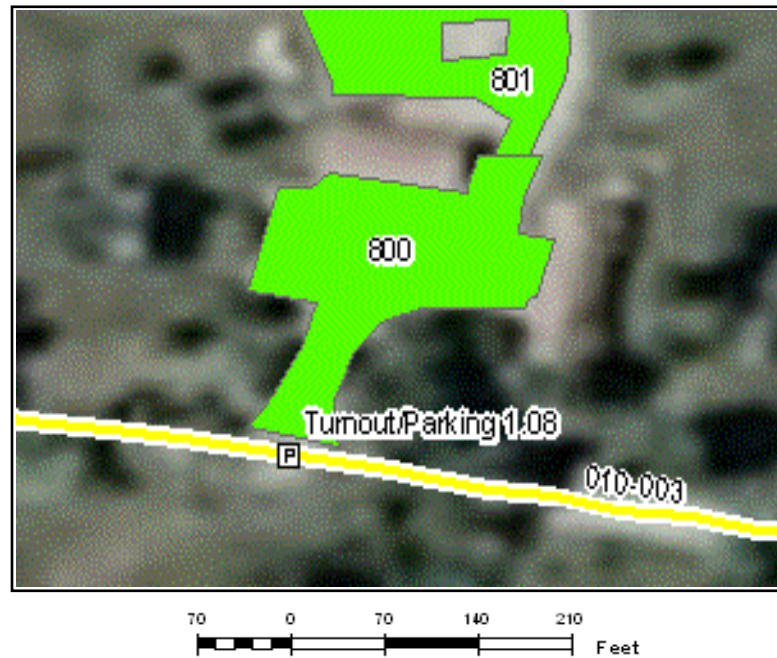
800: Shop Parking South

Asset Number	Date Visited	Surface Type	Area (Sq Ft)	Condition	Cost to Improve
10011888	08/19/2009	Asphalt	11,287	Good	2,300

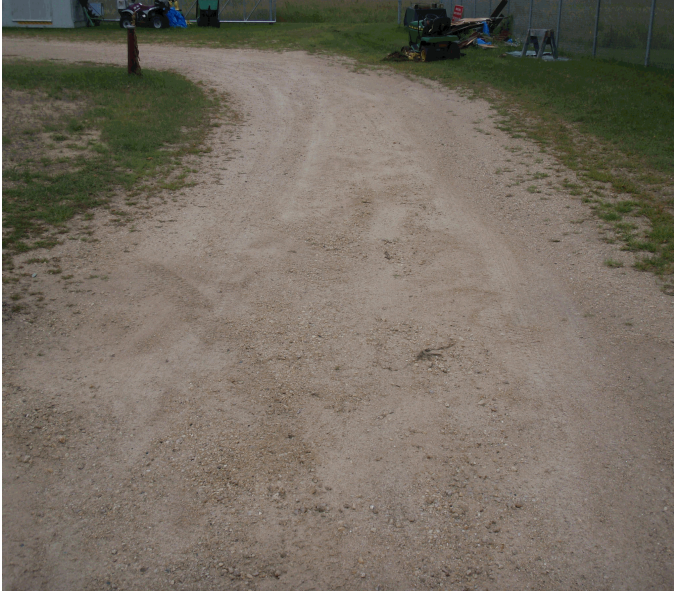
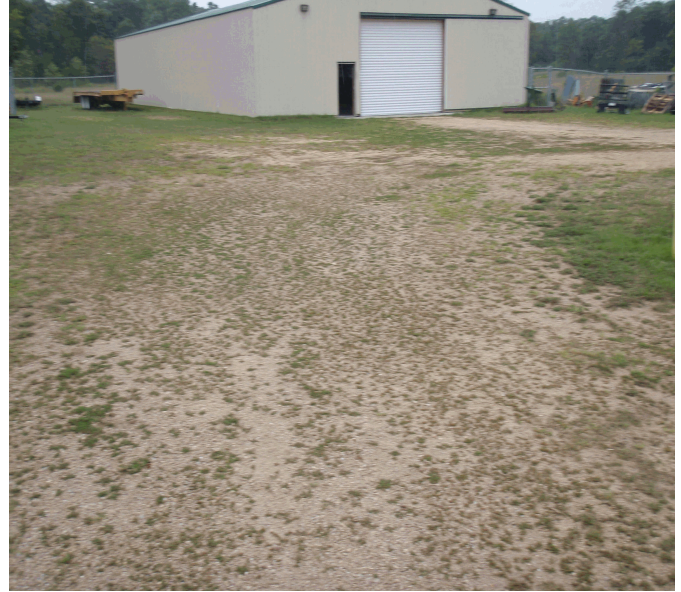
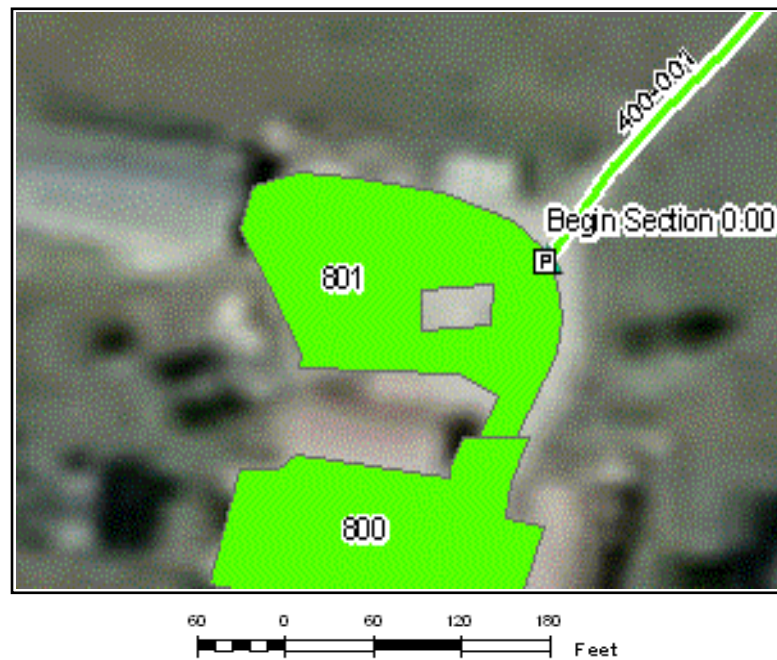
801: Shop Parking North

Asset Number	Date Visited	Surface Type	Area (Sq Ft)	Condition	Cost to Improve
10011888	08/19/2009	Gravel	10,891	Good	1,800

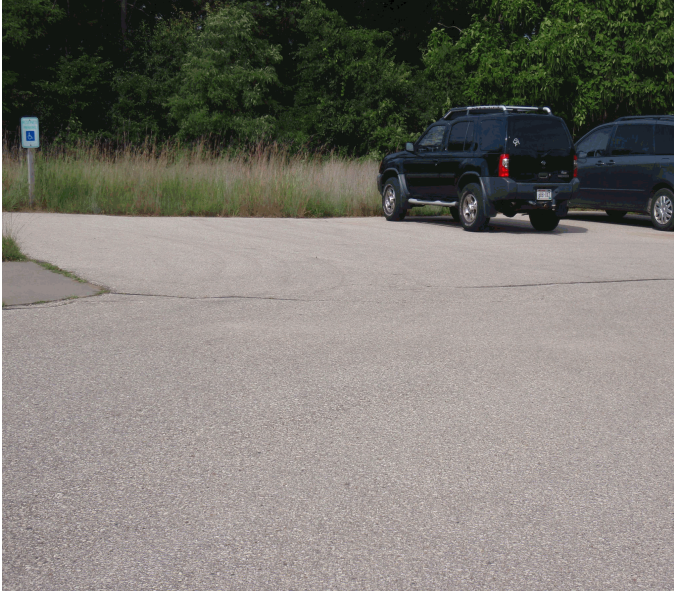
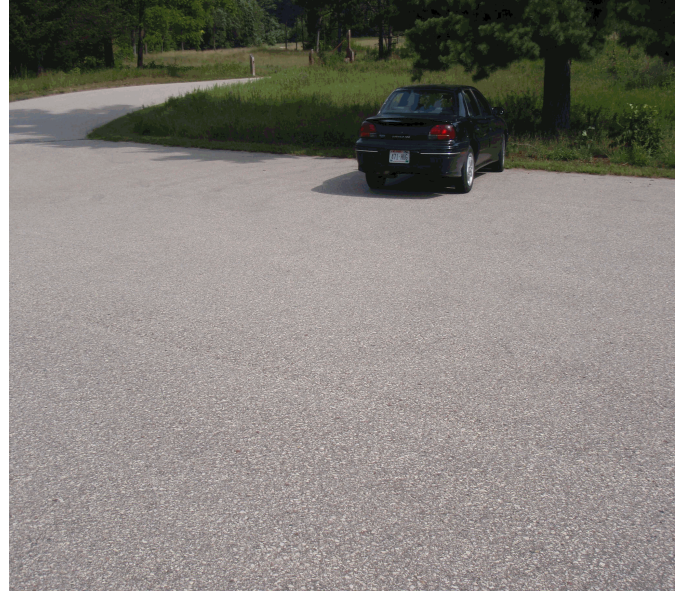
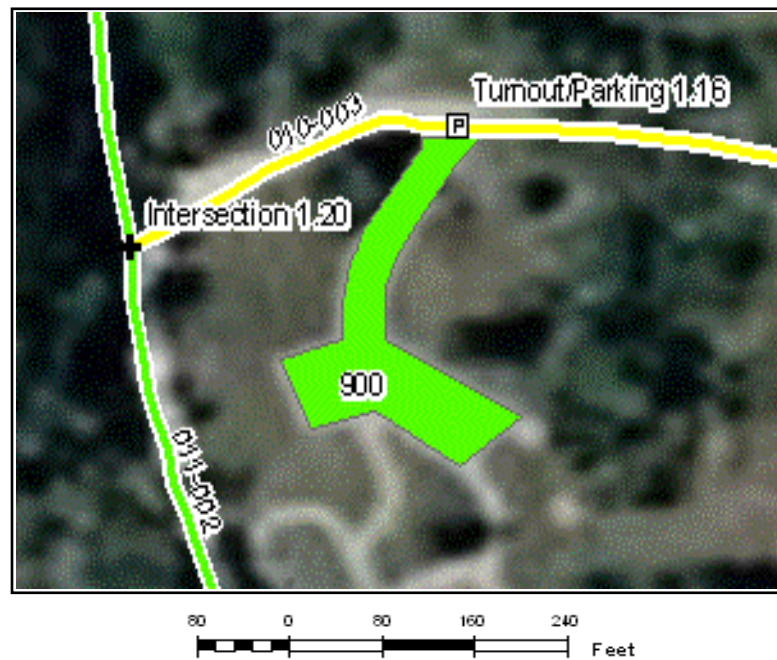
900: Headquarters Parking

Asset Number	Date Visited	Surface Type	Area (Sq Ft)	Condition	Cost to Improve
10035868	08/19/2009	Asphalt	8,616	Good	1,700

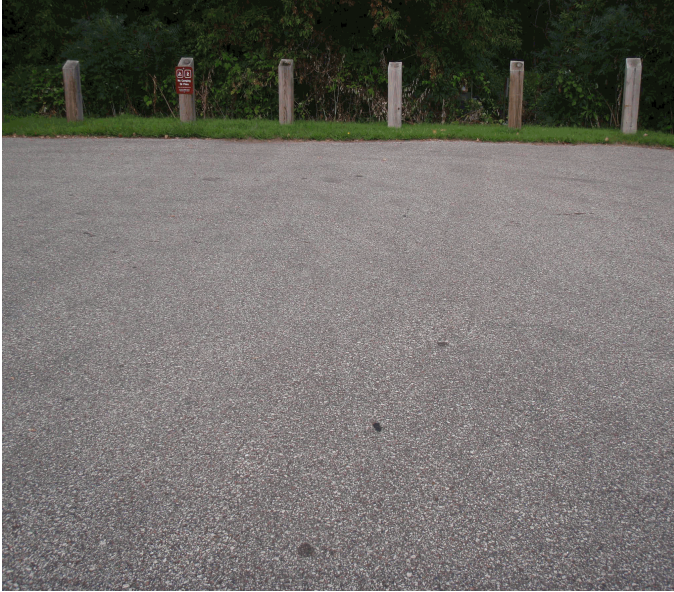
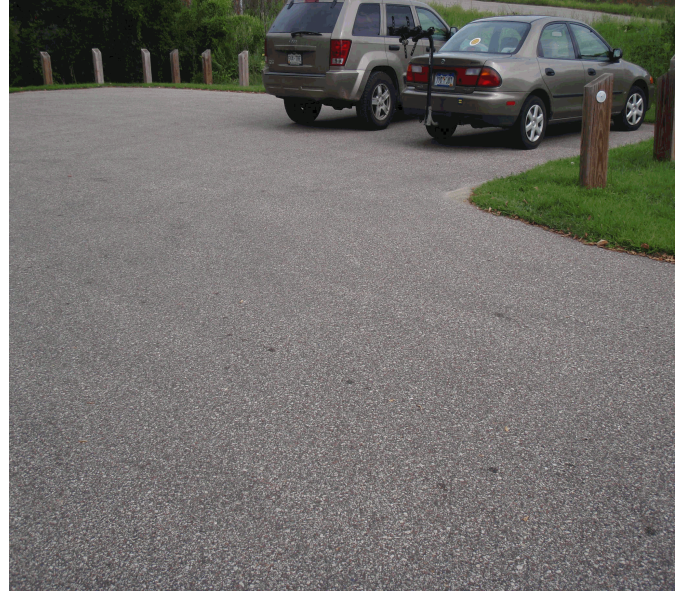
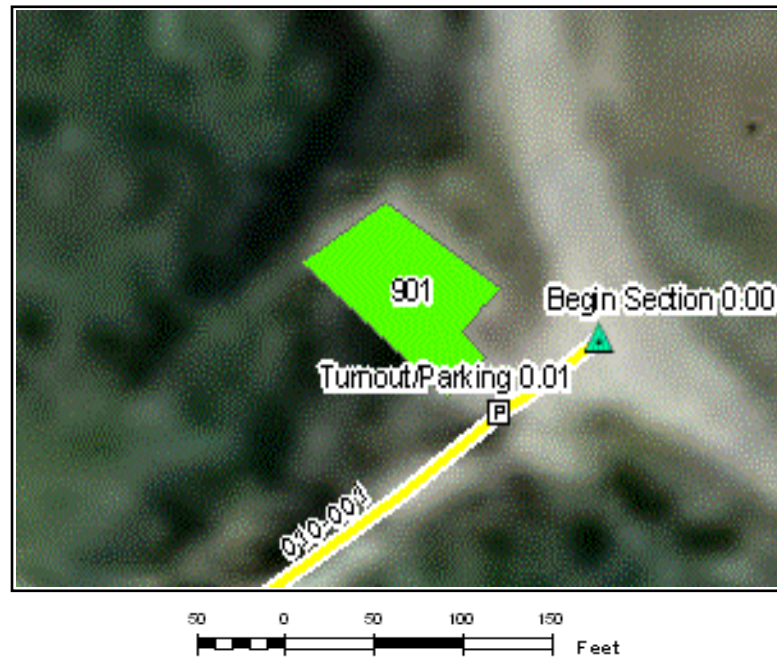
901: Entrance Parking

Asset Number	Date Visited	Surface Type	Area (Sq Ft)	Condition	Cost to Improve
10035869	08/19/2009	Asphalt	2,749	Good	500

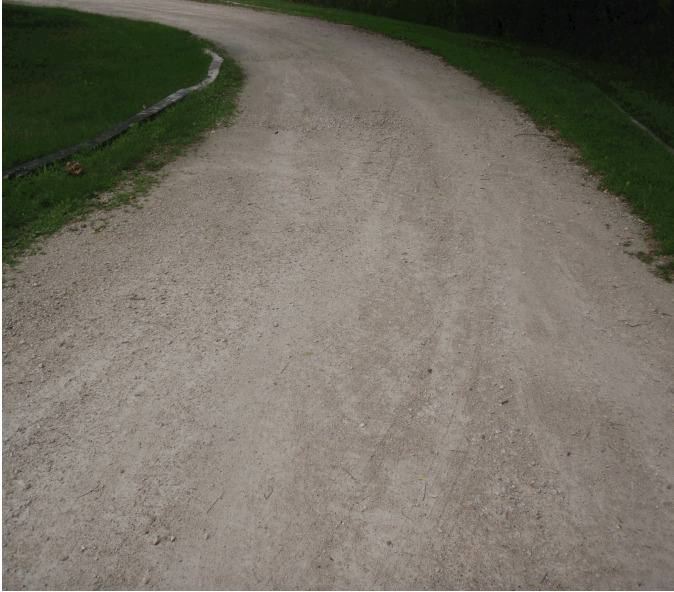
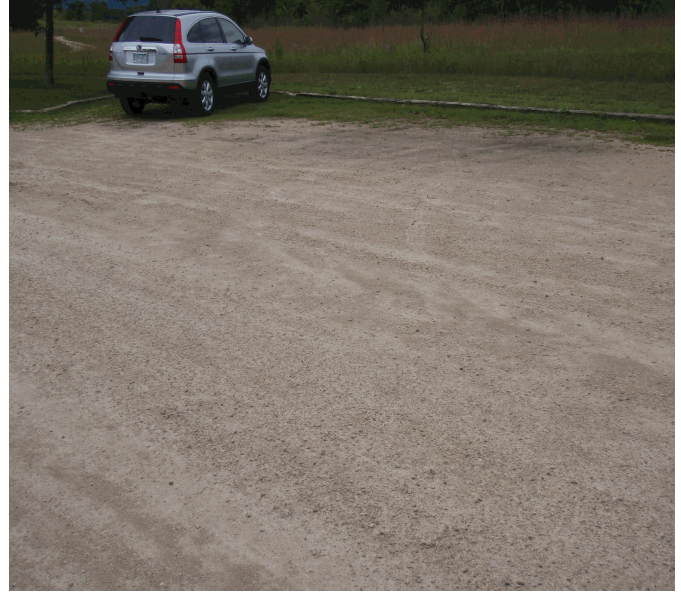
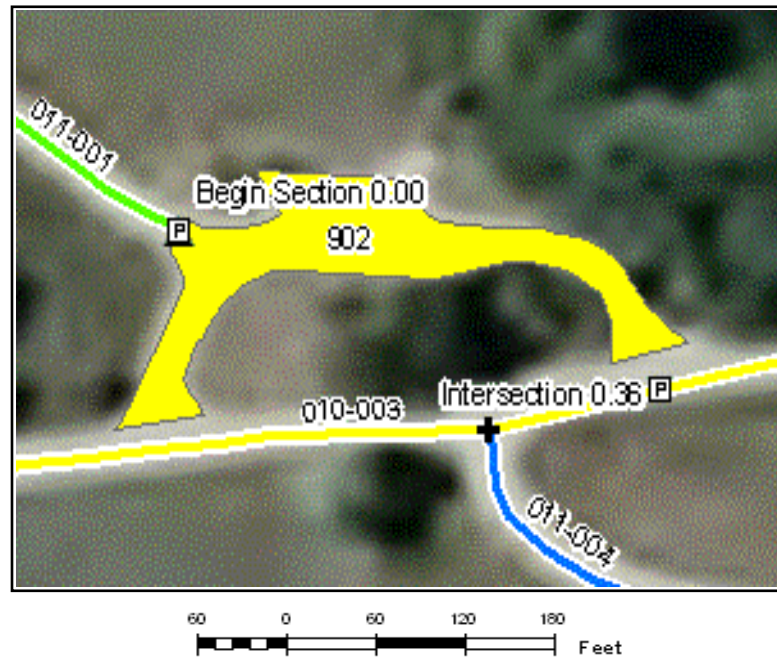
902: Kiosk Parking

Asset Number	Date Visited	Surface Type	Area (Sq Ft)	Condition	Cost to Improve
10011903	08/19/2009	Gravel	8,182	Fair	2,300

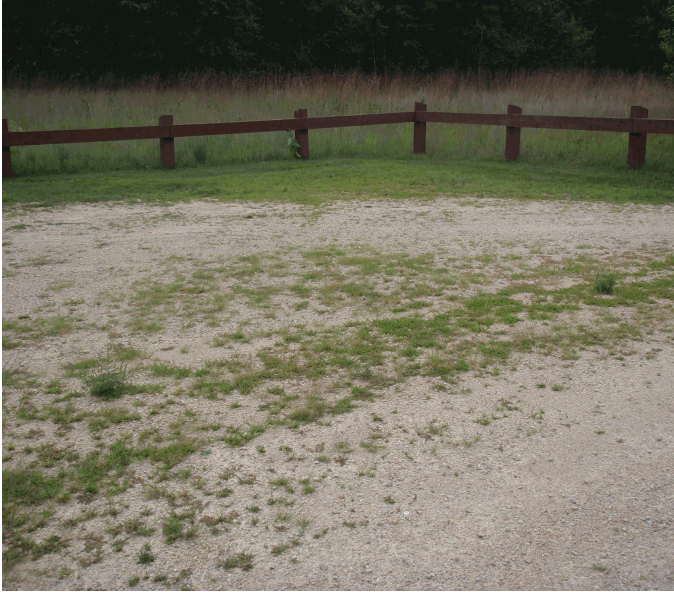
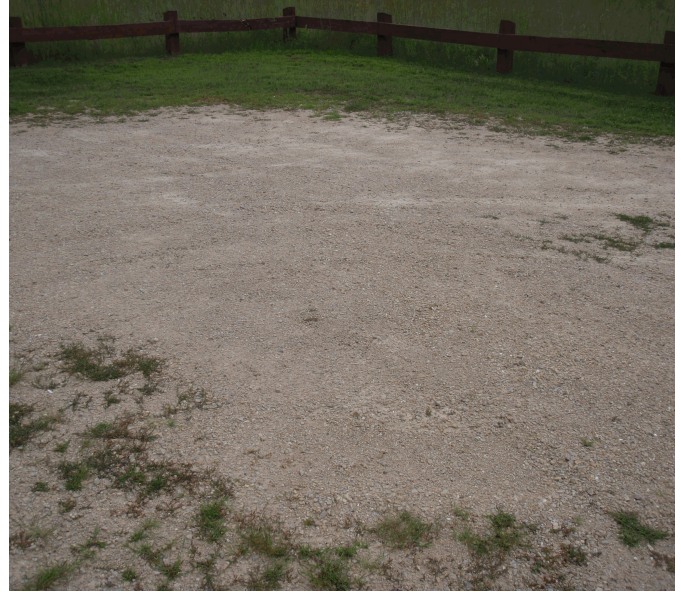
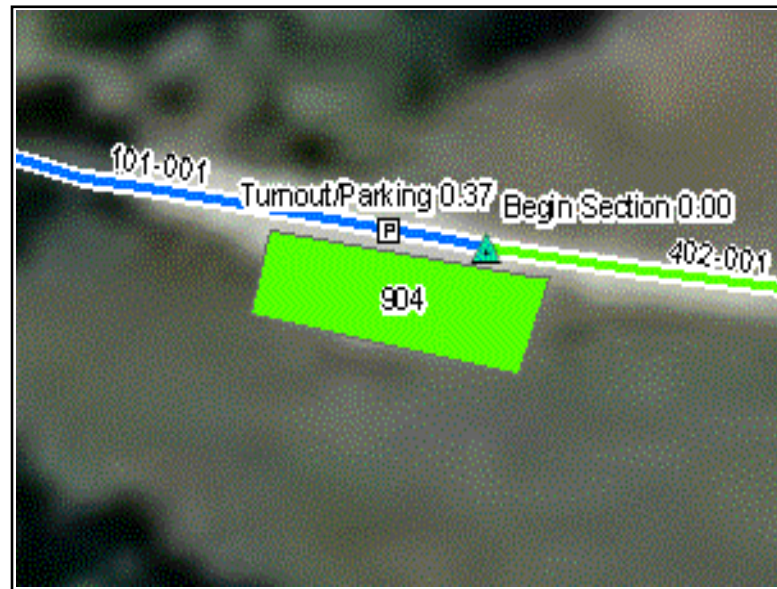
904: Dike Road Parking

Asset Number	Date Visited	Surface Type	Area (Sq Ft)	Condition	Cost to Improve
10043751	08/19/2009	Gravel	2,952	Good	500

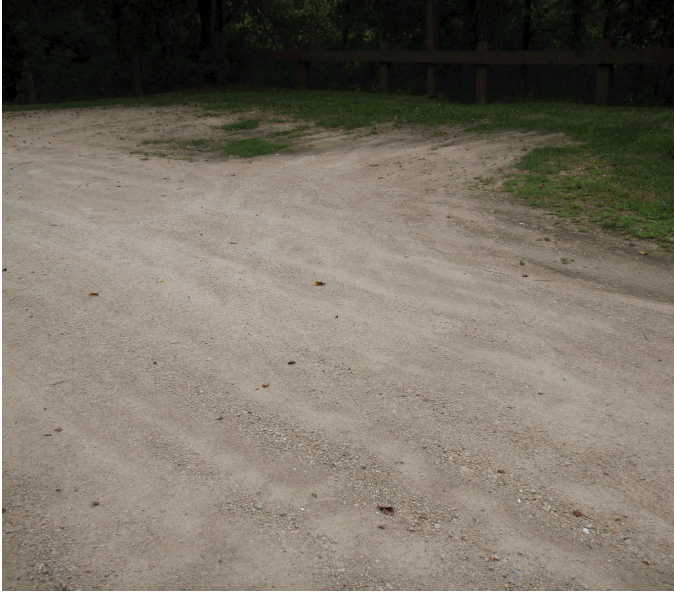
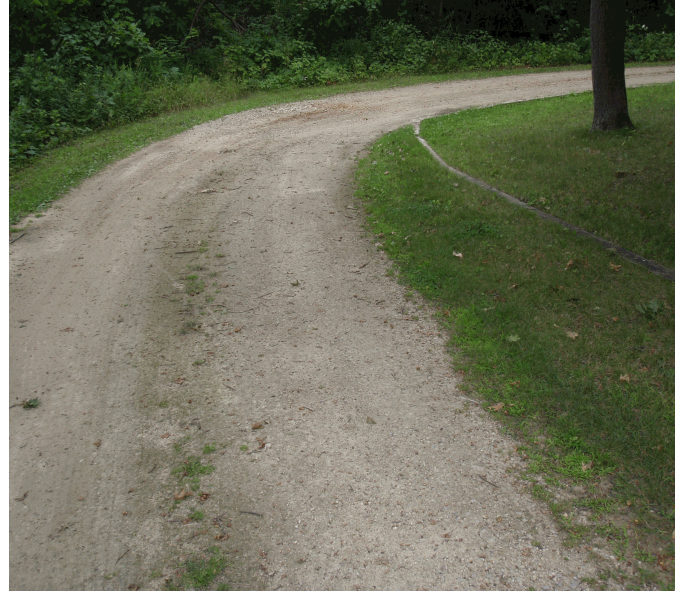
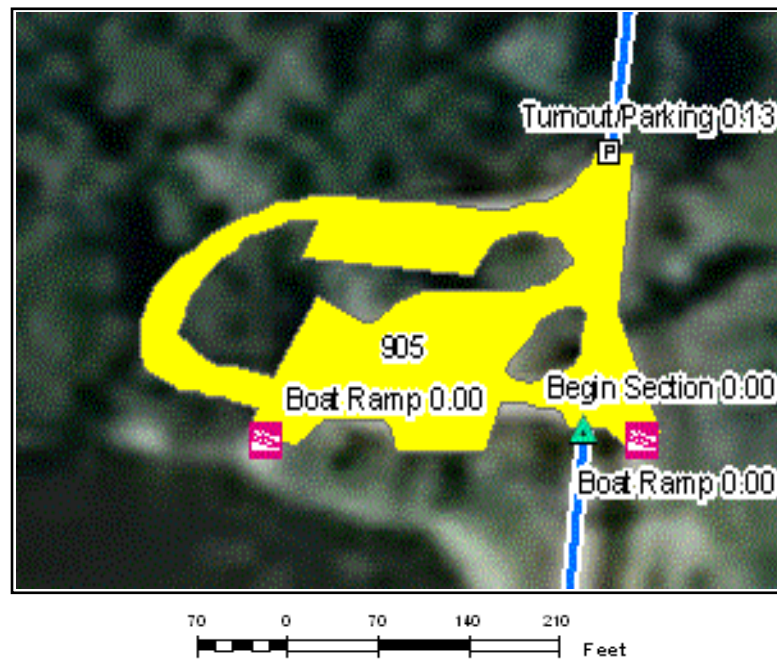
905: Boat Landing Parking

Asset Number	Date Visited	Surface Type	Area (Sq Ft)	Condition	Cost to Improve
10011886	08/19/2009	Gravel	21,769	Fair	6,200

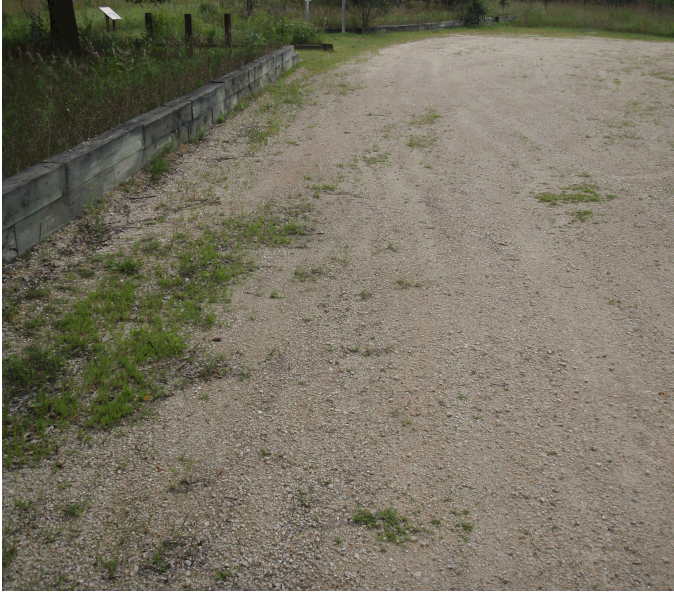
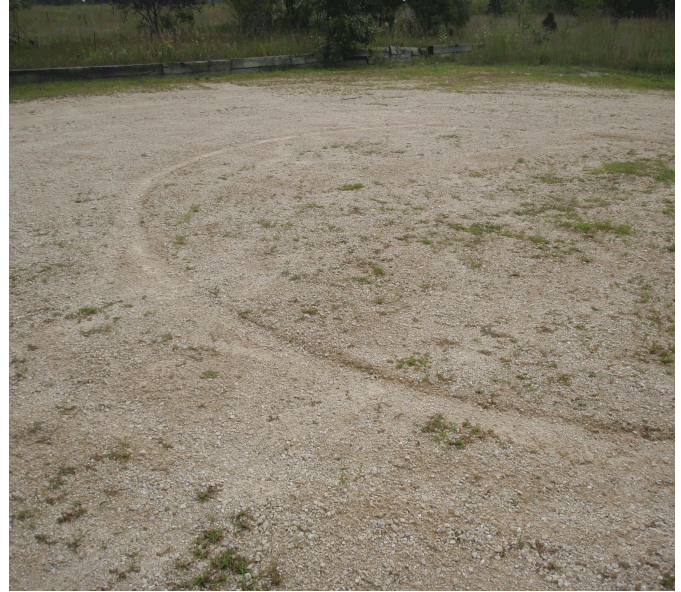
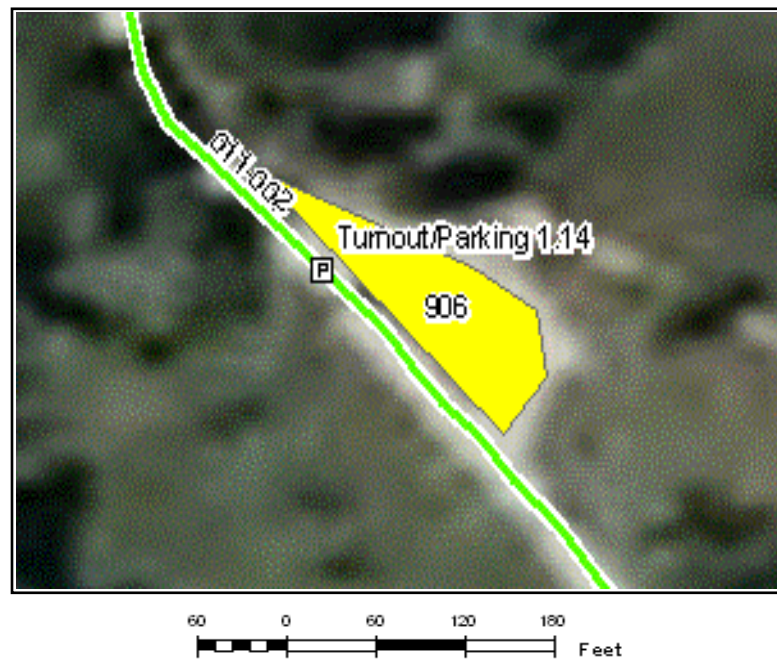
906: Prarie View Parking

Asset Number	Date Visited	Surface Type	Area (Sq Ft)	Condition	Cost to Improve
10043752	08/19/2009	Gravel	4,817	Fair	1,400

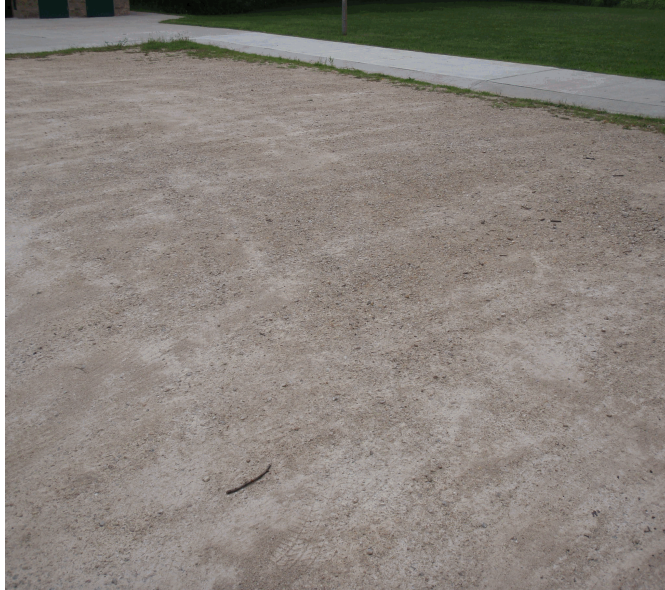
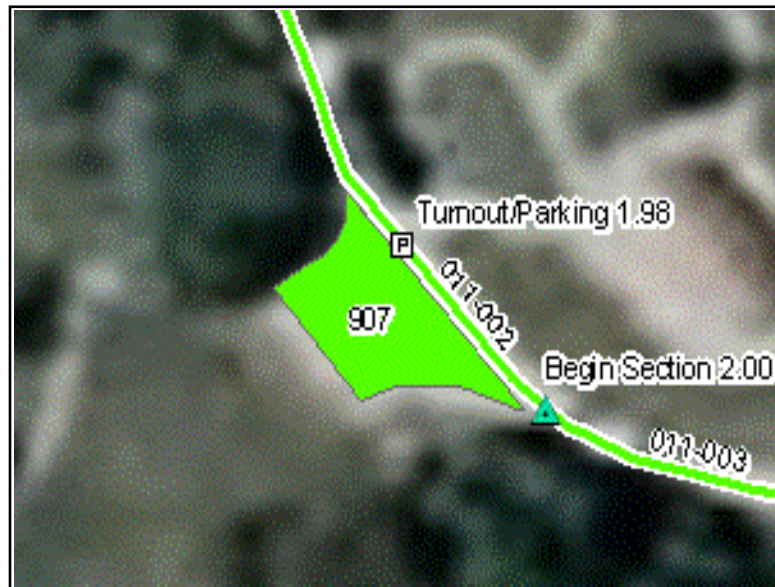
907: Observation Deck Parking

Asset Number	Date Visited	Surface Type	Area (Sq Ft)	Condition	Cost to Improve
10043753	08/19/2009	Gravel	3,590	Good	600

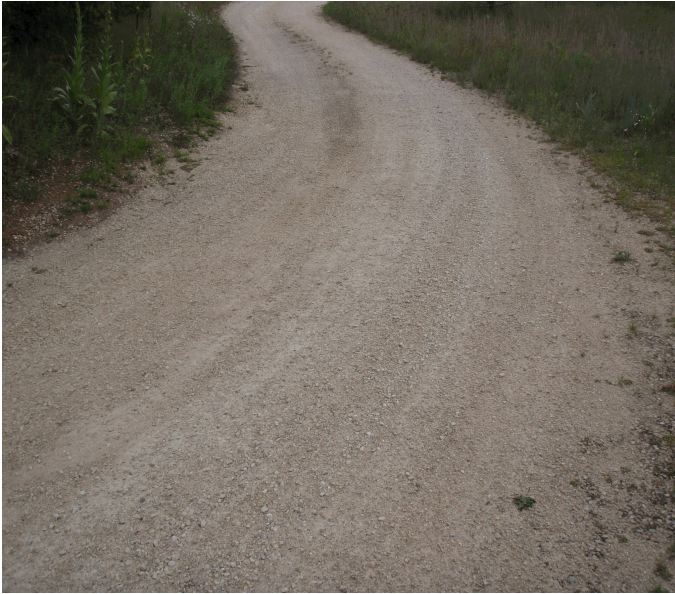
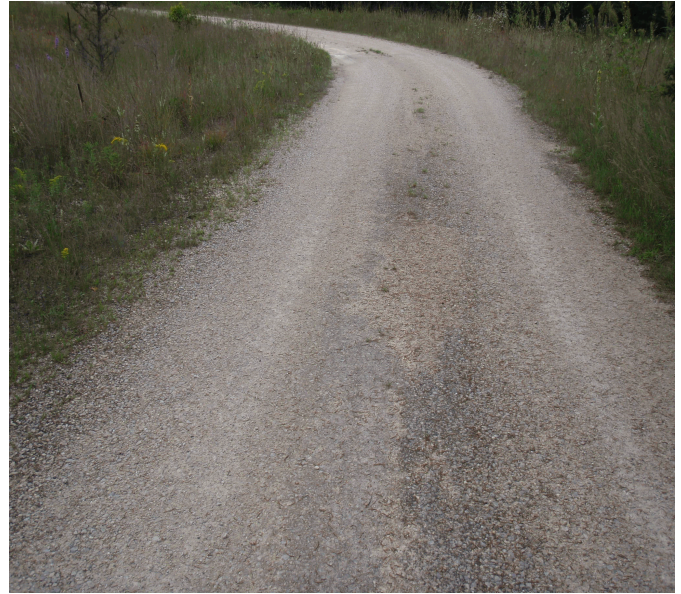
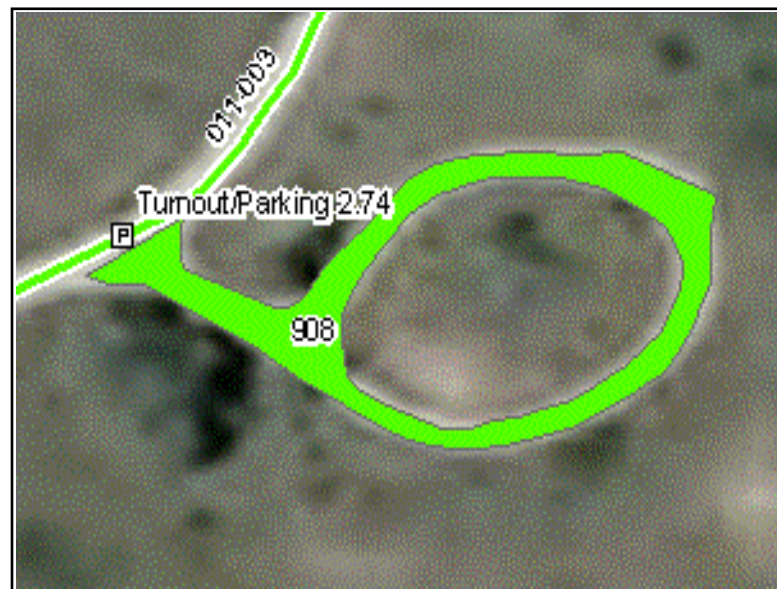
908: Overlook Parking

Asset Number	Date Visited	Surface Type	Area (Sq Ft)	Condition	Cost to Improve
10043754	08/19/2009	Gravel	11,224	Good	1,800

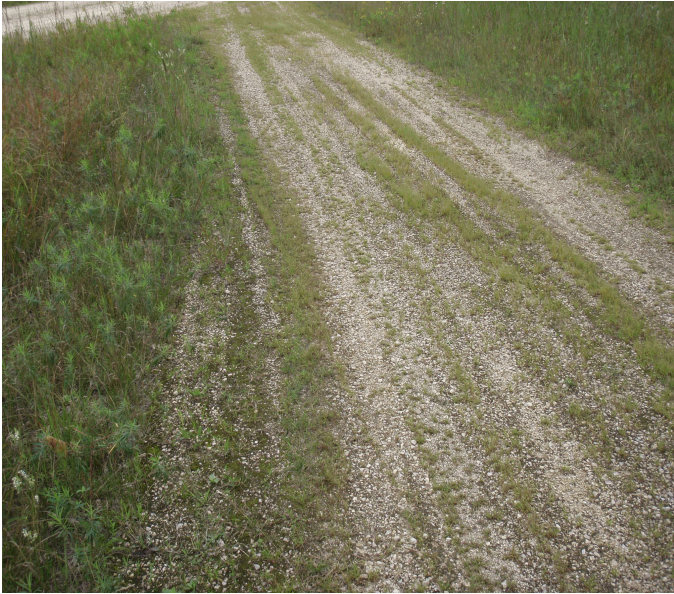
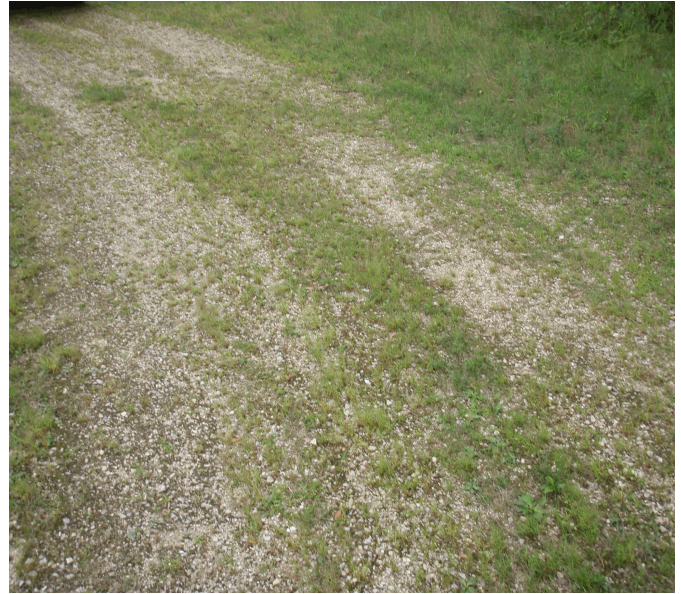
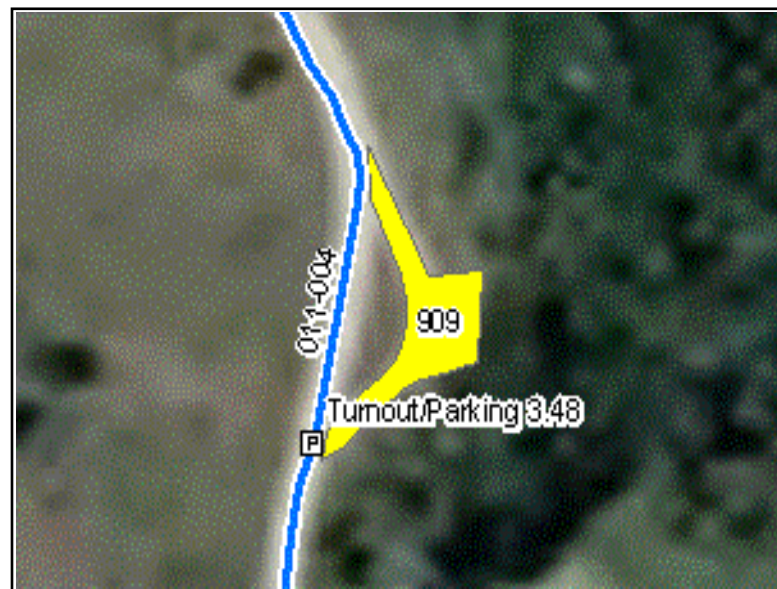
909: Trempealeau River Parking

Asset Number	Date Visited	Surface Type	Area (Sq Ft)	Condition	Cost to Improve
10043755	08/19/2009	Gravel	3,773	Fair	1,100

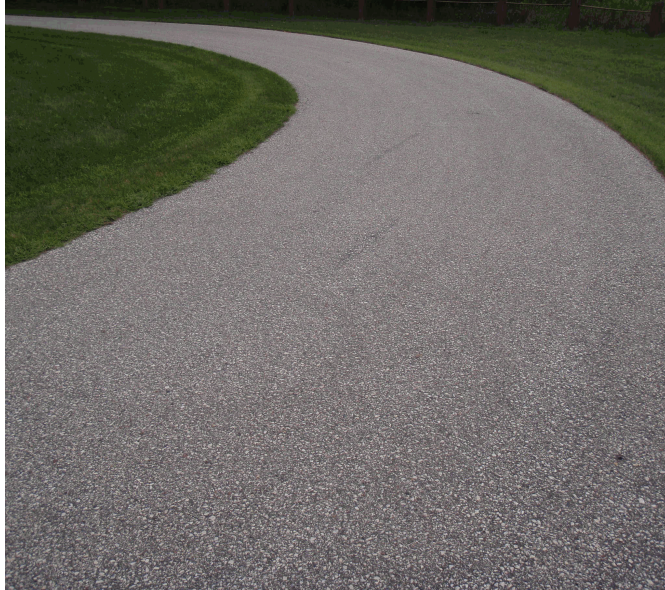
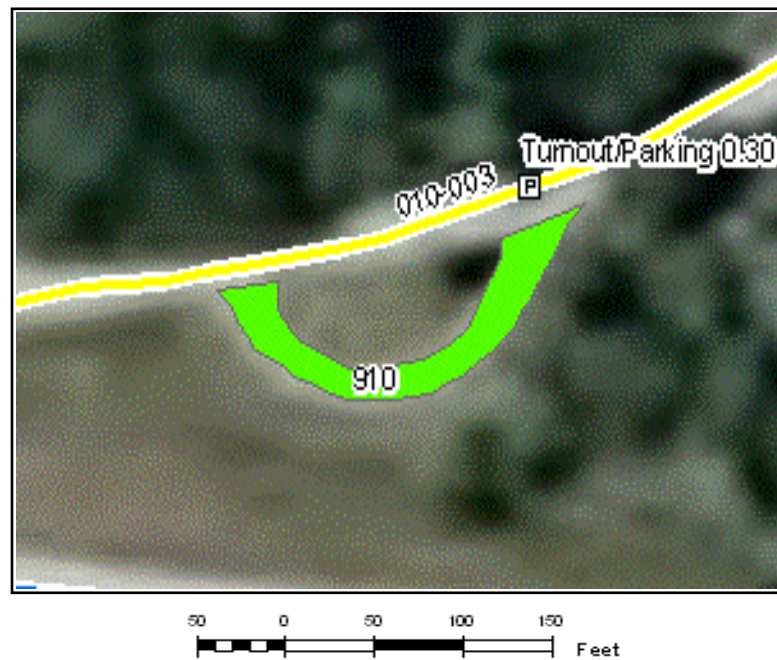
910: Entrance Road Turnaround

Asset Number	Date Visited	Surface Type	Area (Sq Ft)	Condition	Cost to Improve
10011889	08/19/2009	Asphalt	2,433	Good	500

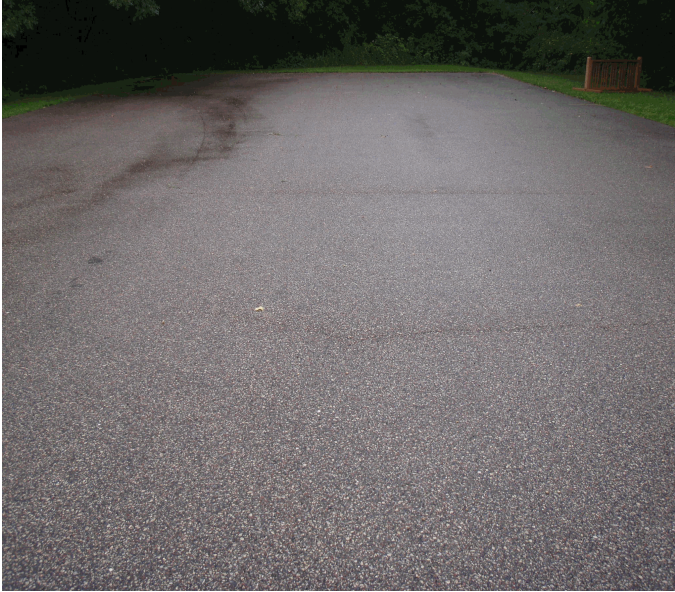
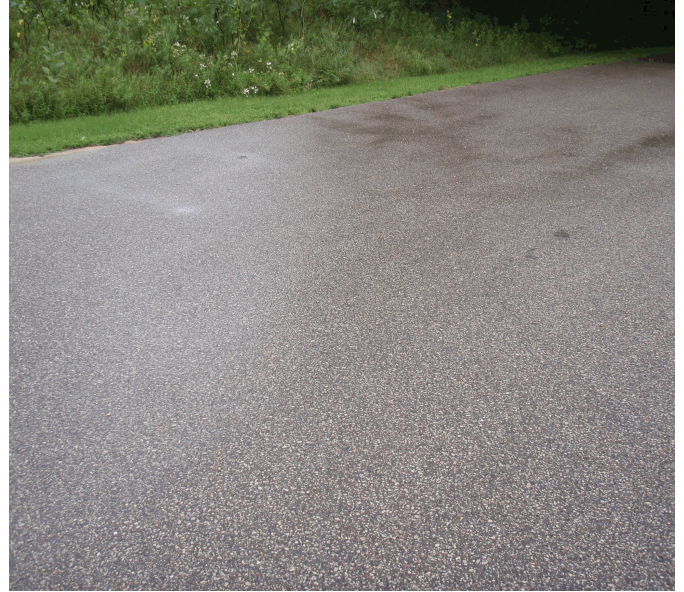
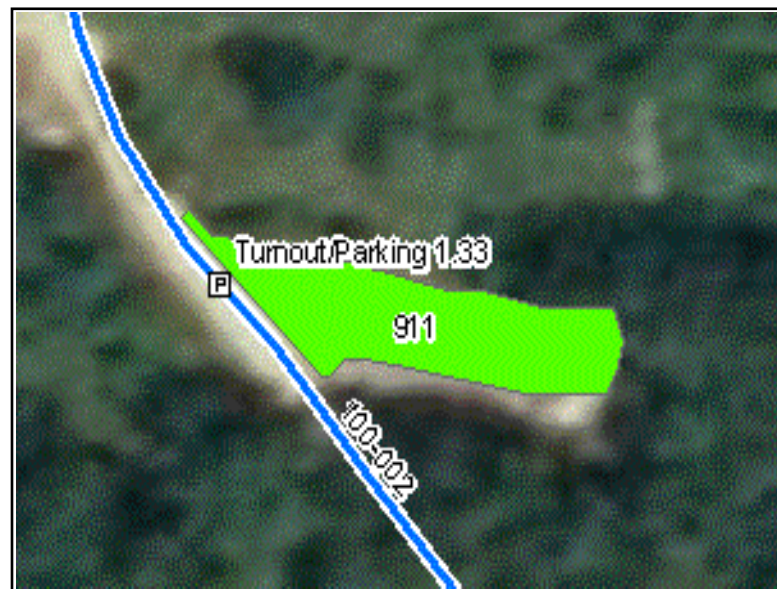
911: Marshland Parking

Asset Number	Date Visited	Surface Type	Area (Sq Ft)	Condition	Cost to Improve
10011908	08/19/2009	Asphalt	4,885	Good	1,000

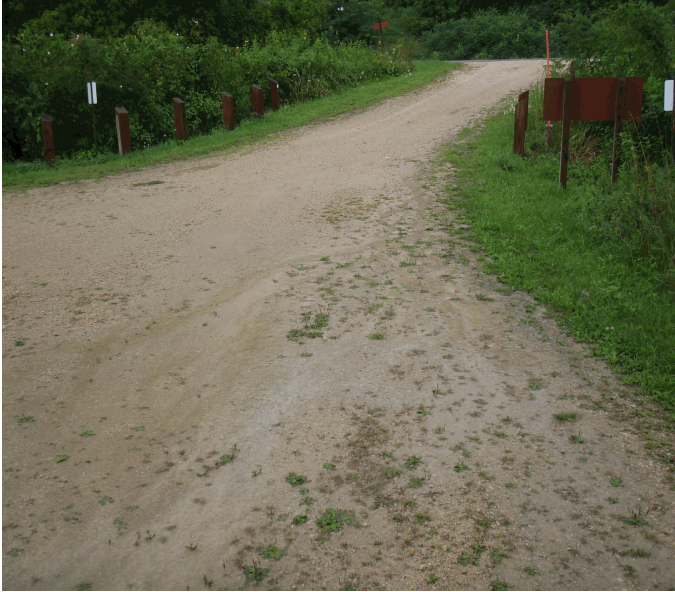
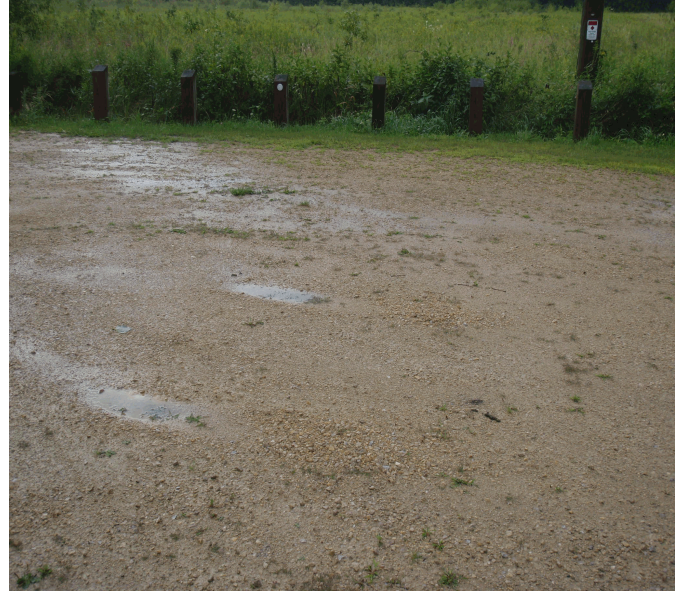
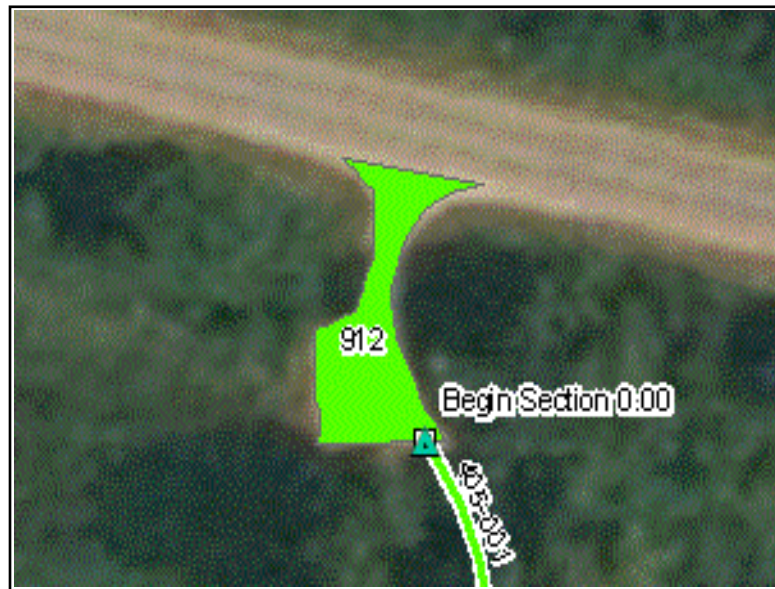
912: River Bottoms Parking

Asset Number	Date Visited	Surface Type	Area (Sq Ft)	Condition	Cost to Improve
10044399	08/19/2009	Gravel	4,796	Good	800

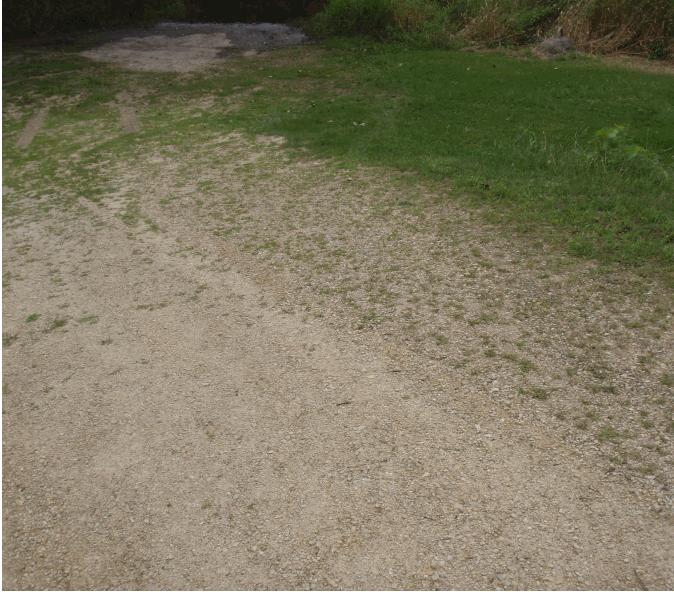
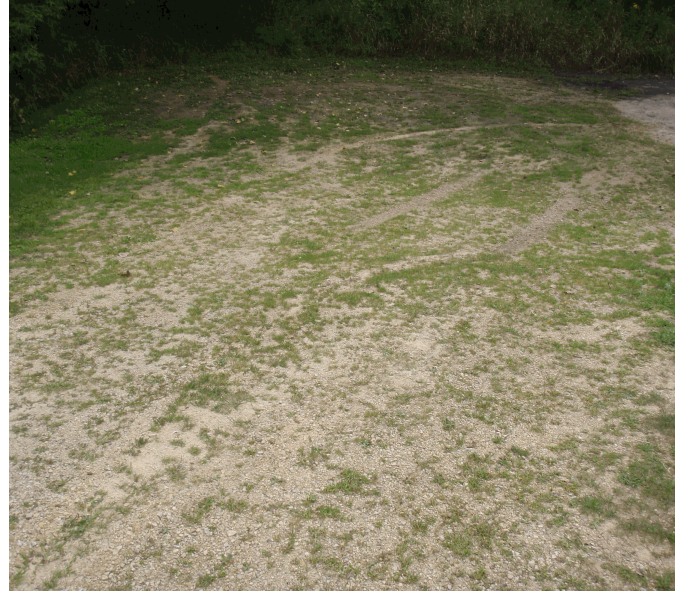
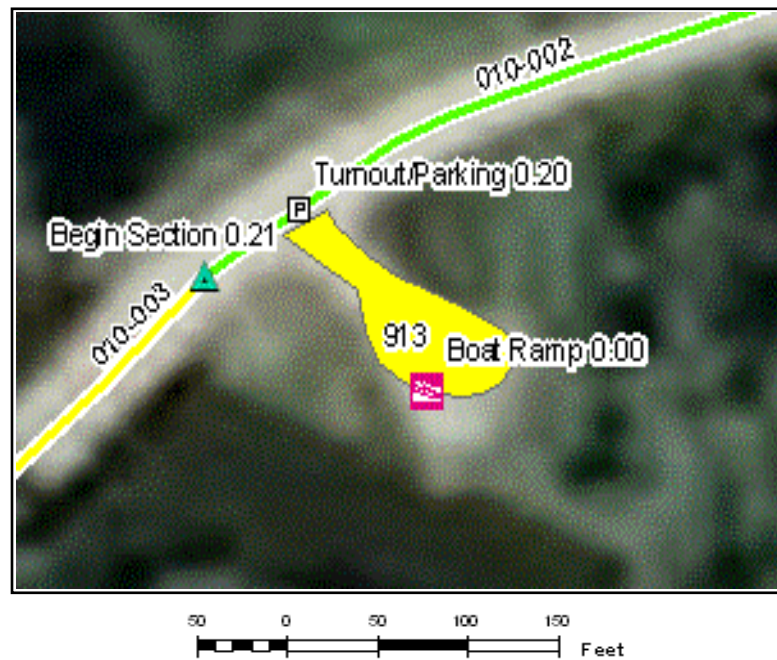
913: Entrance Road Boat Ramp Parking

Asset Number	Date Visited	Surface Type	Area (Sq Ft)	Condition	Cost to Improve
10011924	08/19/2009	Gravel	2,283	Fair	700
