# **The Road Inventory of Back Bay National Wildlife Refuge**

## **Virginia Beach, VA**

Prepared By:  
Federal Highway Administration  
Central Federal Lands Highway Division  
October, 2010

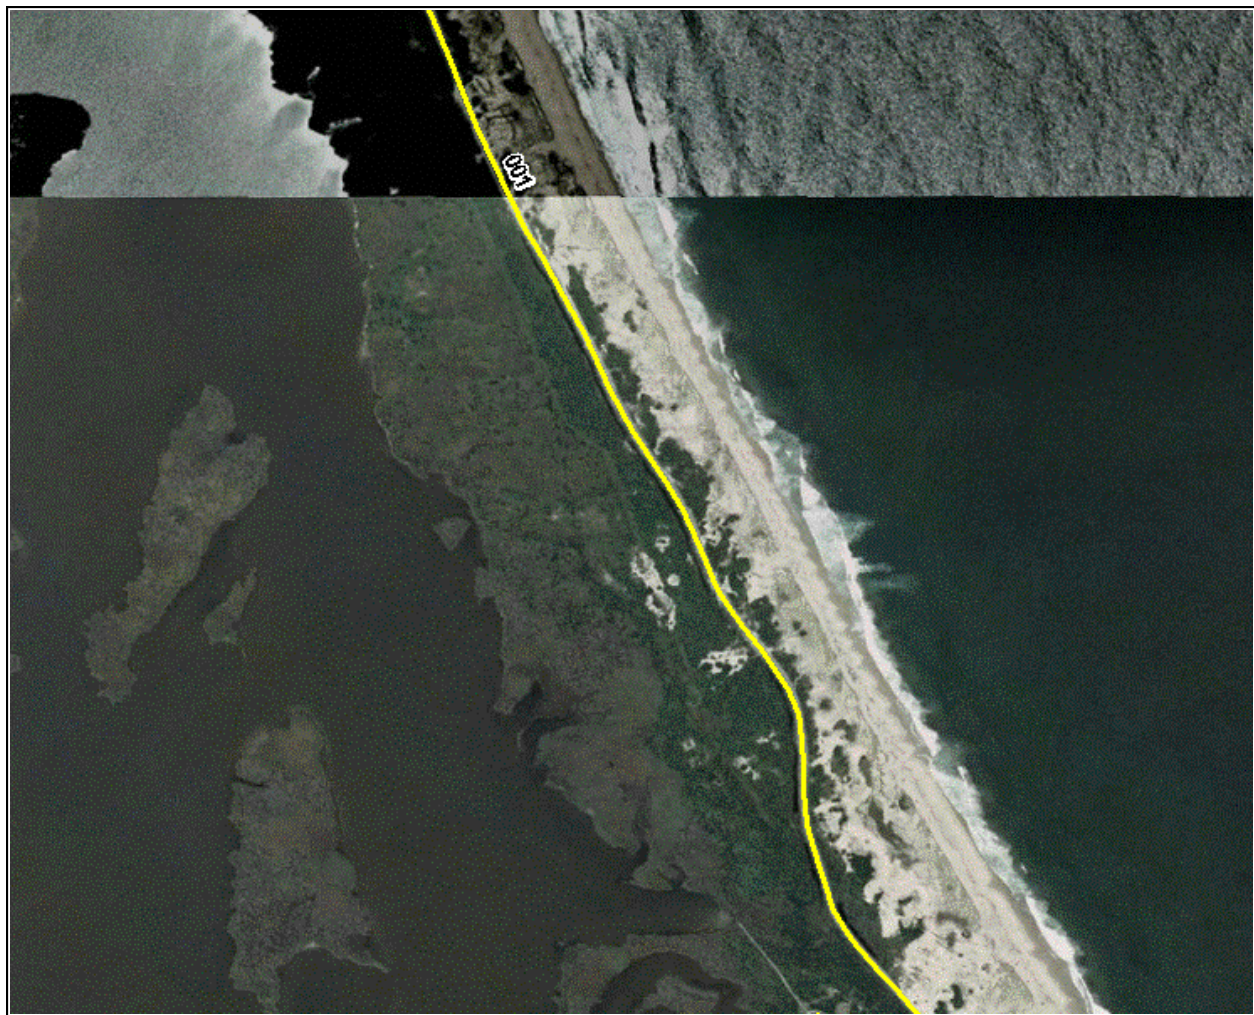
Route: 010 North Entrance Road

Asset Number	10020504
Section Number	001
Section Length (miles)	1.26
Inspection Date	06/03/2010
<b>Section Information</b>	
Surface Type	Asphalt
Number of Lanes	2
Roadway Width (feet)	20.00
<b>Roadway Condition Information</b>	
Condition	Fair
Remaining Service Life (years)	10
Cost Estimate	133,800
CRV	1,482,200.00

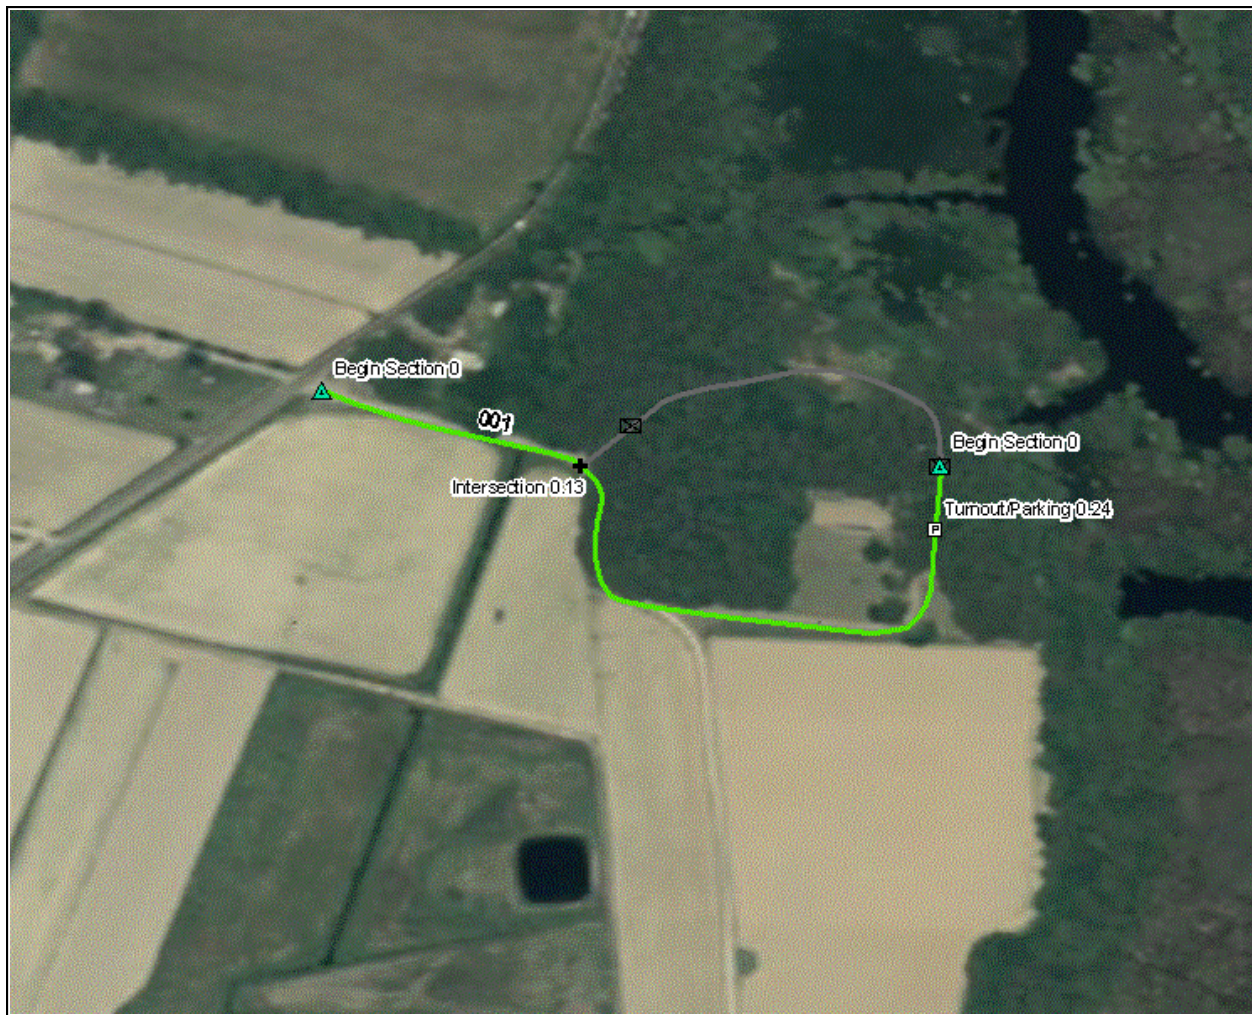
Route: 101 Ashville Bridge Creek Education Center Access

Asset Number	10020527
Section Number	001
Section Length (miles)	0.26
Inspection Date	06/03/2010
<b>Section Information</b>	
Surface Type	Gravel
Number of Lanes	1
Roadway Width (feet)	10.00
<b>Roadway Condition Information</b>	
Condition	Good
Remaining Service Life (years)	5
Cost Estimate	400
CRV	175,500.00

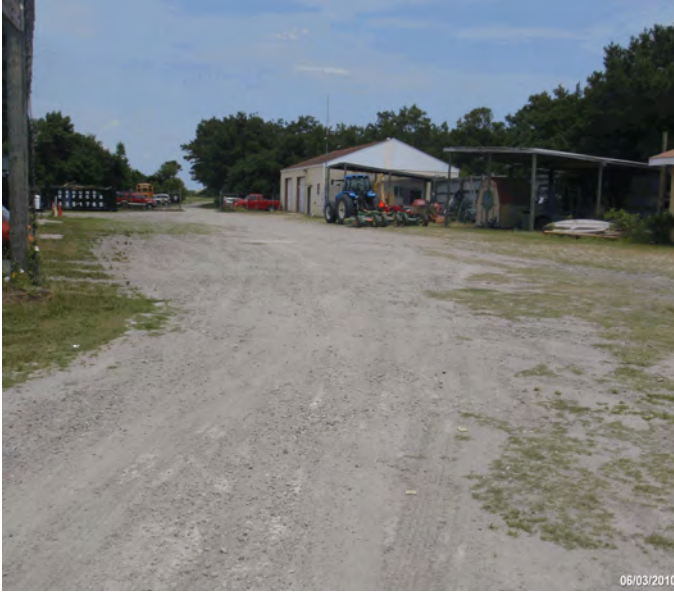
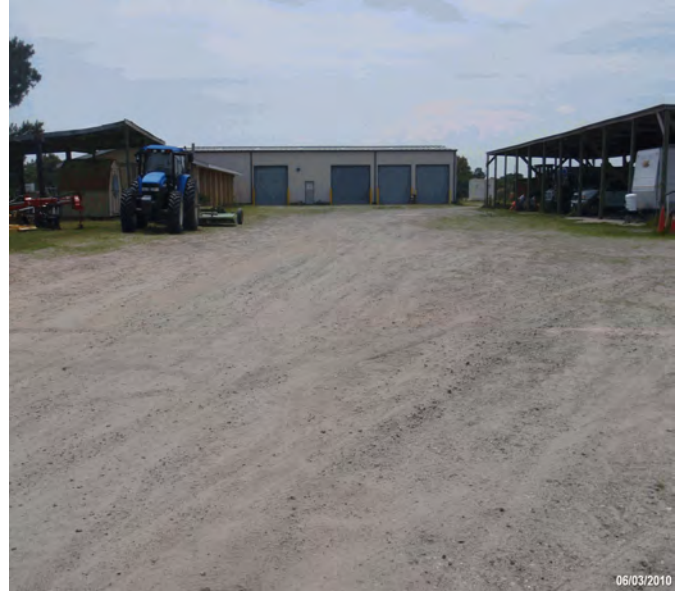
## 800: Back Bay Shop Parking

Asset Number	Date Visited	Surface Type	Area (Sq Ft)	Condition	Cost to Improve
	06/03/2010	Gravel	19,774	Good	2,900

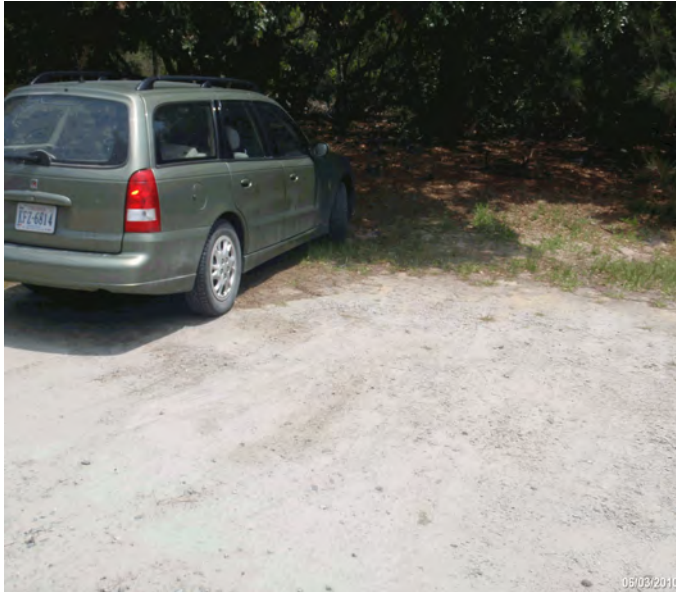
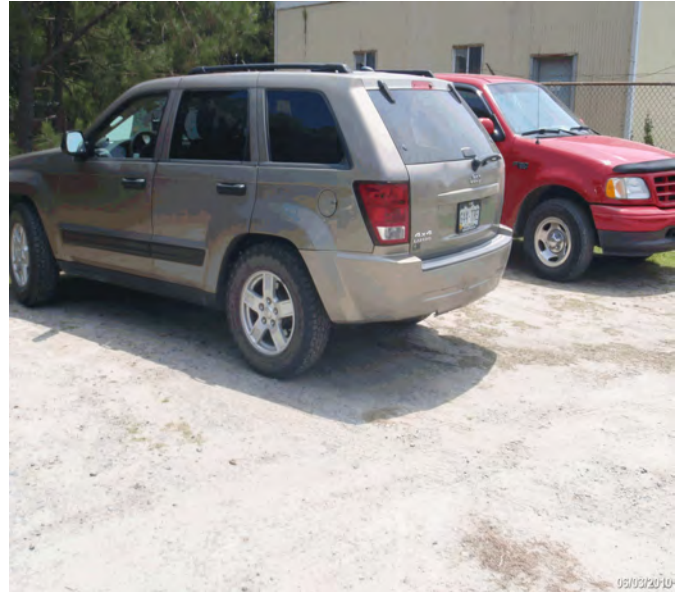
## 801: East Employee Shop Parking

Asset Number	Date Visited	Surface Type	Area (Sq Ft)	Condition	Cost to Improve
	06/03/2010	Gravel	1,392	Good	200

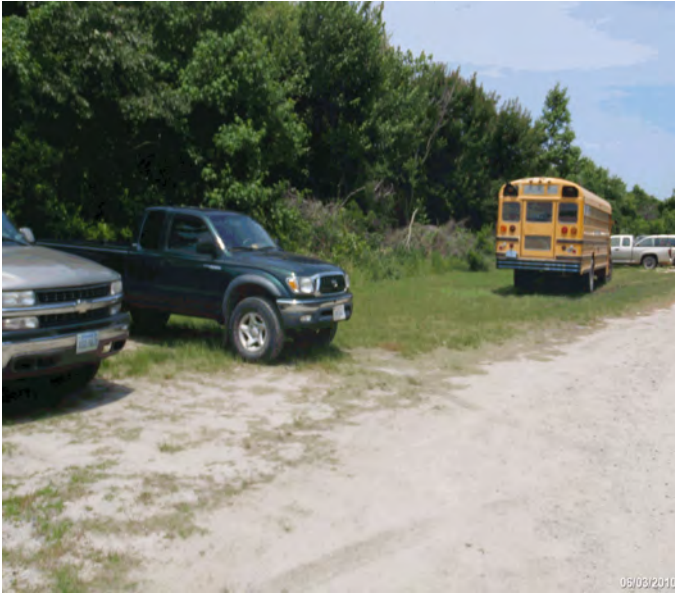
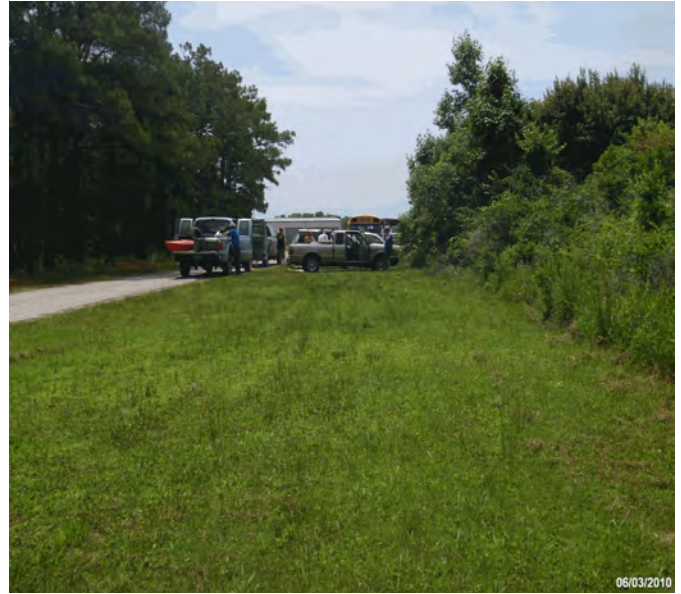
## 802: West Employee Shop Parking

Asset Number	Date Visited	Surface Type	Area (Sq Ft)	Condition	Cost to Improve
	06/03/2010	Native	8,549	Good	1,300

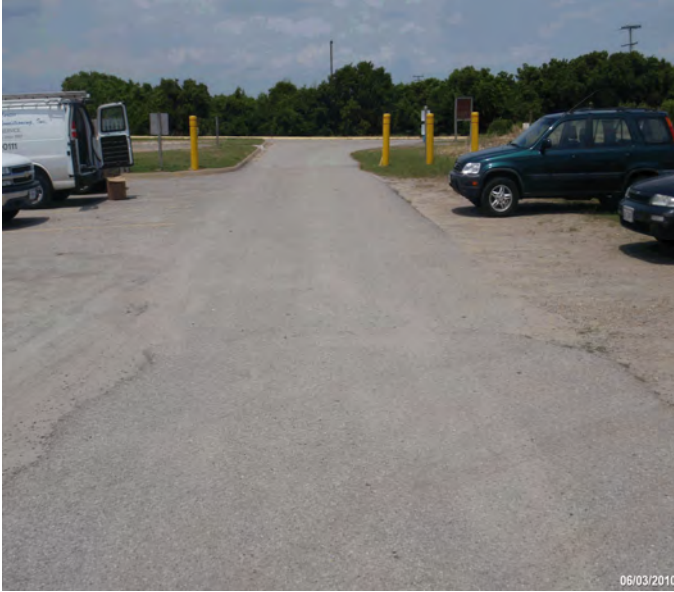
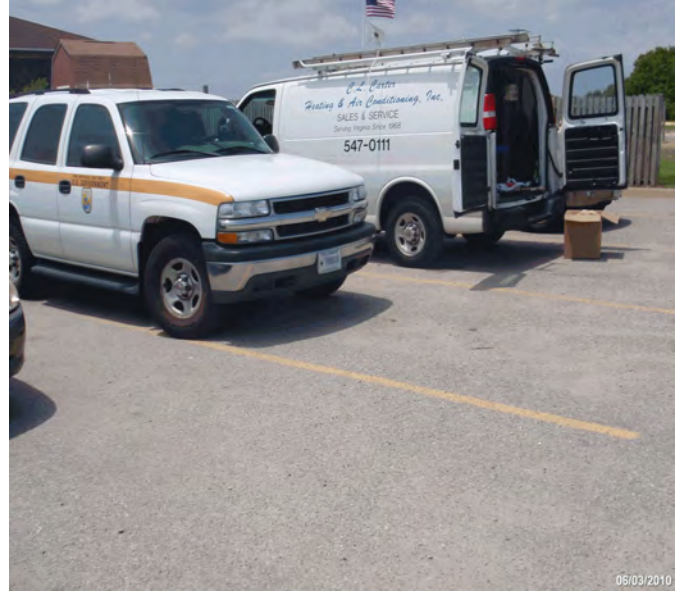
### 803: Employee Visitor Center Parking

Asset Number	Date Visited	Surface Type	Area (Sq Ft)	Condition	Cost to Improve
	06/03/2010	Asphalt	2,721	Fair	2,300

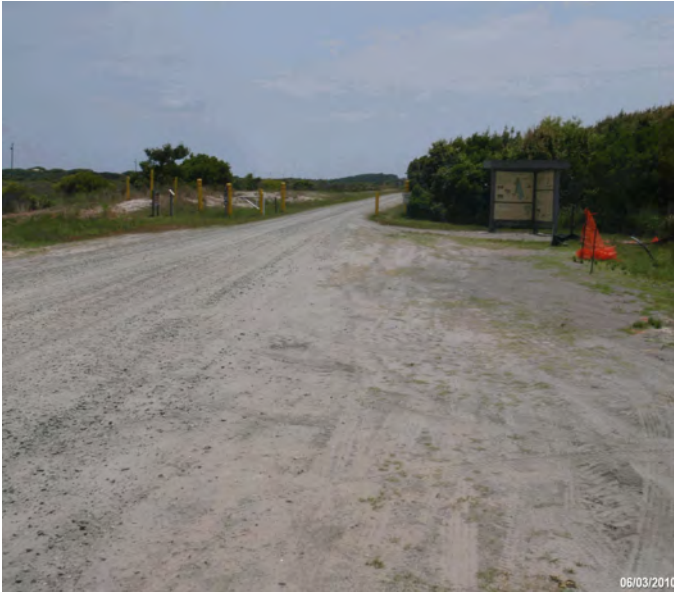
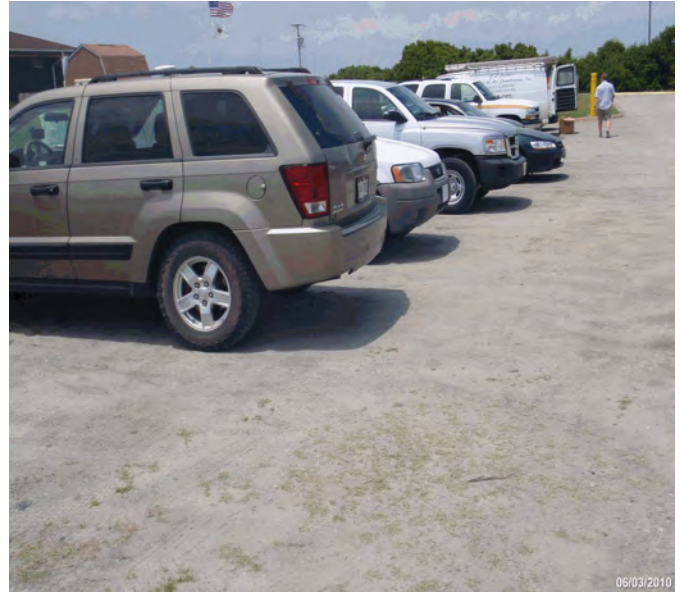
### 804: Employee Vistor Center Native Parking

Asset Number	Date Visited	Surface Type	Area (Sq Ft)	Condition	Cost to Improve
	06/03/2010	Native	9,553	Good	1,400

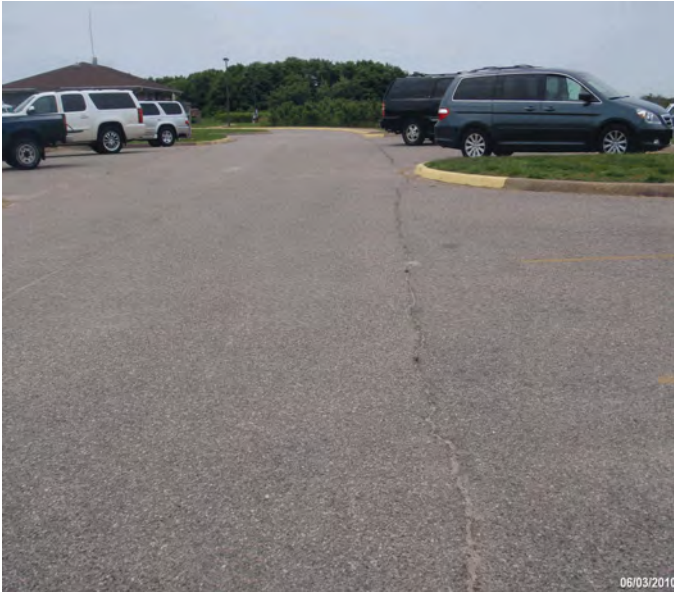
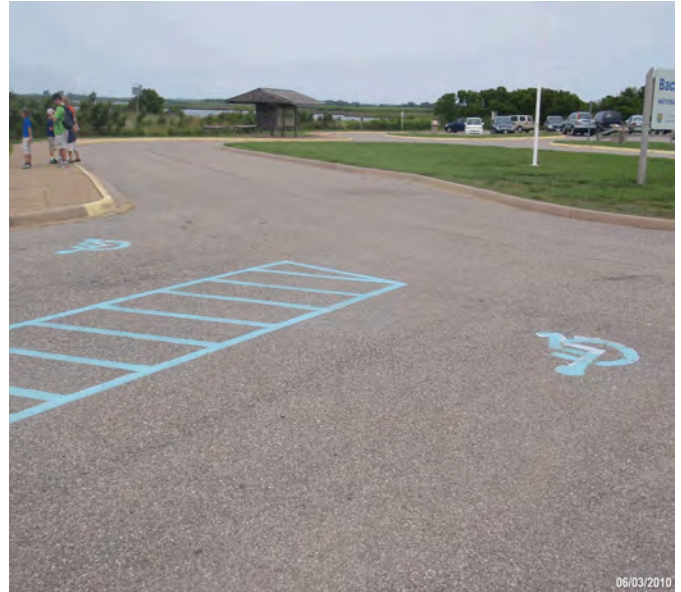
### 900: Visitor Center Parking

Asset Number	Date Visited	Surface Type	Area (Sq Ft)	Condition	Cost to Improve
10020514	06/03/2010	Asphalt	41,516	Fair	35,000

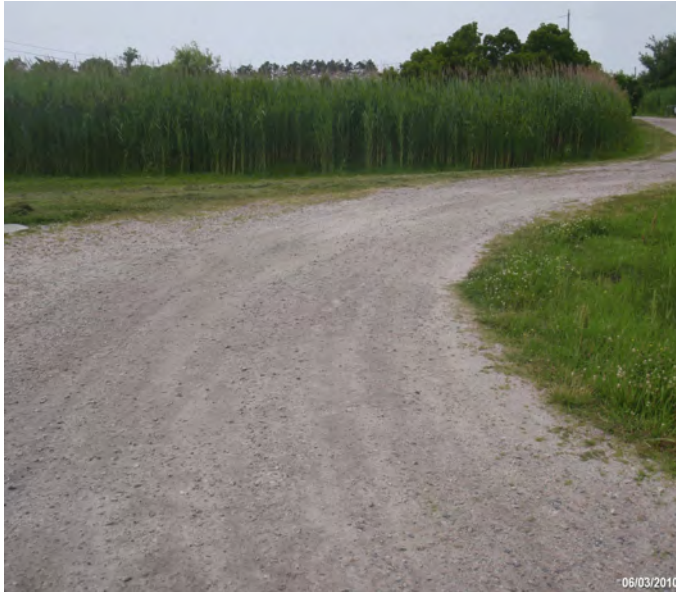
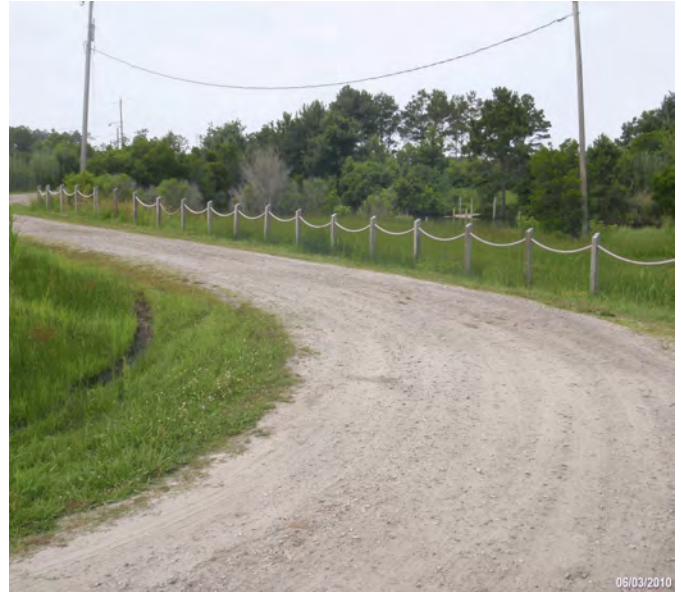
## 901: Horn Point Gravel Parking

Asset Number	Date Visited	Surface Type	Area (Sq Ft)	Condition	Cost to Improve
	06/03/2010	Gravel	7,655	Fair	2,000

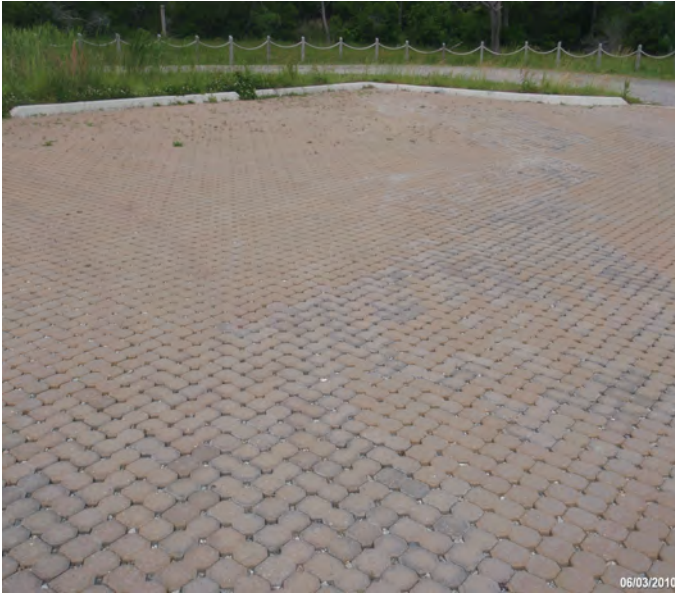
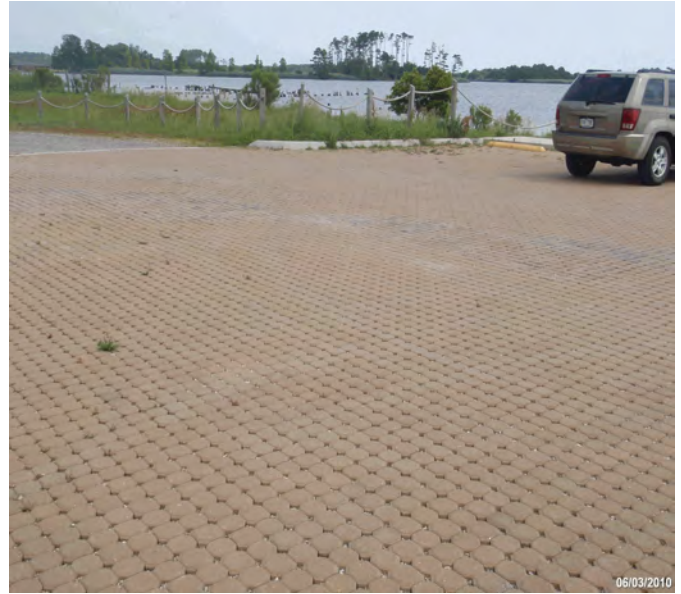
## 902: Horn Point Cobblestone Parking

Asset Number	Date Visited	Surface Type	Area (Sq Ft)	Condition	Cost to Improve
10055872	06/03/2010	Concrete	3,118	Good	400

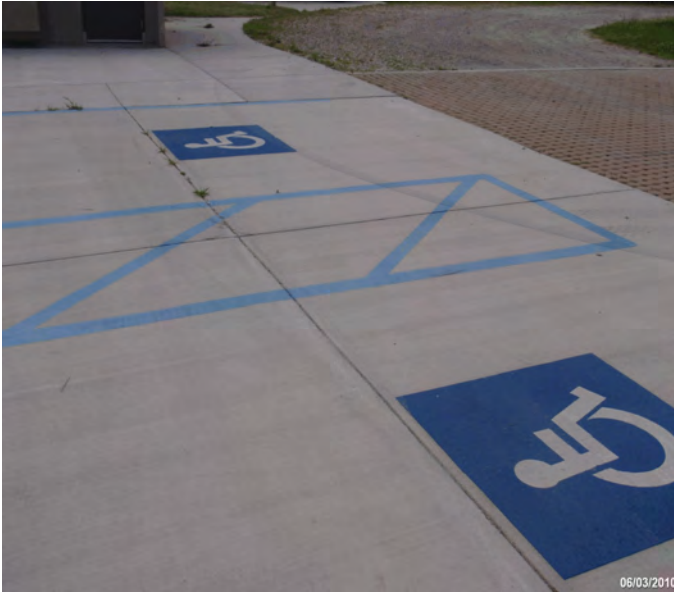
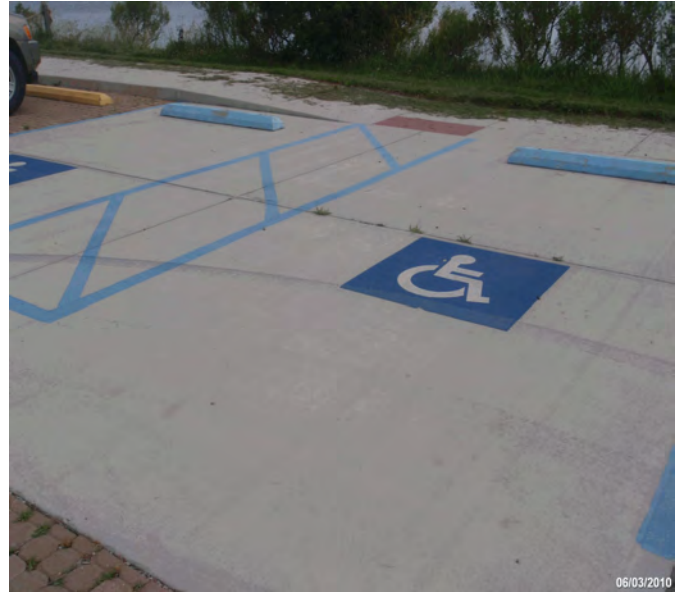
### 903: Horn Point Handicap Parking

Asset Number	Date Visited	Surface Type	Area (Sq Ft)	Condition	Cost to Improve
10055872	06/03/2010	Concrete	400	Good	100

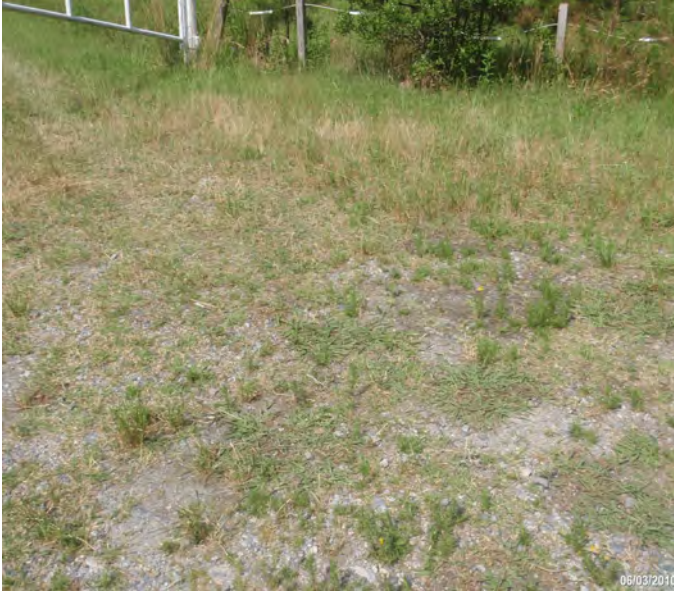
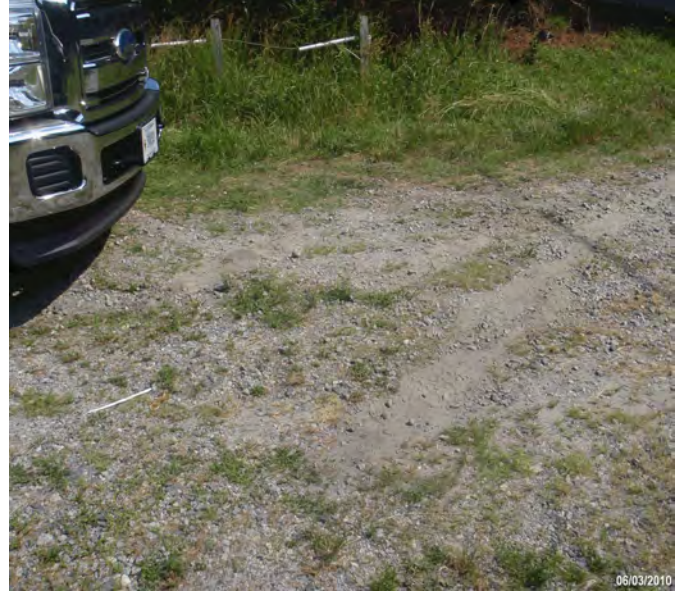
### 904: Colechester Unit Parking

Asset Number	Date Visited	Surface Type	Area (Sq Ft)	Condition	Cost to Improve
10020588	06/03/2010	Gravel	2,468	Fair	600

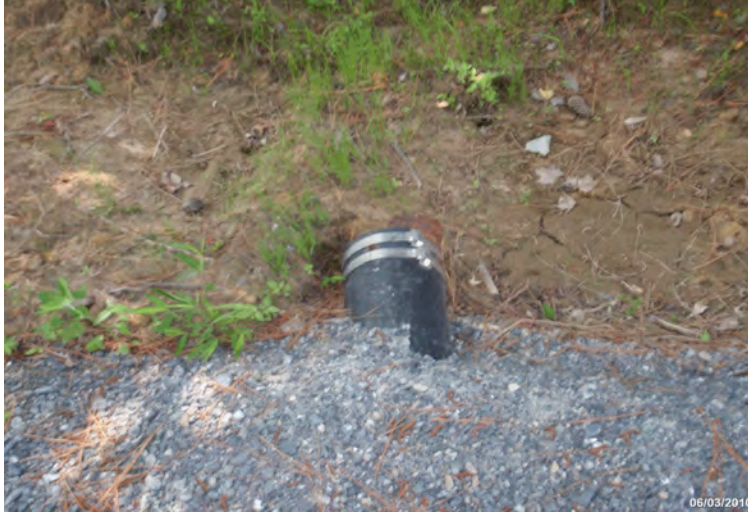
Photo # BaBa\_C4\_0655 - MP 0.11 - Round Culvert Section 001

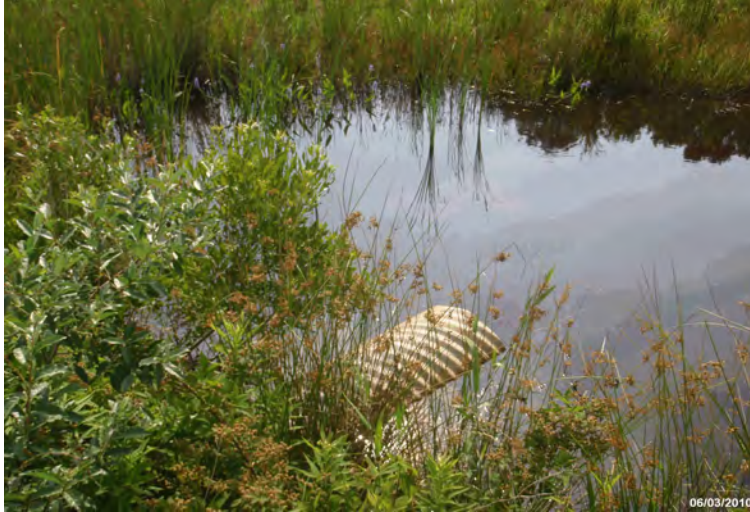
Photo # BaBa\_C4\_0638 - MP 0.04 - Round Culvert Section 001
