## Appendix C

### Big Muddy National Fish and Wildlife Two Year Traffic Counter Report

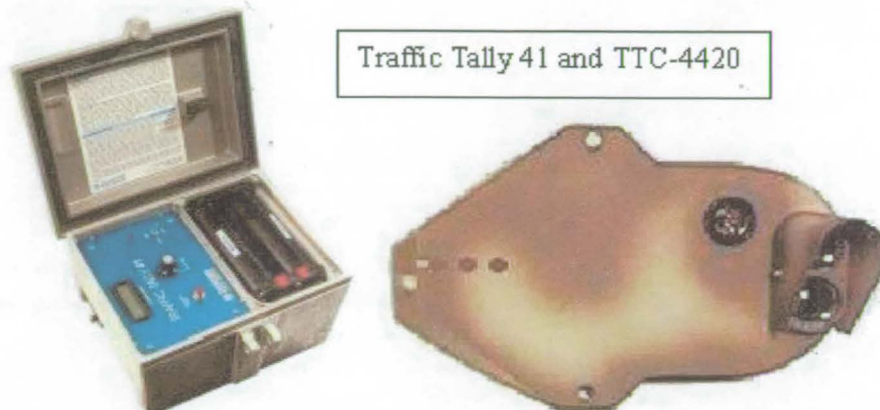
Inductive loop counters count vehicles by a buried inductive loop (wire) under a road bed. The loop gives off a slight magnetic signal and when a large metal vehicle passes over that loop the counter counts. The system has proven successful and will operate for over a year on a set of batteries.

Infrared trail counters use an invisible infrared beam passed across a trail between the counter and a reflector. When ever the beam is broken the counter counts. The counters beam is placed at waist height approximately 4 feet. This system is the most widely used trail counter system.

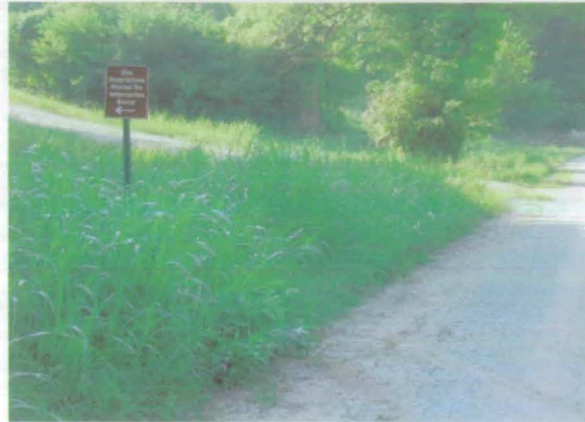
**Big Muddy National Fish and Wildlife Refuge**  
**Lisbon and Jameson Island Units**  
 Saline and Howard Counties 3,885 Acres  
 website: [www.fws.gov/midwest/bigmuddy](http://www.fws.gov/midwest/bigmuddy)

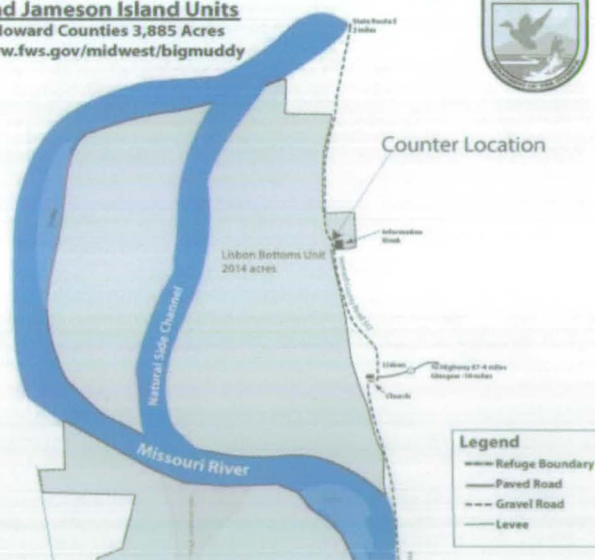
The map demonstrates how the county road serves as a hunting access along the east side of the property boundary in the Lisbon Unit. Many of the hunters who use the unit do not visit the parking lot as the desired hunting area may be closer to the county road. Several blocked roads into the unit provide enough room to park a vehicle. The shoulder of the county road provides areas to park as well

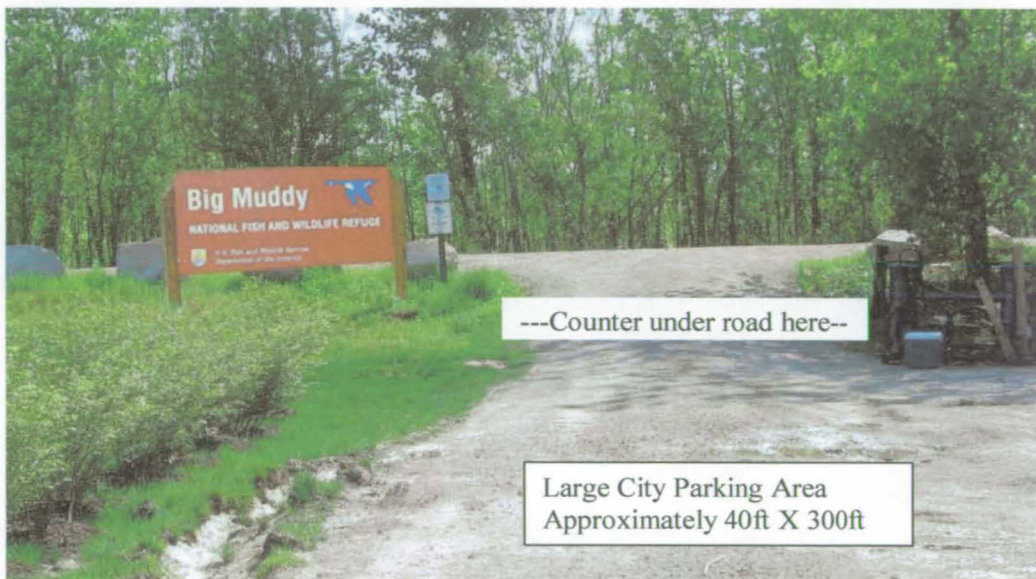
The traffic counter at the Boone's Crossing unit is also located under the road into the parking area for the unit. Unlike the Lisbon unit this is more likely the only area hunters and other refuge specific users utilize to access the area. First installed 1/13/2006.

A large parking lot adjacent to the refuge lot was built by the city of Chesterfield to provide access for people to utilize ball playing fields built next to this refuge unit. The refuge receives occasional visitors that walk from that parking lot into the refuge, and thus are not counted. To offset that count it is assumed that some users of the ball fields may utilize the refuge parking lot because trees adjacent to the refuge parking lot provide shade for vehicles that the city parking lot does not. This is typical of the summer months when refuge use is at its lowest and ball field use is at its highest.

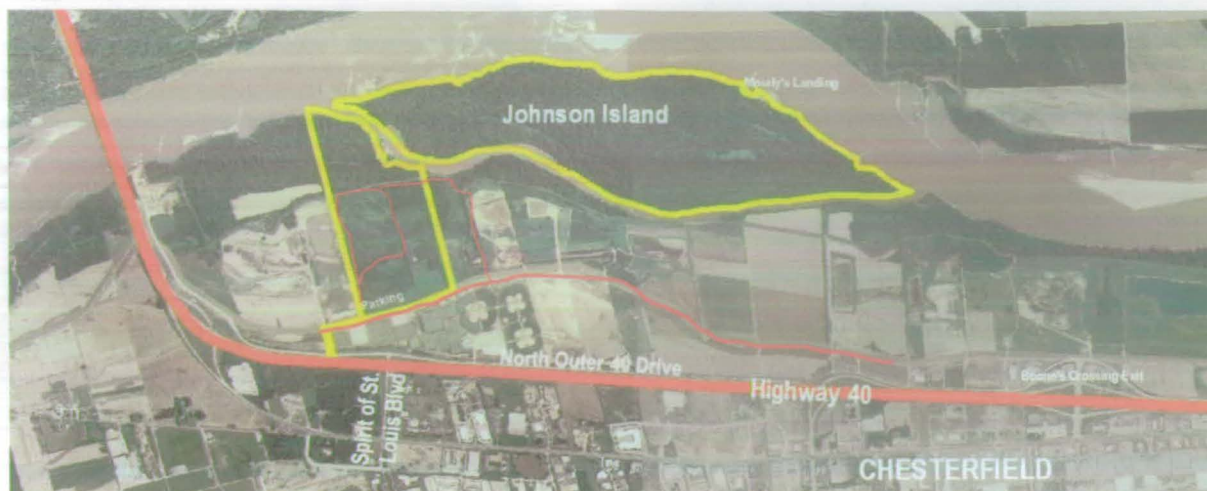
On this aerial photo and refuge outline in yellow the thickest red line represents Interstate 64. The medium red line represents the new multipurpose trail and the small red line represent a mulched trail on refuge and adjacent city property. Johnson Island of this unit is totally separated by a permanent side channel of the Missouri River. The island is getting used by hunters but seldom by other visitors. Mosely's landing provides a visitors information kiosk and access steps up the bank. The majority of the use in this unit of the refuge is on the 131 acre mainland parcel.

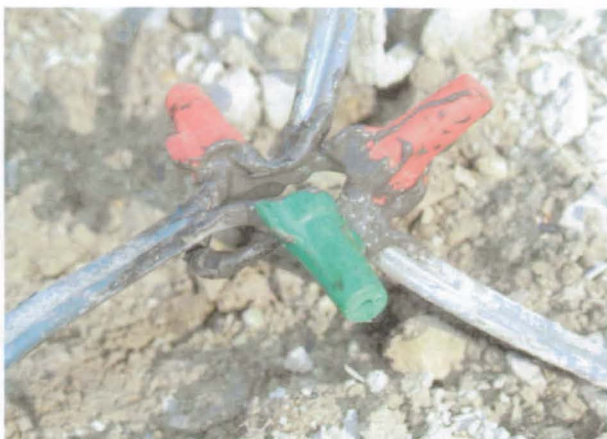
Diamond Traffic Products recommended tar to seal the splice. JB Weld Quickset epoxy or similar flexible epoxy was used to seal the splice. It provided a cleaner and quicker method than tar. After the two parts of the epoxy were mixed you had approximately 5 minutes to seal the splice before the epoxy set. The photo shows the sealed splice for the counter at Lisbon. Wire nuts were used in this case but butt splices were more effective and easier to tape after

the epoxy set. Epoxy was used to cover the entire splice and any exposed wire. After the epoxy set the entire splice was wrapped in electrical tape.

Another problem encountered were the cables of the inductive loop counters would get wet where they were spliced together under the road bed. This would cause the counters to quit counting, or over count. All of the loops were dug up and re-spliced and sealed with and epoxy to make sure that water did not get into the spliced wire. The counts we more productive after the splices were sealed.

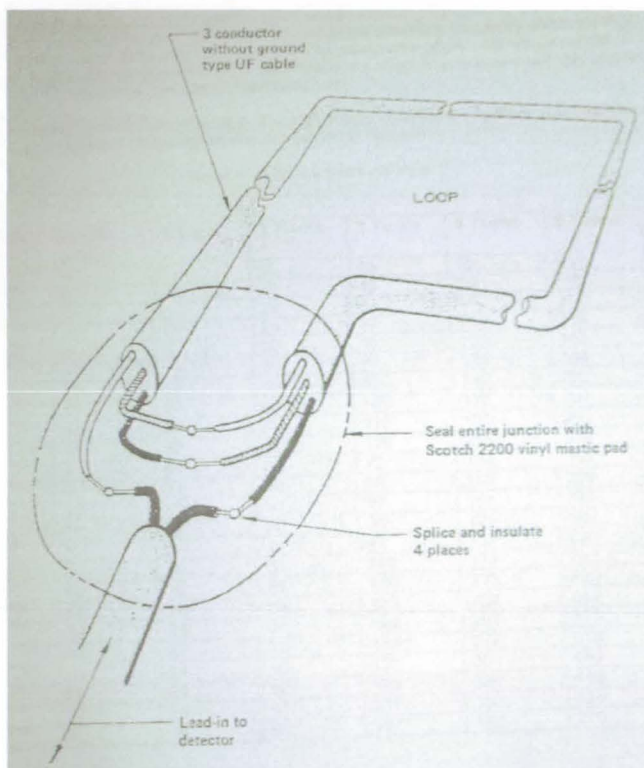
This diagram shows the formation of the inductive loop. This loop was typically buried under the gravel road at least 6 inches. The loop averaged 12 feet long by 6 feet wide. To complete the entire loop and lead into the counter required approximately 50 feet of wire. The wire was 14 AWG (American Wire Gauge). The wire is required to be in three strands insulated impervious to water, sunlight, and other destructive residues.

The wire is available at most retail home improvement centers and at the time of this writing was available for approximately .66 cents a linear foot.
