The Road Inventory of Great River National Wildlife Refuge

Annada, MO

Prepared By:
Federal Highway Administration
Central Federal Lands Highway Division
December 2009

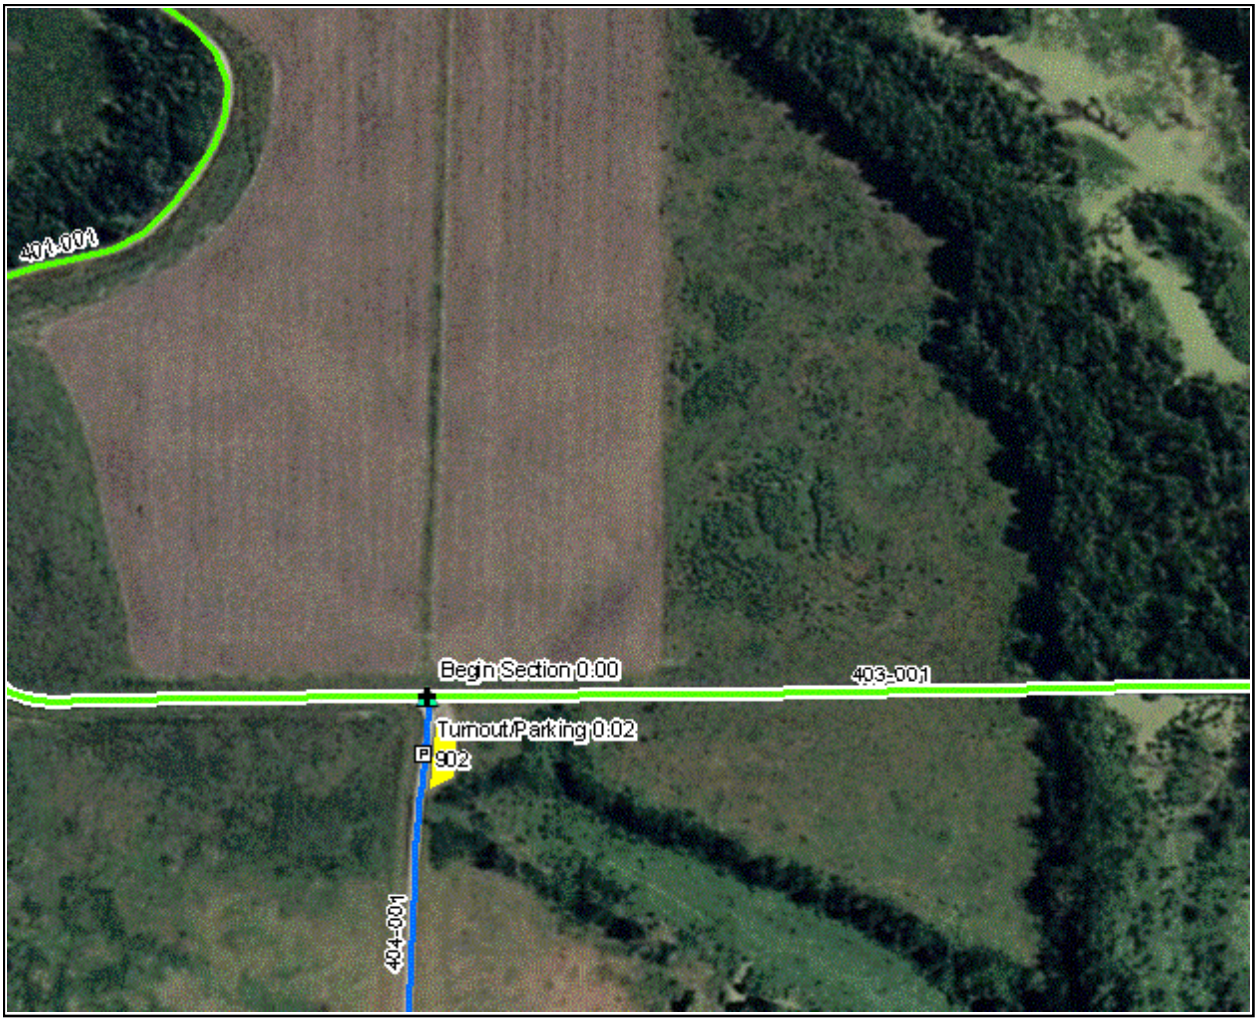
Route Description: From Shoveler Marsh Road (Route 401), To Upper Swan Road (Route 400)

Asset Number	10013922
Section Number	001
Section Length (miles)	0.87
Inspection Date	10/07/2009
Section Information	
Surface Type	Gravel
Number of Lanes	1
Roadway Width (feet)	12.00
Roadway Condition Information	
Condition	Excellent
Remaining Service Life (years)	9
Cost Estimate	0
CRV	613,000.00
