The Road Inventory of Welaka National Fish Hatchery

Welaka, FL

Prepared By:
Federal Highway Administration
Central Federal Lands Highway DivisionJune
June 2010

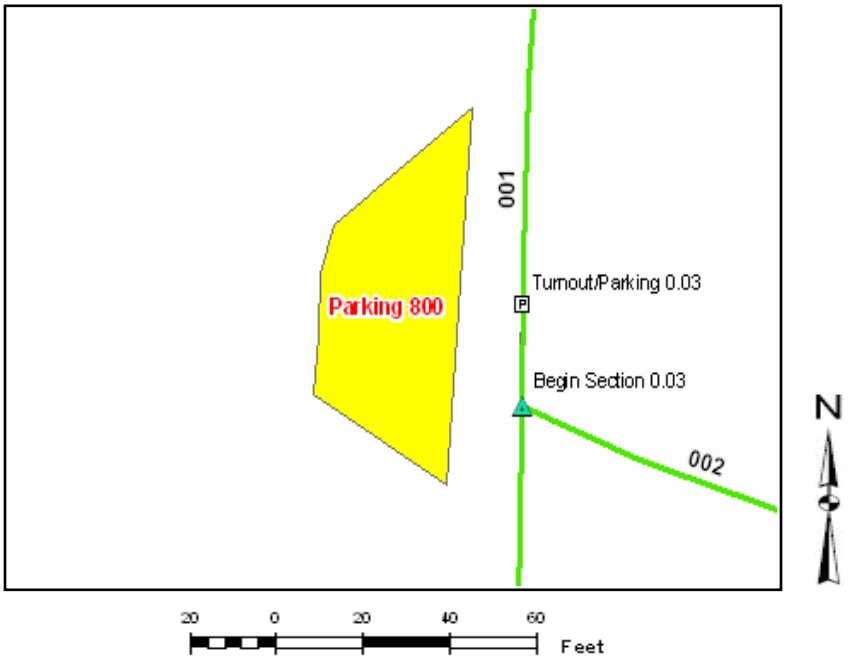
800: Fish Shed Parking

Asset Number	Date Visited	Surface Type	Area (Sq Ft)	Condition	Cost to Improve
	03/25/2010	Gravel	2,494	Fair	600

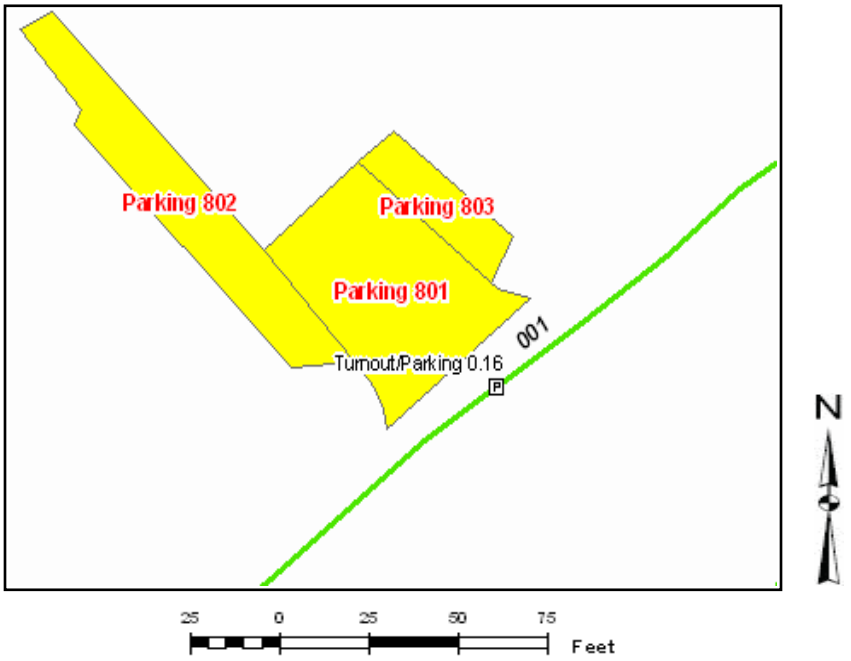
801: Crew Quarters Parking

Asset Number	Date Visited	Surface Type	Area (Sq Ft)	Condition	Cost to Improve
	03/25/2010	Asphalt	3,142	Fair	2,600

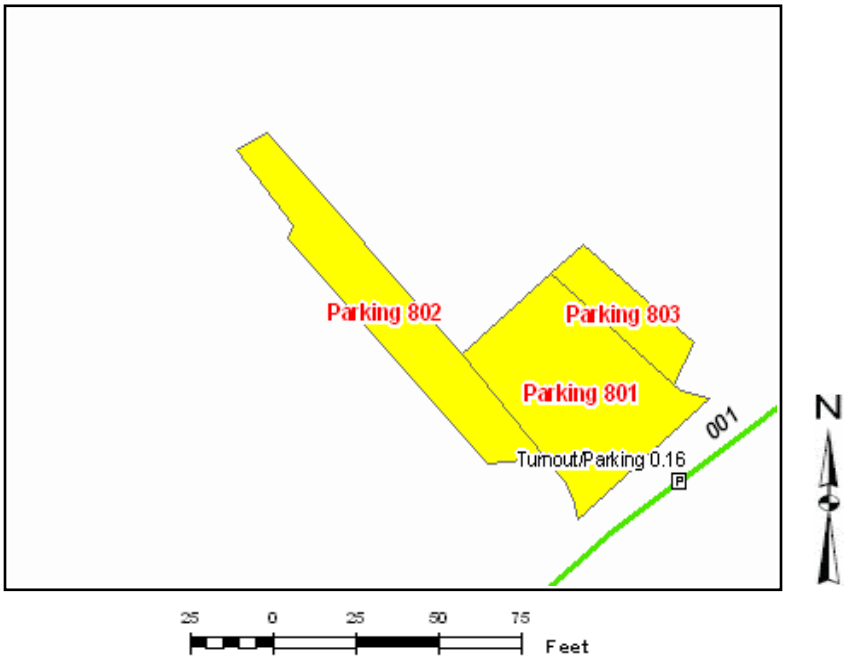
802: Crew Quarters Parking 1

Asset Number	Date Visited	Surface Type	Area (Sq Ft)	Condition	Cost to Improve
10052090	03/25/2010	Concrete	2,354	Fair	4,200

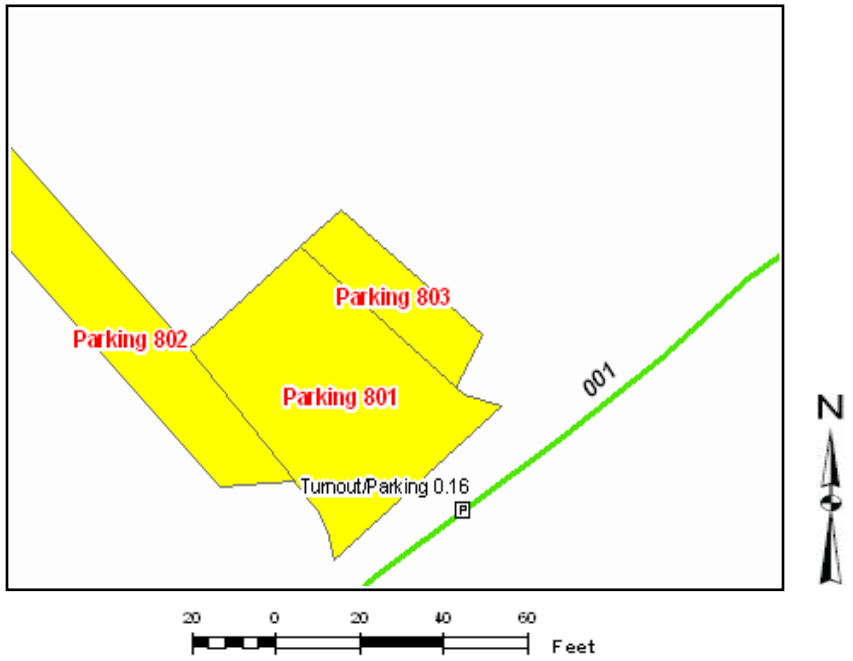
803: Crew Quarters Parking 2

Asset Number	Date Visited	Surface Type	Area (Sq Ft)	Condition	Cost to Improve
10052090	03/25/2010	Concrete	789	Fair	1,400

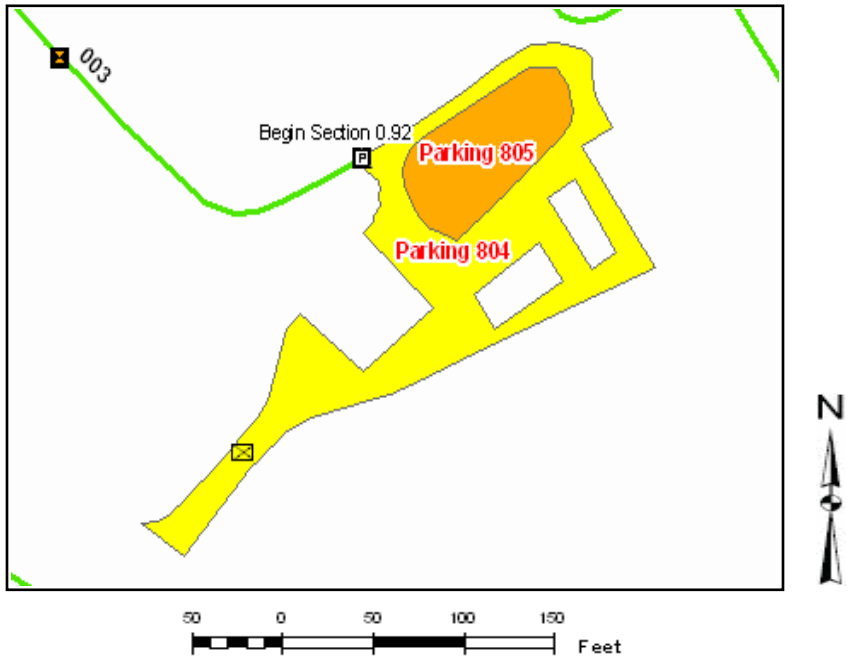
804: Beacher Springs Fish Buildings Parking

Asset Number	Date Visited	Surface Type	Area (Sq Ft)	Condition	Cost to Improve
	03/25/2010	Asphalt	18,982	Fair	15,800

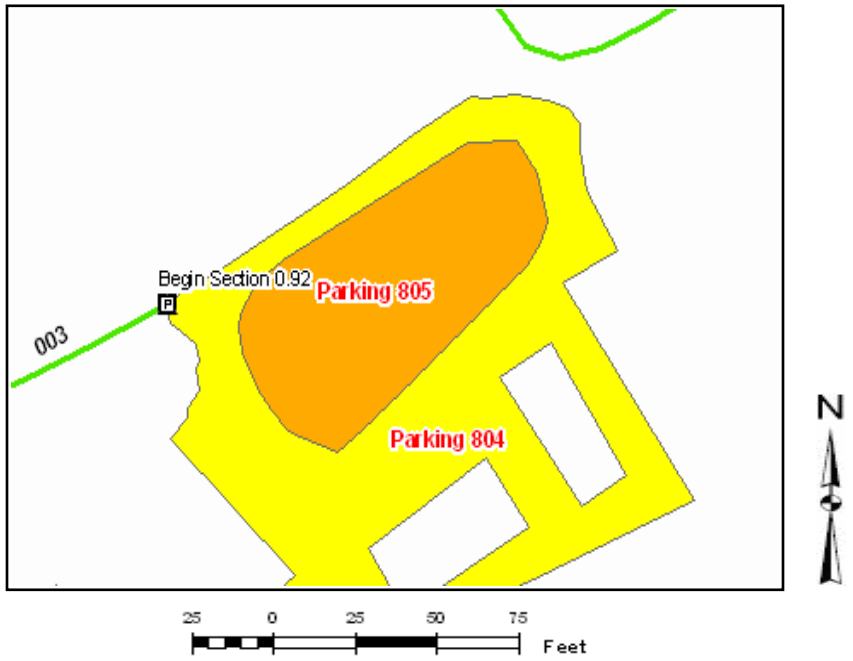
805: Beacher Springs Concrete Parking

Asset Number	Date Visited	Surface Type	Area (Sq Ft)	Condition	Cost to Improve
10052090	03/25/2010	Concrete	6,175	Poor	27,500

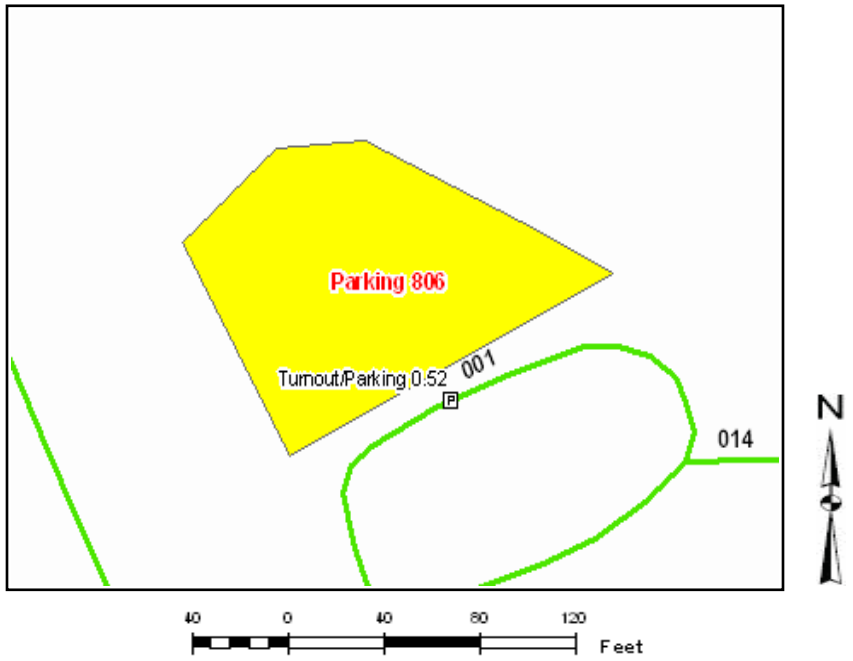
806: Shop Parking

Asset Number	Date Visited	Surface Type	Area (Sq Ft)	Condition	Cost to Improve
	03/25/2010	Native	15,919	Fair	4,100

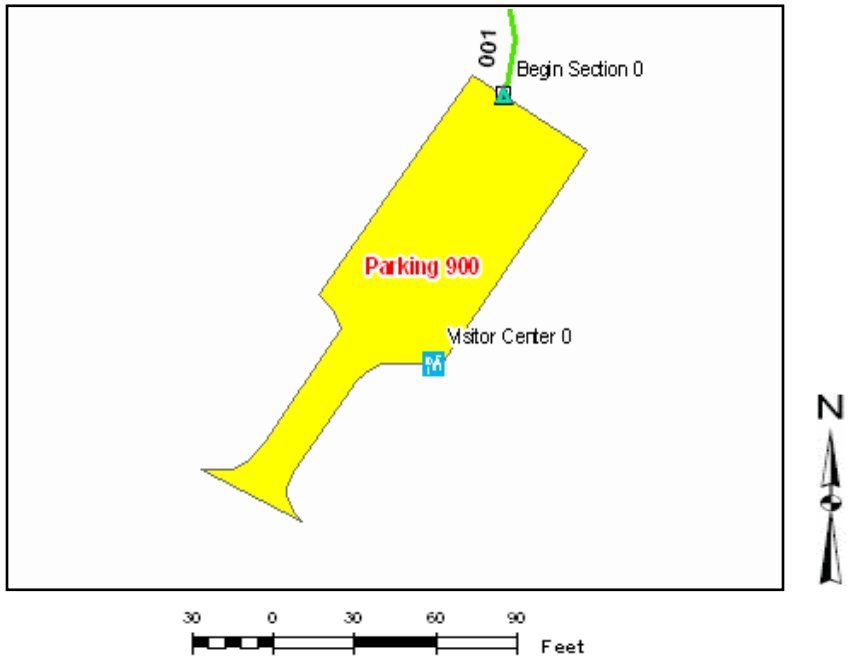
900: HQ/VC Parking

Asset Number	Date Visited	Surface Type	Area (Sq Ft)	Condition	Cost to Improve
10046120	03/25/2010	Asphalt	8,153	Fair	6,800

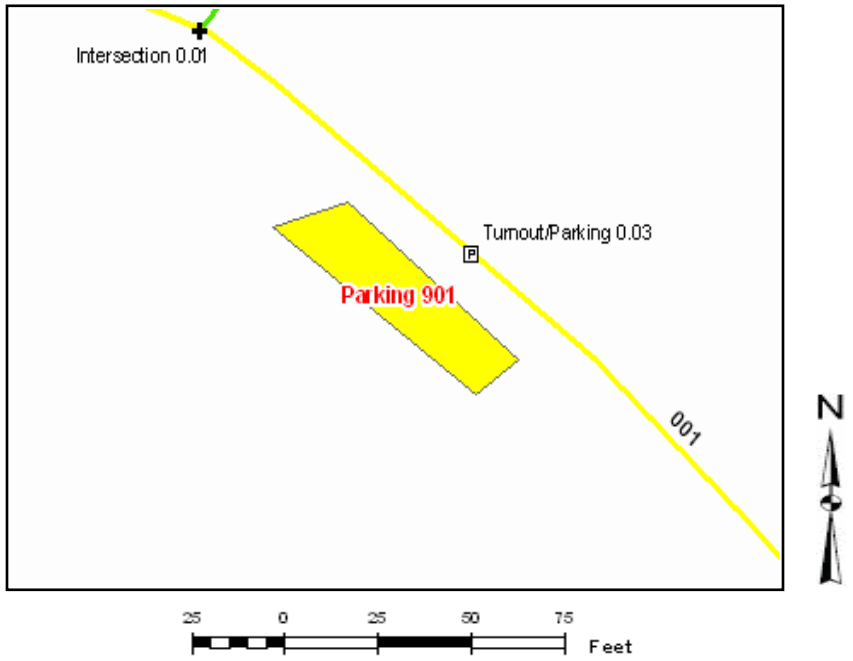
901: Aquarium Parking

Asset Number	Date Visited	Surface Type	Area (Sq Ft)	Condition	Cost to Improve
10046137	03/25/2010	Asphalt	1,367	Fair	1,100

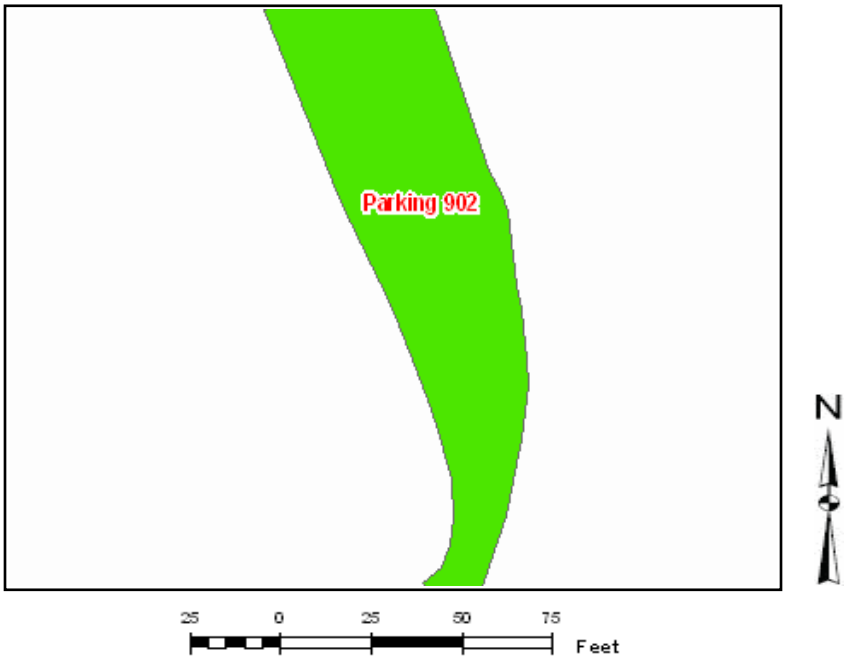
902: Beecher Springs Observation Tower Parking

Asset Number	Date Visited	Surface Type	Area (Sq Ft)	Condition	Cost to Improve
10055689	03/25/2010	Native	7,179	Good	1,000
