The Road Inventory of
Currituck Island
National Wildlife Refuge
Knotts Island, NC

Prepared By:
Federal Highway Administration
Central Federal Lands Highway Division
September, 2010

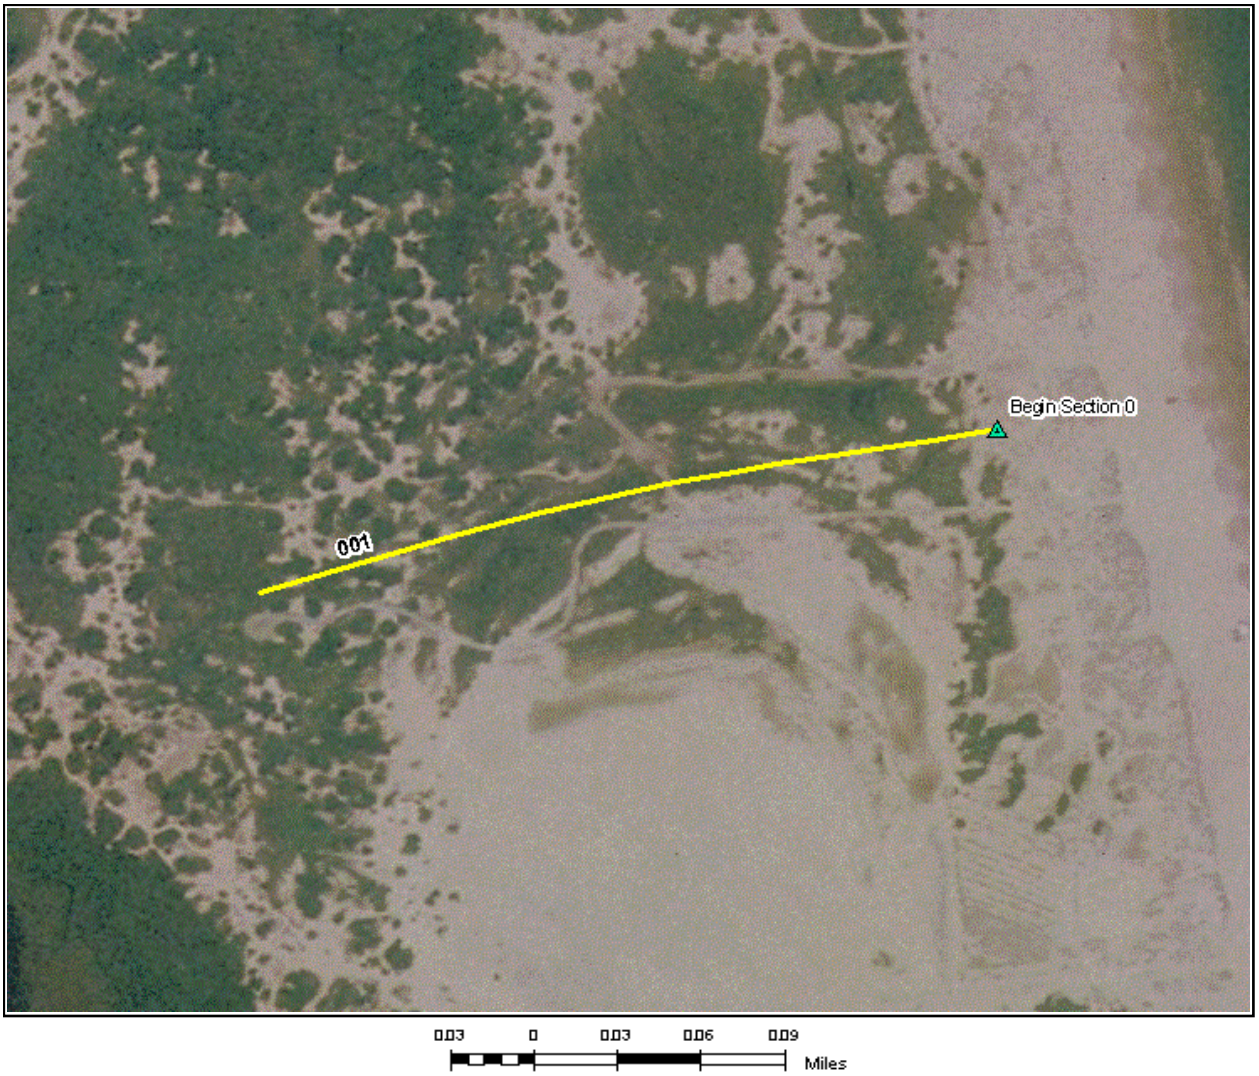
Route: 401 South Swan Island Access Road

Asset Number		
Section Number	001	002
Section Length (miles)	0.24	0.06
Inspection Date	06/05/2010	06/05/2010
Section Information		
Surface Type	Primitive	Primitive
Number of Lanes	1	1
Roadway Width (feet)	10.00	10.00
Roadway Condition Information		
Condition	Fair	Fair
Remaining Service Life (years)	3	3
Cost Estimate	100	0
CRV	0.00	0.00
