The Road Inventory of Richard Cronin National Salmon Station

Sunderland, MA

Prepared By:
Federal Highway Administration
Central Federal Lands Highway Division
September, 2010

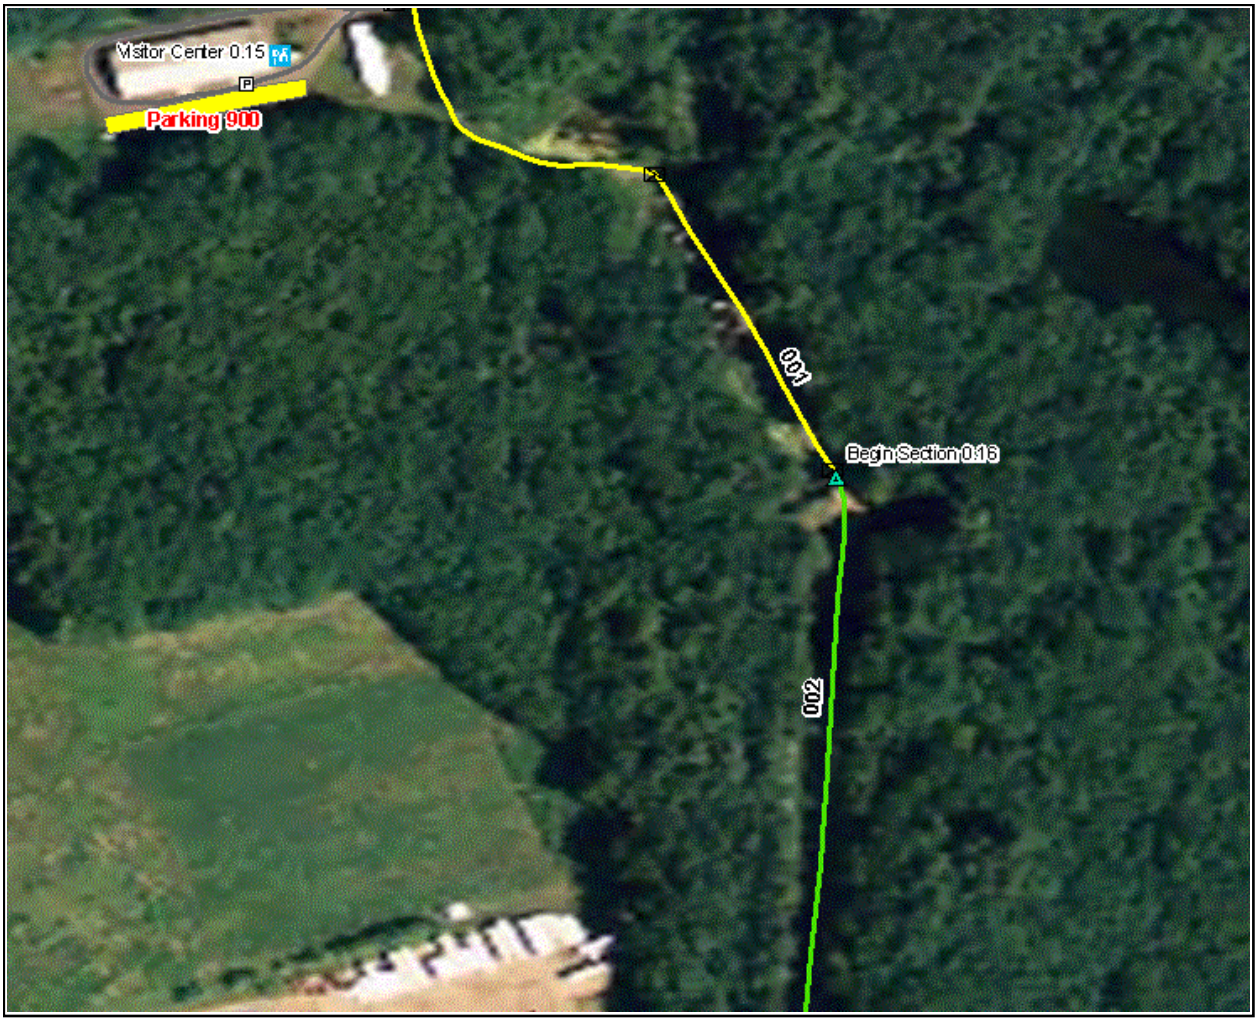
Route: 010 Hatchery Loop

Asset Number	10023439
Section Number	001
Section Length (miles)	0.17
Inspection Date	08/06/2010
Section Information	
Surface Type	Asphalt
Number of Lanes	2
Roadway Width (feet)	16.00
Roadway Condition Information	
Condition	Fair
Remaining Service Life (years)	8
Cost Estimate	20,500
CRV	226,600.00

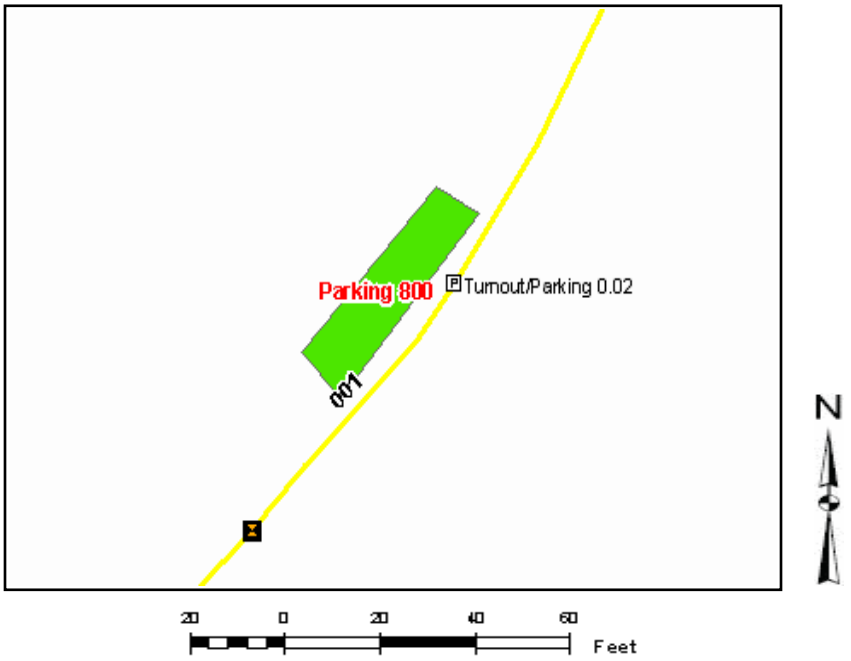
800: Hatchery Service Parking

Asset Number	Date Visited	Surface Type	Area (Sq Ft)	Condition	Cost to Improve
10023439	08/06/2010	Asphalt	586	Good	100

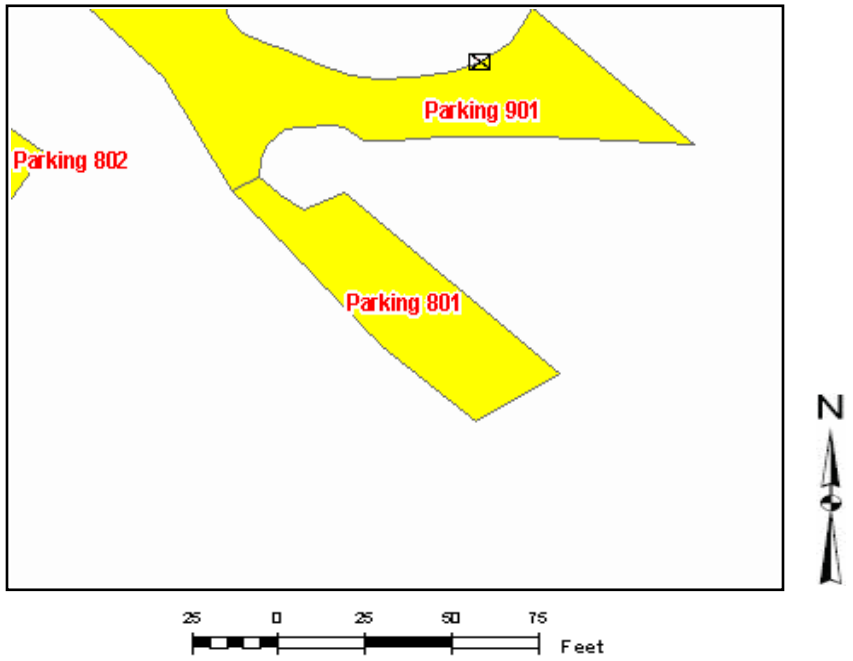
801: Connecticut River Resource Center Service Parking

Asset Number	Date Visited	Surface Type	Area (Sq Ft)	Condition	Cost to Improve
10023428	08/06/2010	Gravel	2,386	Fair	700

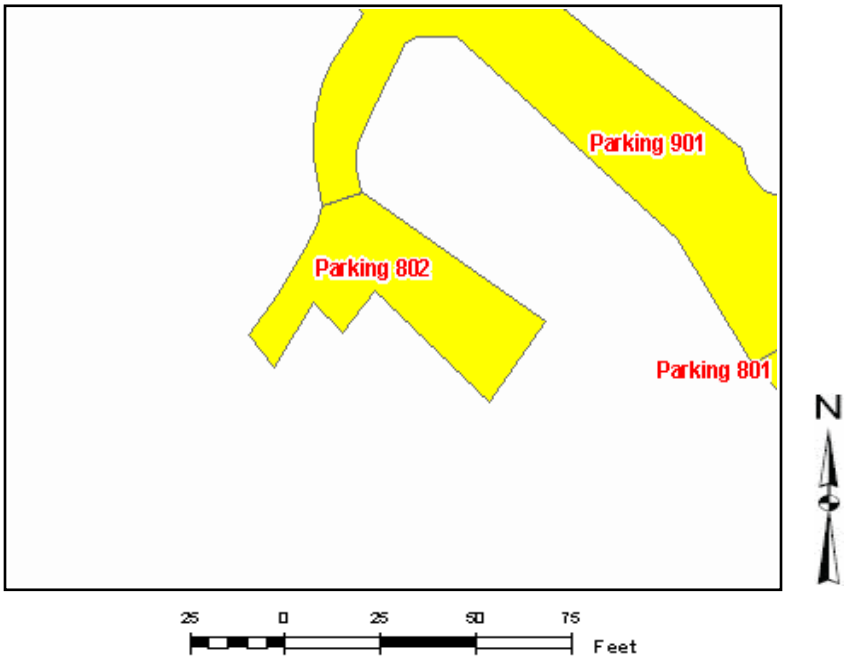
802: Connecticut River Resource Center Administrative Parking

Asset Number	Date Visited	Surface Type	Area (Sq Ft)	Condition	Cost to Improve
10023428	08/06/2010	Gravel	1,903	Fair	600

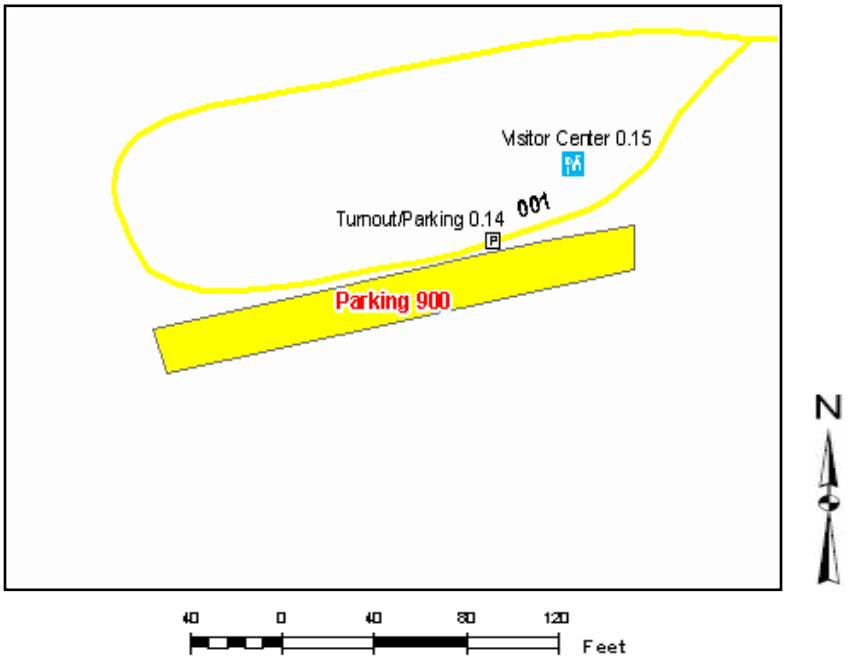
900: Hatchery Parking

Asset Number	Date Visited	Surface Type	Area (Sq Ft)	Condition	Cost to Improve
10023439	08/06/2010	Asphalt	4,533	Fair	4,400

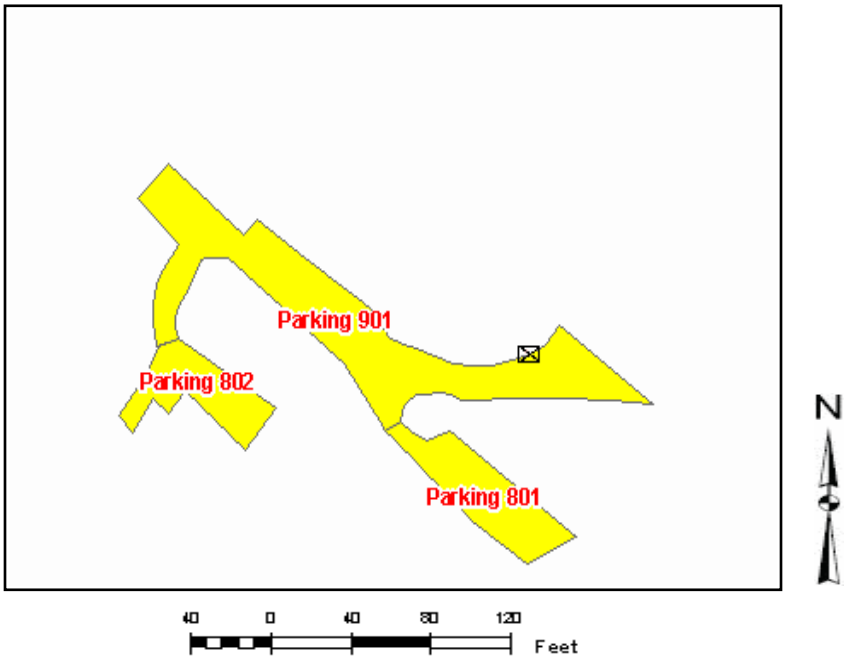
901: Connecticut River Resource Center Parking

Asset Number	Date Visited	Surface Type	Area (Sq Ft)	Condition	Cost to Improve
10023428	08/06/2010	Asphalt	7,882	Fair	7,600
