The Road Inventory of Occoquan Bay National Wildlife Refuge

Woodbridge, VA

Prepared By:
Federal Highway Administration
Central Federal Lands Highway Division
October, 2010

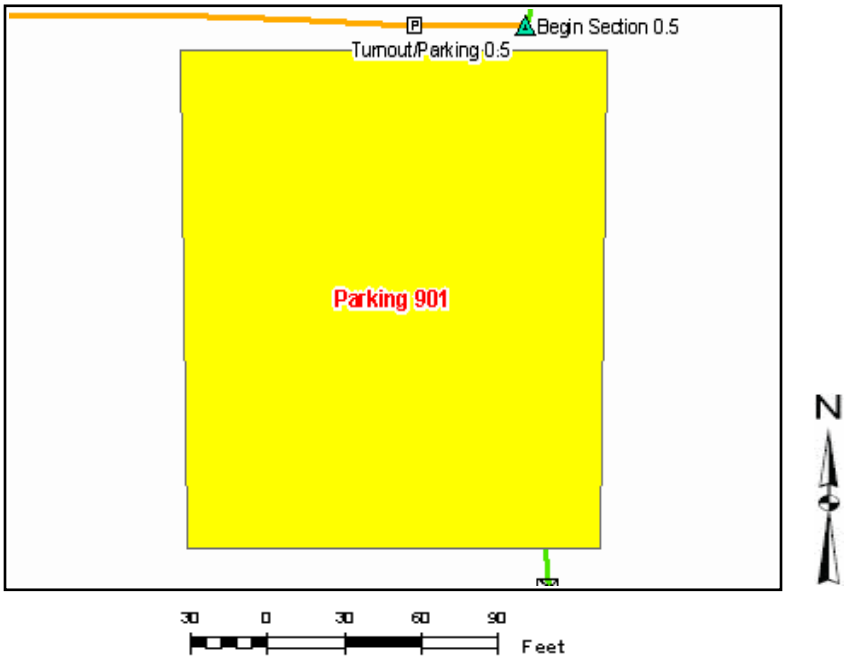
901: Visitor Parking

Asset Number	Date Visited	Surface Type	Area (Sq Ft)	Condition	Cost to Improve
10021403	09/14/2010	Asphalt	35,579	Fair	31,800
