The Road Inventory of Roanoke River National Wildlife Refuge

Windsor, NC

Prepared By:
Federal Highway Administration
Central Federal Lands Highway Division
October, 2010

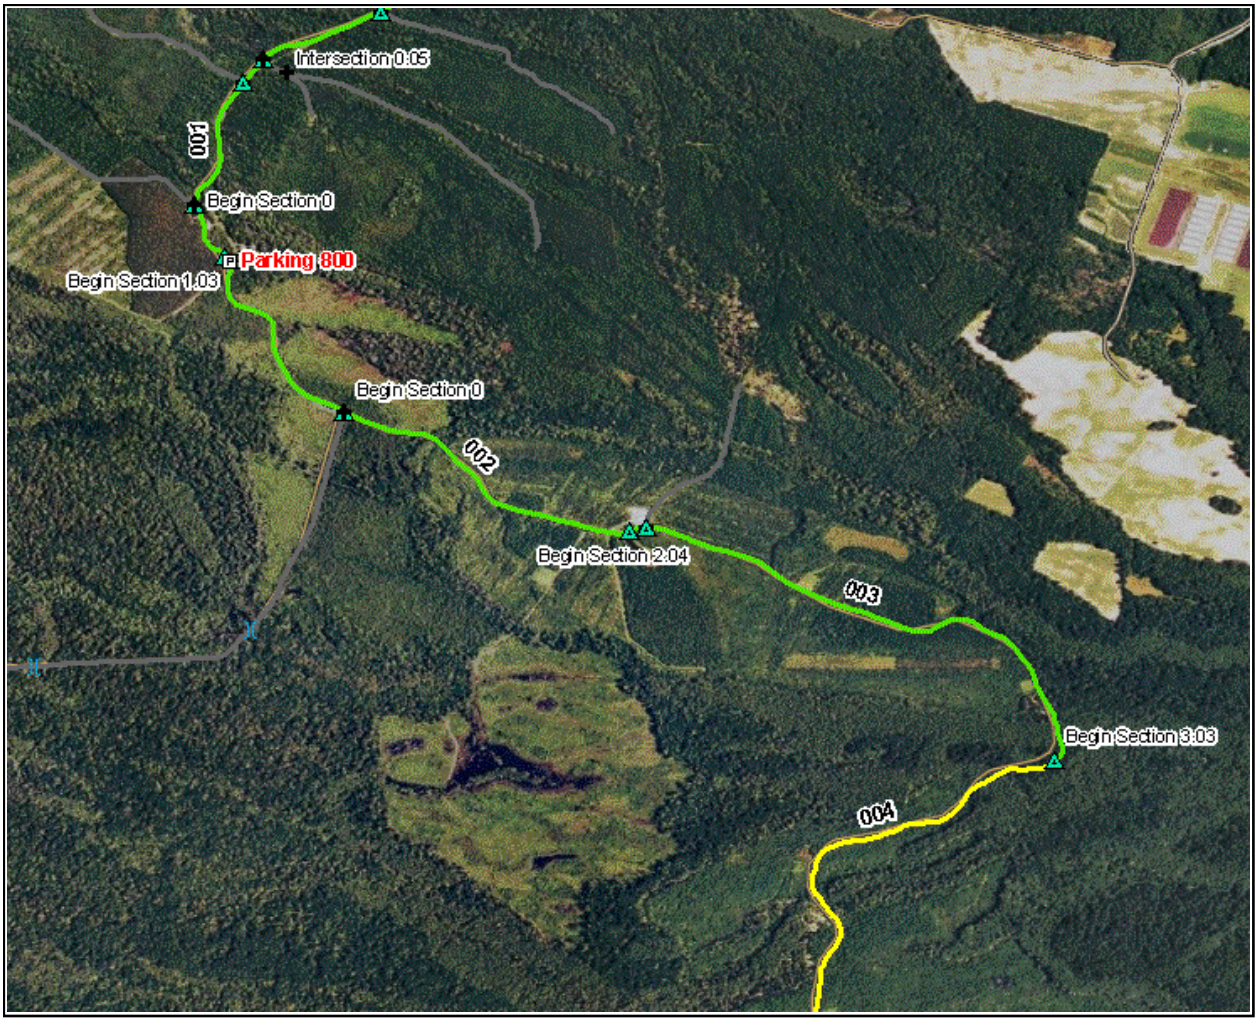
Route: 010 Main Road

Asset Number	10051683	10051683	10051683	10051683
Section Number	001	002	003	004
Section Length (miles)	1.03	1.01	0.99	0.88
Inspection Date	07/14/2006	07/14/2006	07/14/2006	07/14/2006
Section Information				
Surface Type	Native	Native	Native	Native
Number of Lanes	1	1	1	1
Roadway Width (feet)	10.00	12.00	12.00	12.00
Roadway Condition Information				
Condition	Good	Good	Good	Fair
Remaining Service Life (years)	7	7	7	4
Cost Estimate	1,500	1,400	1,400	1,600
CRV	302,900.00	298,100.00	293,400.00	258,800.00

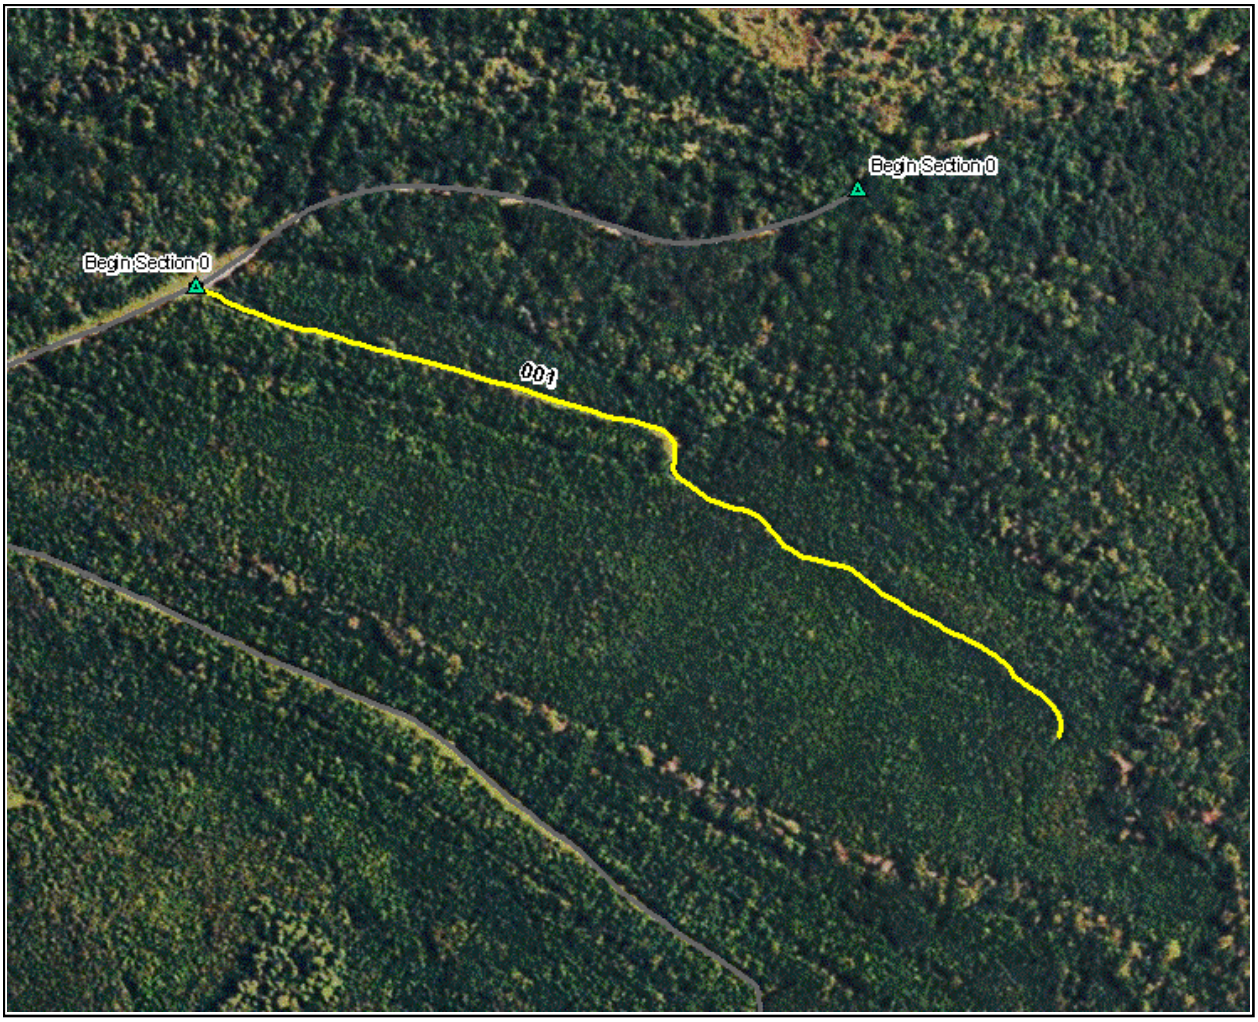
Route: 100 A Road

Asset Number	
Section Number	001
Section Length (miles)	0.49
Inspection Date	07/15/2006
Section Information	
Surface Type	Native
Number of Lanes	1
Roadway Width (feet)	12.00
Roadway Condition Information	
Condition	Fair
Remaining Service Life (years)	4
Cost Estimate	900
CRV	145,300.00

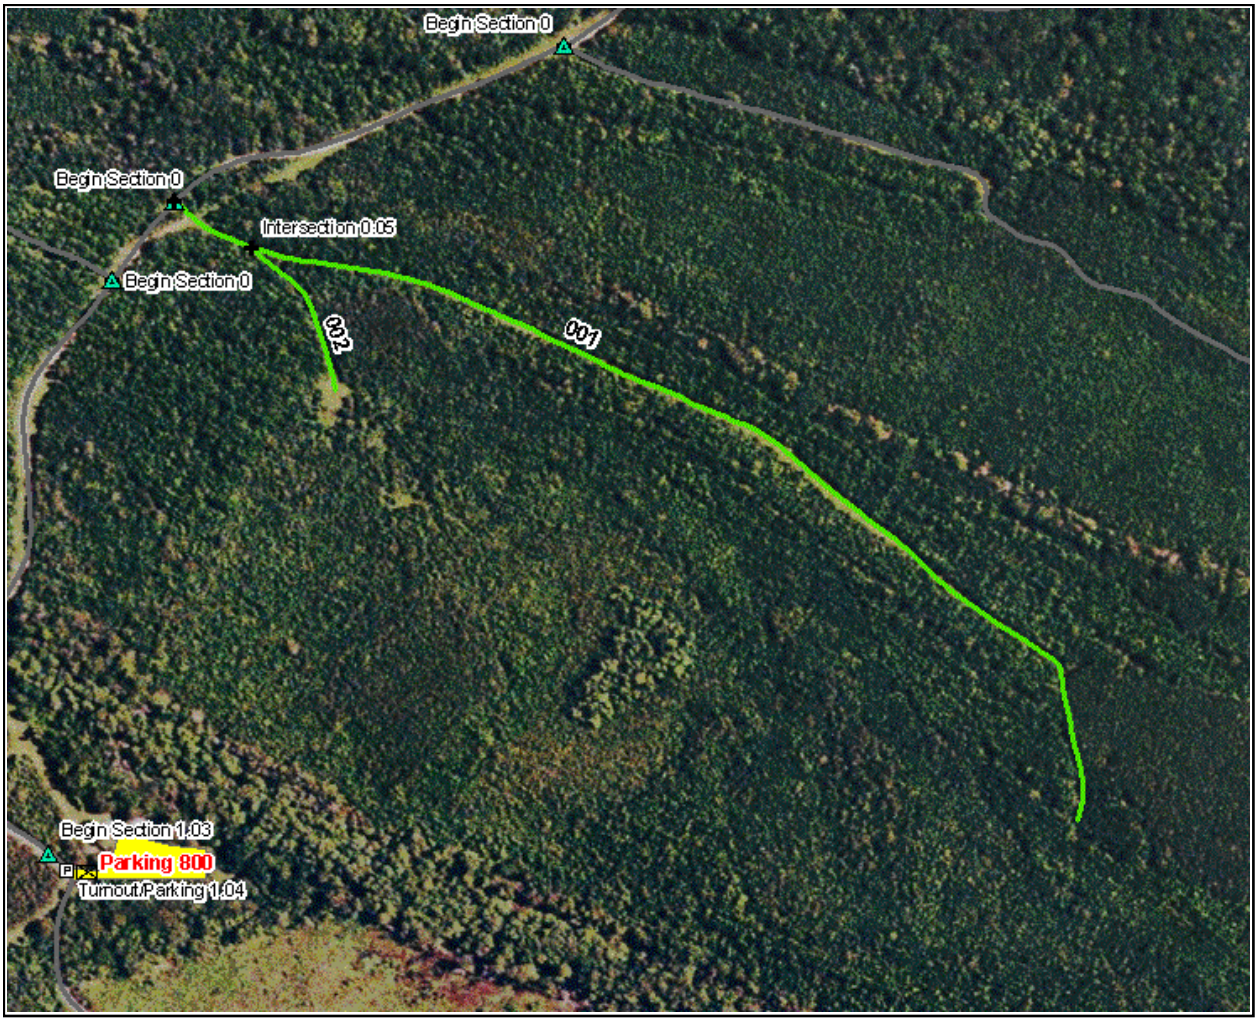
Route Description: From Main Road (Route 010) to Boggy Impassable Area

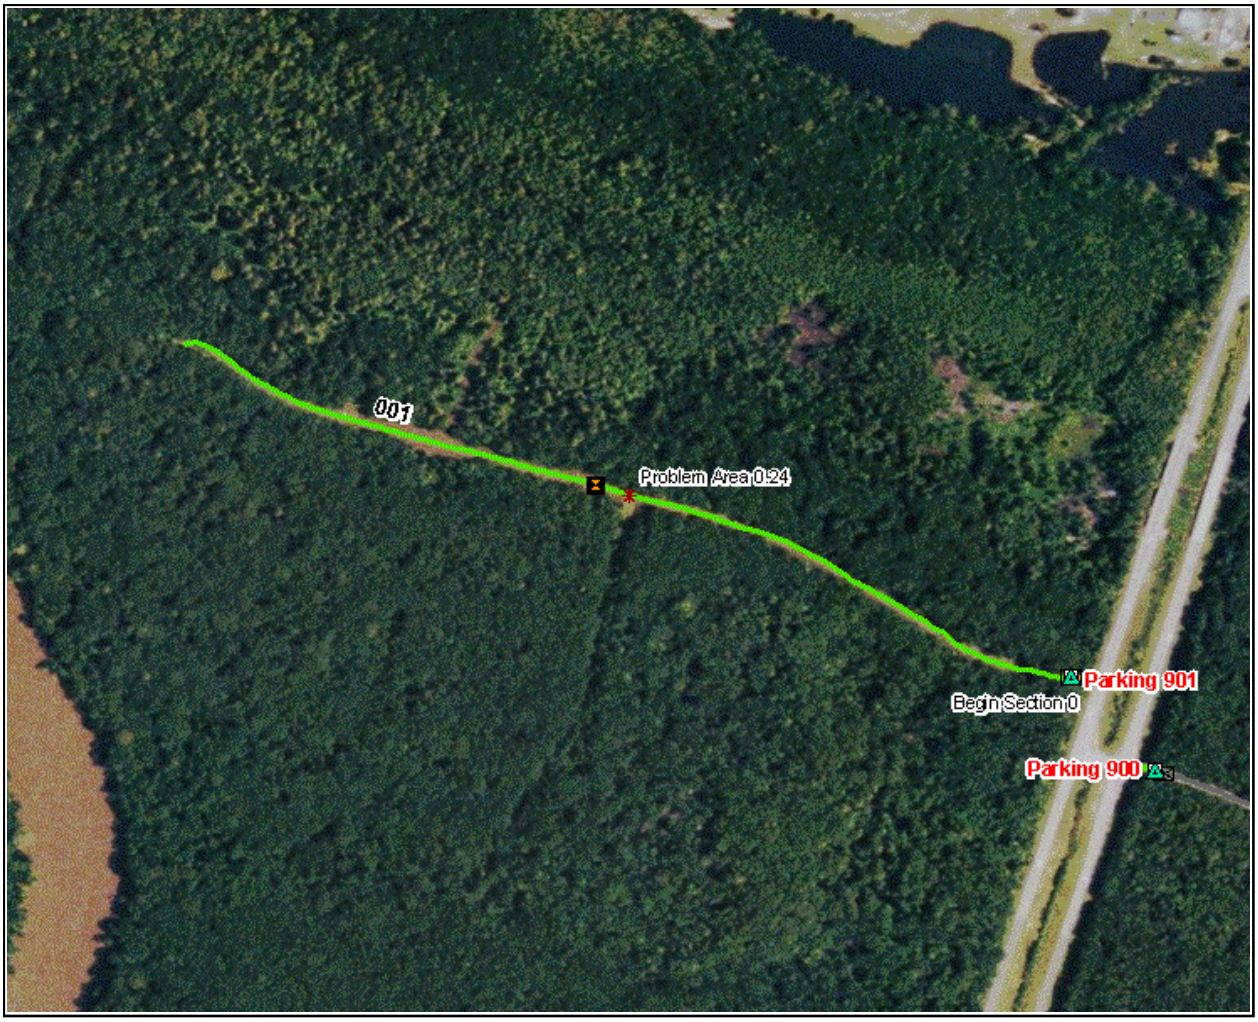
Route Description: From Main Road (Route 010) to end of route

Asset Number	
Section Number	001
Section Length (miles)	0.36
Inspection Date	07/15/2006
Section Information	
Surface Type	Native
Number of Lanes	1
Roadway Width (feet)	12.00
Roadway Condition Information	
Condition	Failed
Remaining Service Life (years)	0
Cost Estimate	36,500
CRV	105,900.00

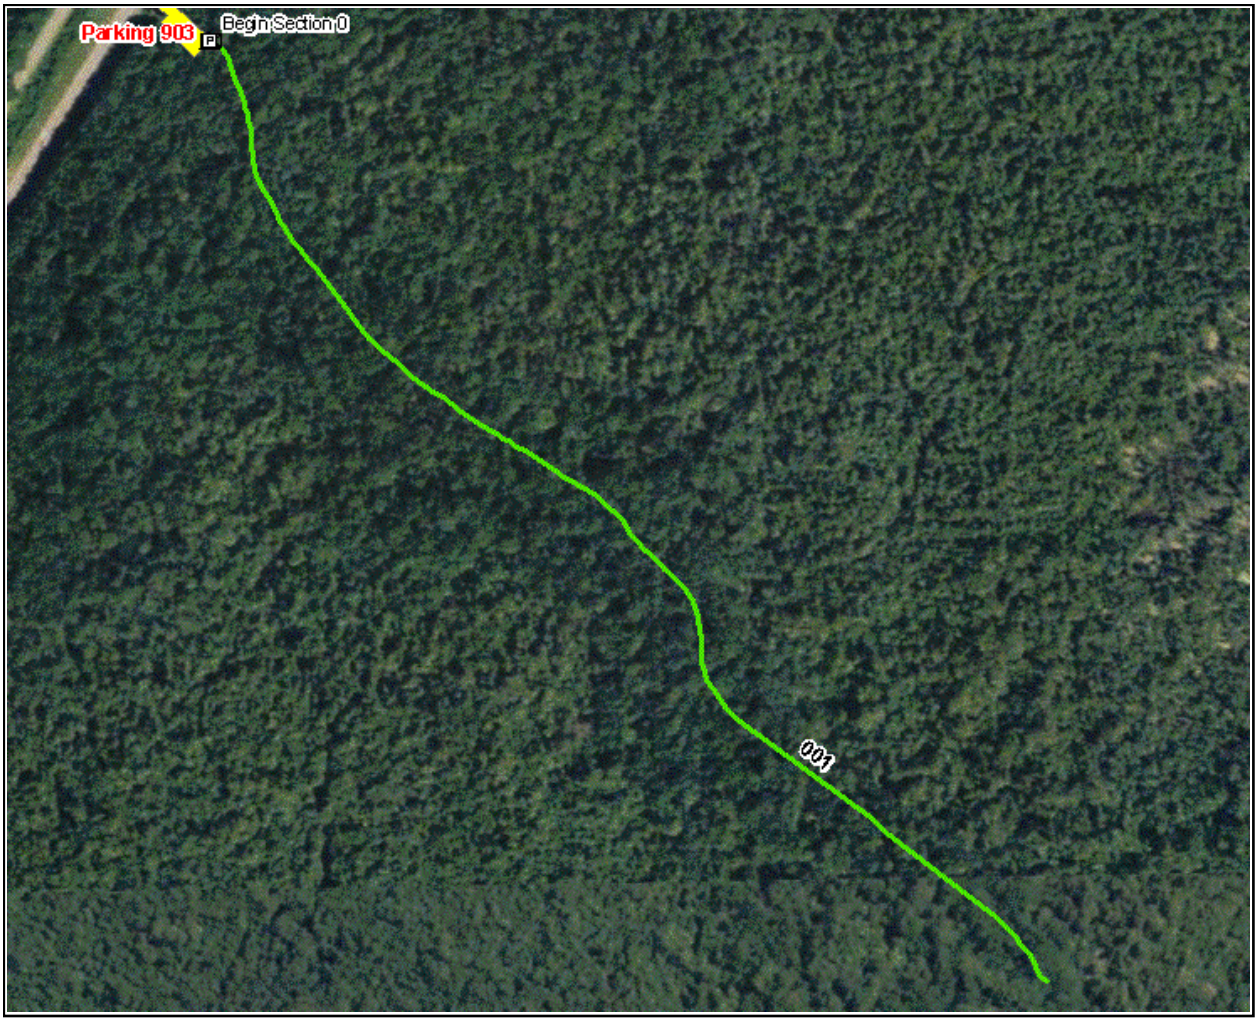
Route Description: From Highway 17 to end of route

Asset Number	10017007
Section Number	001
Section Length (miles)	0.48
Inspection Date	05/13/2010
Section Information	
Surface Type	Gravel
Number of Lanes	1
Roadway Width (feet)	10.00
Roadway Condition Information	
Condition	Good
Remaining Service Life (years)	5
Cost Estimate	600
CRV	274,800.00

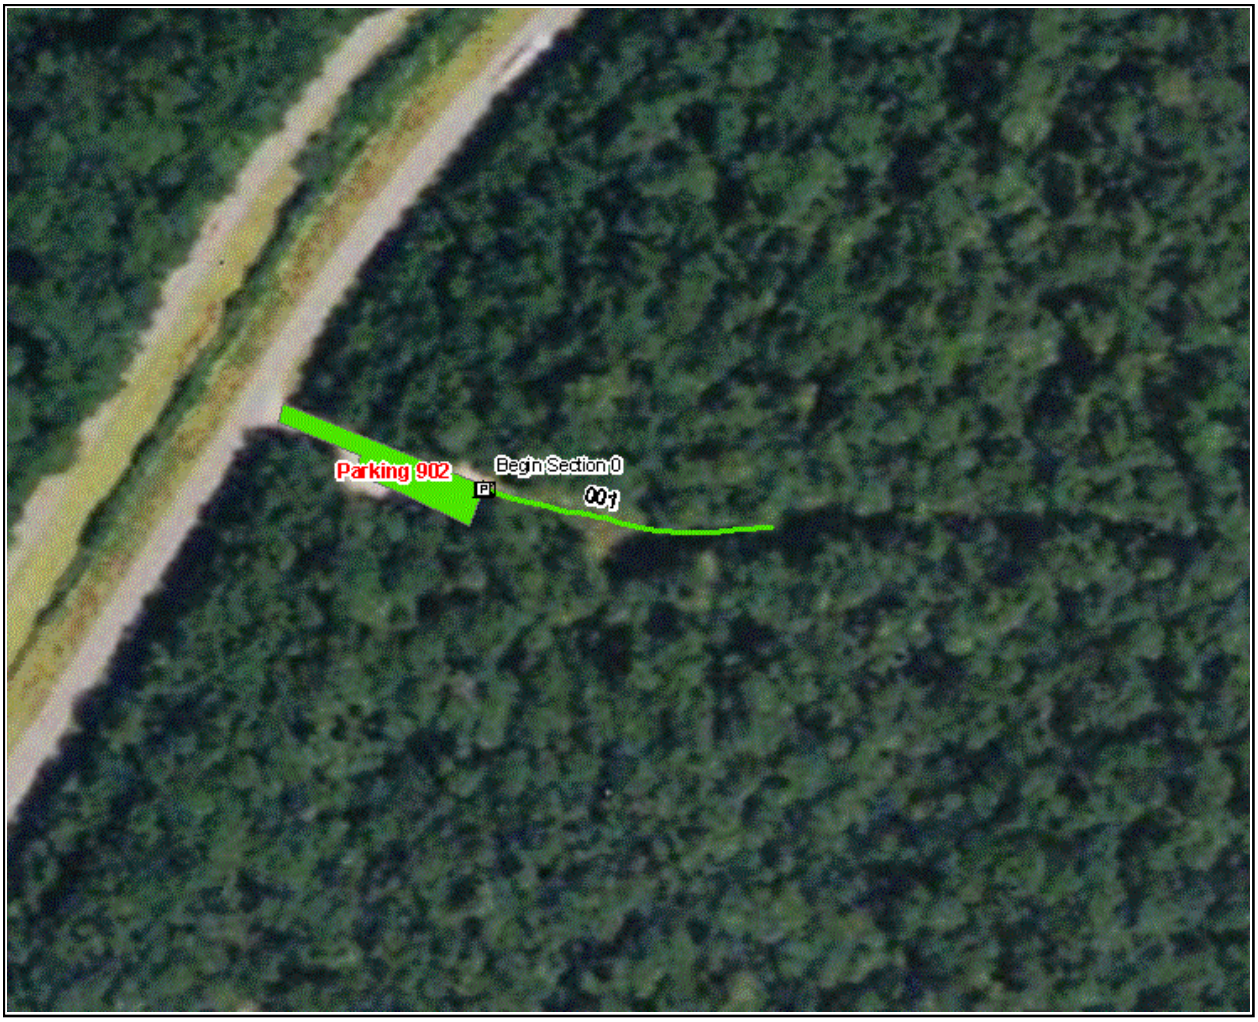
Route: 401 Conine Road

Asset Number	10017011
Section Number	001
Section Length (miles)	0.63
Inspection Date	05/13/2010
Section Information	
Surface Type	Gravel
Number of Lanes	1
Roadway Width (feet)	10.00
Roadway Condition Information	
Condition	Good
Remaining Service Life (years)	7
Cost Estimate	800
CRV	358,300.00

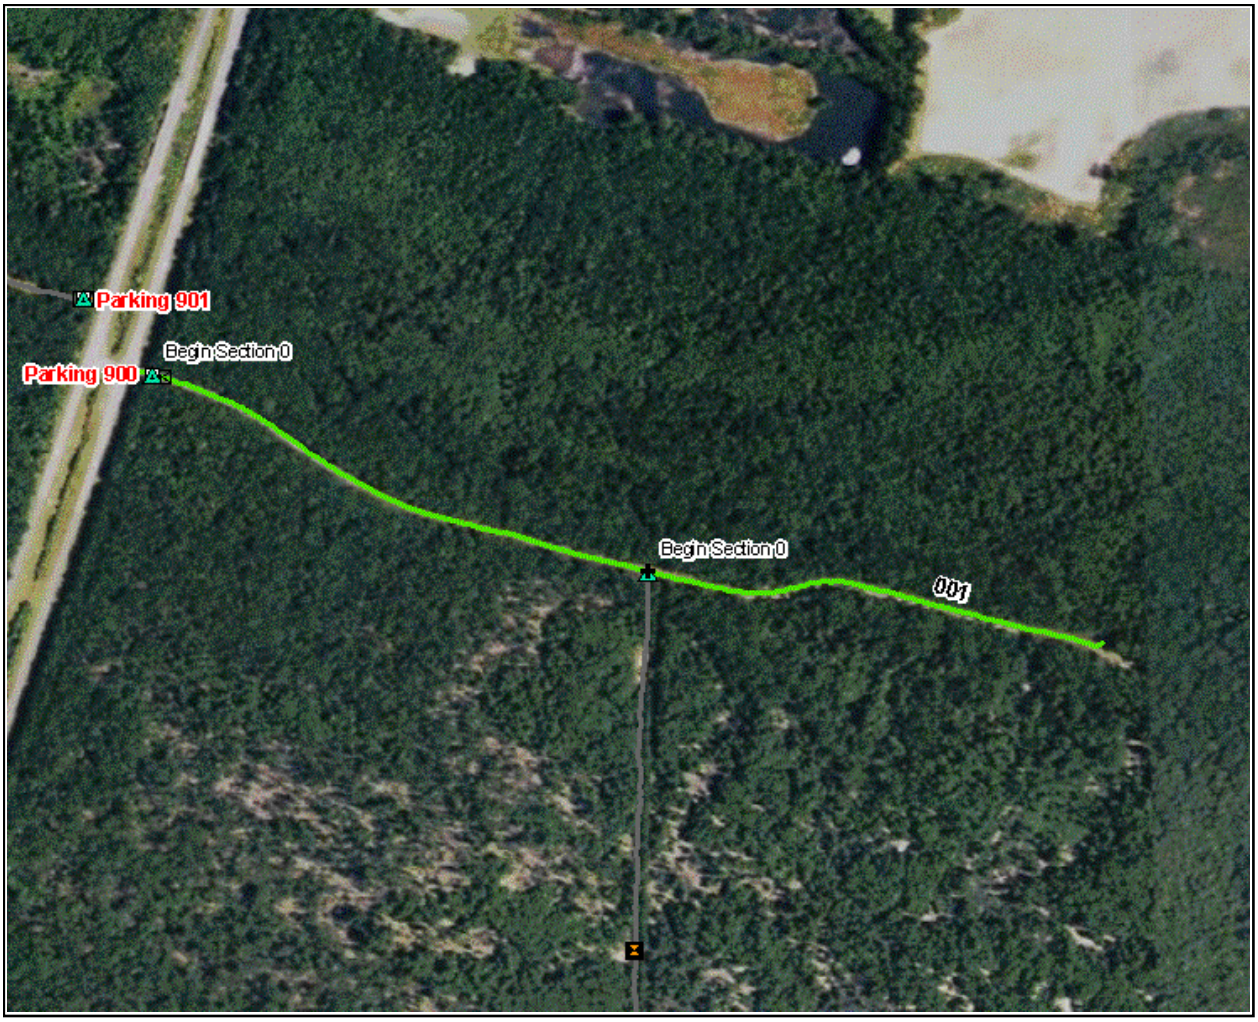
Route Description: From Highway 17 to end of route

Asset Number	10017011
Section Number	001
Section Length (miles)	0.05
Inspection Date	05/13/2010
Section Information	
Surface Type	Native
Number of Lanes	1
Roadway Width (feet)	10.00
Roadway Condition Information	
Condition	Good
Remaining Service Life (years)	7
Cost Estimate	100
CRV	15,800.00

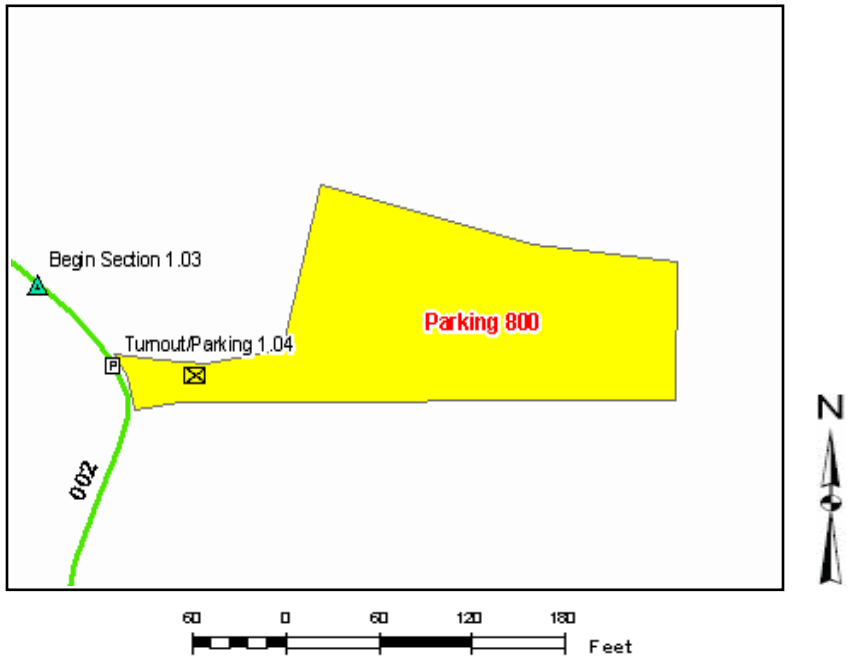
800: Shop/Maintenance Parking

Asset Number	Date Visited	Surface Type	Area (Sq Ft)	Condition	Cost to Improve
	05/13/2010	Gravel	34,924	Fair	7,600

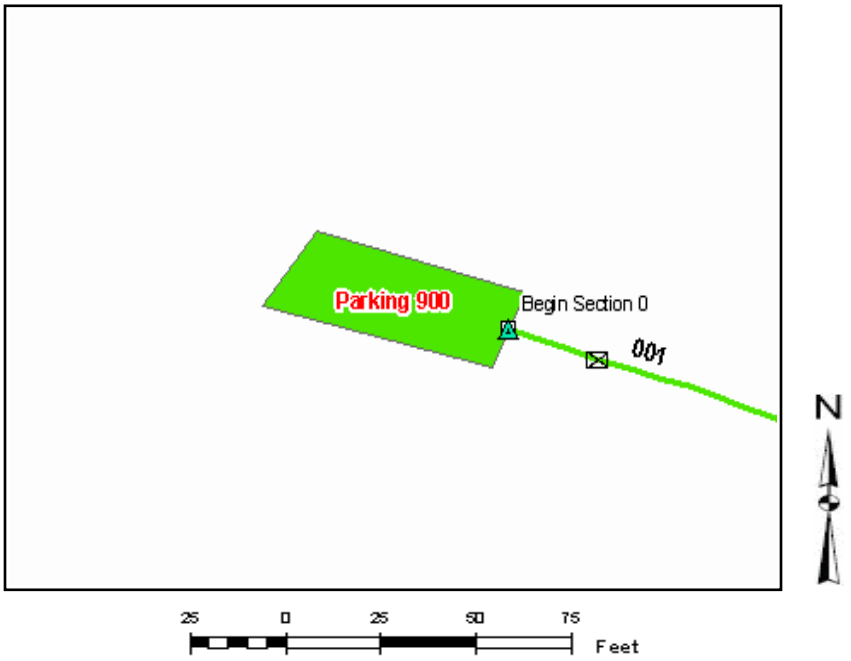
900: Askew East Parking

Asset Number	Date Visited	Surface Type	Area (Sq Ft)	Condition	Cost to Improve
10042662	05/13/2010	Gravel	1,509	Good	200

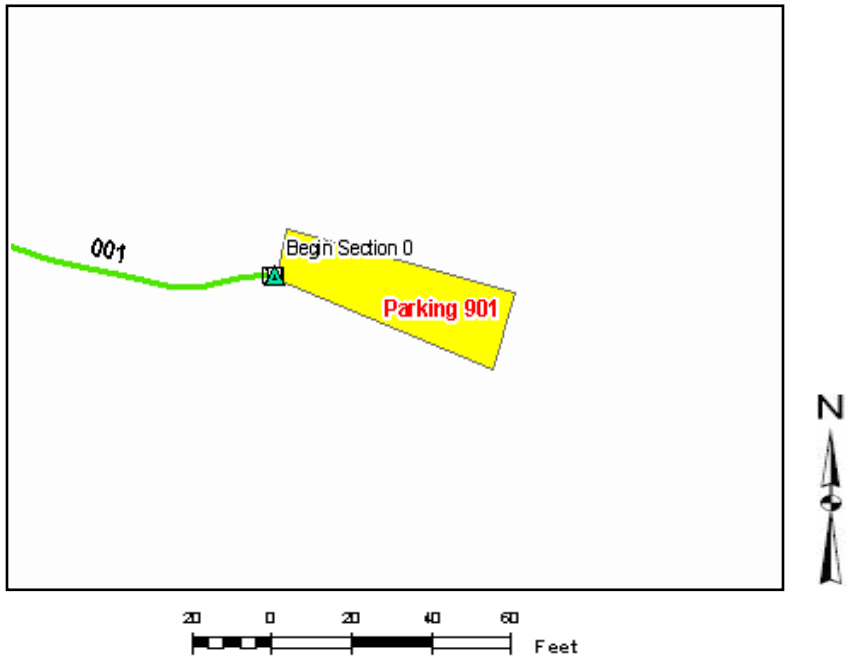
901: Askew West Parking

Asset Number	Date Visited	Surface Type	Area (Sq Ft)	Condition	Cost to Improve
10042663	05/13/2010	Gravel	1,148	Fair	300

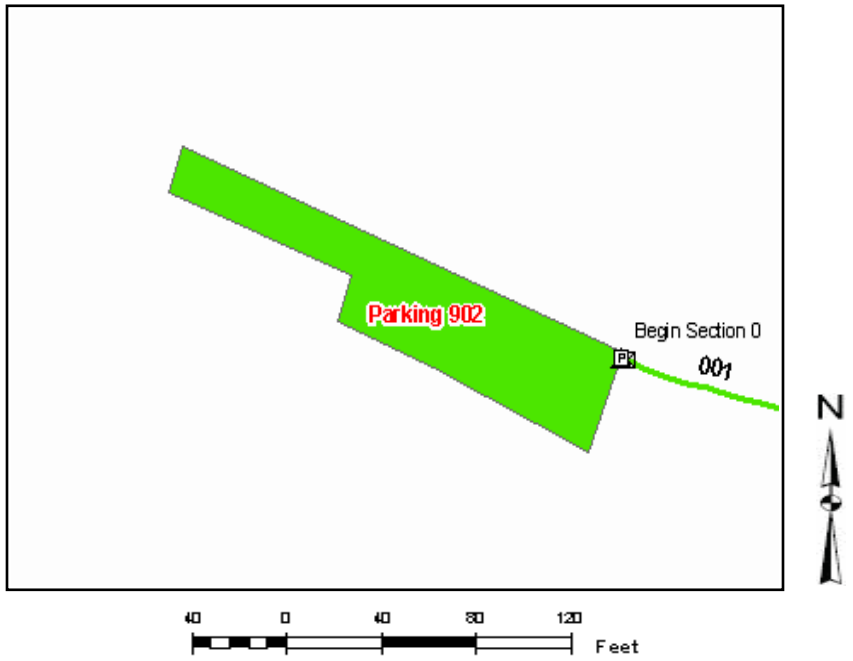
902: Conine North Parking

Asset Number	Date Visited	Surface Type	Area (Sq Ft)	Condition	Cost to Improve
10041746	05/13/2010	Gravel	7,676	Good	1,000

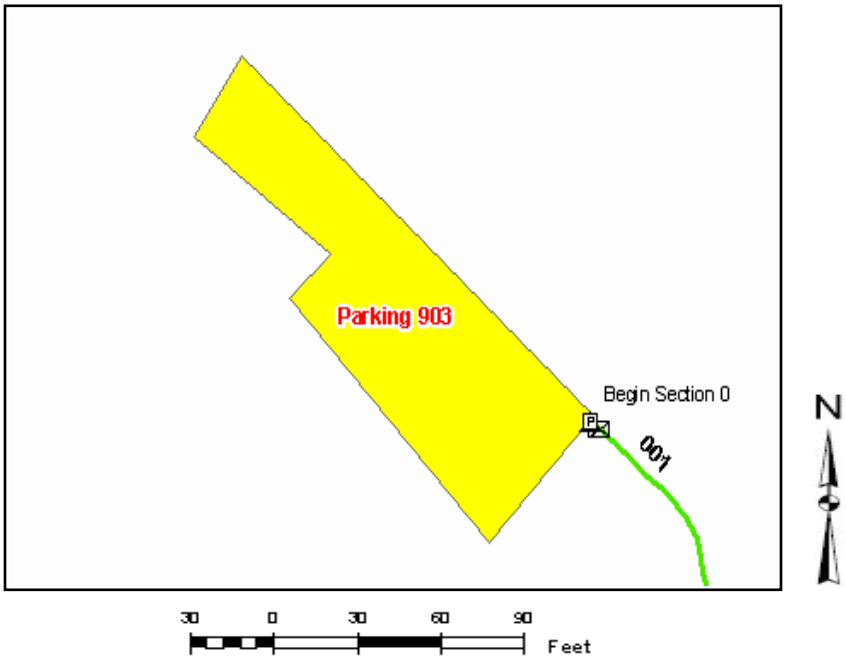
903: Conine South Parking

Asset Number	Date Visited	Surface Type	Area (Sq Ft)	Condition	Cost to Improve
10041751	05/13/2010	Gravel	9,246	Fair	2,000
