The Road Inventory of Franz Lake National Wildlife Refuge

Skamania County, WA

Prepared By:
Federal Highway Administration
Central Federal Lands Highway Division
January 2013

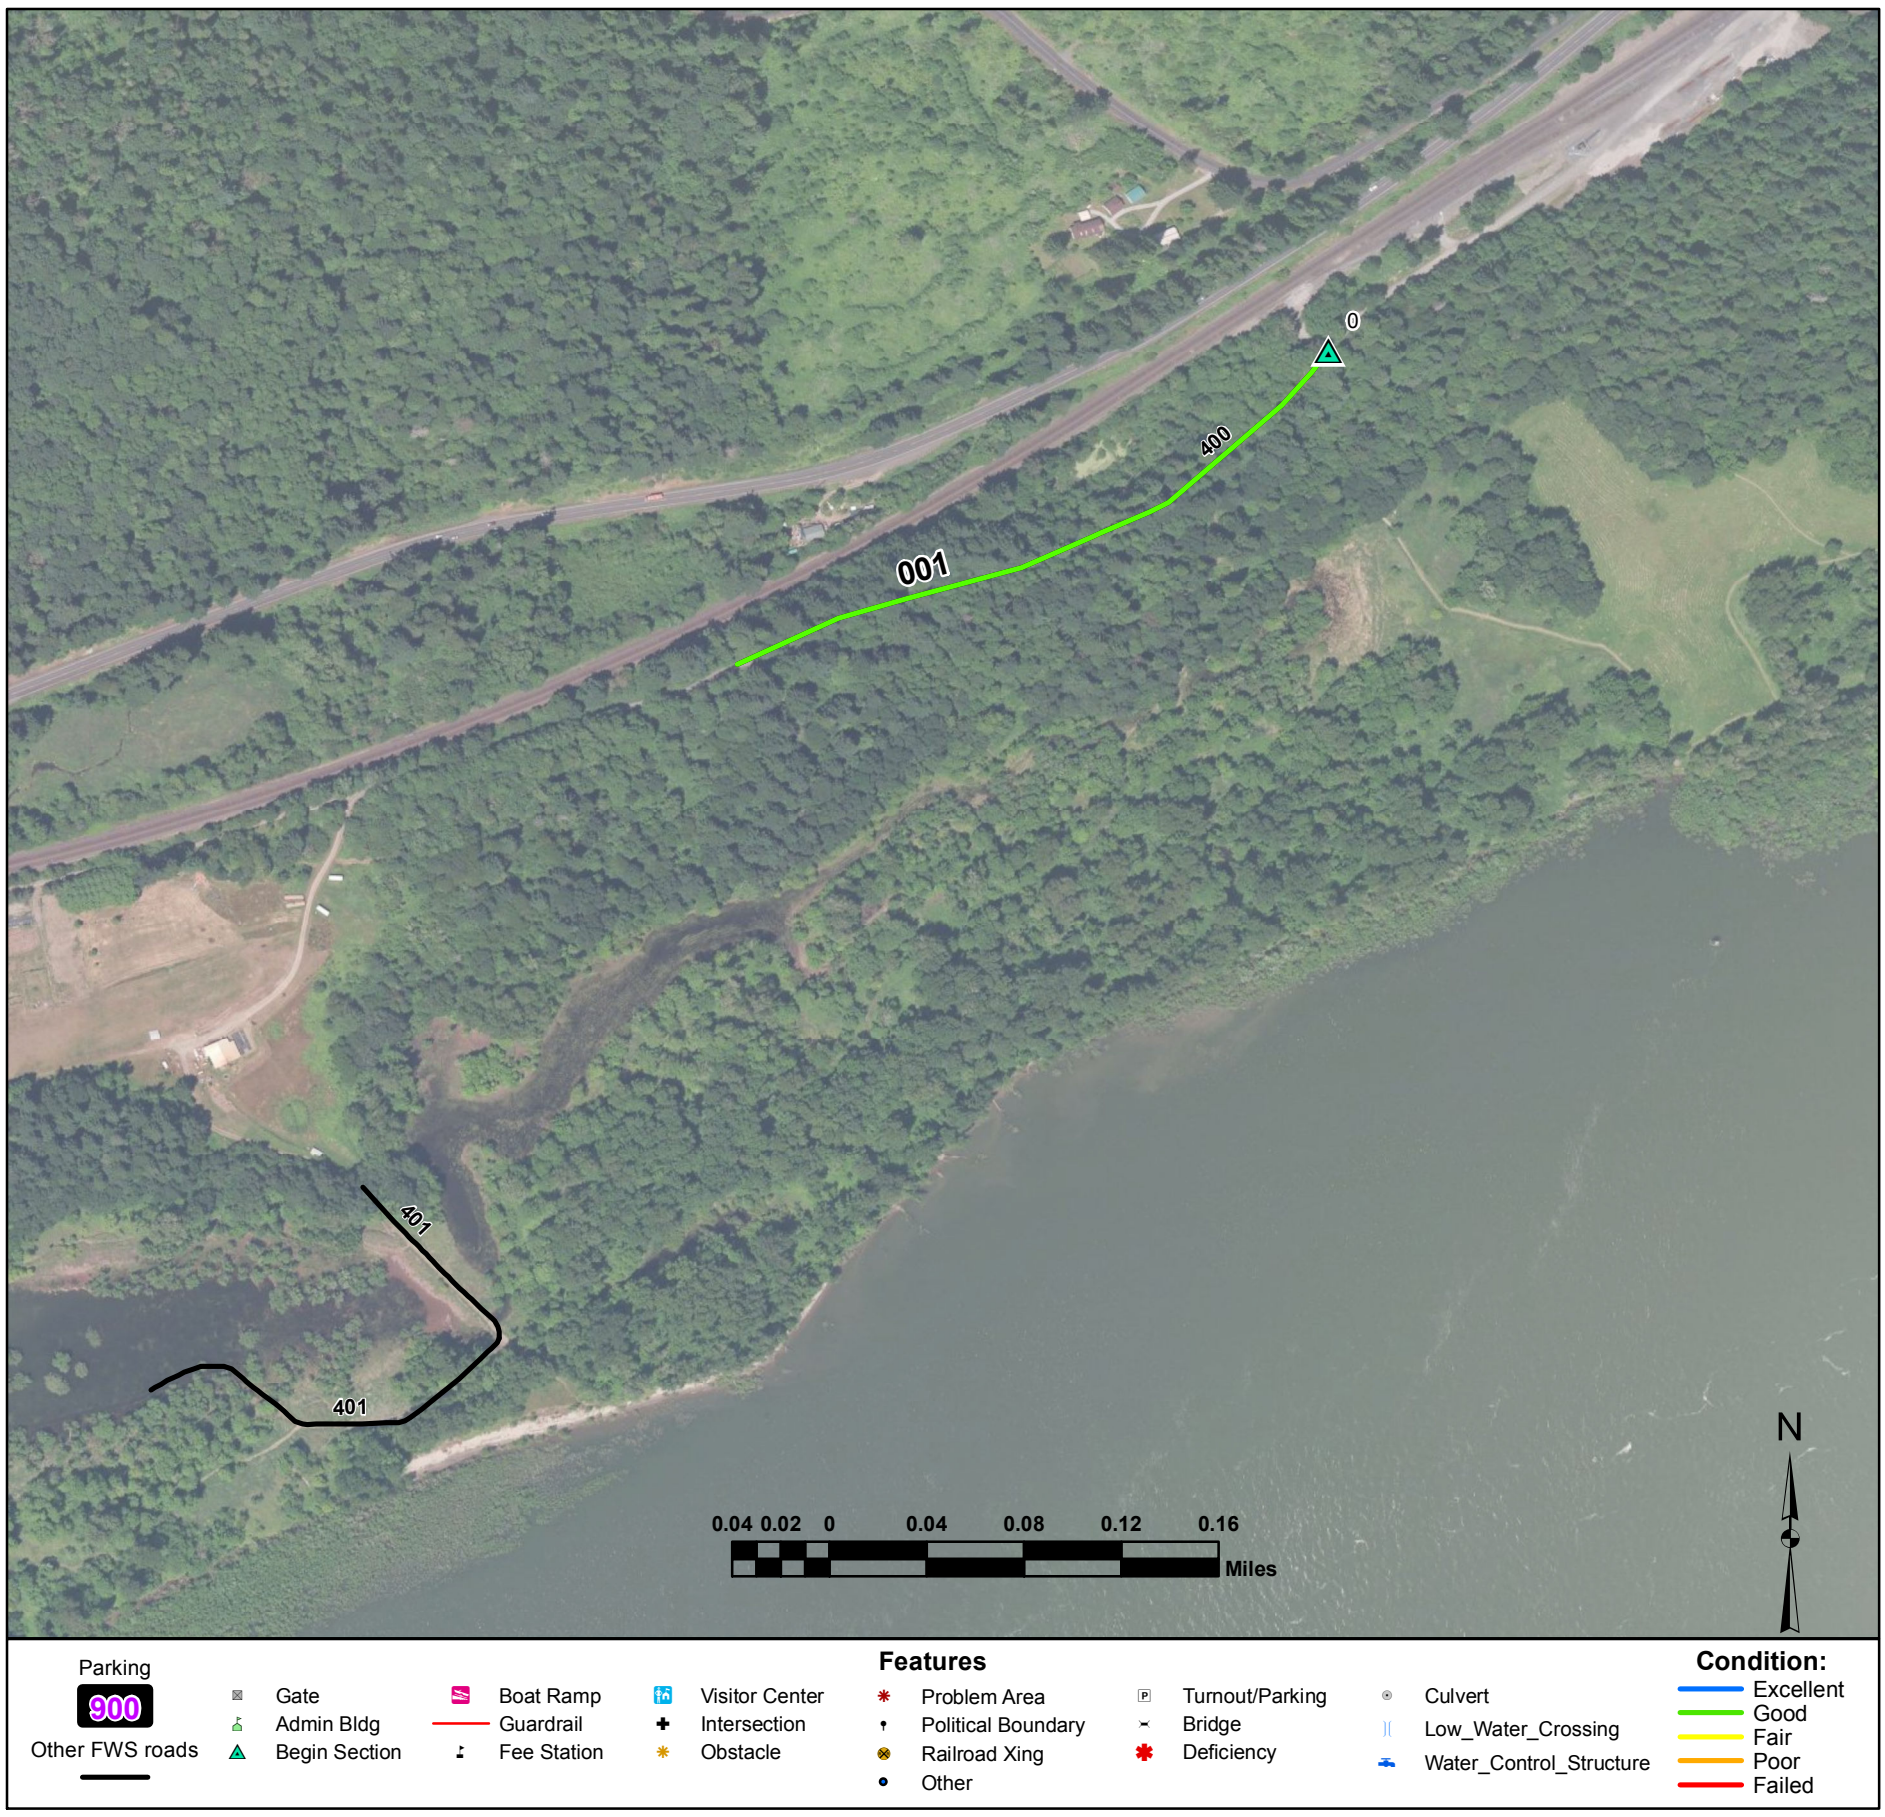
Route Number: 400

Franz Lake Road

From Indian Mary Road to Private Land

Asset Number	10003840				
Section Number	001				
Section Length (miles)	0.28				
Inspection Date	12-04-2012				
Surface Type	Gravel				
Number of Lanes	1				
Roadway Width (feet)	12				
Condition	Good				
Remaining Service Life (years)	5				
Estimated Cost to Repair	$500				
Current Replacement Value	$223,200

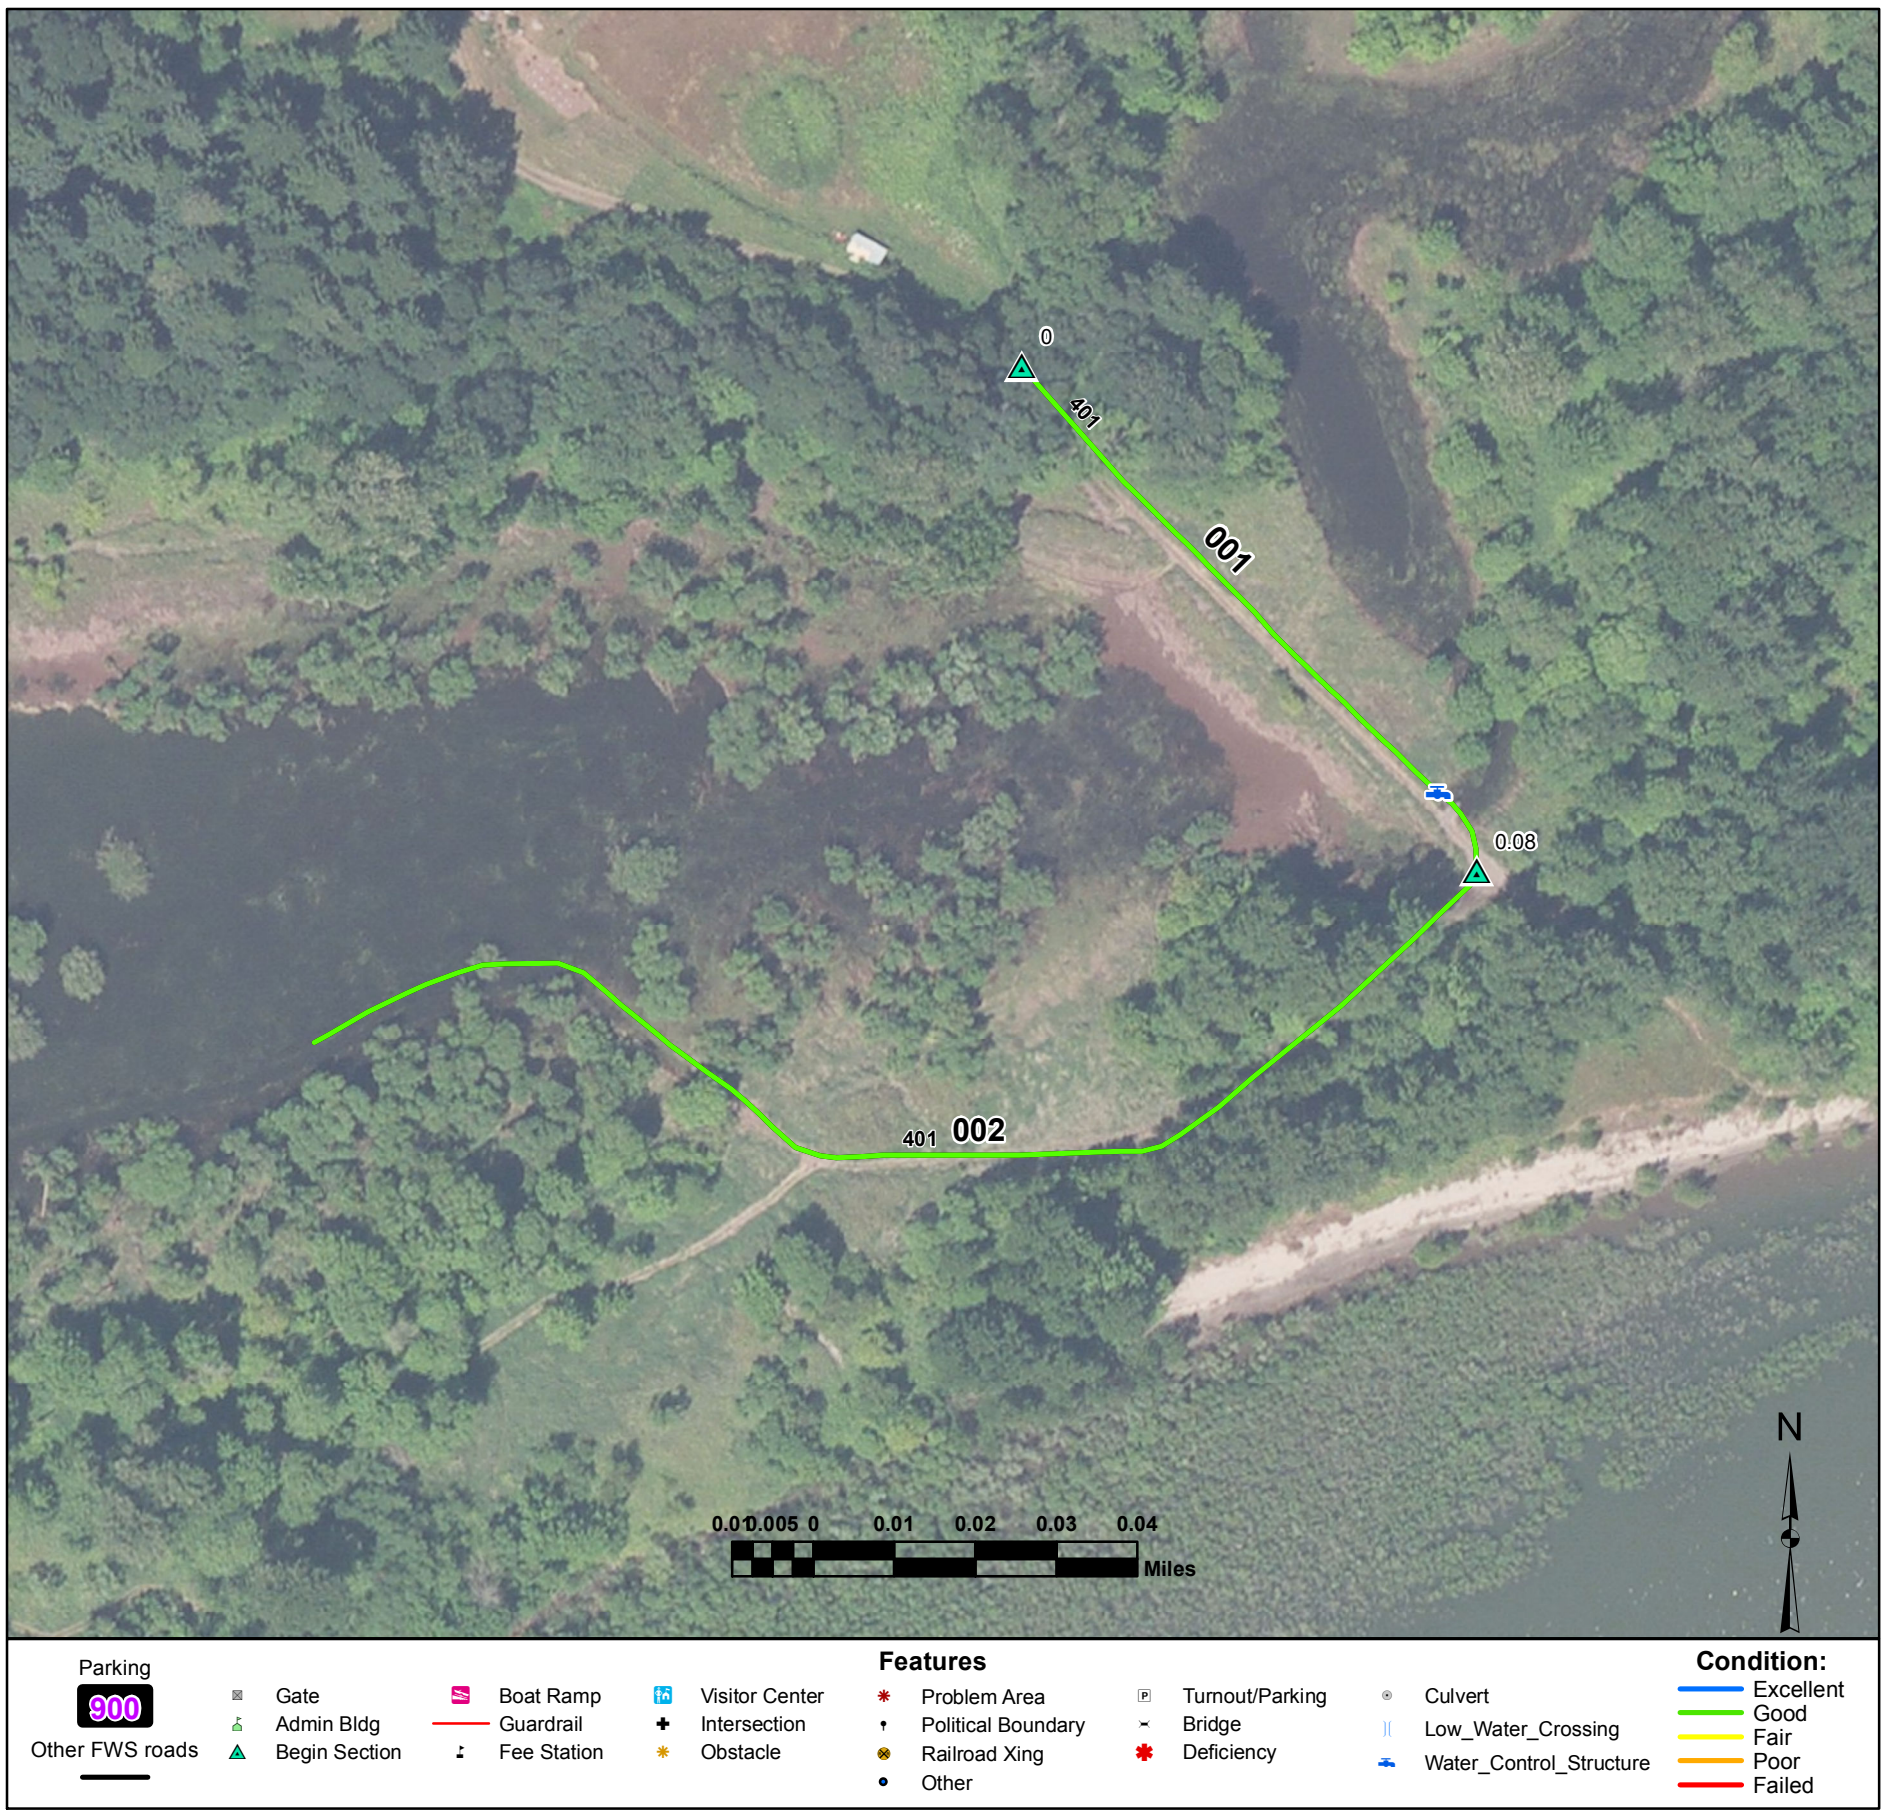
Route Number: 401 Total Route Mileage: 0.25

Dike Road

From Private Land to Columbia River

Asset Number	10003839	10003839			
Section Number	001	002			
Section Length (miles)	0.08	0.17			
Inspection Date	12-04-2012	12-04-2012			
Surface Type	Gravel	Native			
Number of Lanes	1	1			
Roadway Width (feet)	10	10			
Condition	Good	Good			
Remaining Service Life (years)	5	5			
Estimated Cost to Repair	$100	$300			
Current Replacement Value	$63,800	$70,100

Features	Mile Post	Features	Mile Post	Features	Mile Post	Features	Mile Post
Begin Section	001-0.0						
Water Control Structure	001-0.07						
Begin Section	002-0.08
