# The Road Inventory of Sawtooth National Fish Hatchery

## Stanley, ID

Prepared By:
Federal Highway Administration
Central Federal Lands Highway Division
January 2013

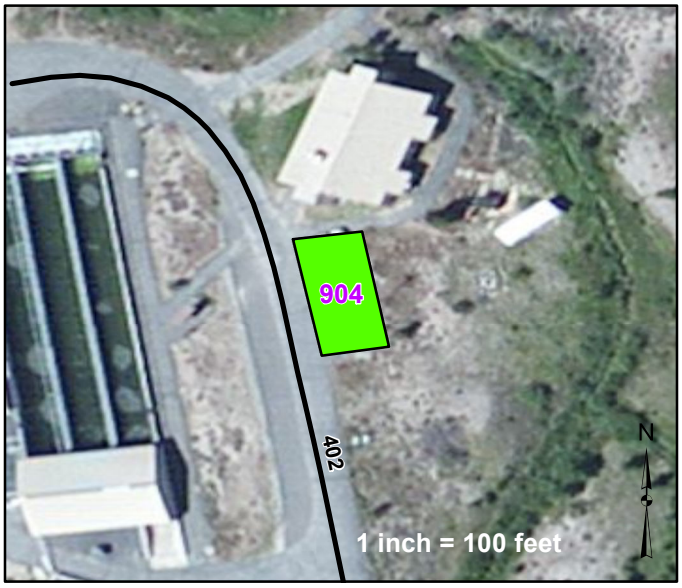
Parking

| Asset Number | Area (Sq Ft) | Spaces | Condition | Surface Type | Cost to Improve | Inspection Date | Current Replacement Value |
|---|---|---|---|---|---|---|---|
| - | 1586 | 2 | Good | Asphalt | $300 | 10-02-2012 | $15,800 |
