The Road Inventory of East Fork Salmon River National Fish Hatchery

Stanley, ID

Prepared By:
Federal Highway Administration
Central Federal Lands Highway Division
February 2013

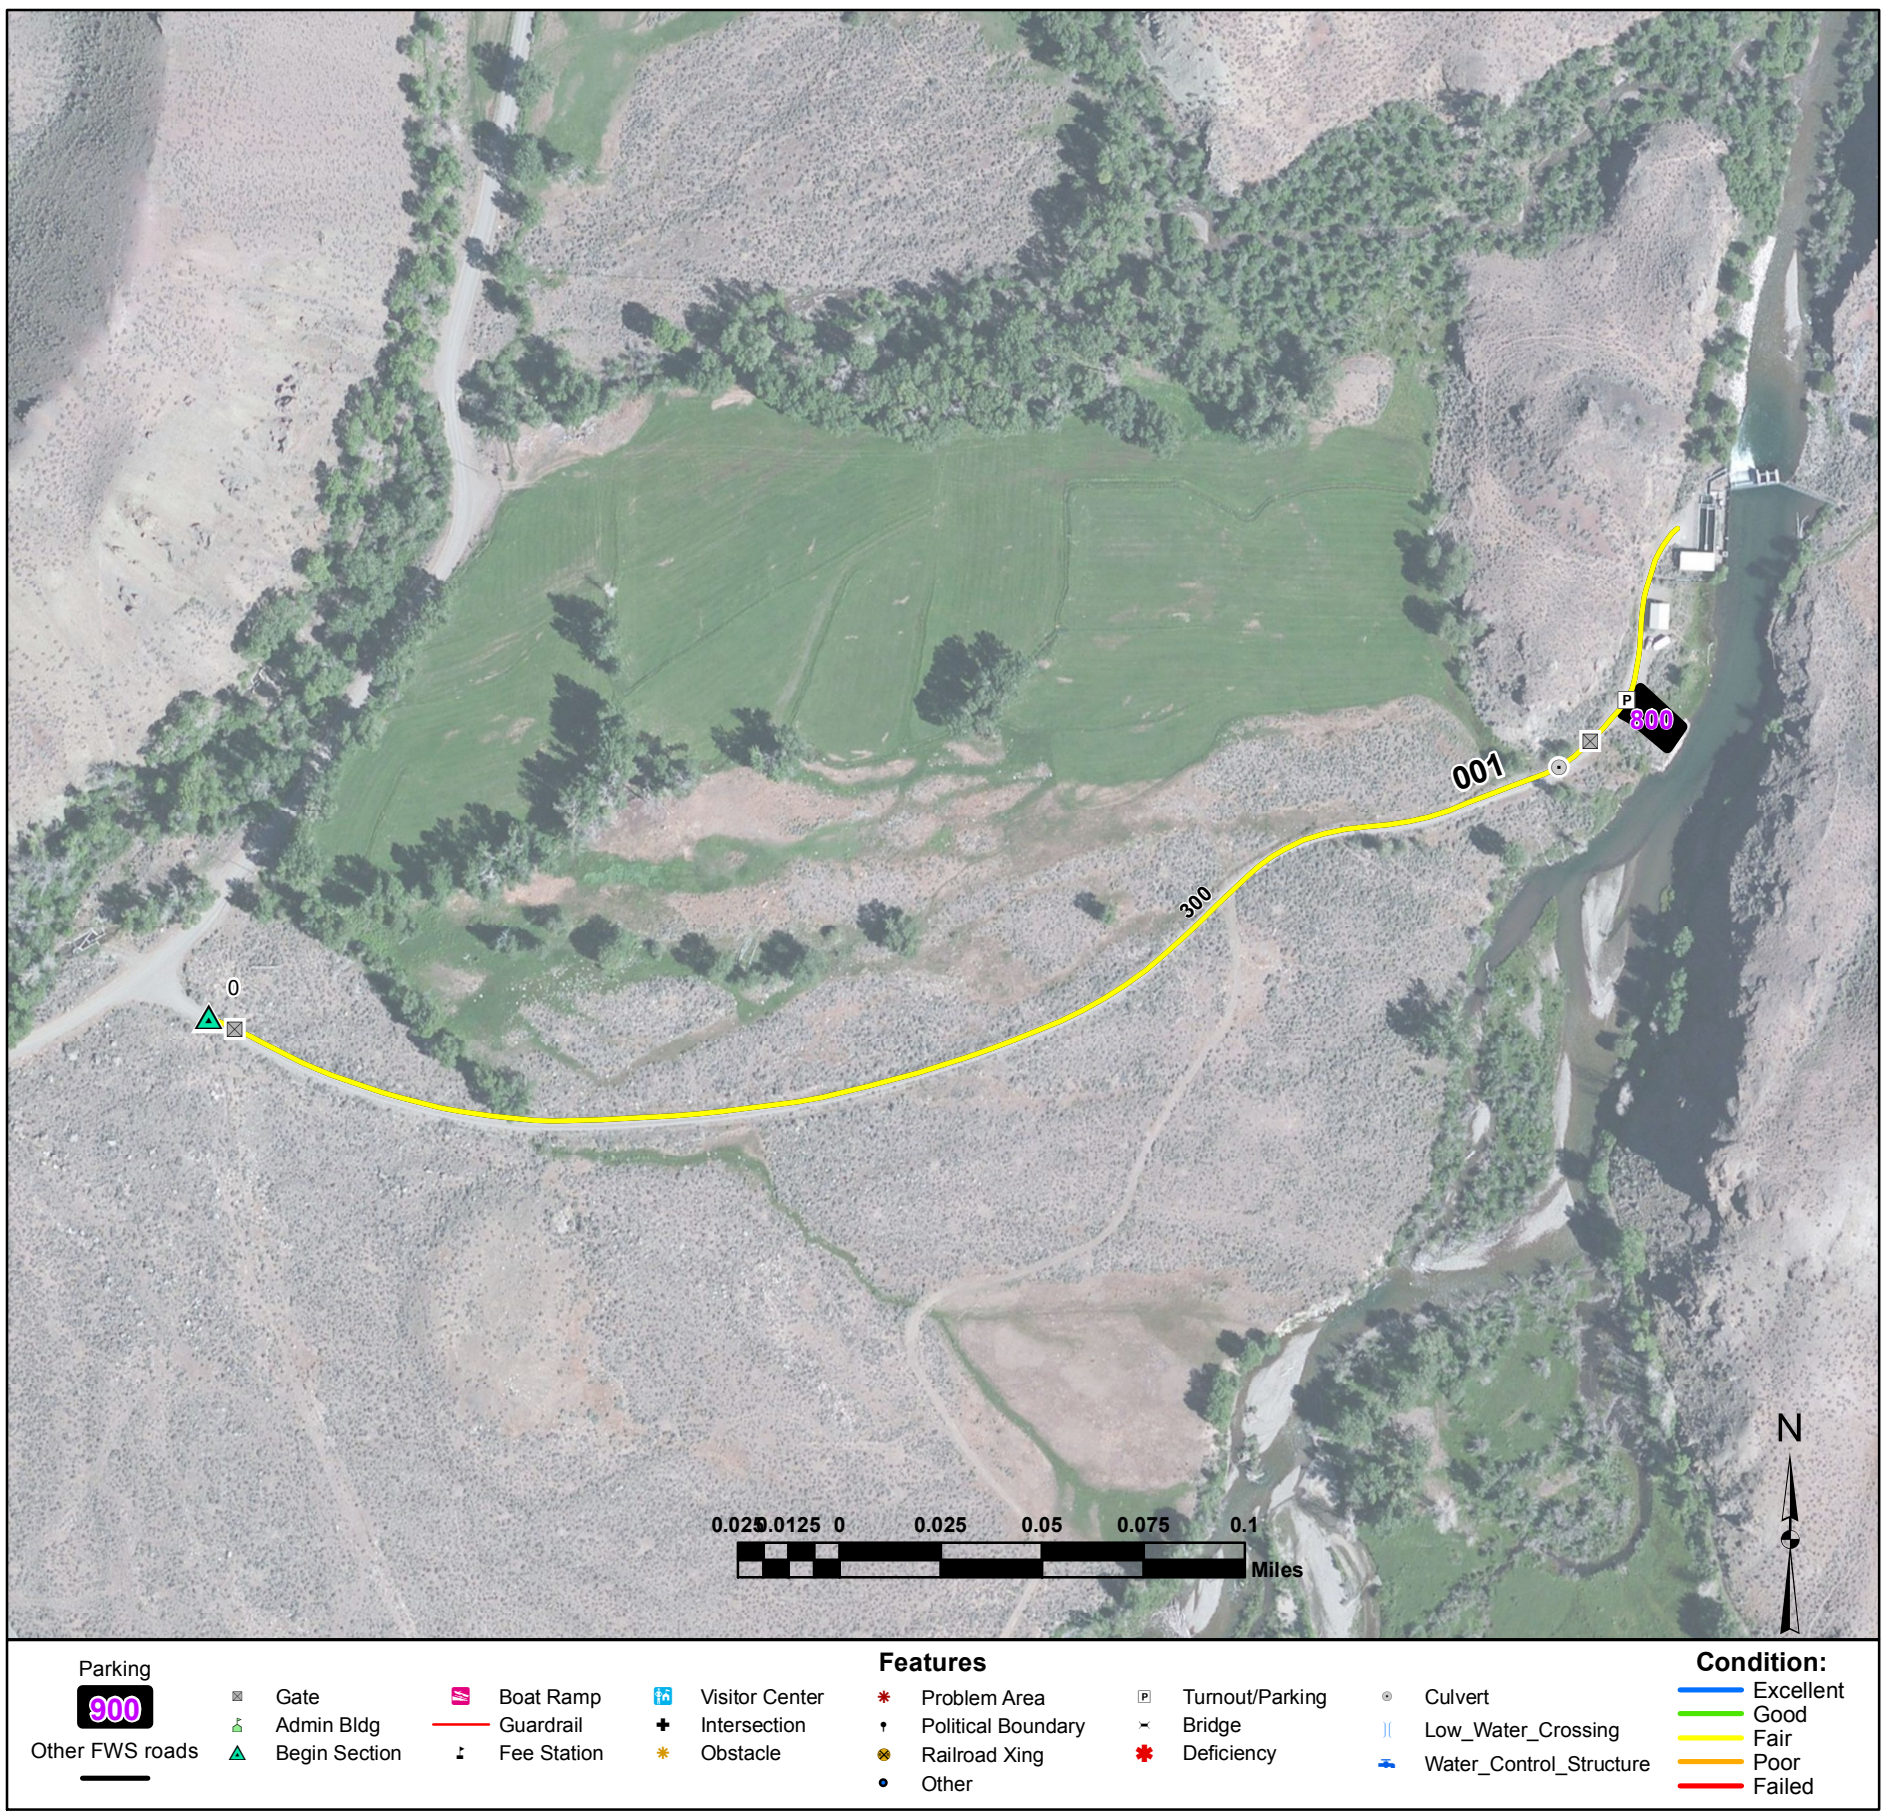
East Fork Salmon Facility Entrance Road

Asset Number	10059329				
Section Number	001				
Section Length (miles)	0.43				
Inspection Date	10-02-2012				
Surface Type	Gravel				
Number of Lanes	1				
Roadway Width (feet)	12				
Condition	Fair				
Remaining Service Life (years)	4				
Estimated Cost to Repair	$1,700				
Current Replacement Value	$326,000

Features	Mile Post	Features	Mile Post	Features	Mile Post	Features	Mile Post
Begin Section	001-0.0						
Gate	001-0.01						
Culvert	001-0.37						
Gate	001-0.38						
Turnout/Parking	001-0.39

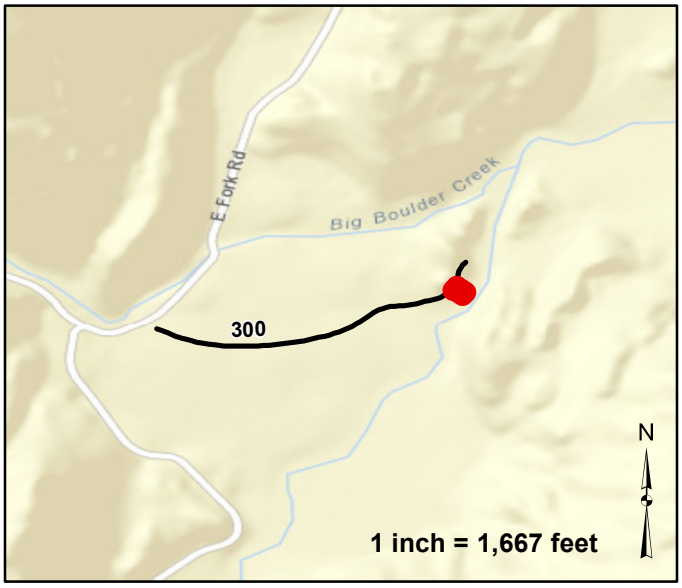
East Fork Salmon Facility Parking

Asset Number	Area (Sq Ft)	Spaces	Condition	Surface Type	Cost to Improve	Inspection Date	Current Replacement Value
10059328	2612	5	Good	Gravel	$400	10-02-2012	$14,200
