The Road Inventory of Siletz Bay National Wildlife Refuge

Newport, OR

Prepared By:
Federal Highway Administration
Central Federal Lands Highway Division
February 2013

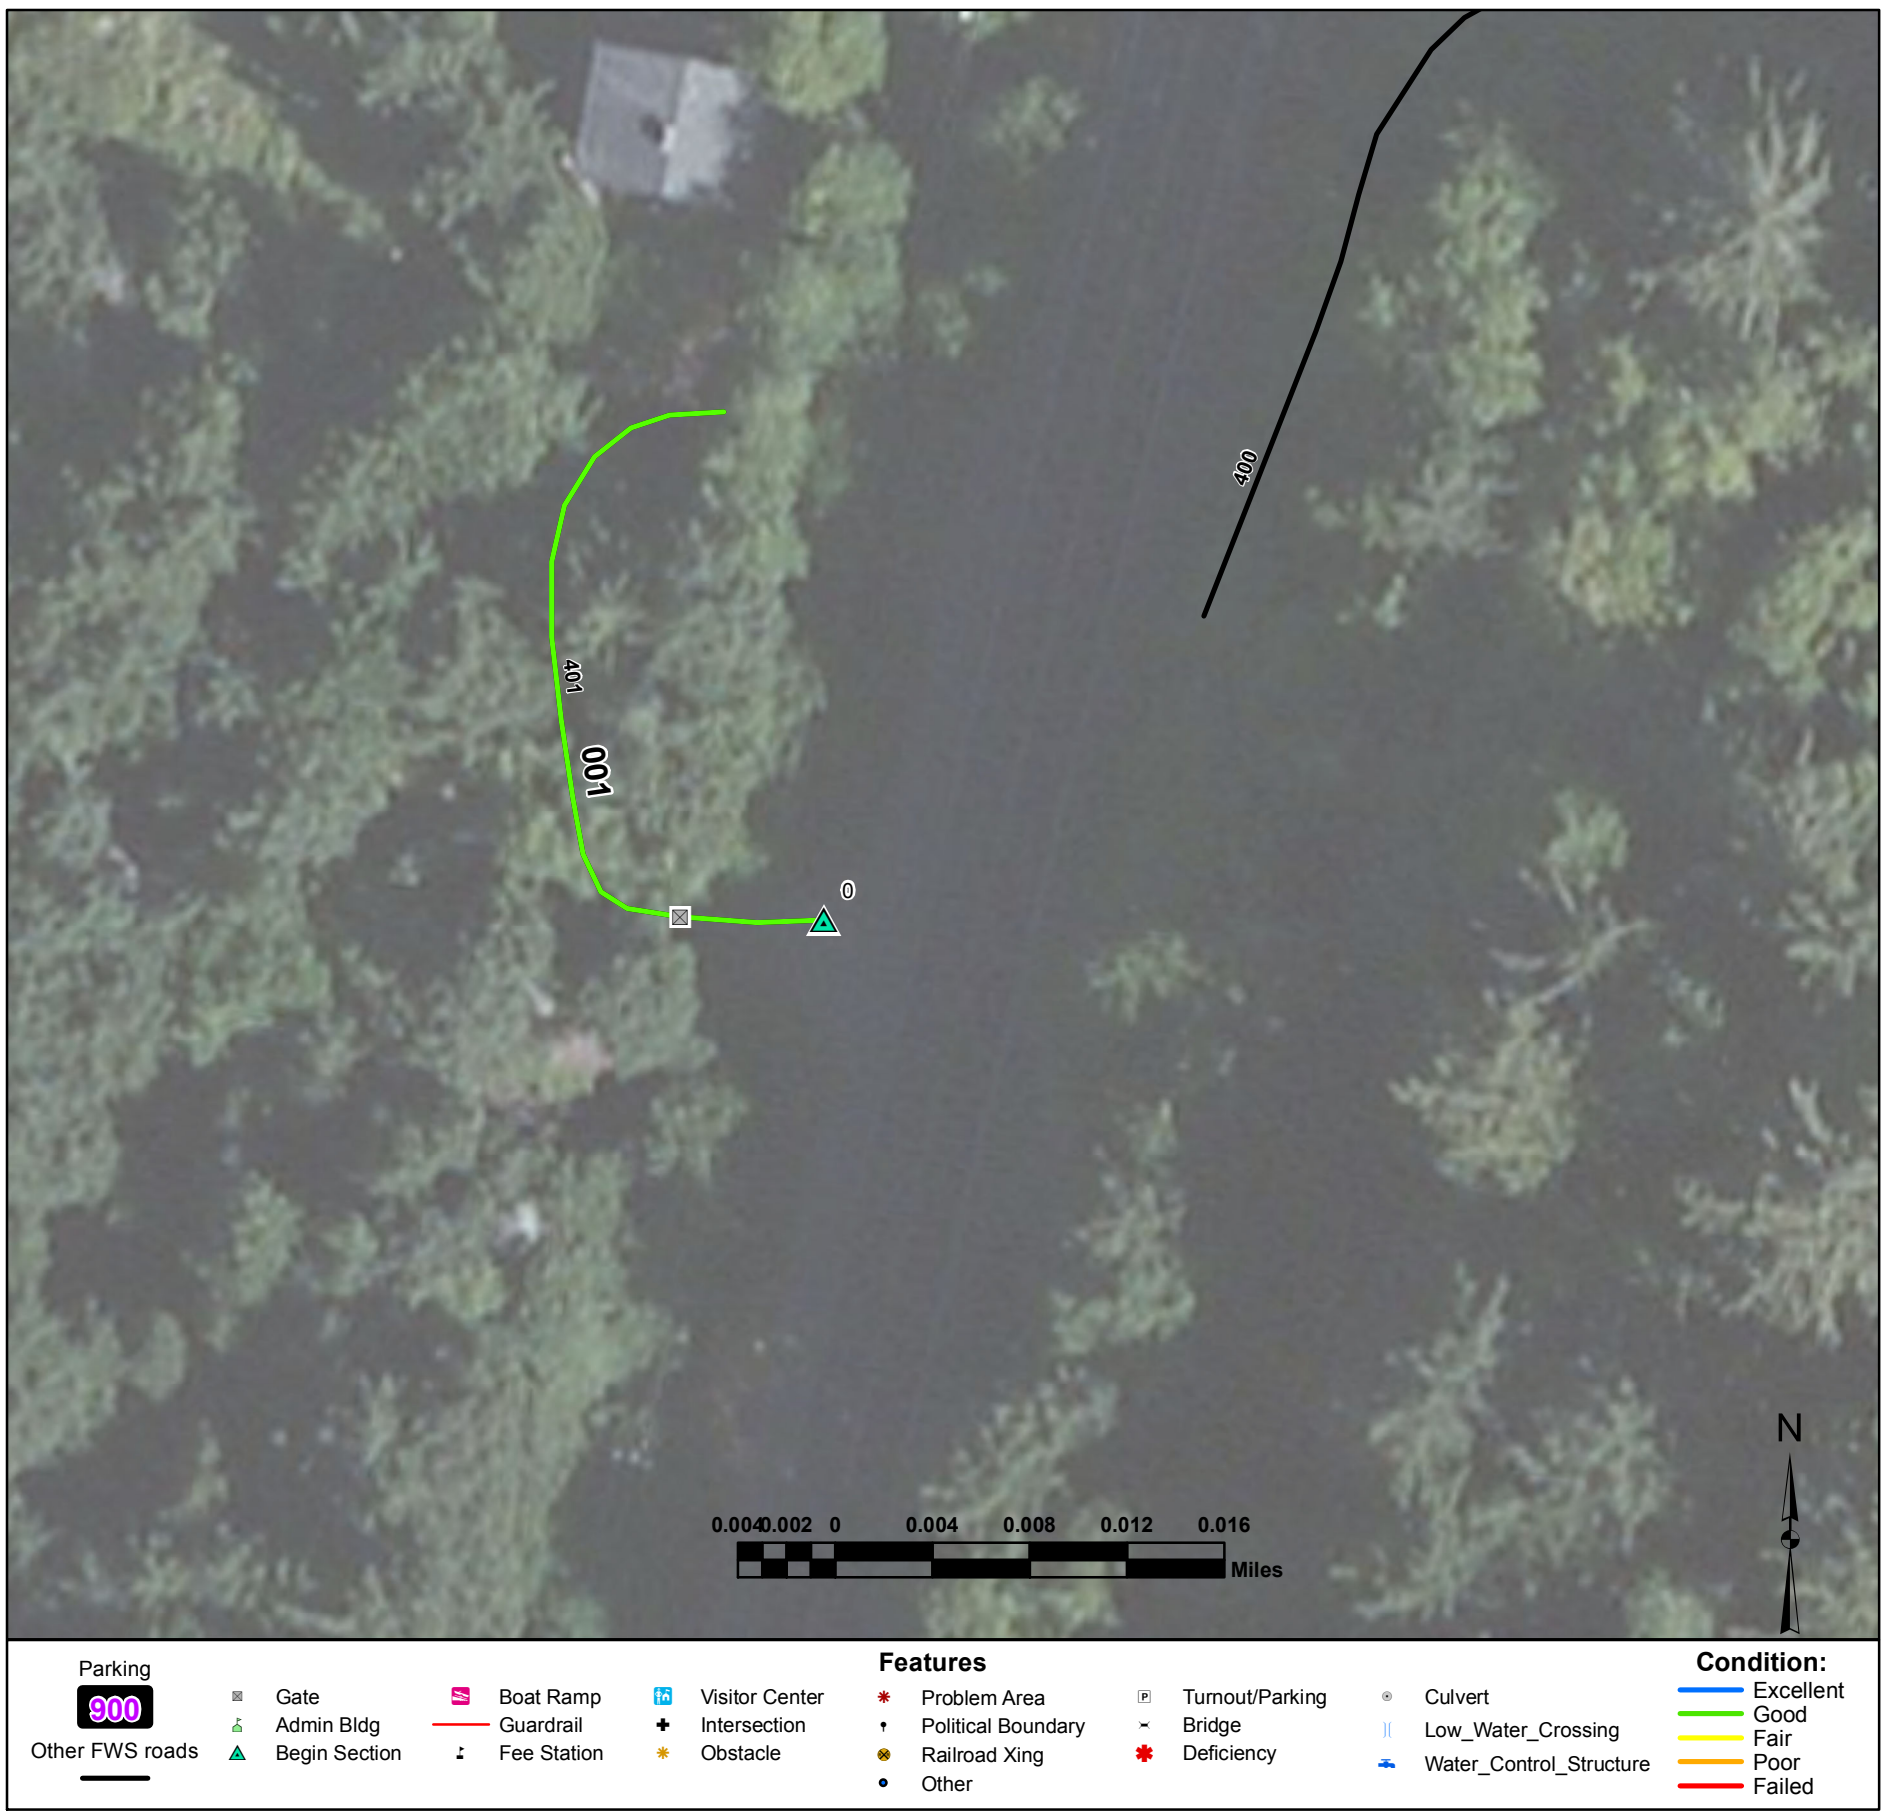
Watson House

Asset Number	10004558				
Section Number	001				
Section Length (miles)	0.13				
Inspection Date	01-10-2013				
Surface Type	Gravel				
Number of Lanes	1				
Roadway Width (feet)	12				
Condition	Good				
Remaining Service Life (years)	7				
Estimated Cost to Repair	$200				
Current Replacement Value	$102,600
