The Road Inventory of Cold Springs National Wildlife Refuge

Boardman, OR

Prepared By:
Federal Highway Administration
Central Federal Lands Highway Division
March 2013

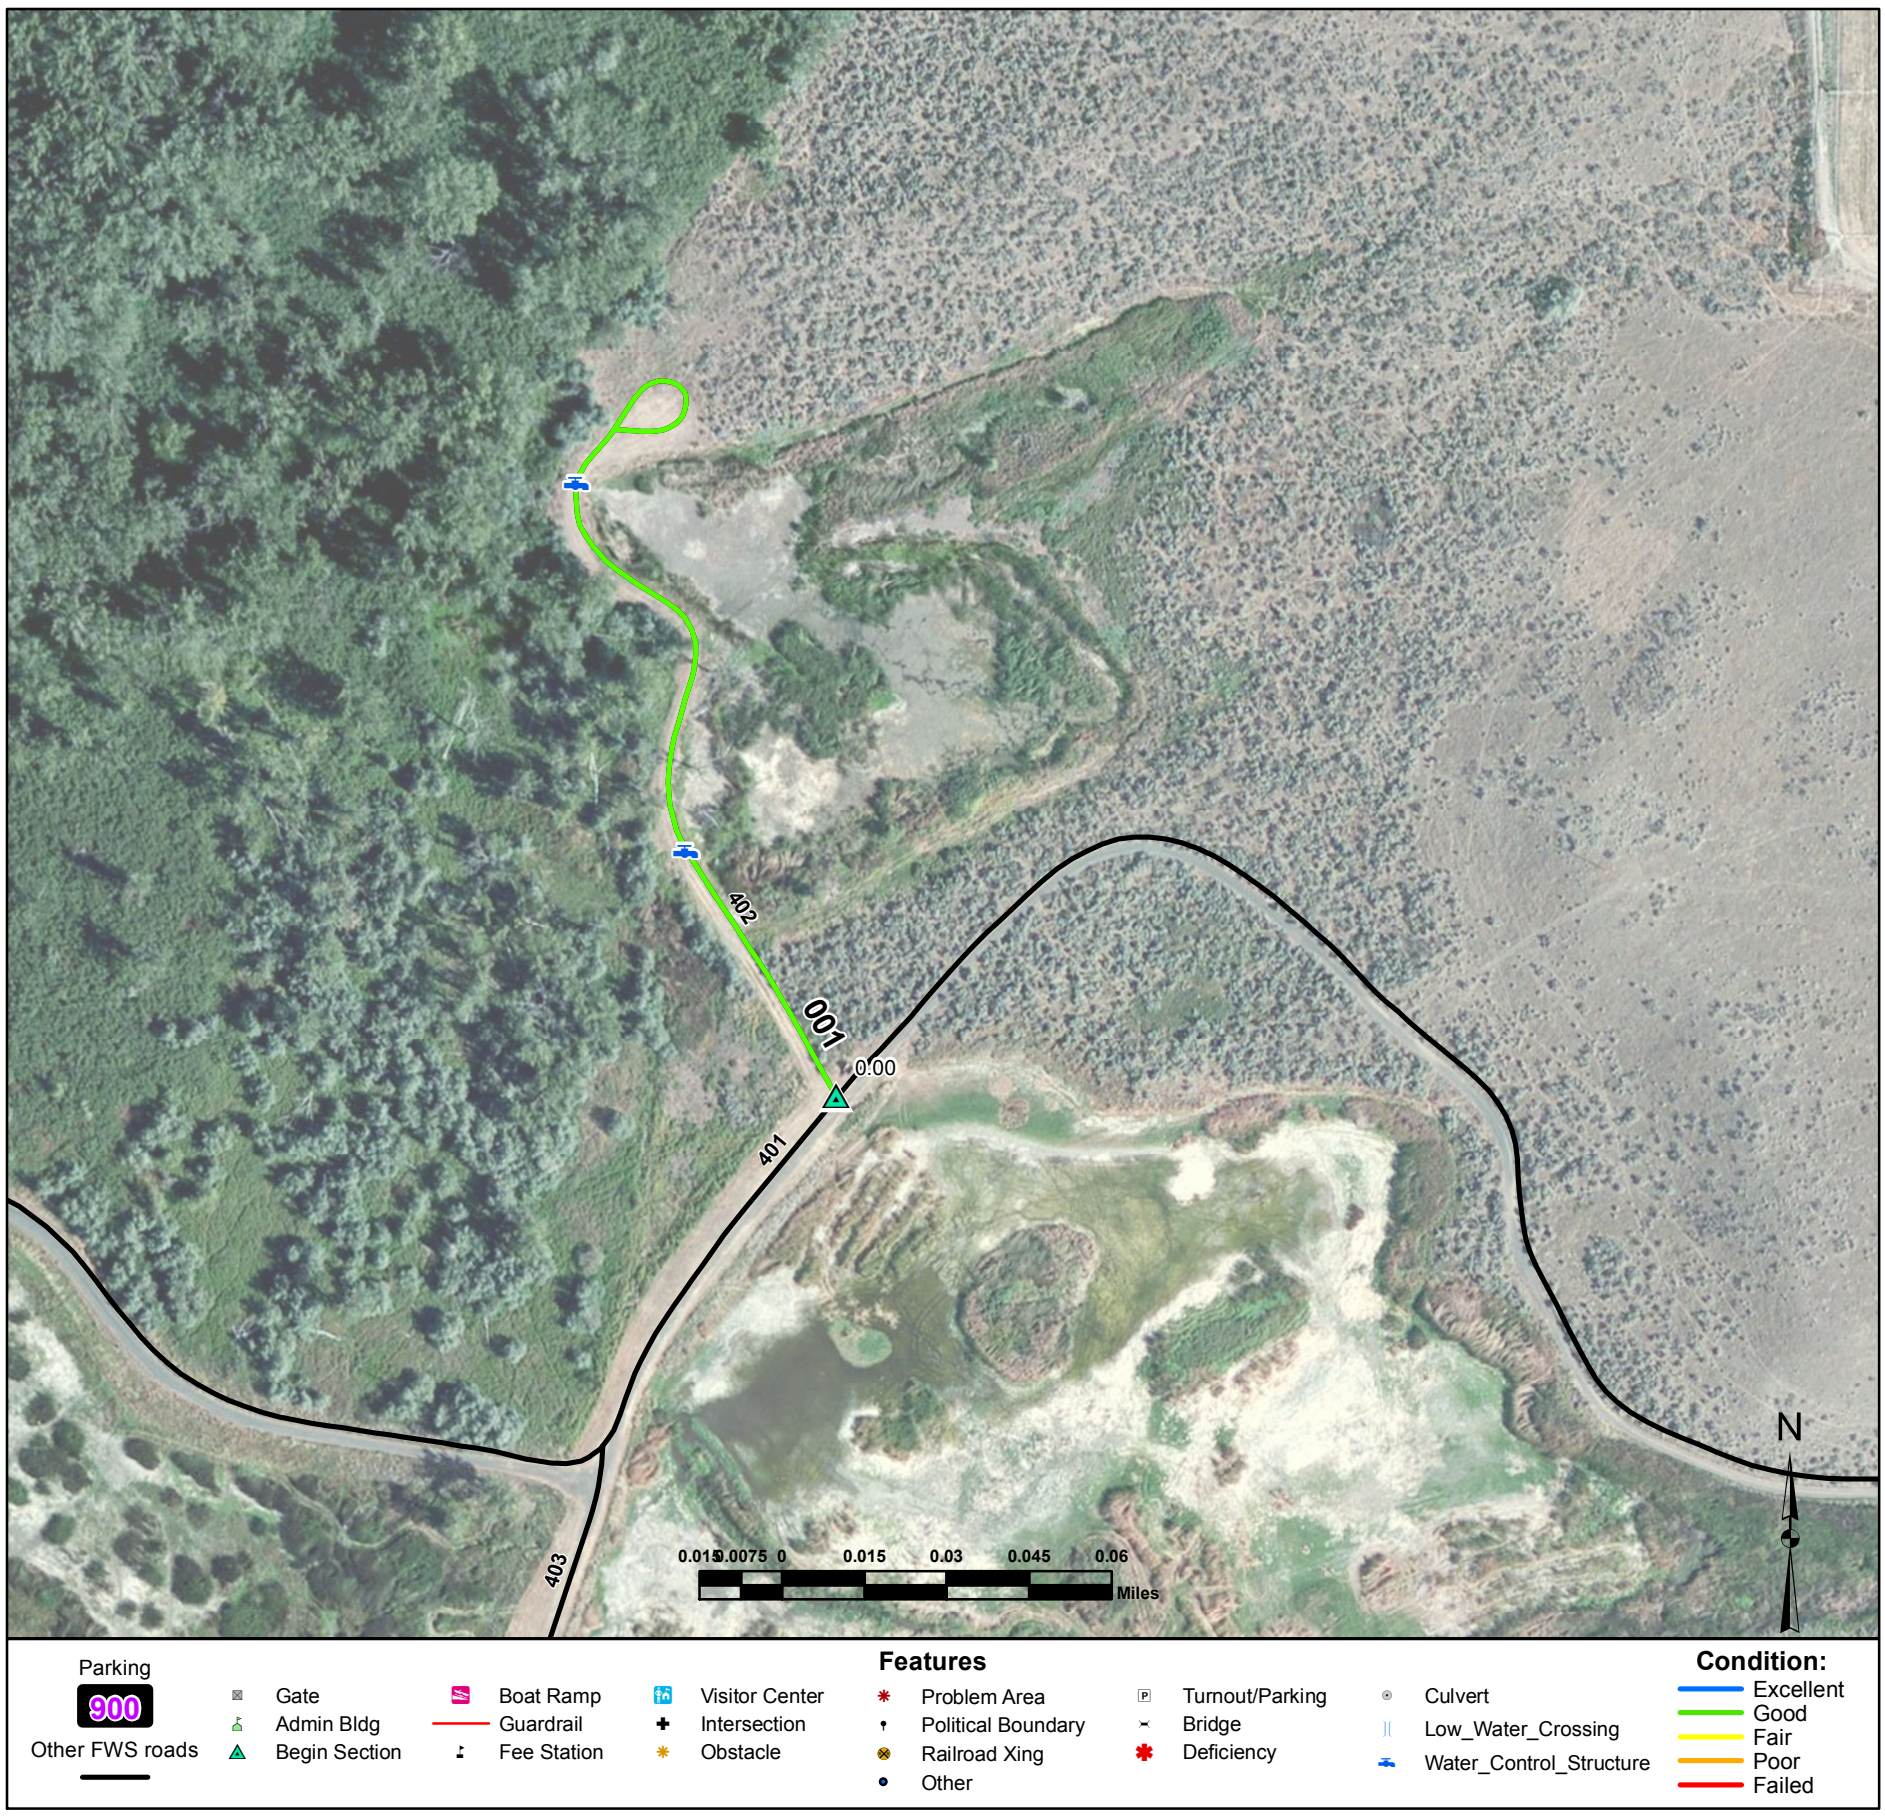
Mo's Pond Access Road

Asset Number	10004255				
Section Number	001				
Section Length (miles)	0.18				
Inspection Date	11-02-2012				
Surface Type	Native				
Number of Lanes	1				
Roadway Width (feet)	12				
Condition	Good				
Remaining Service Life (years)	5				
Estimated Cost to Repair	$300				
Current Replacement Value	$71,200
