The Road Inventory of Eagle Fish Health Laboratory

Eagle, ID

Prepared By:
Federal Highway Administration
Central Federal Lands Highway Division
April 2013

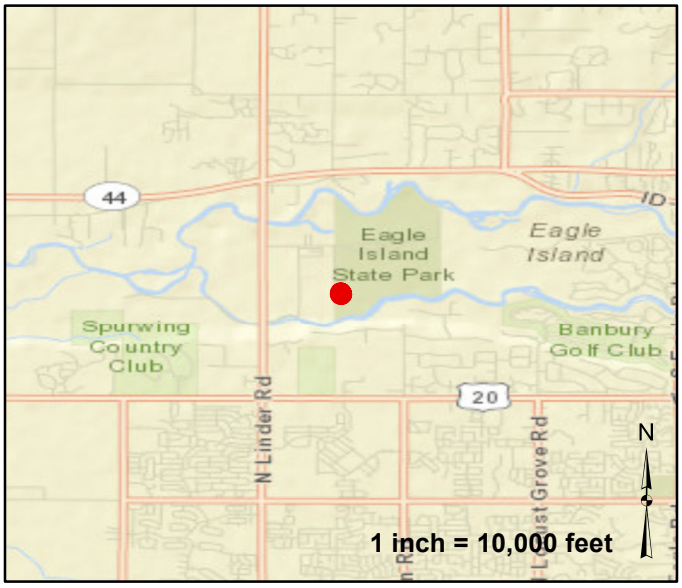
Route Number: 900

Asset Number	Area (Sq Ft)	Spaces	Condition	Surface Type	Cost to Improve	Inspection Date	Current Replacement Value
10004979	2114	7	Good	Asphalt	$400	03-13-2013	$17,800
