The Road Inventory of James Campbell National Wildlife Refuge

Haleiwa, HI

Prepared By:
Federal Highway Administration
Central Federal Lands Highway Division
April 2013

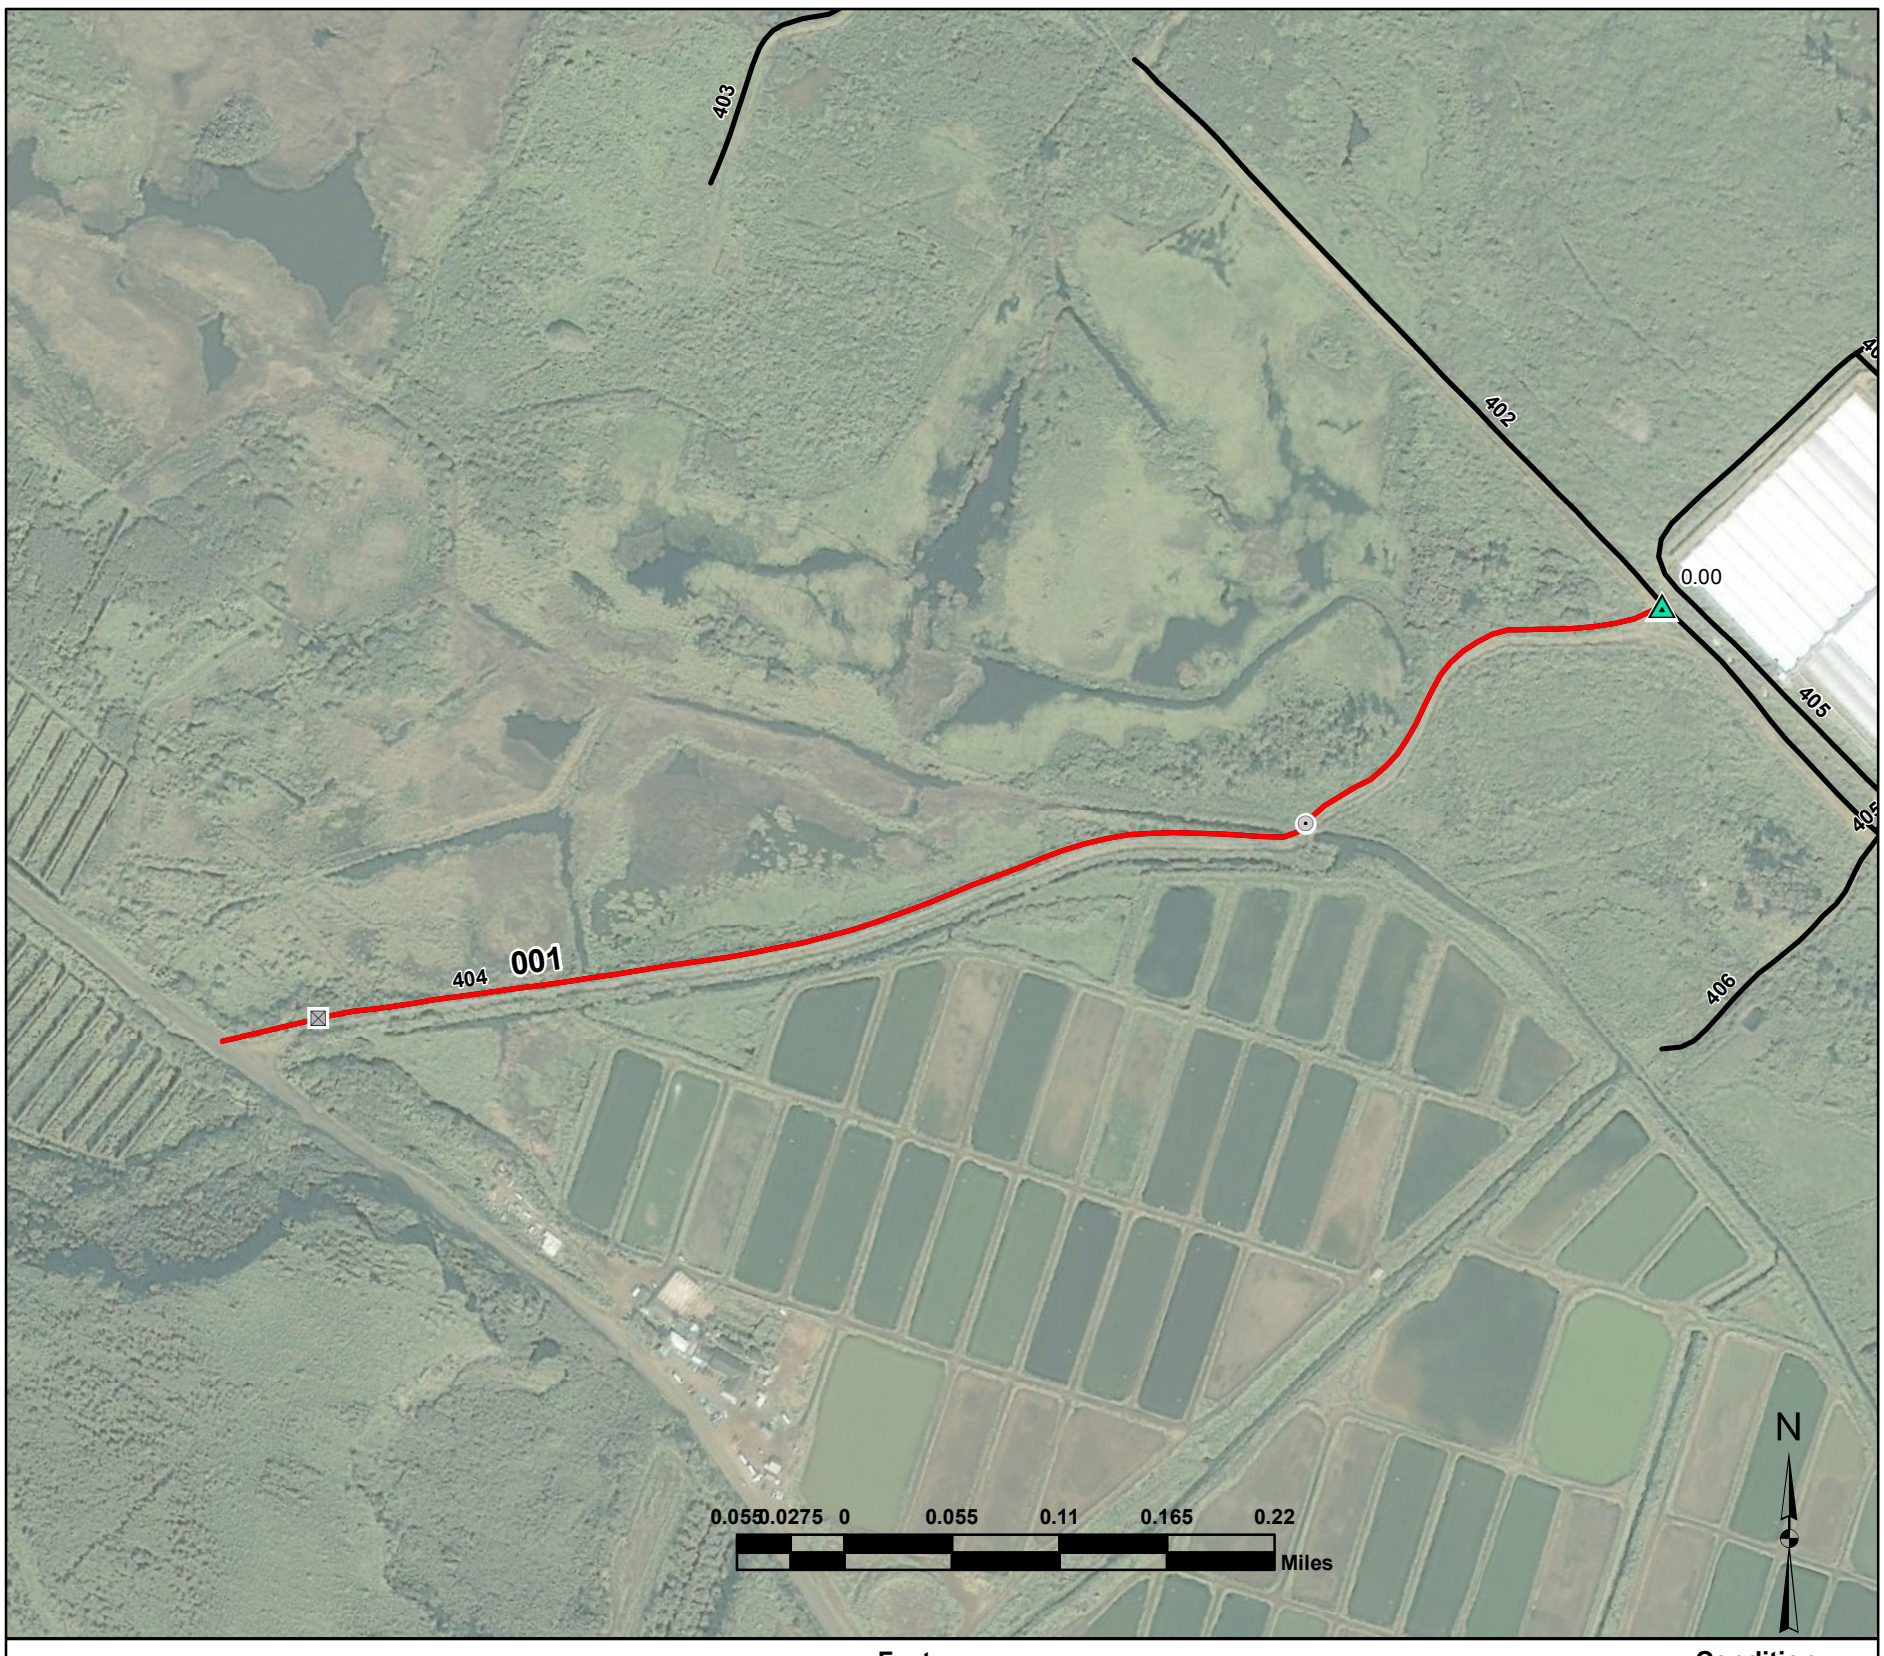
Nudist Camp Road

Asset Number	10062617				
Section Number	001				
Section Length (miles)	0.63				
Inspection Date	01-18-2013				
Surface Type	Asphalt				
Number of Lanes	1				
Roadway Width (feet)	12				
Condition	Failed				
Remaining Service Life (years)	0				
Estimated Cost to Repair	$987,100				
Current Replacement Value	$1,033,600

Features	Mile Post	Features	Mile Post	Features	Mile Post	Features	Mile Post
Begin Section	001-0.0						
Culvert	001-0.18						
Gate	001-0.59

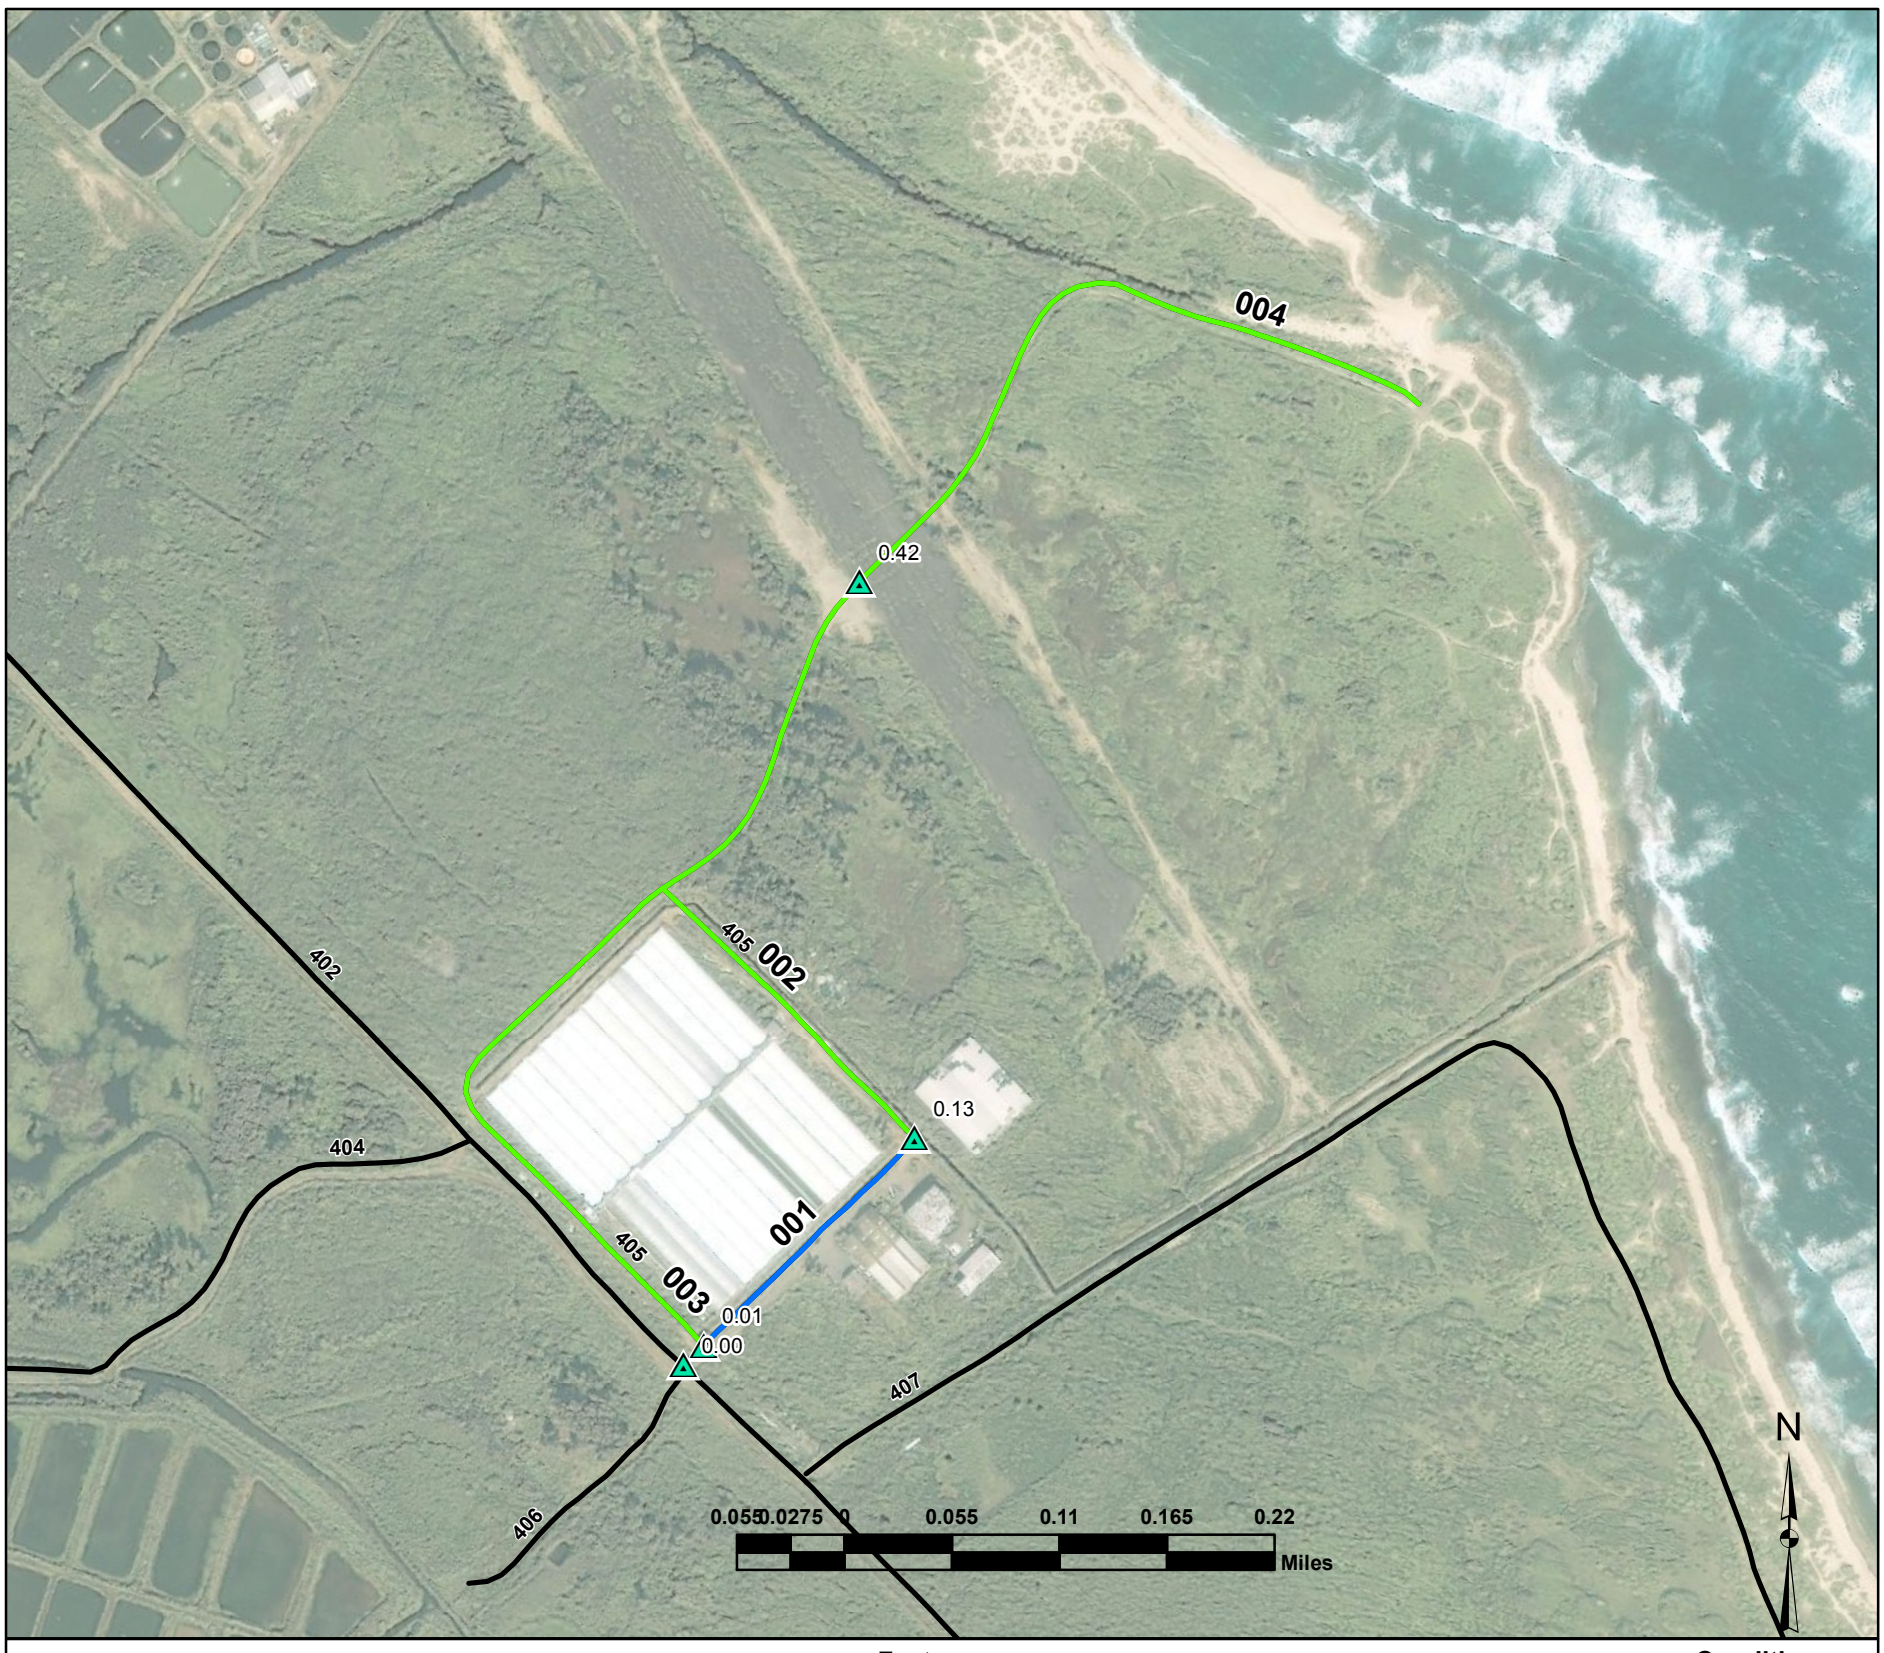
Runway Road

Asset Number	-	-	-	-	
Section Number	001	002	003	004	
Section Length (miles)	0.13	0.14	0.41	0.30	
Inspection Date	01-18-2013	01-18-2013	01-18-2013	01-18-2013	
Surface Type	Gravel	Native	Native	Native	
Number of Lanes	1	1	1	1	
Roadway Width (feet)	14	12	14	14	
Condition	Excellent	Good	Good	Good	
Remaining Service Life (years)	9	5	5	5	
Estimated Cost to Repair	$0	$300	$1,000	$700	
Current Replacement Value	$122,900	$68,500	$200,600	$146,800

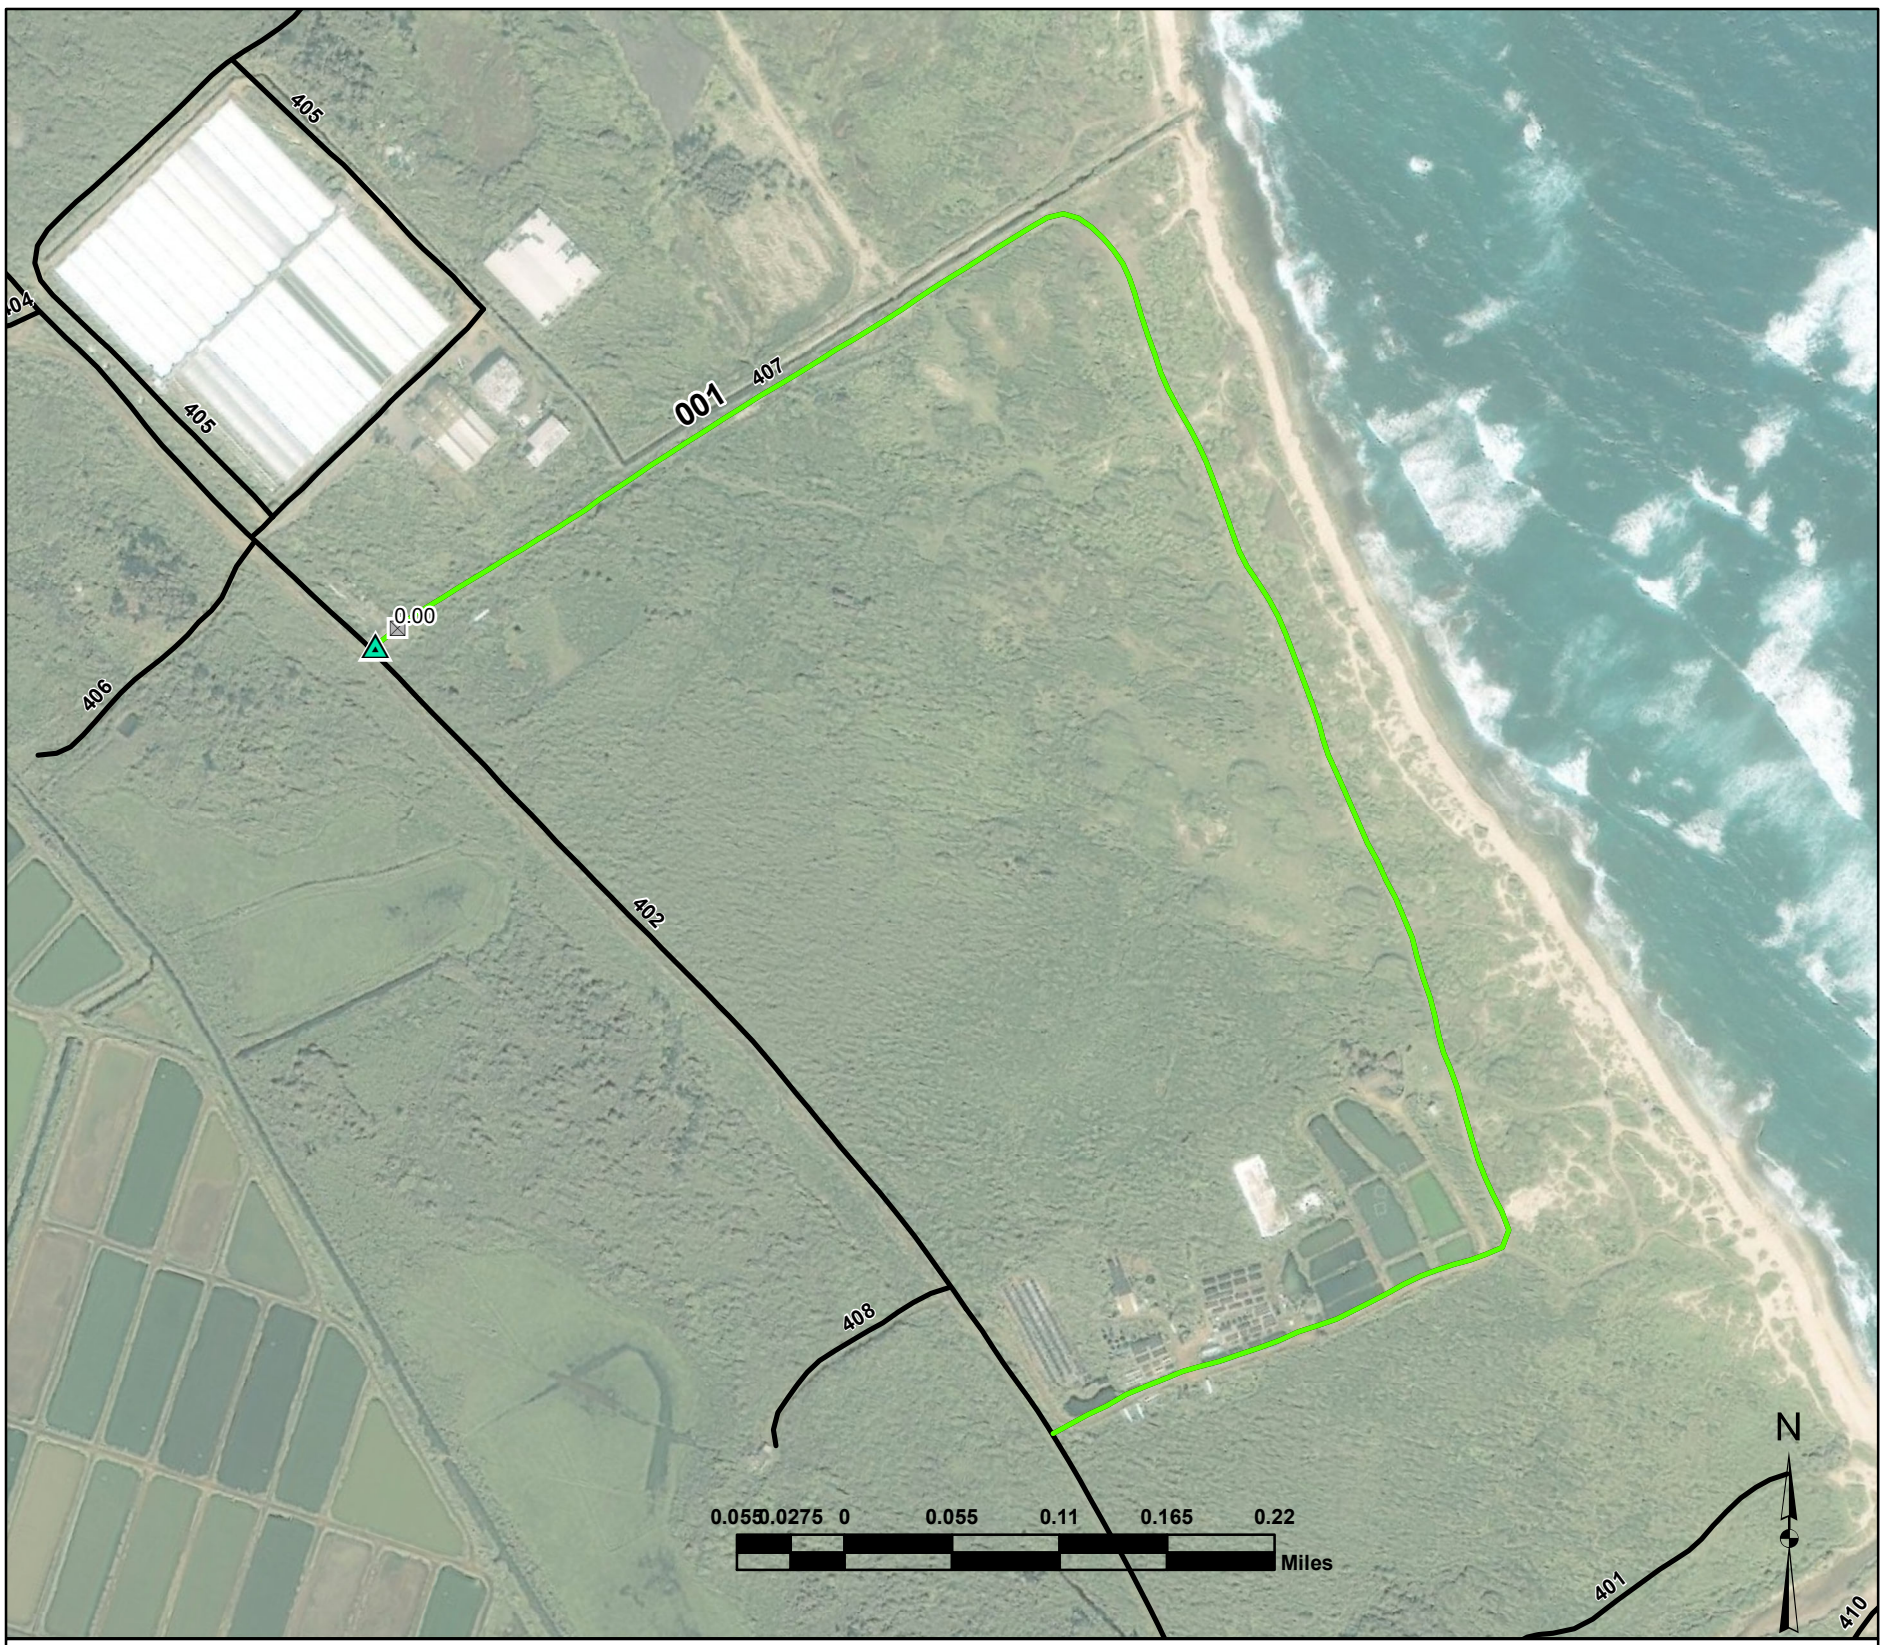
Sea Bird Road

Asset Number	-				
Section Number	001				
Section Length (miles)	0.99				
Inspection Date	01-18-2013				
Surface Type	Native				
Number of Lanes	1				
Roadway Width (feet)	12				
Condition	Good				
Remaining Service Life (years)	5				
Estimated Cost to Repair	$2,300				
Current Replacement Value	$484,300

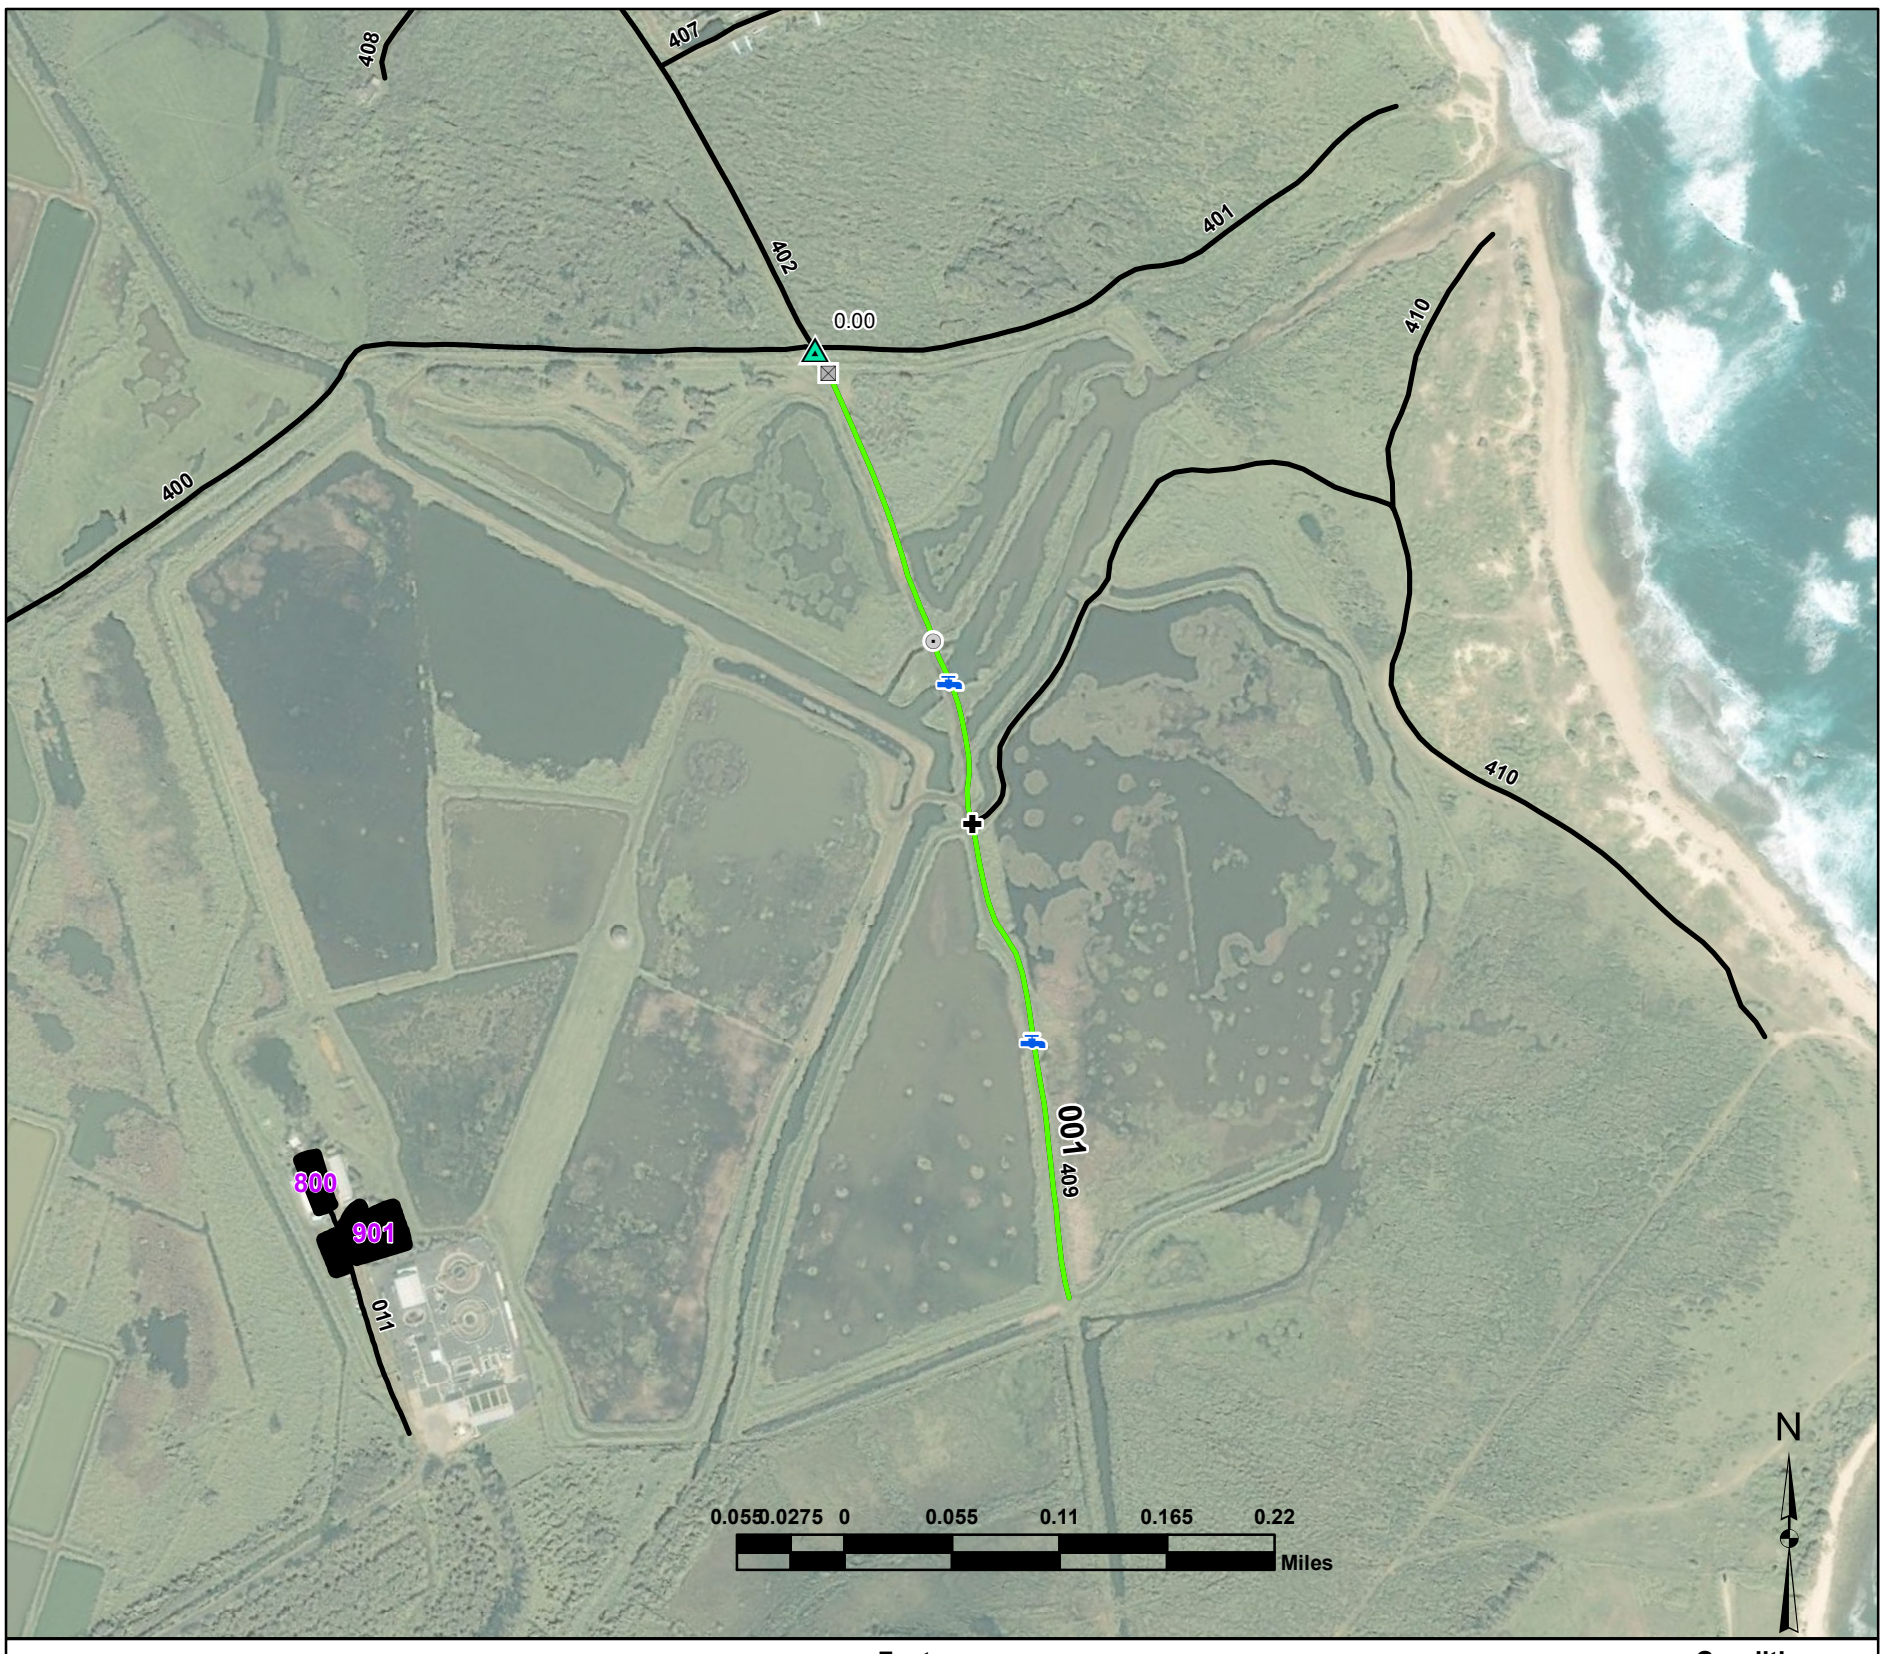
Right of Way Road - Kii Unit

Asset Number	-				
Section Number	001				
Section Length (miles)	0.40				
Inspection Date	01-18-2013				
Surface Type	Native				
Number of Lanes	1				
Roadway Width (feet)	10				
Condition	Good				
Remaining Service Life (years)	7				
Estimated Cost to Repair	$900				
Current Replacement Value	$195,700

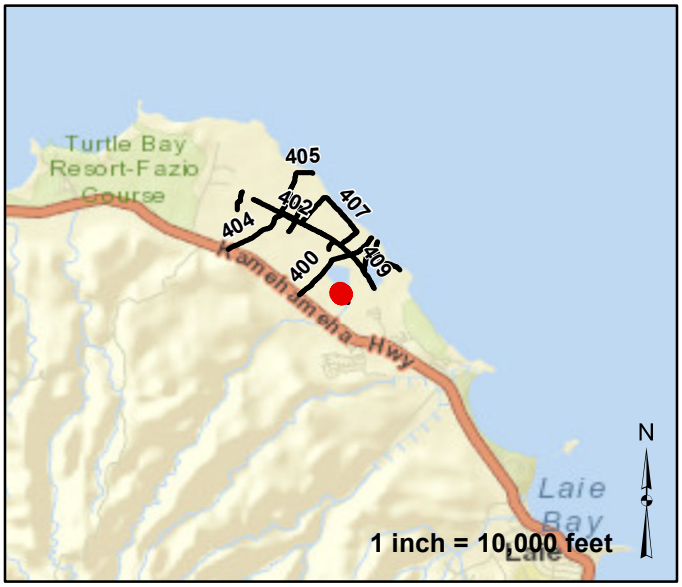
900

Asset Number	Area (Sq Ft)	Spaces	Condition	Surface Type	Cost to Improve	Inspection Date	Current Replacement Value
-	4266	8	Excellent	Gravel	$0	01-18-2013	$29,000

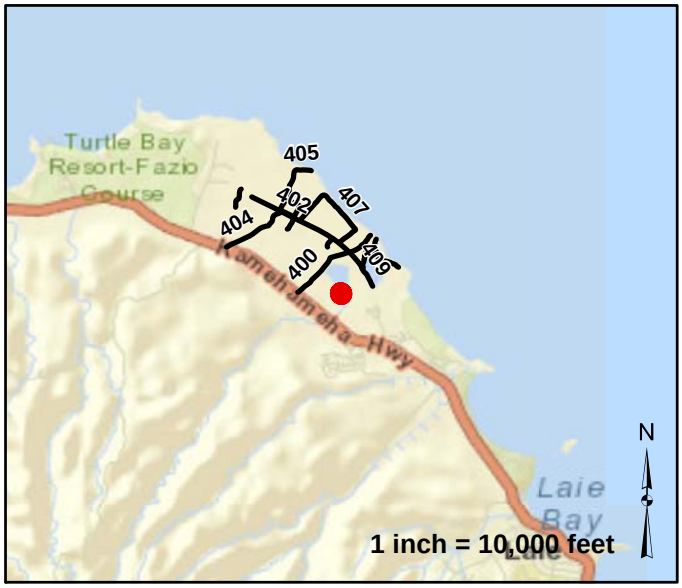
900

Asset Number	Area (Sq Ft)	Spaces	Condition	Surface Type	Cost to Improve	Inspection Date	Current Replacement Value
10002335	2609	15	Good	Native	$500	01-18-2013	$7,600
