The Road Inventory of Quilcene National Fish Hatchery

Quilcene, WA

Prepared By:
Federal Highway Administration
Central Federal Lands Highway Division
April 2013

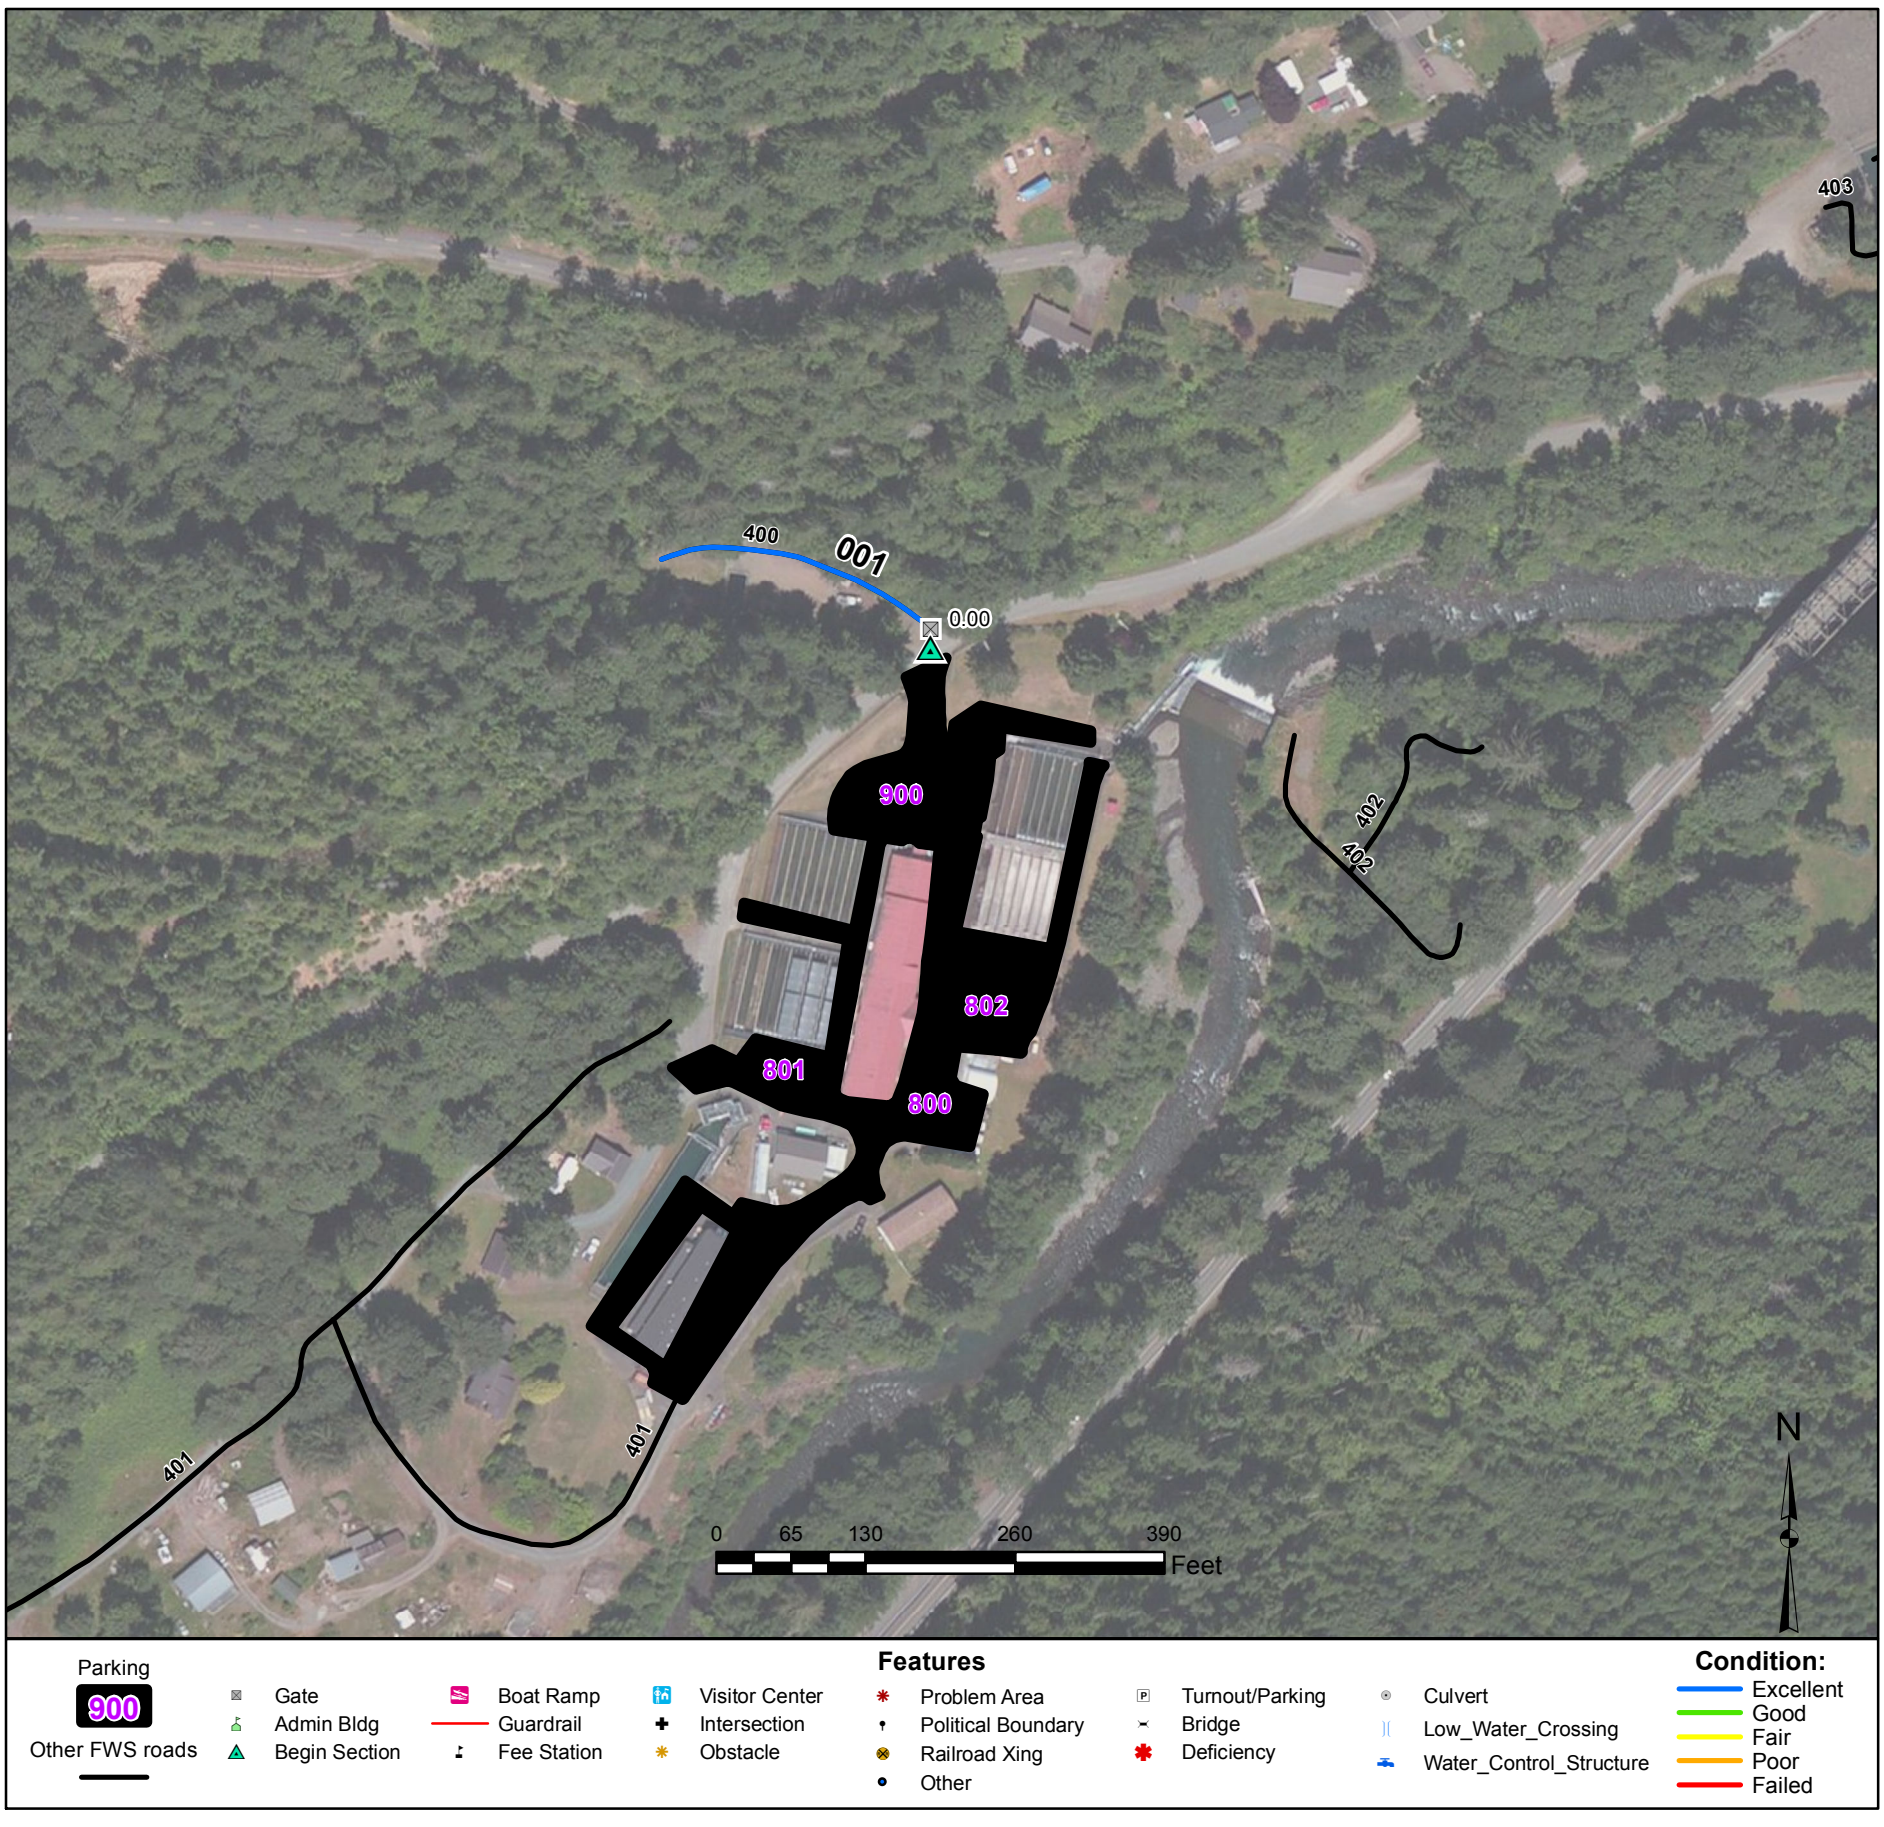
Penny Creek Intake Service Road

Asset Number	-				
Section Number	001				
Section Length (miles)	0.05				
Inspection Date	02-25-2013				
Surface Type	Gravel				
Number of Lanes	2				
Roadway Width (feet)	16				
Condition	Excellent				
Remaining Service Life (years)	9				
Estimated Cost to Repair	$0				
Current Replacement Value	$40,600

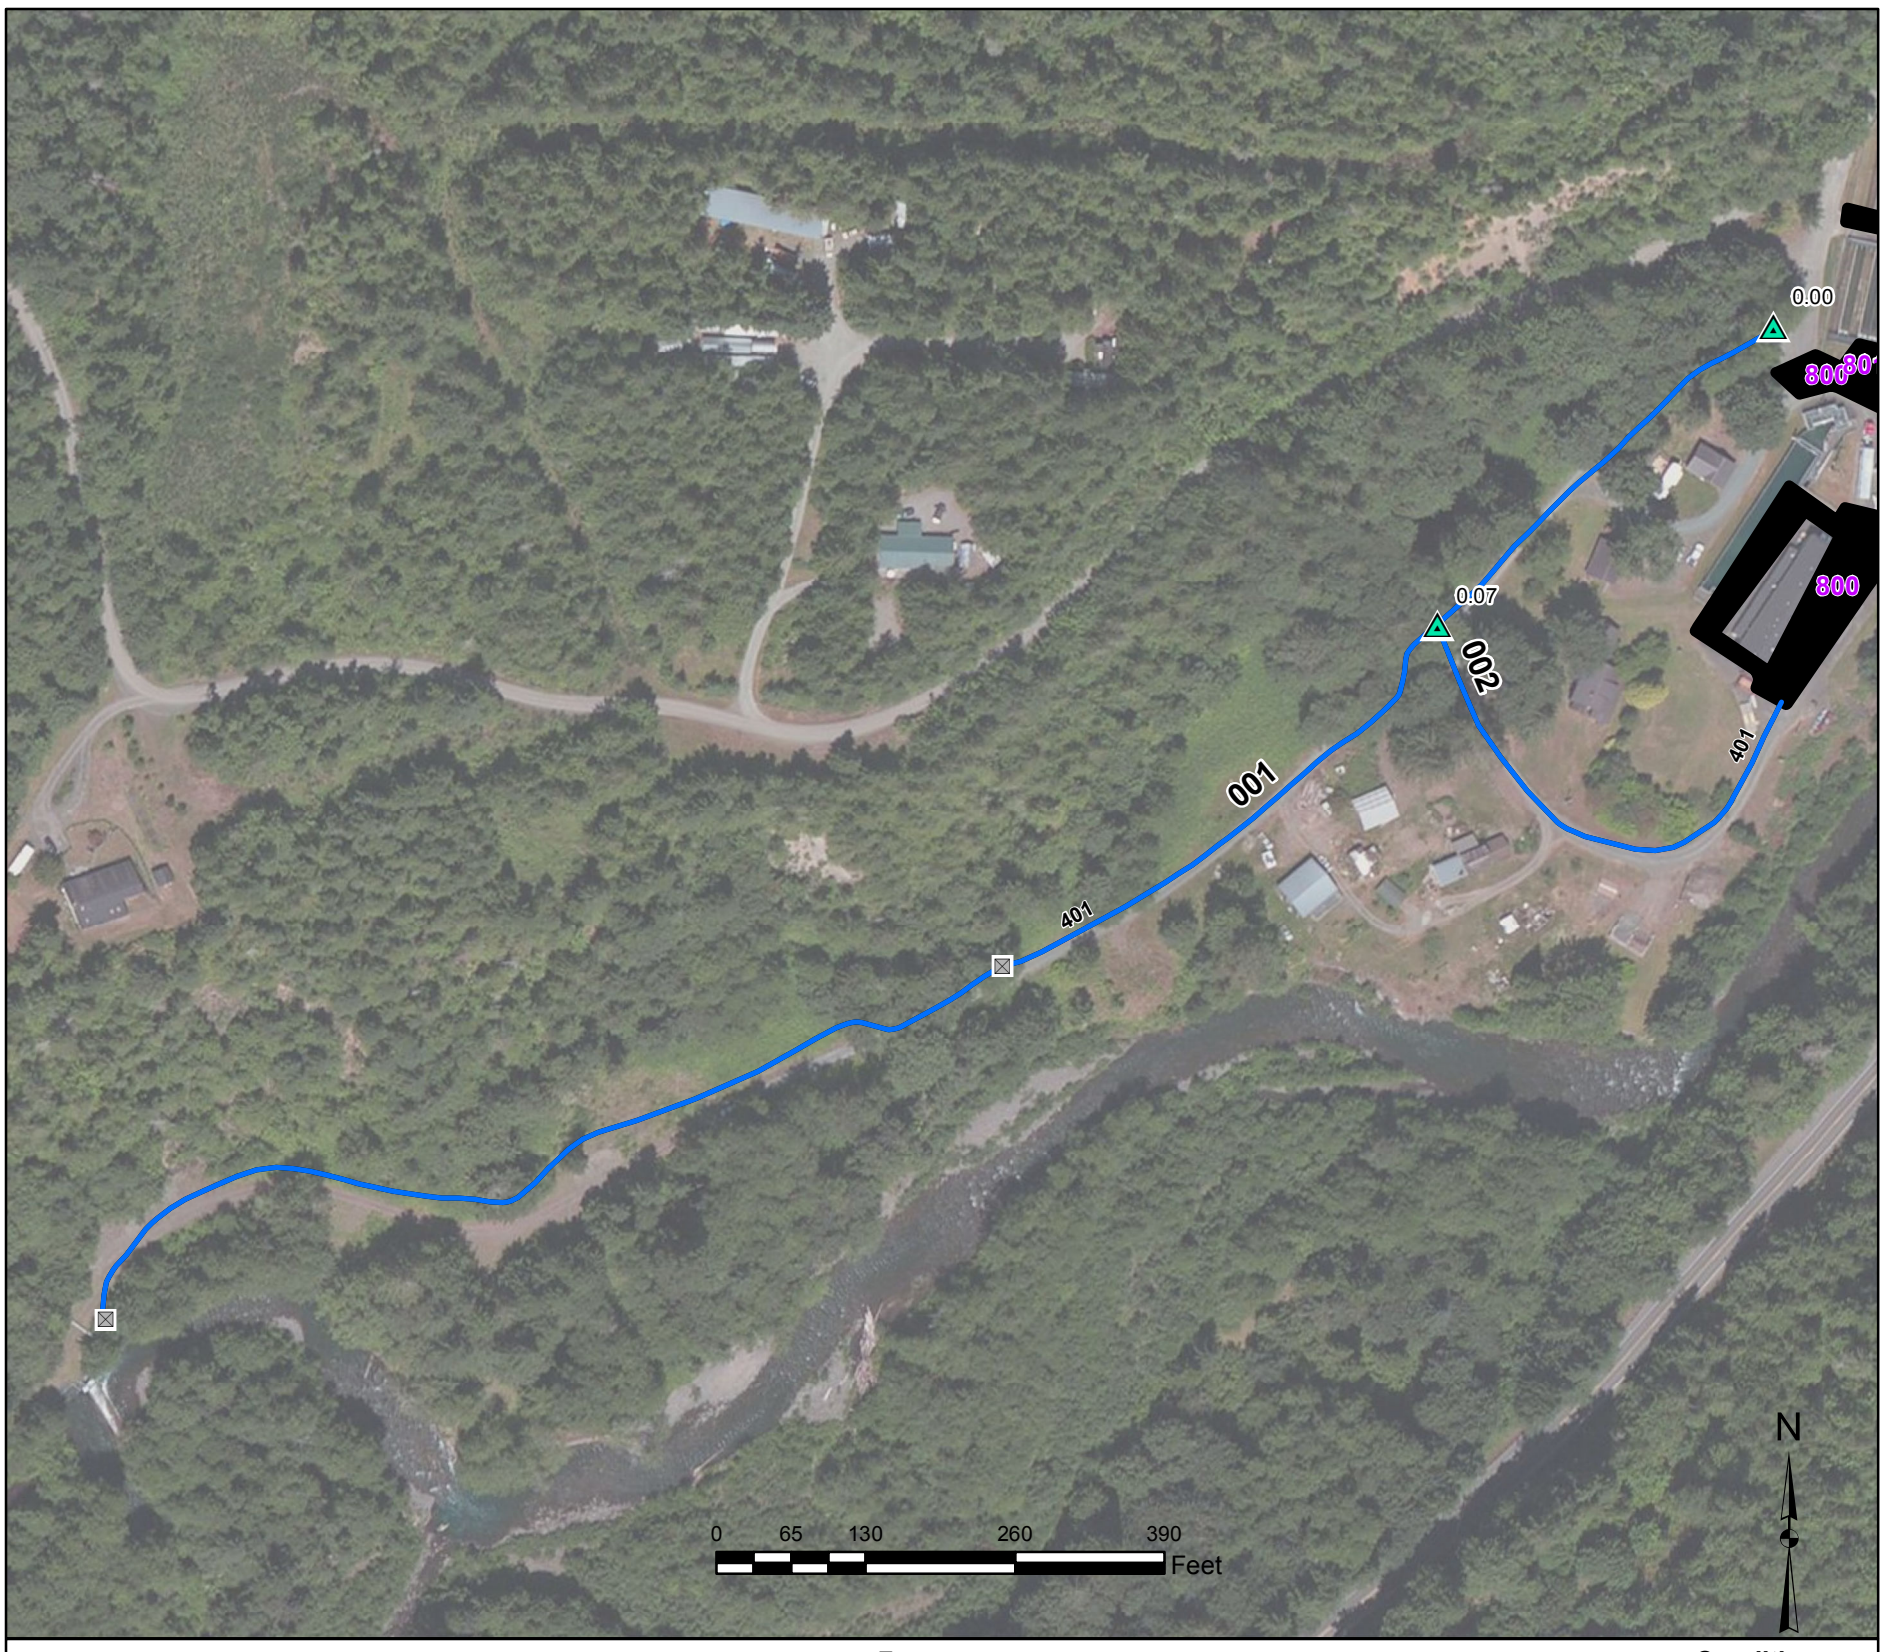
Big Quilcene River Intake Service Road

Asset Number	10049229	10049229			
Section Number	001	002			
Section Length (miles)	0.34	0.08			
Inspection Date	02-25-2013	02-25-2013			
Surface Type	Gravel	Gravel			
Number of Lanes	1	1			
Roadway Width (feet)	12	12			
Condition	Excellent	Excellent			
Remaining Service Life (years)	8	8			
Estimated Cost to Repair	$0	$0			
Current Replacement Value	$276,400	$65,000

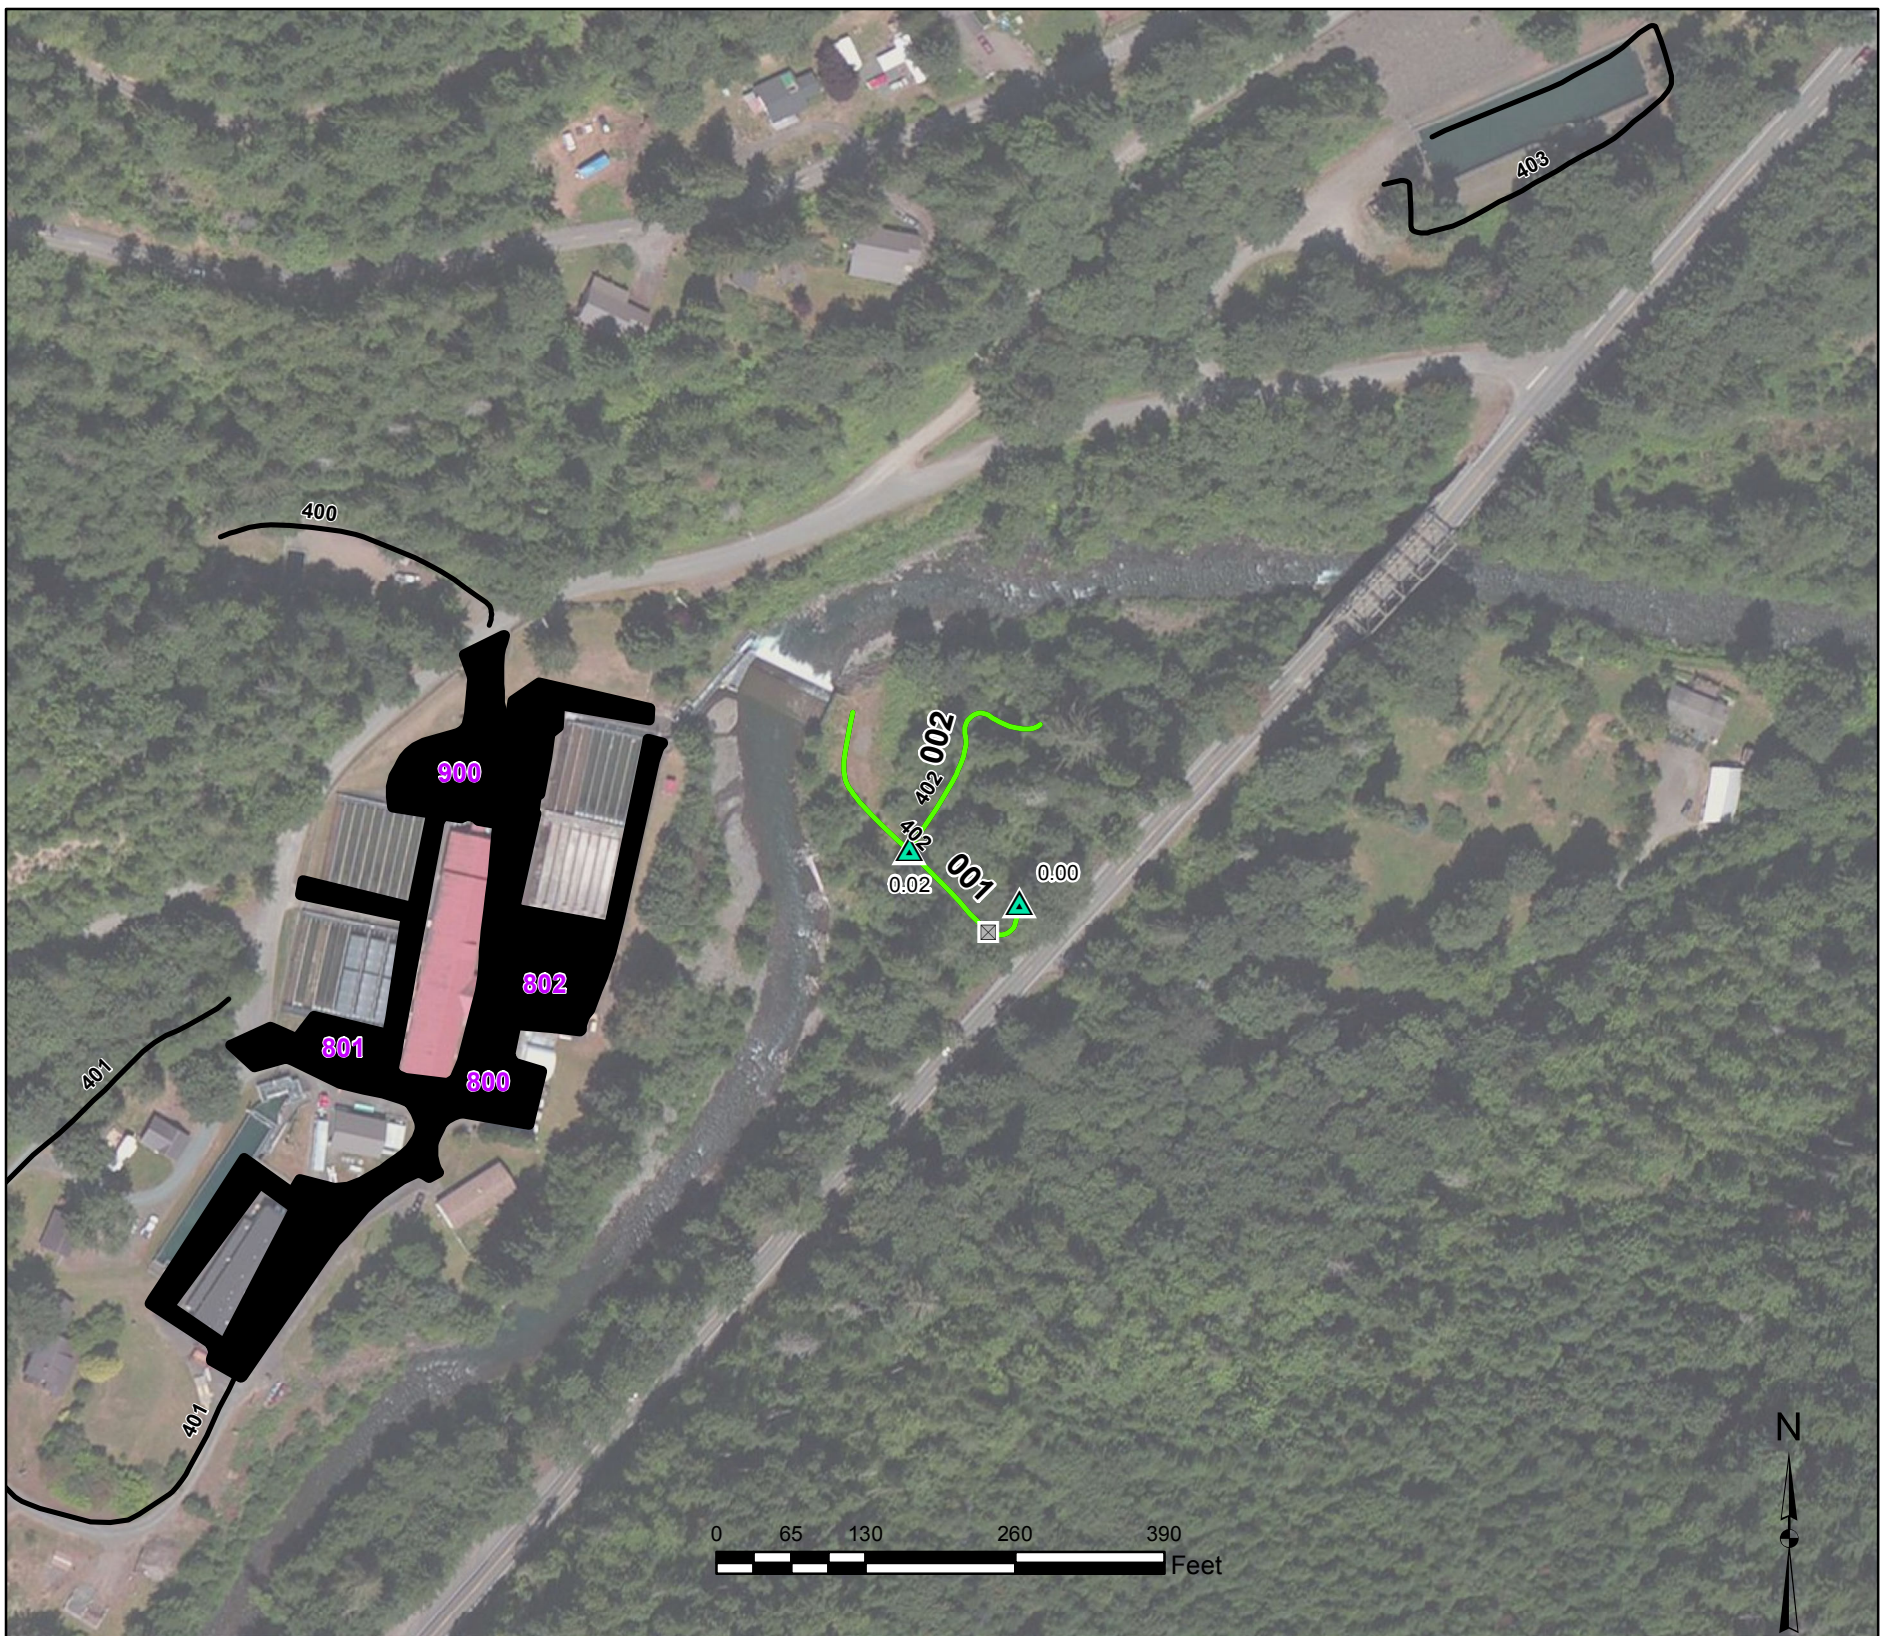
Weir Access Road

Asset Number	10049229	10049229			
Section Number	001	002			
Section Length (miles)	0.05	0.03			
Inspection Date	02-25-2013	02-25-2013			
Surface Type	Gravel	Native			
Number of Lanes	1	1			
Roadway Width (feet)	12	14			
Condition	Good	Good			
Remaining Service Life (years)	5	7			
Estimated Cost to Repair	$100	$100			
Current Replacement Value	$40,600	$12,600

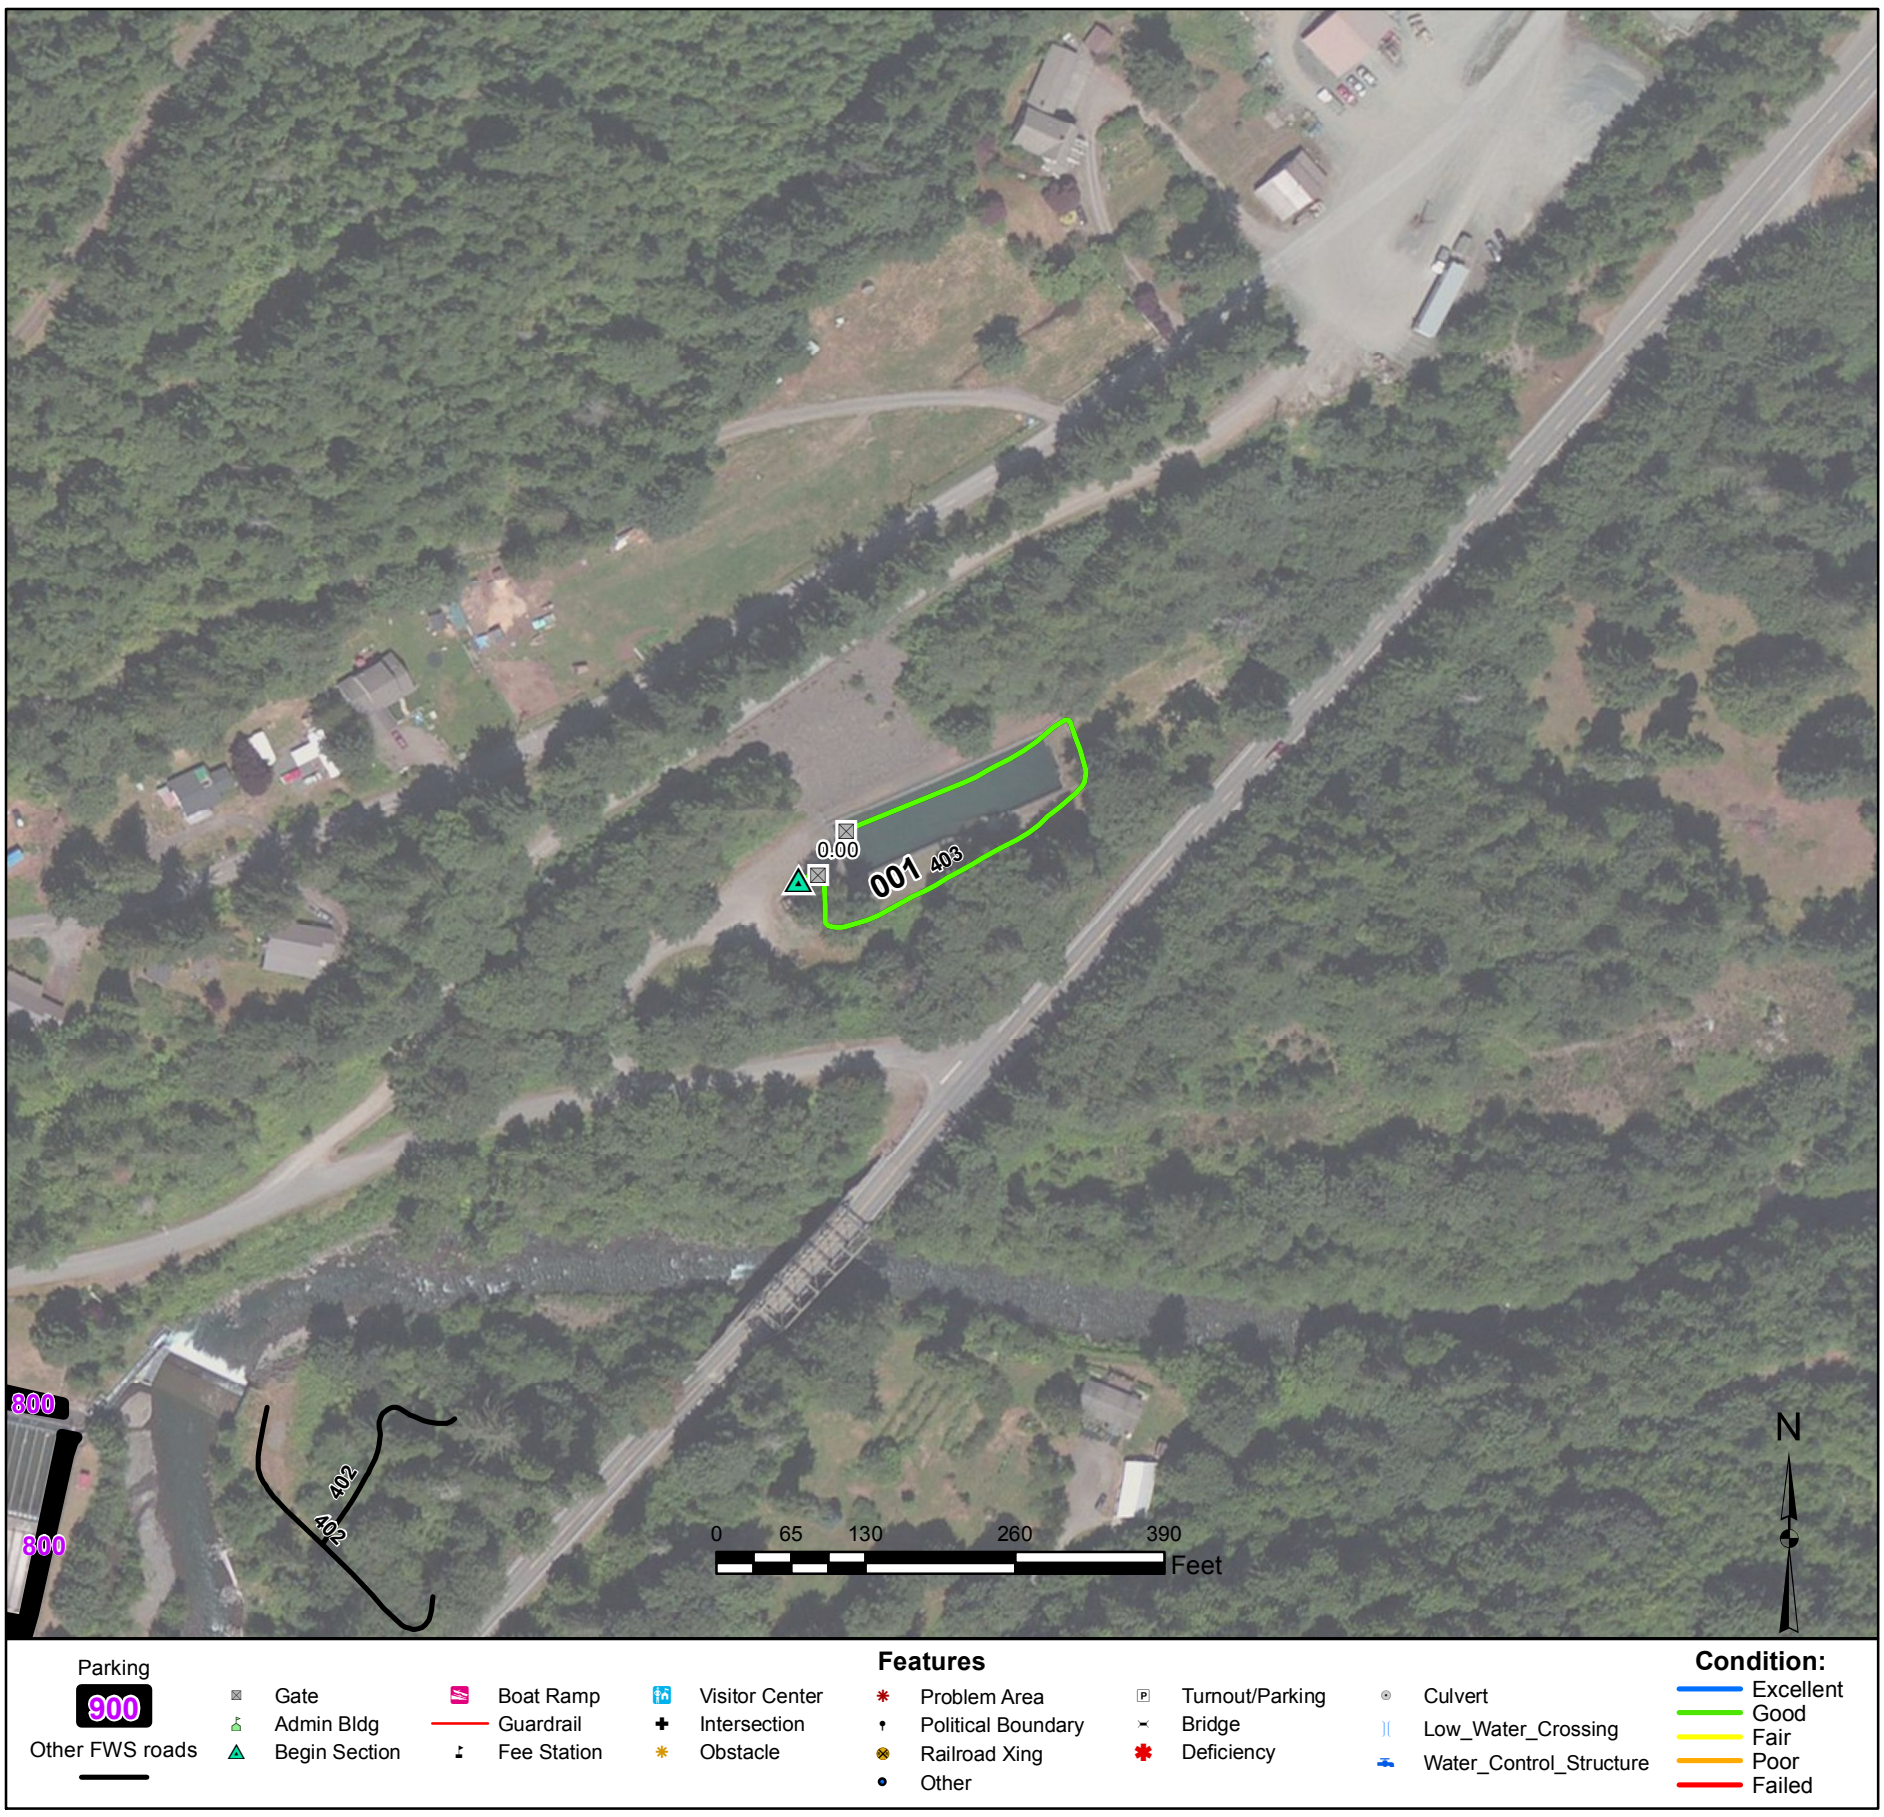
EPA Pond Service Road

Asset Number	-				
Section Number	001				
Section Length (miles)	0.11				
Inspection Date	02-25-2013				
Surface Type	Gravel				
Number of Lanes	2				
Roadway Width (feet)	16				
Condition	Good				
Remaining Service Life (years)	7				
Estimated Cost to Repair	$200				
Current Replacement Value	$89,400

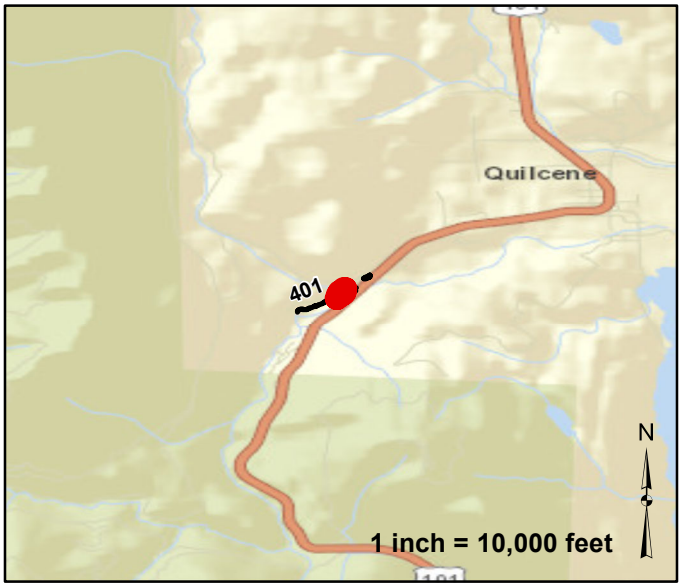
Asset Number	Area (Sq Ft)	Spaces	Condition	Surface Type	Cost to Improve	Inspection Date	Current Replacement Value
10002782	40326	15	Fair	Asphalt	$40,700	02-25-2013	$431,100

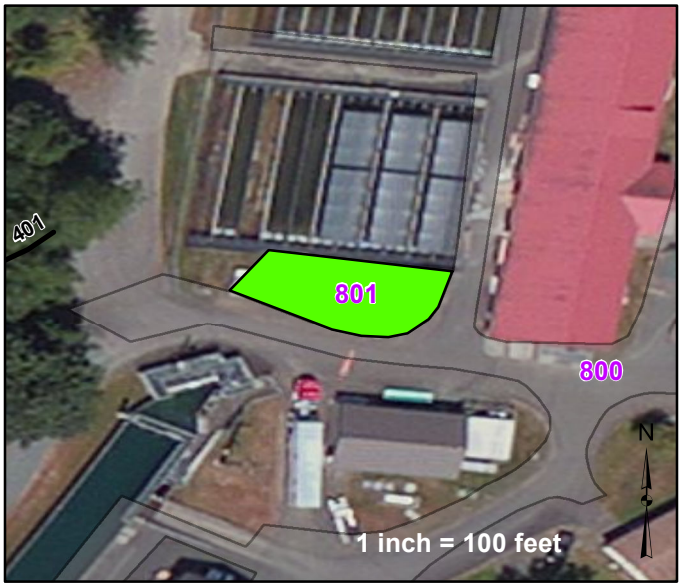
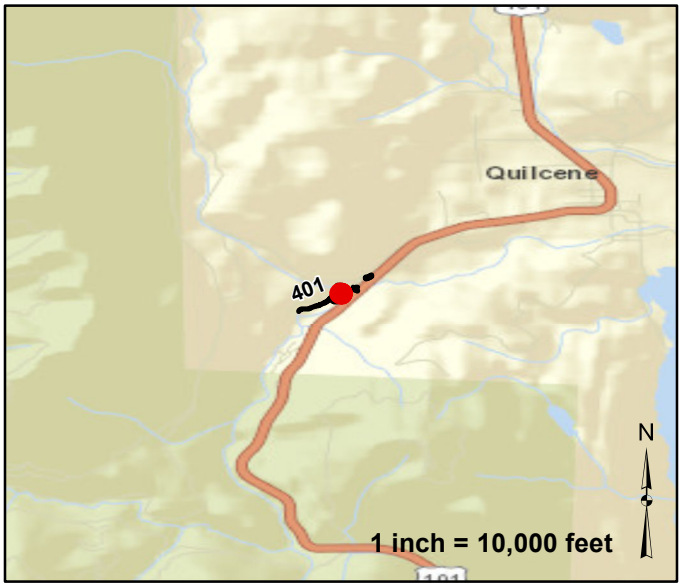
Asset Number	Area (Sq Ft)	Spaces	Condition	Surface Type	Cost to Improve	Inspection Date	Current Replacement Value
-	2293	8	Good	Gravel	$400	02-25-2013	$13,400

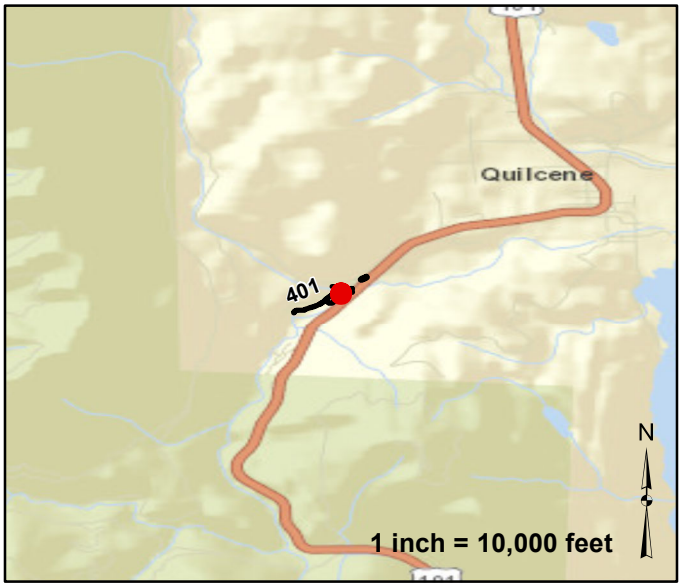
Asset Number	Area (Sq Ft)	Spaces	Condition	Surface Type	Cost to Improve	Inspection Date	Current Replacement Value
-	2614	15	Fair	Concrete	$5,600	02-25-2013	$33,900

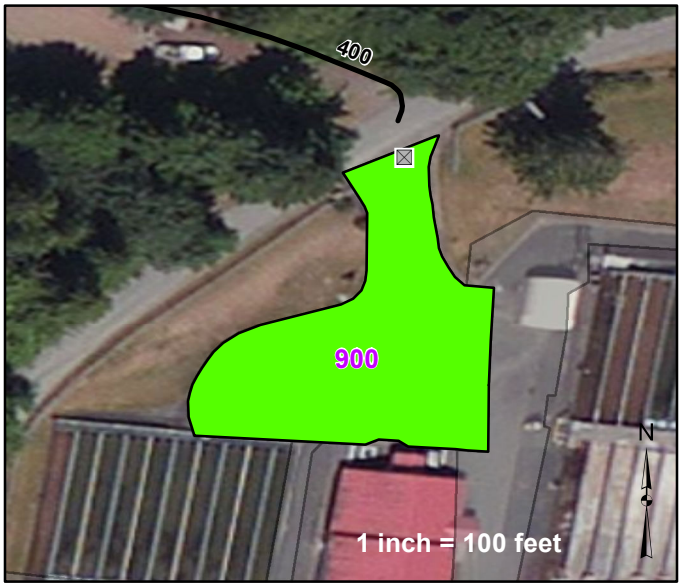
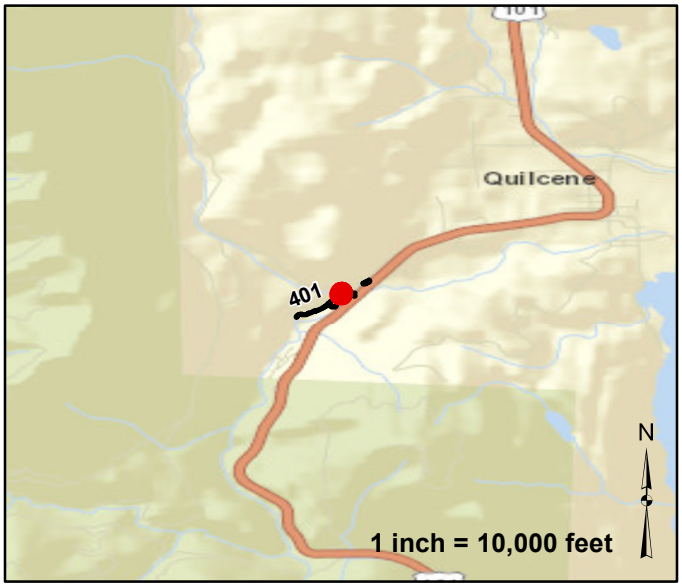
Asset Number	Area (Sq Ft)	Spaces	Condition	Surface Type	Cost to Improve	Inspection Date	Current Replacement Value
10063723	8574	8	Good	Asphalt	$1,900	02-25-2013	$91,700
