The Road Inventory of Oxford Slough Waterfowl Production Area

Pocatello, ID

Prepared By:
Federal Highway Administration
Central Federal Lands Highway Division
May 2013

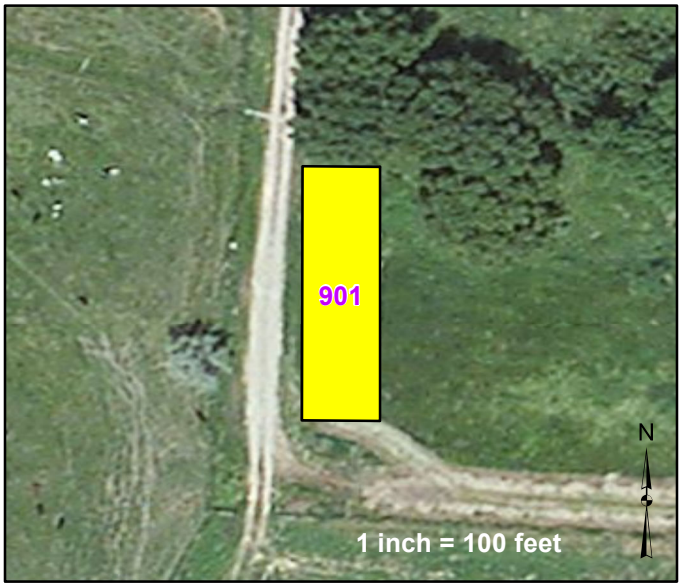
Route Number: 901

Harkness Street Parking

Asset Number	Area (Sq Ft)	Spaces	Condition	Surface Type	Cost to Improve	Inspection Date	Current Replacement Value
-	3984	10	Fair	Native	$1,000	04-30-2013	$8,300
